**Catkins  
2 Betty Grove Lane  
Sindlesham  
Berkshire  
RG41 5DR**

# **Preliminary Bat Roost Assessment**

**Ref: R3311/b**

**September 2023**

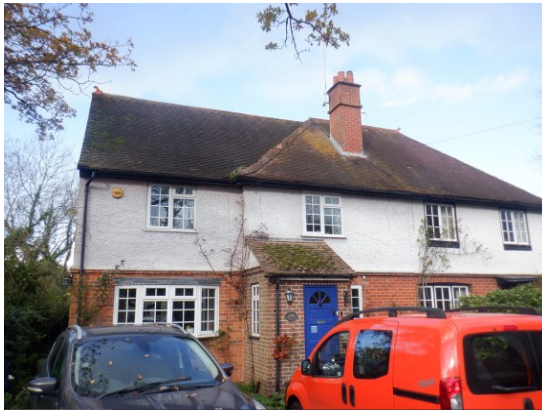
- 4.2.1** The semi-detached property had a pitched roof and was of modern cavity wall construction with rendered walls on the second-storey. There was a front porch and single-storey rear extension (**Photographs 1 & 2**).

**1. Front of the property, viewed from the southeast.**

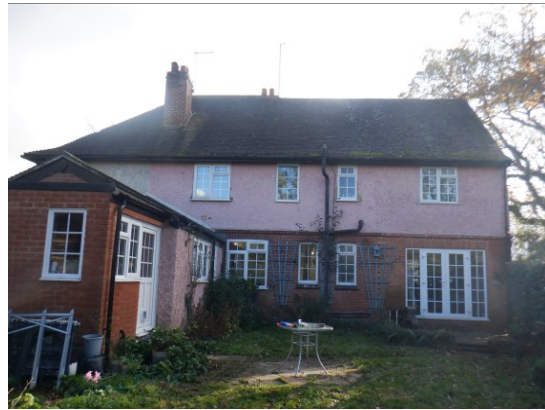
**2. Rear of the property, viewed from the north.**

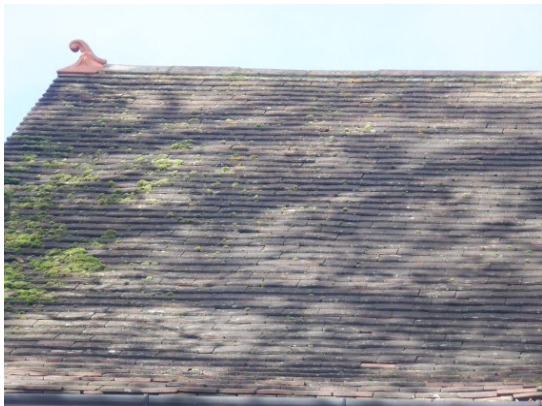
- 4.2.2** The clay roof tiles on the main roof were frequently lifted, damaged or missing on both the front and rear elevations, particularly along the southwest verge where the tiles were uneven (**Photographs 3 & 4; Target notes 1 & 2**). Furthermore, the curved roof tiles on the existing rear extension were also frequently lifted or damaged (**Photograph 5; Target note 3**). The mortar along the ridge and hip tiles on the main roof was fully intact and the verge mortar on the southwest gable was intact (**Photographs 6 & 7; Target notes 4 & 5**). In addition, the verge mortar and ridge tiles were fully intact on the existing rear extension (**Photograph 8**).

**5.1.3** In addition, externally the property had features suitable for crevice-dwelling bat species such as gaps behind lifted, damaged or missing roof tiles, particularly along the southwest verge, and gaps between the lead flashing around the chimneys and the roof tiles. Droppings from crevice-dwelling bats can be hidden from view between roof tiles and roof linings or within cavity walls.

**3. Frequently lifted, damaged or missing clay roof tiles, viewed from the southeast.**

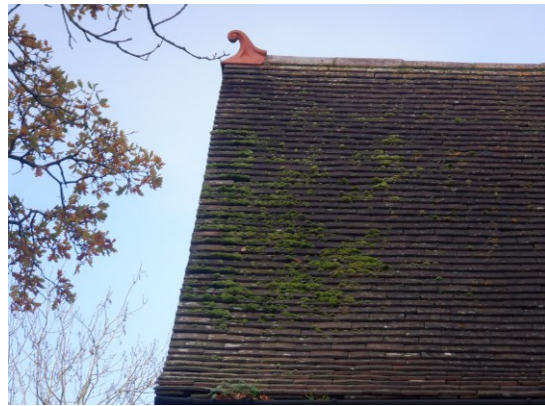
**4. Uneven row of clay roof tiles along the southwest verge, viewed from the southeast.**

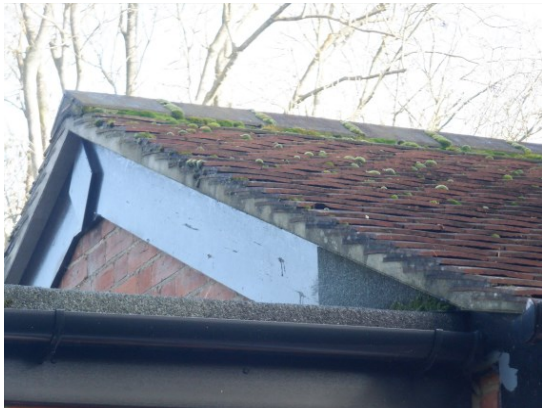
**5.2.2** The small rear extension will connect partly to the lower part of the exiting single storey roof, which had curved tiles with gaps of sufficient size for use by crevice dwelling bat species; however, the close endoscopic inspection combined with the earlier findings shows it is unlikely this small roof is used by bats and therefore

**5. Frequently lifted clay roof tiles on the existing rear extension, viewed from the west.**

**5.3.2** The licensed ecologist will complete an updated inspection of the existing single storey roof for bats and signs of use by bats before tiles are removed. The tiles will be lifted by gloved hand, and bats are discovered during the work, it will stop immediately. Work will only recommence when the licensed ecologist has provided further written advice, and if necessary, a mitigation licence has been obtained.

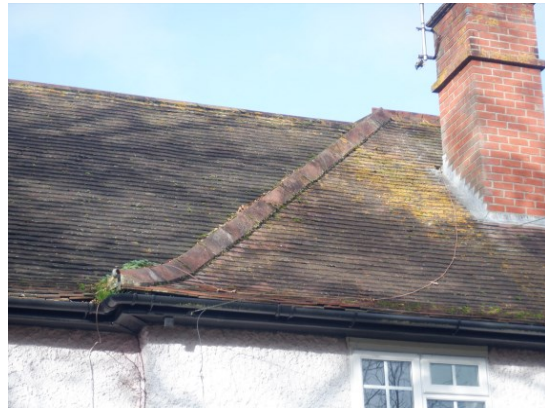
**6. Mortar along the hip & ridge tiles fully intact, viewed from the southeast.**

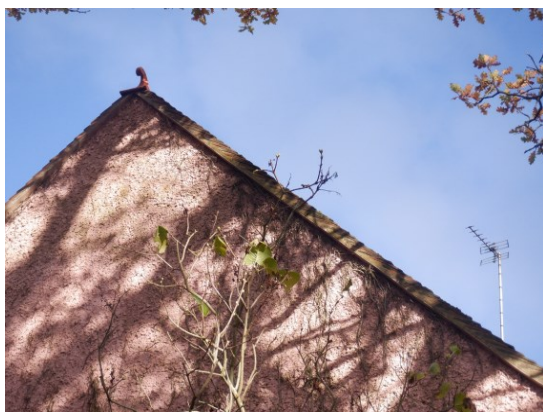
**7. Verge mortar fully intact along the southwest gable.**

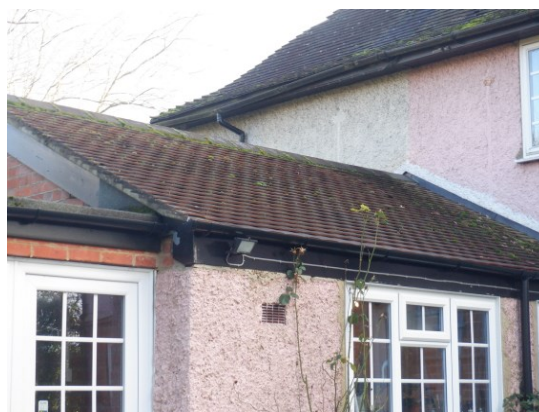
**8. Verge mortar and ridge tiles fully intact on the existing rear extension, viewed from the west.**

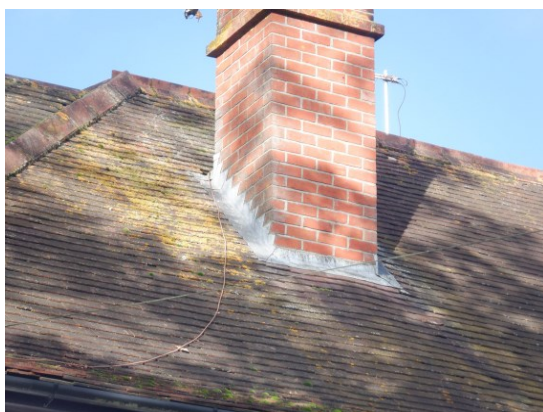
- 4.2.3** Whilst the lead flashing was tight to the front chimney and the mortared tiles to the rear chimney, gaps were situated between the top row of roof tiles and the lead flashing (**Photographs 9 & 10; Target note 6**). The timber soffit was tight to the rendered wall of the main house on all elevations and the timber fascia was tight to the existing rear extension (**Photographs 11 & 12; Target notes 7 & 8**). Two bird boxes were situated on the southwest side elevation with a third bird box on the rear wall (**Photograph 13; Target note 9**).

**9. Tight lead flashing but gap between clay roof tiles and lead flashing to the rear of the chimney, viewed from the southeast.**

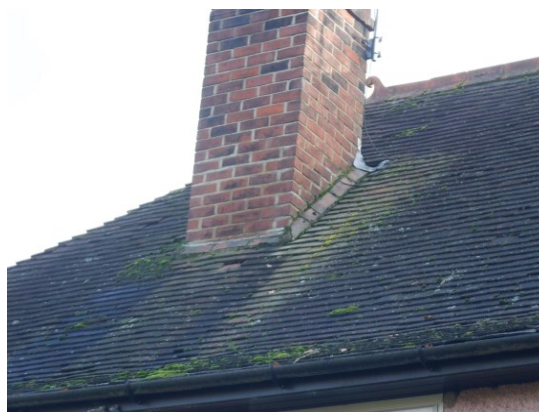
**10. Gap between clay roof tiles and lead flashing to the rear of the chimney, viewed from the west.**

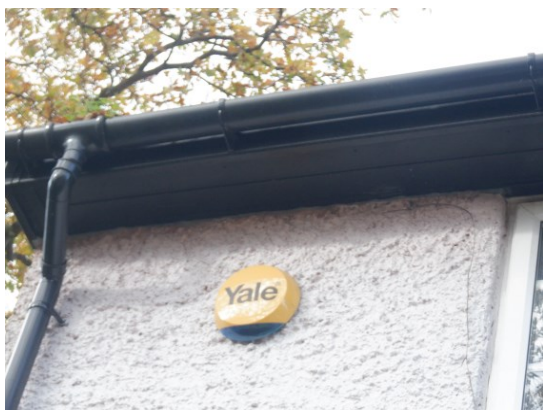
**11. Timber soffit flush to the rendered wall of the main house, viewed from the southeast.**

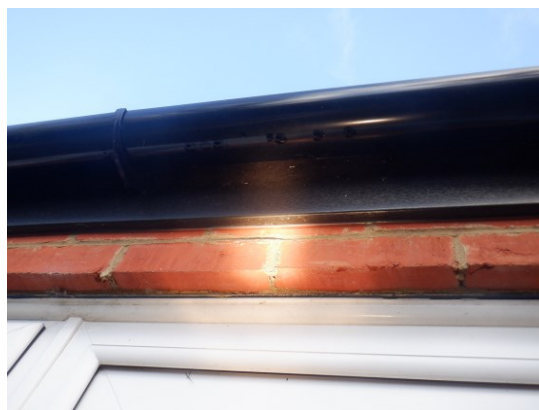
**12. Timber fascia flush to the wall of the existing rear extension, viewed from the west.**

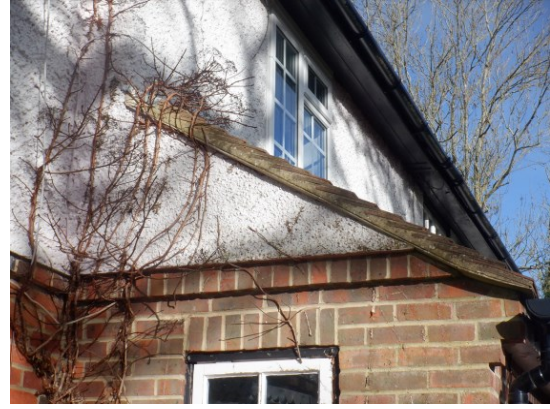
- 4.2.4** The verge mortar was fully intact along the front porch (**Photograph 14**). Whilst the moss-covered clay roof tiles on the porch were occasionally lifted, the lead flashing was flush to the roof tiles and rendered wall (**Photograph 15; Target notes 10 & 11**).

**14. Verge mortar fully intact on front porch, viewed from the southwest.**

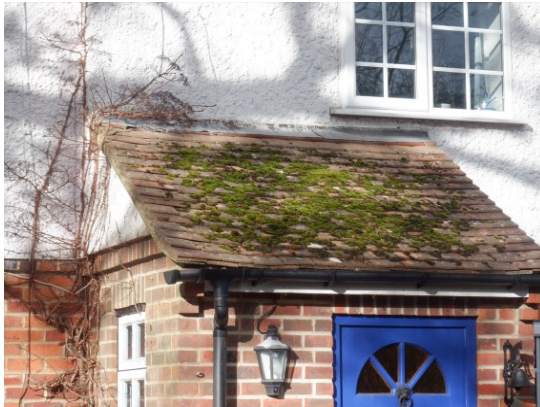
**15. Occasionally lifted clay roof tiles under moss with lead flashing flush to the rendered wall, viewed from the southeast.**

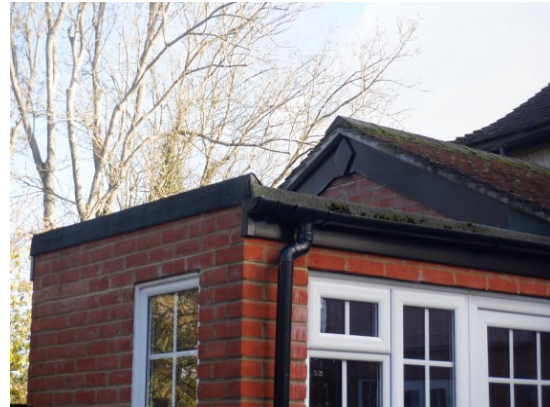
- 4.2.5** The flat roof section connecting to the existing rear extension was lined with bitumen felt which was tight to the brick wall (**Photograph 16; Target note 12**).

**16. Bitumen felt tight to the brick wall of the flat roof section, viewed from the northwest.**

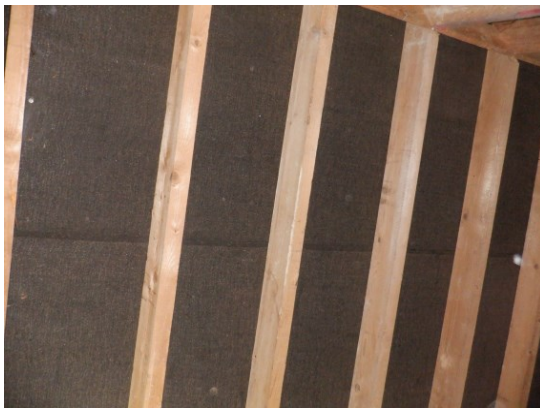
**4.3.2** The roof was lined with Type 1F bitumen felt which was mostly intact, however, sections of felt were missing by the northeast party wall where the clay roof tiles were visible (**Photographs 17 & 18; Target notes 13 & 14**). Slight gaps were also situated between the bitumen felt and the ridge which was tightly sealed against an internal block wall within the southeast corner of the void (**Photograph 19; Target notes 15 & 16**). The bitumen felt against the southeast chimney was loose with roof tiles visible behind (**Photograph 20; Target note 17**). The roof was partially boarded over fiberglass insulation which filled most eaves other than in the southwest section (**Photograph 21; Target notes 18 & 19**). The northeast party wall was half exposed and was of brick and blockwork construction with end rafters sealed to the wall (**Photograph 22; Target note 20**). The southwest gable end was of blockwork construction with gaps between the end rafters and gable, particularly at the apex (**Photograph 23; Target note 21**).

**17. Type 1F bitumen felt mostly intact throughout the roof void.**

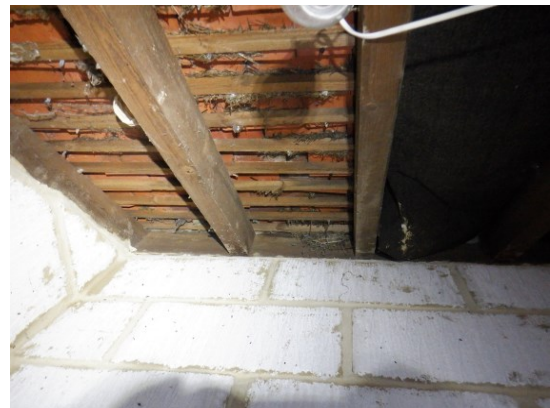
**18. Section of unlined roof with clay roof tiles visible.**

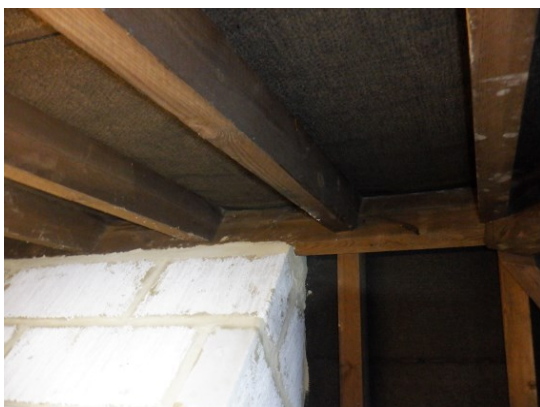
**19. Slight gaps between bitumen felt and ridge which are both connected to an internal blockwork wall.**

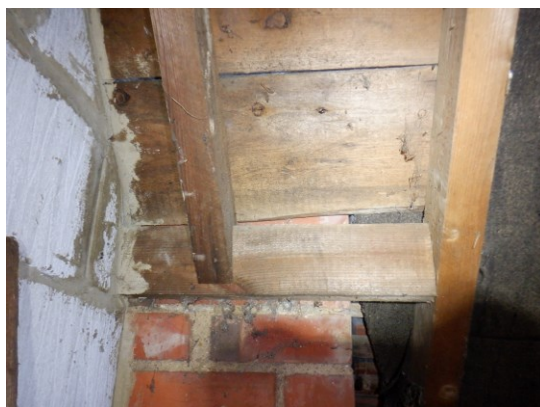
**20. Bitumen felt loose against southeast chimney with roof tiles visible.**

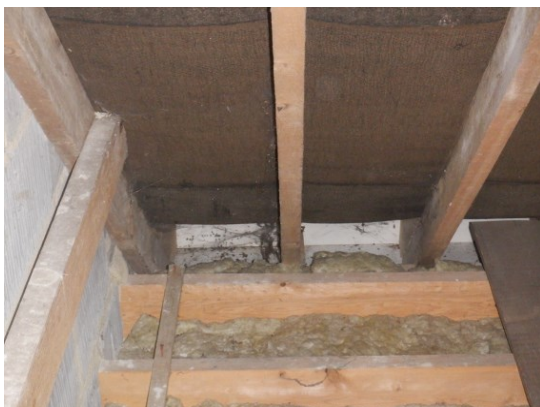
**21. Open eaves within the southwest section of the roof void.**

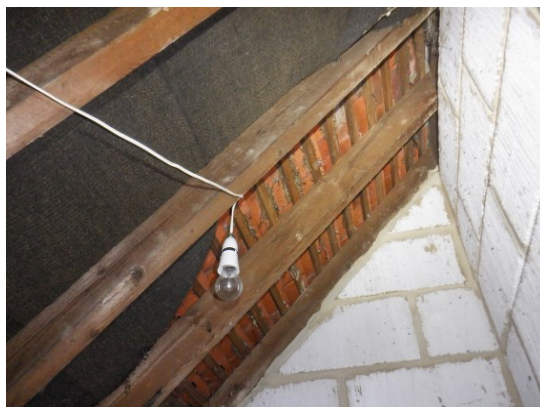
**22. End rafter sealed to the northeast party wall.**

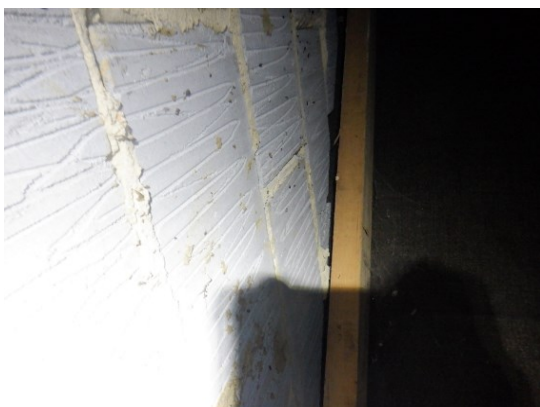
**23. Gaps between southwest blockwork gable and end rafter.**

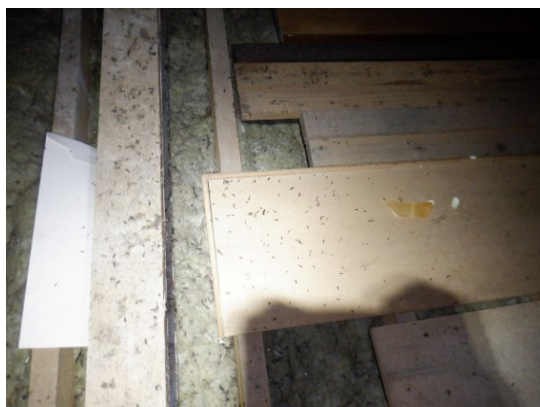
**4.3.3** Approximately 750 - 1000 medium-sized bat droppings were scattered throughout the entirety of the roof void with the highest density concentrated on the southwest gable wall (50-100 droppings) and at its base (300-400 droppings) (**Photographs 24, 25 & 26**). In addition, approximately 200 – 300 medium-sized droppings were situated at the base of the northeast party wall, under the unlined section of the roof (**Photograph 27**).

**5.1.1** Internally, the observation of approximately 750 - 1000 medium-sized bat droppings – resembling those typically deposited by long-eared bats (*Plecotus* spp, indicates that the roof void is likely to have been used as a well-used day roost by small numbers of non-breeding brown long-eared bats or a small brown long-eared maternity roost. Potential access points were identified to likely be along the southwest gable end, particularly under the uneven roof tiles on the verge. The bat droppings found at the party wall indicate that there is likely to be further droppings in the neighbouring attached property so a full assessment of the status of the roost is not possible from droppings alone.

**24. Medium-sized bat droppings scattered throughout the roof void.**

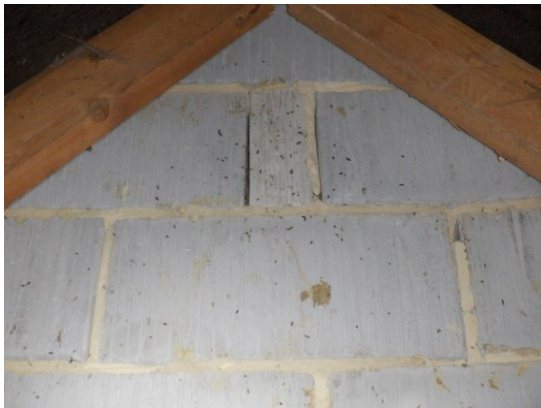
**25. Approximately 50 - 100 medium-sized bat droppings on the southwest gable wall**

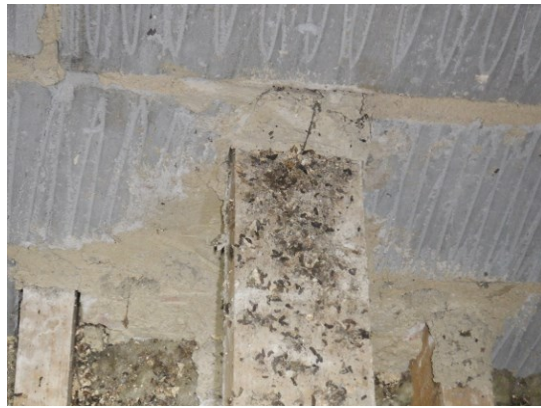
**26. Approximately 300 - 400 medium-sized bat droppings at the base of the southwest gable wall.**

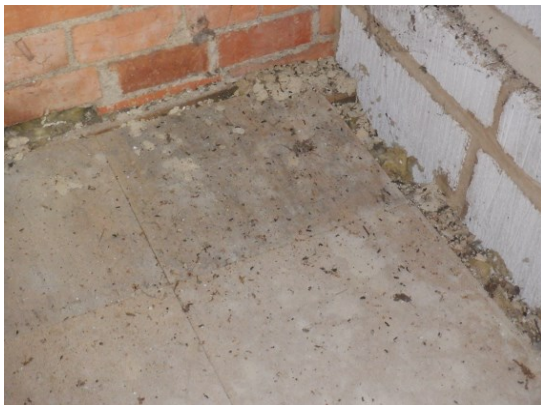
**27. Approximately 200 - 300 medium-sized bat droppings at the base of the northeast party wall.**

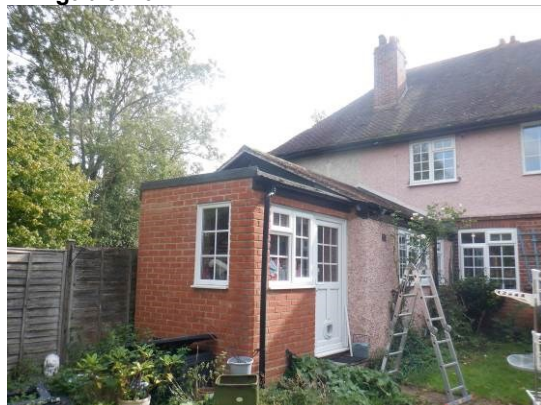
**4.4.1** No bats or evidence of bats was visible during the close endoscopic inspection (**Photographs 28 & 29**).

**28. The single storey extension to be extended (Sept 23).**

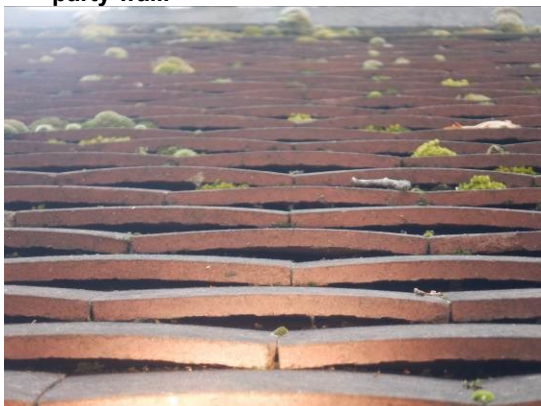
**29. Gaps beneath curved tiles inspected (Sept 23)**
