## **URS BUILDING REFURBISHMENT**

### **EXTERNAL CONCRETE REPAIR – HERITAGE OFFER**

**JUNE 2024**

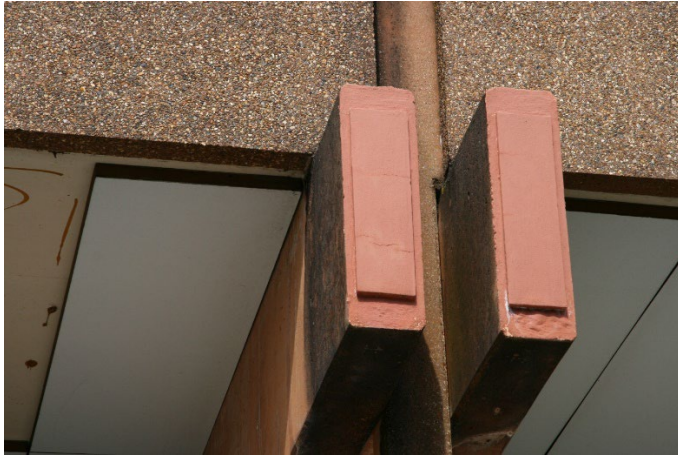
There are numerous small / fine cracks across the building together with some large cracks (classified in this report as being over 3mm wide). Cracking is a natural feature of concrete structures and in many cases will have little effect on strength and durability. Some of the cracks will be non-structural and will have developed during the construction process or be the result of thermal variation.

Example of Defect Type A1

| DEFECT TYPE | REPAIR TYPE | REPAIR DESCRIPTION |
|---|---|---|
| <b>A1</b><br>Hairline cracking to concrete less than 3mm. | <b>RA1A</b> | Cracking 0 to 3 mm width: do nothing, monitor through periodic inspection. |
| | <b>RA1B</b> | <b>1.HAND PLACED – SMALL STATIC</b><br>Mortar/grout samples required for prior approval and subject to testing/trials. Remove loose materials and flush out fine cracks with a sharp tool and water to remove dirt/debris and prepare surface. Using a fine tool, apply the approved mortar mix to the crack, being careful not to smear mortar across the adjacent surface. Once the crack is full, carefully clean the surface with a damp sponge and allow to set. Dry brush surface after 24 hours to remove any excess material and ensure finish matches adjacent.<br><b>OR</b> |

| | | <p><b>2.GROUT INJECTION – LARGER STATIC</b></p> <p>Mortar/grout samples required for prior approval and subject to testing/trials. Remove loose materials and flush out fine cracks with a sharp tool and water to remove dirt/debris and prepare surface. Drill very fine holes at intermittent centres along the crack and insert bleeder tube secured with plasticine.</p> <p>Insert grout mix on lowest bleed tube (working from the base up) and fill for established time (duration to be established as part of trials process). Remove grout feeder after established time period. Insert the grout feeder tube on the bleeder tube above and repeat the process until all bleeder tubes are filled. Once initial set is achieved, remove plasticine and grout tip from wall and allow to fully cure.</p> <p><b>OR</b></p> <p><b>3.ACTIVE (resin inject and surface repair to fill cracks 0.1-10mm)</b></p> <p>Sealing or undertaking a mortar repair to the crack is the first stage, and is to be undertaken as outlined in RA1B-1/RA1B-2(dependent on the size of the crack), prior to undertaking the resin repair to address the ongoing movement.</p> <p>Note: the area must be dry, free from dirt, dust, grease and debris.</p> <p>Drill a series of injection points at intermittent locations along the crack using a 6mm drill, to a depth of 50mm. The distance between ports should be 1.5x the estimated depth of the crack.</p> <p>Flush through the holes with clean water to remove any debris/drill dust. Insert the resin/feeder tubes along the line of the crack and grouted on the surface. Allow to set.</p> <p>Prepare the resin mix using a slow speed drill. Transfer the mix to a suitably sized injection syringe. Attach the syringe to the feeder tube and slowly inject the resin until it appears out of the end of the next feeder tube. Record the amount injected (at each injection point). Close the feeder tube and move the syringe to the port above and repeat progressing up the crack until all ports are fed and closed.</p> <p>Allow to cure, only then removing the injection tubes and making good any holes as RD1A.</p> <p>At all stages care is to be taken to avoid bleeds/smears/seepage onto adjacent concrete.</p> <p><i>Note: Where cracks are repairs to previously painted/coated surfaces, paint/coating is to be reapplied following crack repair, to nearest junction/edge. Extent of recoating to be confirmed by architect.</i></p> |

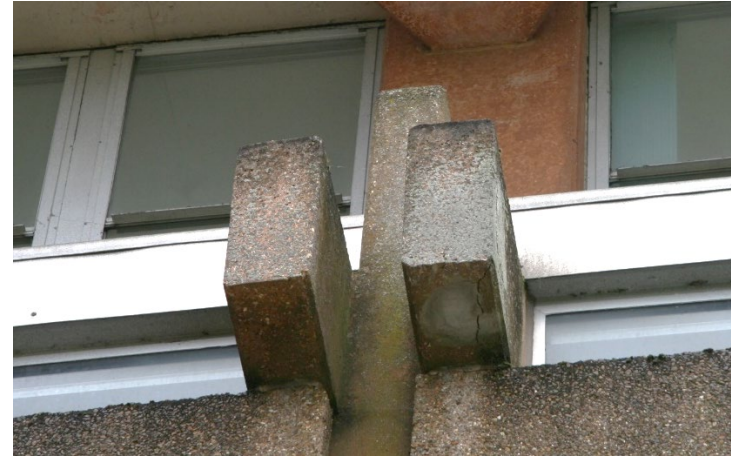
Much of the cracking appears to be the result of corrosion of the reinforcement and is a precursor to spalling. The cracks provide a route for water to ingress the structure and exacerbate the corrosion process. Many of the cracks were viewed from a distance and so should be assessed close up to establish whether they are a sign of more extensive spalling. Cracking along the top edge of transfer beams, as viewed to the gridline return elevations may be due to spalling of the upper reinforcement bars, although further investigation is required.

Example of Defect Type A2

| <p><b>A2</b></p> <p><b>Hairline cracking to concrete more than 3mm.</b></p> | <p><b>RA2A</b></p> | <p><b>1.HAND PLACED – SMALL STATIC</b></p> <p>Mortar/grout samples required for prior approval and subject to testing/trials. Remove loose materials and flush out fine cracks with a sharp tool and water to remove dirt/debris and prepare surface. Using a fine tool, apply the approved mortar mix to the crack, being careful not to smear mortar across the adjacent surface. Once the crack is full, carefully clean the surface with a damp sponge and allow to set. Dry brush surface after 24 hours to remove any excess material and ensure finish matches adjacent.</p> <p><b>OR</b></p> <p><b>2.GROUT INJECTION – LARGER STATIC</b></p> <p>Mortar/grout samples required for prior approval and subject to testing/trials. Remove loose materials and flush out fine cracks with a sharp tool and water to remove dirt/debris and prepare surface. Drill very fine holes at intermittent centres along the crack and insert bleeder tube secured with plasticine.</p> <p>Insert grout mix on lower bleed tube and fill for established time (duration to be established as part of trials process). Remove grout feeder after established time period. Insert the grout feeder tube on the bleeder tube above and repeat the process until all bleeder tubes are filled. Once initial set is achieved, remove plasticine and grout tip from wall and allow to fully cure.</p> <p><b>OR</b></p> <p><b>3.ACTIVE (resin inject and surface repair to fill cracks 0.1-10mm)</b></p> <p>Sealing or undertaking a mortar repair to the crack is the first stage, and is to be undertaken as outlined in RA1B-1/RA1B-2(dependent on the size of the crack), prior to undertaking the resin repair to address the ongoing movement.</p> <p>Note: the area must be dry, free from dirt, dust, grease and debris.</p> <p>Drill a series of injection points at intermittent locations along the crack using a 6mm drill, to a depth of 50mm. The distance between ports should be 1.5x the estimated depth of the crack.</p> <p>Flush through the holes with clean water to remove any debris/drill dust. Insert the resin/feeder tubes along the line of the crack and grouted on the surface. Allow to set.</p> <p>Prepare the resin mix using a slow speed drill. Transfer the mix to a suitably sized injection syringe. Attach the syringe to the feeder tube and slowly inject the resin until it appears out of the end of the next feeder tube. Record the amount injected (at each injection point). Close the feeder tube and move the syringe to the port above and repeat progressing up the crack until all ports are fed and closed.</p> |

| | | <p>Allow to cure, only then removing the injection tubes and making good any holes as RD1A.</p> <p>At all stages care is to be taken to avoid bleeds/smears/seepage onto adjacent concrete.</p> <p><i>Note: Where cracks are repairs to previously painted/coated surfaces, paint/coating is to be reapplied following crack repair, to nearest junction/edge. Extent of recoating to be confirmed by architect.</i></p> |

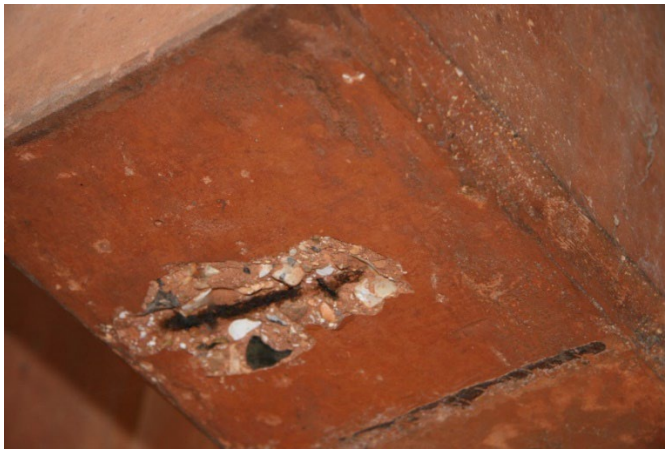
Spalling of concrete occurs where the steel reinforcements have corroded, and the expansion of the metal exerts pressure on the surrounding concrete. The principal causes are shallow cover of concrete to the reinforcement bars, progress of carbonation to the depth of the concrete cover, or beyond, and water ingress. Spalling could be seen to all areas around the building and to both in situ and pre-cast concrete components. In some areas the loss of concrete has exposed the reinforcement bars. Spalling is more notable to exposed areas of concrete, including post and beam ends, and also to soffits where water has tracked into the structure via open construction joints.

*Example of Defect Type B1*

| B – Spalling | | |
|---|---|---|
| <b>BI</b><br><br><b>Spalling or damaged surface – reinforcement bar is visible</b> | <b>RBIA</b> | <p>Identify repair mortar from approved samples as closest match to parent material. Mask/protect adjacent surface to prevent dust, residue/smearing to adjacent concrete.</p> <p><b>Concrete breakout/cutting out</b></p> <p>The affected area is to be cut out back to sound substrate, removing all carbonated/contaminated concrete, including behind reinforcement bars where necessary.</p> <p>Mark out damaged area. Extent and shape to be agreed with architect. Use a diamond core drill (diameter size dependent on size of repair areas) with drill guide to mark rounded corners of repair area to prevent spalling/damage to the adjacent fabric (sharp corners are to be avoided). Drill to a suitable depth to reach sound material. Follow by cutting along the edges of the repair area with a diamond blade to the internal angles of the corner. Undercut by 2-4 mm and to a depth of 25mm to create a dovetail to improve adhesion of patch repair.</p> <p>Where delamination is severe, the depth of the repair should be a minimum of 40mm depth to provide sufficient cover. The amount of material removed must however be minimised to ensure the area is not undermined structurally. Where reinforcement is exposed due to insufficient cover or has suffered significant corrosion or loss in section, cut back to sound material, this may extend behind the reinforcement. The extent of cutting out should be determined as part of the trial repairs and will likely vary across the building, but should extend a minimum of 30mm behind the reinforcement in carbonated/chloride contaminated areas.</p> <p>Carefully break out the remainder of the repair area, taking care not to bruise or damage the substrate using a sharp chisel or jack hammer held at a shallow angle. Remove any loose material and brush clean etc. The base of the cut-out area should be left rough to aid the key/adhesion of the repair material.</p> <p>Corroded reinforcement bars should be cleaned by hand or by grit blasting. Prior to any repairs/mortar application the exposed/cleaned re-bars will need to be re-passivated by applying an alkali cement slurry. Where exposed reinforcement has an existing protective treatment, this should be removed.</p> <p>Treatment of the reinforcement is to be agreed by a structural engineer. Where possible, the existing reinforcement may be able to be pushed back further into the concrete, to allow sufficient cover between the reinforcement and the new repaired finished face of the concrete. Where new reinforcement is required, this is to be specified by a structural engineer.</p> |

| | | <p>Temporary structural support is to be provided for the duration of the repair where required, and designed by a suitably qualified engineer.</p> <p><b>Shutters &amp; Formwork &amp; Hand placed repairs</b></p> <p>Shuttering and formwork design will vary and is subject to the area under repair and should replicate the existing finish/profile/details. Shutters likely to be made from plywood to match the fair faced finish. Shutters to be sized according to repair area and butt jointed and sealed to the perimeter to prevent seepage. Insert a letterbox into the top of the formwork/shuttering for the concrete to be poured into. Coat the shuttering with a release agent or retarder as required prior to use. Additional fixings for formwork/shuttering to be avoided where possible. Allow to make good if necessary.</p> <p>For hand placed repairs, once the repair area has been broken out, prime the repair area using a cement slurry, prior to application of the repair mortar.</p> <p><b>Implementing repair</b></p> <p>Wet the area, sufficiently to avoid the parent material absorbing all water, but do not over wet to avoid poor adhesion. In some instances a bond coat may be beneficial. Pour the concrete mix (as per agreed sample) in batches through opening/letterbox to repair area and tamp/vibrate to eliminate air until the formwork is completely filled and all air gaps eradicated. Ensure water content is minimised to prevent shrinkage. Allow to set before removing the shuttering. Curing time will be subject to environmental conditions and all repairs should be covered in damp blankets.</p> <p>For hand placed repairs, apply and build up the repair in layers.</p> <p><b>Surface finish</b></p> <p>Finishing will be subject to trials/sample areas. Finish to match adjacent/original surface finish, and cover with damp hessian/blankets to ensure sufficient hydration. Ensure access is retained to provide access until curing is complete.</p> <p>Reapply coatings as required and in accordance with manufacturer's instructions (coatings specification subject to trials and analysis).</p> <p><i><b>NOTE: To painted soffits, it may be appropriate to use a proprietary repair mortar, subject to agreement with the architect, trials, and further discussion with the relevant stakeholders. Proprietary mortars to be installed in accordance with manufacturer's instructions, surface finish to match adjacent surface and to receive paint finish to match adjacent surfaces.</b></i></p> |

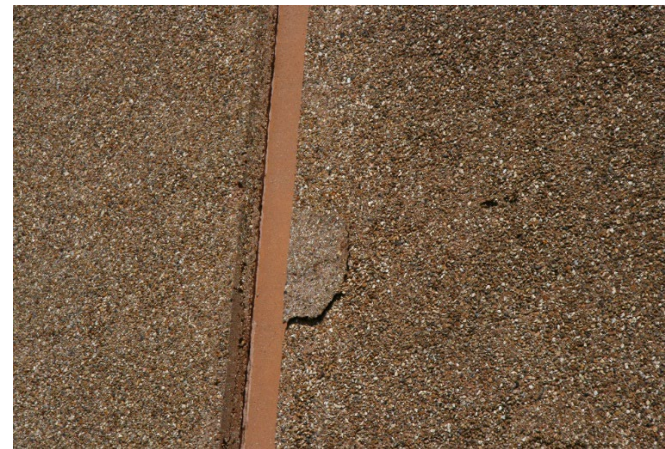
*Example of Defect Type B2*

| <p><b>B2</b></p> <p>Spalling or damaged surface – reinforcement bar is not visible at this stage (note, once defective material removed/ further investigations are completed, reinforcement may be found and the repair type will revert to RB1A)</p> | <p><b>RB2A</b></p> | <p>Identify repair mortar from approved samples as closest match to parent material. Mask/protect adjacent surface to prevent dust, residue/smearing to adjacent concrete.</p> <p><b>Concrete breakout/Cutting Out</b></p> <p>The affected area is to be cut out back to sound substrate, removing all loose/defective material.</p> <p>Mark out damaged area. Extent and shape to be agreed with architect. Use a diamond core drill (diameter size dependent on size of repair areas) with drill guide to mark rounded corners of repair area to prevent spalling/damage to the adjacent fabric (sharp corners are to be avoided). Drill to a suitable depth to reach sound material. Follow by cutting along the edges of the repair area with a diamond blade to the internal angles of the corner. Undercut by 2-4 mm and to a depth of 25mm to create a dovetail to improve adhesion of patch repair.</p> <p>Where delamination is severe, the depth of the repair should be a minimum of 40mm depth to provide sufficient cover. The amount of material removed must however be minimised to ensure the area is not undermined structurally. Where reinforcement is exposed, refer to RB1A for the repair methodology.</p> <p>Carefully break out the remainder of the repair area, taking care not to bruise or damage the substrate using a sharp chisel or jack hammer held at a shallow angle. Remove any loose material and brush clean etc. The base of the cut-out area should be left rough to aid the key/adhesion of the repair material.</p> <p>Temporary structural support is to be provided for the duration of the repair where required, and designed by a suitably qualified engineer.</p> <p><b>Shutters &amp; Formwork &amp; Hand placed repairs</b></p> <p>Shuttering and formwork design will vary and is subject to the area under repair and should replicate the existing finish/profile/details. Shutters likely to be made from plywood to match the fair faced finish. Shutters to be sized according to repair area and butt jointed and sealed to the perimeter to prevent seepage. Insert a letterbox into the top of the formwork/shuttering for the concrete to be poured into. Coat the shuttering with a release agent or retarder as required prior to use. Additional fixings for formwork/shuttering to be avoided where possible.</p> <p>For hand placed repairs, once the repair area has been broken out, prime the repair area using a cement slurry, prior to application of the repair mortar.</p> <p><b>Implementing repair</b></p> <p>Wet the area, sufficiently to avoid the parent material absorbing all water, but do not over wet to avoid poor adhesion. In some instances, a bond coat may be beneficial. Pour the concrete mix (as per agreed sample) in batches through opening/letterbox to repair area and tamp/vibrate to eliminate air until the formwork is</p> |

| | | <p>completely filled and all air gaps eradicated. Ensure water content is minimised to prevent shrinkage. Allow to set before removing the shuttering. Curing time will be subject to environmental conditions and all repairs should be covered in damp blankets.</p> <p>For hand placed repairs, apply and build up the repair in layers.</p> <p><b>Surface finish</b></p> <p>Finishing will be subject to trials/sample areas. Finish to match adjacent/original surface finish, and cover with damp hessian/blankets to ensure sufficient hydration. Ensure access is retained to provide access until curing is complete.</p> <p>Reapply coatings as required and in accordance with manufacturer's instructions (coatings specification subject to trials and analysis).</p> <p><i>NOTE: In some instances, a precast unit may be deemed more appropriate. This is subject to further review and discussion, for example to the damaged concrete ventilation grilles to ground floor perimeter.</i></p> <p><i>NOTE: To painted soffits, it may be appropriate to use a proprietary repair mortar, subject to agreement with the architect, trials, and further discussion with the relevant stakeholders. Proprietary mortars to be installed in accordance with manufacturer's instructions, surface finish to match adjacent surface and to receive paint finish to match adjacent surfaces.</i></p> |

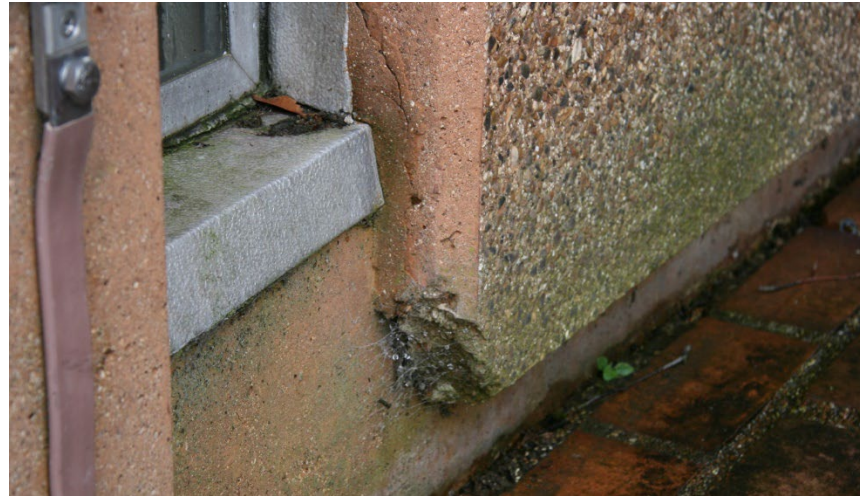
There are a very small number of instances of impact damage to both in situ and pre-cast concrete panels, where there is a small loss of concrete but with no exposure of reinforcement bars. There is no notable pattern to the impact damage and so there are no obvious management actions to avoid future mechanical damage. As noted above, where there has been a loss of concrete, this can reduce the amount of cover over steel reinforcement and pushes the carbonation front closer to the reinforcement, increasing the risk of corrosion and spalling. Localised concrete repairs should be undertaken to reduce the risk of more extensive damage.

Example of Defect Type B3

| <p><b>B3</b></p> <p><b>Impact damage</b></p> | <p><b><i>RB3A</i></b></p> | <p>Identify repair mortar from approved samples as closest match to parent material. Mask/protect adjacent surface to prevent dust, residue/smearing to adjacent concrete.</p> <p><b>Concrete breakout/Cutting Out</b></p> <p>The affected area is to be cut out back to sound substrate, removing all loose/defective material.</p> <p>Mark out damaged area. Extent and shape to be agreed with architect. Use a diamond core drill (diameter size dependent on size of repair areas) with drill guide to mark rounded corners of repair area to prevent spalling/damage to the adjacent fabric (sharp corners are to be avoided). Drill to a suitable depth to reach sound material. Follow by cutting along the edges of the repair area with a diamond blade to the internal angles of the corner. Undercut by 2-4 mm and to a depth of 25mm to create a dovetail to improve adhesion of patch repair.</p> <p>Where delamination is severe, the depth of the repair should be a minimum of 40mm depth to provide sufficient cover. The amount of material removed must however be minimised to ensure the area is not undermined structurally. Where reinforcement is exposed, refer to RBIA for the repair methodology.</p> |

| | | <p>Carefully break out the remainder of the repair area, taking care not to bruise or damage the substrate using a sharp chisel or jack hammer held at a shallow angle. Remove any loose material and brush clean etc. The base of the cut-out area should be left rough to aid the key/adhesion of the repair material.</p> <p>Temporary structural support is to be provided for the duration of the repair where required, and designed by a suitably qualified engineer.</p> <p><b>Shutters &amp; Formwork &amp; Hand placed repairs</b></p> <p>Shuttering and formwork design will vary and is subject to the area under repair and should replicate the existing finish/profile/details. Shutters likely to be made from plywood to match the fair faced finish. Shutters to be sized according to repair area and butt jointed and sealed to the perimeter to prevent seepage. Insert a letterbox into the top of the formwork/shuttering for the concrete to be poured into. Coat the shuttering with a release agent or retarder as required prior to use. Additional fixings for formwork/shuttering to be avoided where possible.</p> <p>For hand placed repairs, once the repair area has been broken out, prime the repair area using a cement slurry, prior to application of the repair mortar.</p> <p><b>Implementing repair</b></p> <p>Wet the area, sufficiently to avoid the parent material absorbing all water, but do not over wet to avoid poor adhesion. In some instances, a bond coat may be beneficial. Pour the concrete mix (as per agreed sample) in batches through opening/letterbox to repair area and tamp/vibrate to eliminate air until the formwork is completely filled and all air gaps eradicated. Ensure water content is minimised to prevent shrinkage. Allow to set before removing the shuttering. Curing time will be subject to environmental conditions and all repairs should be covered in damp blankets.</p> <p>For hand placed repairs, apply and build up the repair in layers.</p> <p><b>Surface finish</b></p> <p>Finishing will be subject to trials/sample areas. Finish to match adjacent/original surface finish, and cover with damp hessian/blankets to ensure sufficient hydration. Ensure access is retained to provide access until curing is complete.</p> |

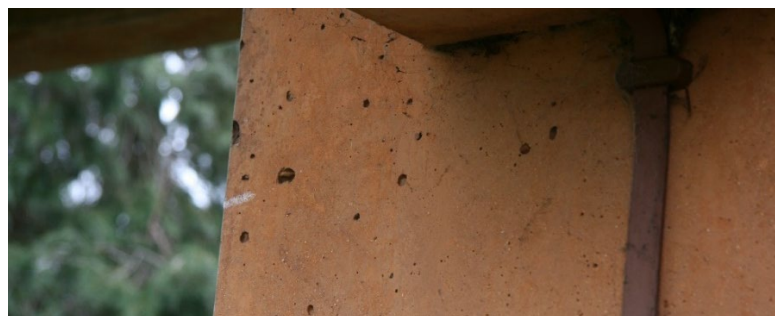
Honeycombing and voids are inherent problems relating to poor workmanship and the original construction materials. They are the result of poor compaction and are mostly found in corners where the presence of a concentration of reinforcement makes access for compaction difficult. The cement paste does not surround aggregate, so the particles are loosely bound. The consequence of honeycombing and voids can be enhanced rates of carbonation.

There are examples of honeycombing and voids across the building but most notably in the following locations. Firstly, to the sides of concrete beams where there is slight honeycombing in occasional vertical strips and also occasional individual voids. Secondly, to the base of the base of beams within the undercroft areas. There is corresponding spalling of concrete in these positions, potentially the result of honeycombing.

Example of Defect Type B4

| <p><b>B4</b></p> <p><b>Compaction Issues</b></p> | <p><b><i>RB4A</i></b></p> | <p>Voids less than 1.25mm deep: do nothing, monitor through periodic inspection.</p> |
| | <p><b><i>RB4B</i></b></p> | <p>Identify repair mortar from approved samples as closest match to parent material avoiding large aggregate. Mask/protect adjacent surface to prevent dust, residue/smearing to adjacent concrete.</p> <p><b>Concrete breakout/Cutting Out</b></p> <p>Remove all loose/defective material from in and around voids.</p> <p>Ensure edges of void are perpendicular to surface or slightly dovetailed, to improve adhesion of patch repair. Clean substrate and remove all loose material, dust, etc.</p> <p>Where reinforcement is exposed, refer to RB1A for the repair methodology.</p> <p><b>Implementing repair</b></p> <p>Wet the area, sufficiently to avoid the parent material absorbing all water, but do not over wet to avoid poor adhesion. In some instances, a bond coat may be beneficial.</p> <p>For hand placed repairs, apply and build up the repair in layers. Use only enough mixing water to create mortar with a stiff consistency but with sufficient workability for handling and placing.</p> <p>Curing time will be subject to environmental conditions.</p> <p><b>Surface finish</b></p> <p>Finishing will be subject to trials/sample areas. Finish to match adjacent/original surface finish, and cover with damp hessian/blankets to ensure sufficient hydration. Ensure access is retained to provide access until curing is complete.</p> |

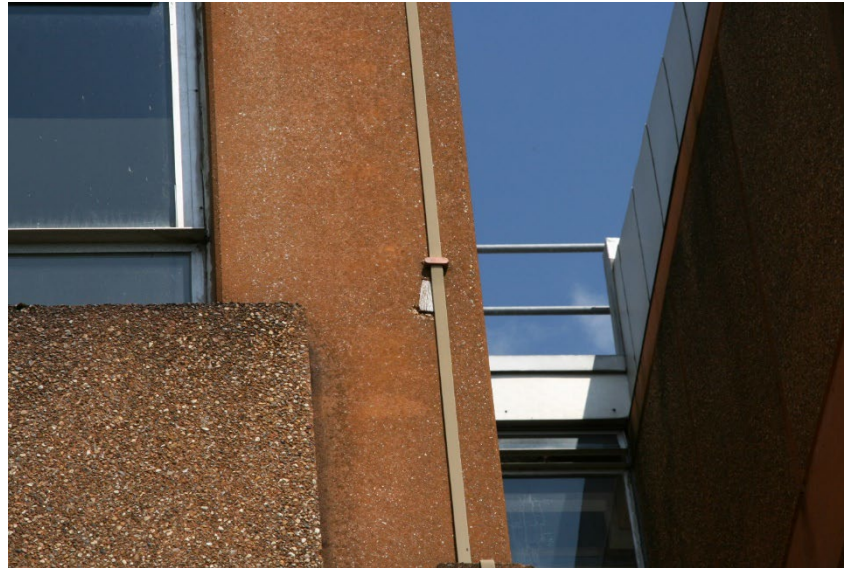
In a number of locations, small pieces of timber were observed, embedded in the concrete. It is likely that these were used as spacers, not removed before the concrete was poured, or as fixing blocks installed after construction. In either case, the presence of the timber on the surface of the concrete is likely to enhance the rate of carbonation in a localised area and should be removed and replaced with a hand-placed mortar repair.

Example of Defect Type B5

| <b>B5</b><br><br>Timber inclusions in cast concrete | <b>RB5A</b> | Identify repair mortar from approved samples as closest match to parent material. Mask/protect adjacent surface to prevent dust, residue/smearing to adjacent concrete.<br><br><b>Concrete breakout/Cutting Out</b><br><br>The affected area is to be cut out back to sound substrate, removing all timber inclusions and loose/defective material. On removal of timber inclusions, the void may be suitable for direct repair. Where the surrounding concrete is in poor condition or unsuitable for immediate repair, further cutting out and preparation may be required, in accordance with recommendations for repairs to spalls. |

| | | <p>Mark out damaged area. Extent and shape to be agreed with architect. Use a diamond core drill (diameter size dependent on size of repair areas) with drill guide to mark rounded corners of repair area to prevent spalling/damage to the adjacent fabric (sharp corners are to be avoided). Drill to a suitable depth to reach sound material. Follow by cutting along the edges of the repair area with a diamond blade to the internal angles of the corner. Undercut by 2-4 mm and to a depth of 25mm to create a dovetail to improve adhesion of patch repair.</p> <p>Where delamination is severe, the depth of the repair should be a minimum of 40mm depth to provide sufficient cover. The amount of material removed must however be minimised to ensure the area is not undermined structurally. Where reinforcement is exposed, refer to RBIA for the repair methodology.</p> <p>Carefully break out the remainder of the repair area, taking care not to bruise or damage the substrate using a sharp chisel or jack hammer held at a shallow angle. Remove any loose material and brush clean etc. The base of the cut-out area should be left rough to aid the key/adhesion of the repair material.</p> <p>Temporary structural support is to be provided for the duration of the repair where required, and designed by a suitably qualified engineer.</p> <p><b>Hand placed repairs</b></p> <p>For hand placed repairs, once the repair area has been broken out, prime the repair area using a cement slurry, prior to application of the repair mortar.</p> <p><b>Implementing repair</b></p> <p>Wet the area, sufficiently to avoid the parent material absorbing all water, but do not over wet to avoid poor adhesion. In some instances, a bond coat may be beneficial. Pour the concrete mix (as per agreed sample) in batches through opening/letterbox to repair area and tamp/vibrate to eliminate air until the formwork is completely filled and all air gaps eradicated. Ensure water content is minimised to prevent shrinkage. Allow to set before removing the shuttering. Curing time will be subject to environmental conditions and all repairs should be covered in damp blankets.</p> <p>For hand placed repairs, apply and build up the repair in layers.</p> <p><b>Surface finish</b></p> <p>Finishing will be subject to trials/sample areas. Finish to match adjacent/original surface finish, and cover with damp hessian/blankets to ensure sufficient hydration. Ensure access is retained to provide access until curing is complete.</p> |

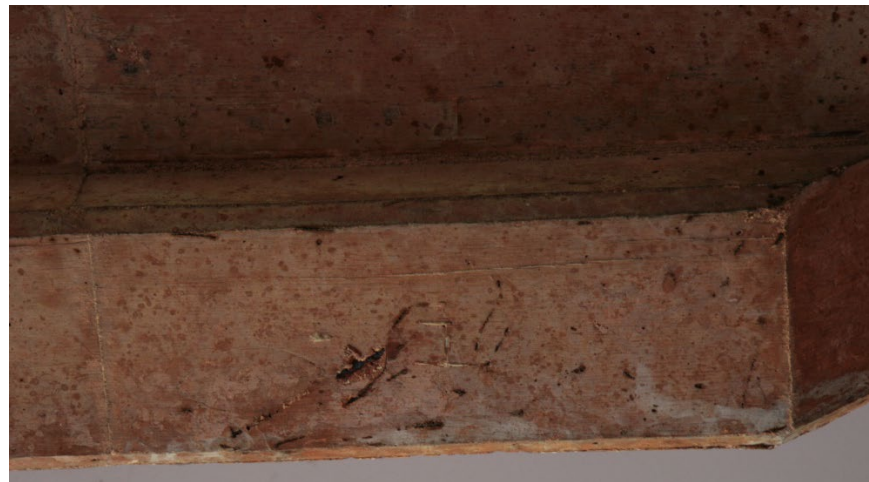
To all undercroft areas, numerous small pieces of metal debris were observed to the underside of the concrete beams and beam ends. These appear to be mostly steel wire off-cuts, which have been cut when tying the reinforcement and allowed to fall into the bottom of the formwork, subsequently being cast into the beams. The metal debris is now corroding and causing small amounts of concrete to spall from the underside of the beams. The presence of small amounts of corroding metal wire on the underside of the beams and minor spalls are unlikely to affect the overall integrity of the concrete structure and reinforcement. Removal is likely to be very disruptive for the limited benefits that it offers and so it is considered to be preferable to leave the metal debris in place and to remove any loose material. Removal of loose and spalling material will need to be undertaken periodically to ensure that falling material does not affect people using the building.

Example of Defect Type B6

| <p><b>B6</b></p> <p><b>Small pieces of corroding metal in underside of cast concrete</b></p> | <p><b><i>RB6A</i></b></p> | <p>Using hand tools, carefully remove loose concrete spalls and corroding material from the surface of the beams, avoiding damage to surrounding fabric.</p> <p>For large spalls or voids, or where reinforcement has been exposed, refer to RB1A for the repair methodology.</p> <p><i>Note: The underside of beams will need monitoring and period removal of loose material to reduce the risk of falling material in public areas.</i></p> |

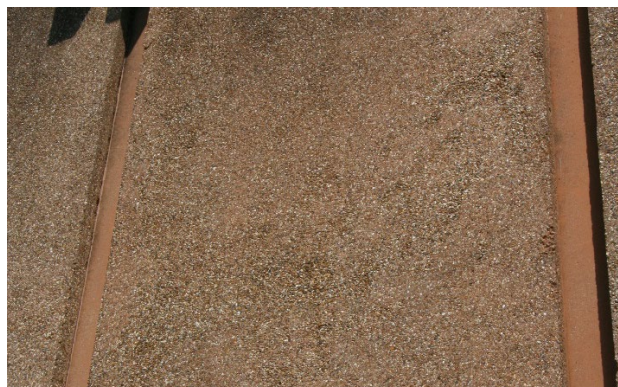
To some of the large pre-cast panels, to the south elevation in particular, the cement matrix in which the aggregate is embedded appears to have weathered away resulting in an uneven appearance and localised failure of the exposed aggregate with some loss of gravel/aggregate. This only appears to be a localised problem to a small number of panels and may be the result of poor original workmanship or the specification of the concrete and may even be an original construction defect of these panels.

Example of Defect Type B7

A tactile inspection should be undertaken to assess to what extent the loss or absence of cement matrix has destabilised the aggregate or whether the impact is mostly superficial and whether the condition can be monitored for deterioration with only limited and localised repairs. The tactile inspection should be reviewed in conjunction with the outcome of intrusive investigations by CRL, to establish whether the loss of cement matrix and aggregate corresponds with a loss of cover to the reinforcement and evidence of associated corrosion.

Where the loss of matrix and aggregate is not extensive, then localised, cast in situ or hand-placed repairs can be undertaken with particular care being paid to the choice of aggregate and mortar mix, based on detailed investigation of the existing and on-site trials and samples.

| <p><b>B7</b><br/>Uneven finish to pre-cast panels</p> <p>Spalling or damaged surface – reinforcement bar is not visible at this stage (note, once defective material removed/ further investigations are completed, reinforcement may be found and the repair type will revert to RB1A)</p> | <p><b>RB7A</b></p> | <p>Note: Prior to repairs, undertake tactile inspection of pre-cast panels to ascertain extent of defects. Review findings in conjunction with findings of CRL's intrusive inspections.</p> <p><b>Concrete breakout/Cutting Out</b></p> <p>The affected area is to be cut out back to sound substrate, removing all loose/defective material.</p> <p>Mark out damaged area. Extent and shape to be agreed with architect. Use a diamond core drill (diameter size dependent on size of repair areas) with drill guide to mark rounded corners of repair area to prevent spalling/damage to the adjacent fabric (sharp corners are to be avoided). Drill to a suitable depth to reach sound material. Follow by cutting along the edges of the repair area with a diamond blade to the internal angles of the corner. Undercut by 2-4 mm and to a depth of 25mm to create a dovetail to improve adhesion of patch repair.</p> <p>Where delamination is severe, the depth of the repair should be a minimum of 40mm depth to provide sufficient cover. The amount of material removed must however be minimised to ensure the area is not undermined structurally. Where reinforcement is exposed, refer to RB1A for the repair methodology.</p> <p>Carefully break out the remainder of the repair area, taking care not to bruise or damage the substrate using a sharp chisel or jack hammer held at a shallow angle. Remove any loose material and brush clean etc. The base of the cut-out area should be left rough to aid the key/adhesion of the repair material.</p> <p>Temporary structural support is to be provided for the duration of the repair where required, and designed by a suitably qualified engineer.</p> |

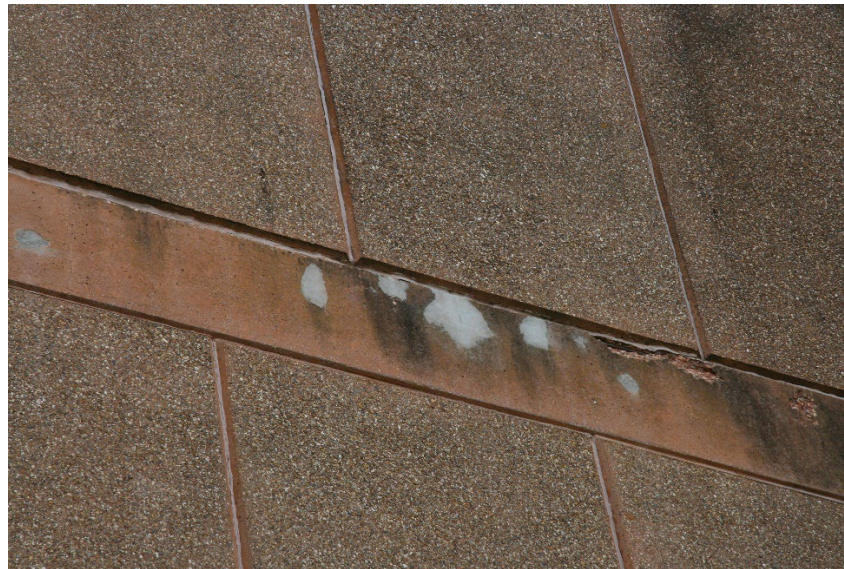
A sizeable proportion of repairs are failing with cracking and spalling which appears to be the result, at least in part, of continued corrosion of the steel reinforcements. The failing repairs will require cutting out and replacement to prevent further corrosion of the reinforcement and more extensive damage.

*Example of Defect Type C1*

Across the building, the poor previous repairs should be renewed with new in-situ concrete or hand-placed mortar repairs, designed to blend with the original concrete fabric.

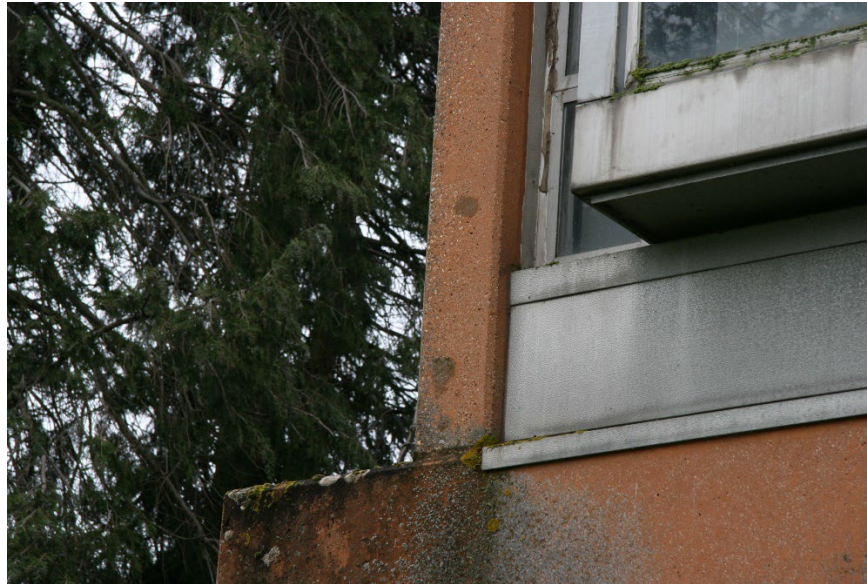
Where the mortar fills are cracked, loose or missing they should be refilled to reduce the risk of corrosion and associated cracking and spalling. Where the socket is heavily corroding, and this is causing damage to the concrete panel a more extensive repair will be required involving the removal of the socket and an in-situ concrete or hand-placed mortar repair to fill the void. Further investigation will be required to establish the relationship of the socket.

*Example of Defect Type C2*

| <p><b>C2</b></p> <p>Construction phase making good</p> | <p><b>RC2A</b></p> | <p>Do nothing, monitor through periodic inspection.</p> |

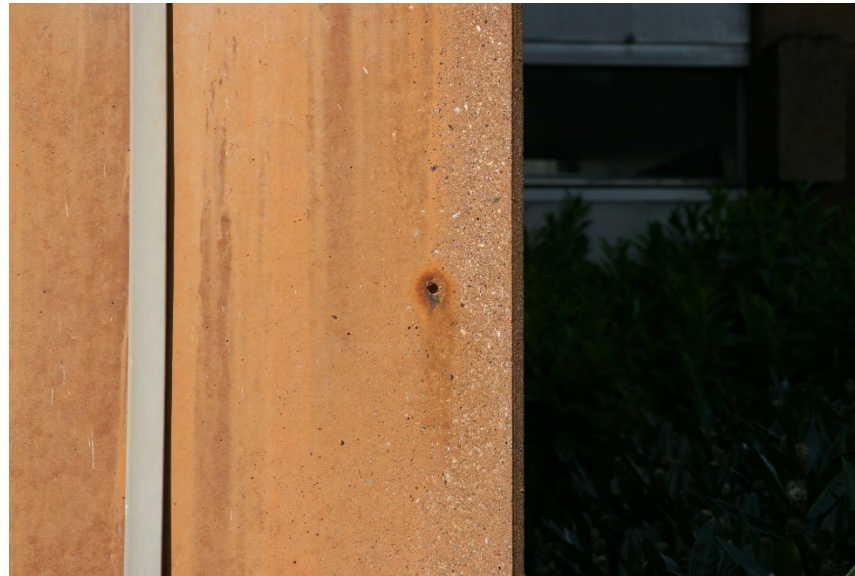
Holes in the concrete are vulnerable to water ingress which could result in corrosion of the steel reinforcements, they also increase the depth of carbonation within a localised area, which also increases the risk of reinforcement corrosion and associated spalling. Holes that are not required for a specific purpose should be filled with a suitable repair mortar and, where still required, holes should be provided with suitable weatherings to reduce the risk of water penetration.

*Example of Defect Type D1*

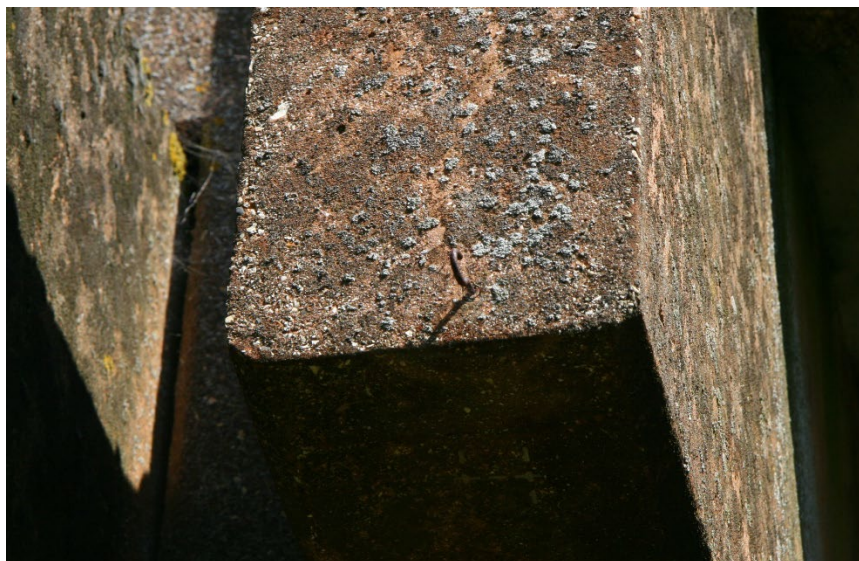
There are numerous fixings around the building, many of which appear to be redundant. In some instances, the fixings are corroding with the potential to cause cracking and spalling of the concrete as well as more superficial rust staining to the surface. A review should be made of the fixings to ascertain which are still required and which are redundant. Where redundant, the fixings should be removed, and the hole filled with a suitable repair mortar. Where the fixings are still required, it may be necessary to change the fixings for a non-ferrous alternative.

*Example of Defect Type D2*

| D2 Redundant fixings<br>(fixing present) | RD2A | Hole 25mm diameter and below (for larger holes, consult architect, in situ repair may be required): remove fixing / fitting (rawl plug, screws etc). Where fixings are large/resin fixed, localised cutting out may be required with an in-situ repair to follow as RB1A or RB2A. Remove loose material etc. Mask/protect adjacent surface to prevent dust residue/smearing to adjacent concrete. Drill (with drill guide) to min depth of 15mm. Fill with mortar to full depth (as approved from samples) to match adjacent concrete in colour and texture and ensure flush finish. Finish to match adjacent surfaces and ensure surfaces are clean. |

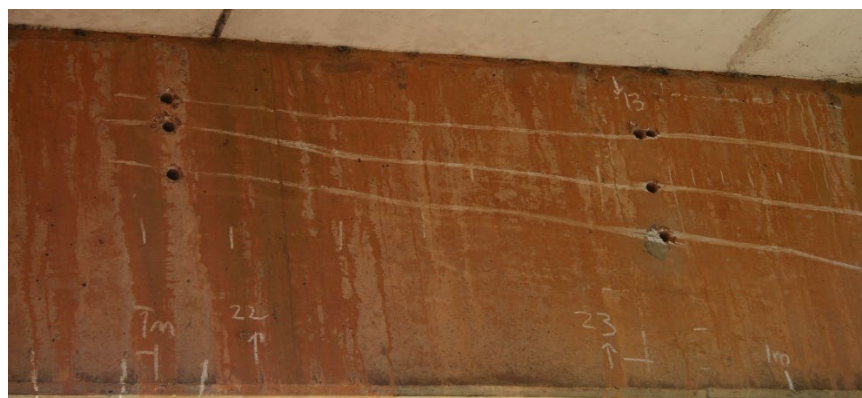
Over the past 10 years there have been a series of intrusive concrete investigations undertaken by CRL, under the supervision of the Structural Engineers at the time. The investigations have involved drilling holes, taking core samples, opening up works to inspect reinforcement and fixing details, hammer testing and various other intrusive investigations, undertake with the objective of understanding the composition and current condition of the concrete and reinforcements and to assess the extent and rate of deterioration since the previous investigations. The result has been the formation of numerous holed and openings in concrete components across the building. While the holes have generally been filled with proprietary mortars, at the time of the inspection, a new round of intrusive investigations were underway and a number of openings had been formed. It may be that these have subsequently been filled with proprietary repair mortars. In either case, the outline repair methodology for poor previous repairs should be applied.

*Example of Defect Type D3*

| <p><b>D3</b></p> <p><b>Testing/investigation holes made by contractors</b></p> | <p><b>RD3A</b></p> | <p>Identify repair mortar from approved samples as closest match to parent material. Mask/protect adjacent surface to prevent dust, residue/smearing to adjacent concrete.</p> <p><b>Concrete breakout/Cutting Out</b></p> <p>The affected area is to be cut out back to sound substrate, removing all loose/defective material.</p> <p>Mark out damaged area. Extent and shape to be agreed with architect. Use a diamond core drill (diameter size dependent on size of repair areas) with drill guide to mark rounded corners of repair area to prevent spalling/damage to the adjacent fabric (sharp corners are to be avoided). Drill to a suitable depth to reach sound material. Follow by cutting along the edges of the repair area with a diamond blade to the internal angles of the corner. Undercut by 2-4 mm and to a depth of 25mm to create a dovetail to improve adhesion of patch repair.</p> <p>Where delamination is severe, the depth of the repair should be a minimum of 40mm depth to provide sufficient cover. The amount of material removed must however be minimised to ensure the area is not undermined structurally. Where reinforcement is exposed, refer to RB1A for the repair methodology.</p> <p>Carefully break out the remainder of the repair area, taking care not to bruise or damage the substrate using a sharp chisel or jack hammer held at a shallow angle. Remove any loose material and brush clean etc. The base of the cut out area should be left rough to aid the key/adhesion of the repair material.</p> <p>Temporary structural support is to be provided for the duration of the repair where required and designed by a suitably qualified engineer.</p> <p><b>Shutters &amp; Formwork &amp; Hand placed repairs</b></p> <p>Shuttering and formwork design will vary and is subject to the area under repair and should replicate the existing finish/profile/details. Shutters likely to be made from plywood to match the fair faced finish. Shutters to be sized according to repair area and butt jointed and sealed to the perimeter to prevent seepage. Insert a letterbox into the top of the formwork/shuttering for the concrete to be poured into. Coat the shuttering with a release agent or retarder as required prior to use. Additional fixings for formwork/shuttering to be avoided where possible.</p> <p>For hand placed repairs, once the repair area has been broken out, prime the repair area using a cement slurry, prior to application of the repair mortar.</p> <p><b>Implementing repair</b></p> <p>Wet the area, sufficiently to avoid the parent material absorbing all water, but do not over wet to avoid poor adhesion. In some instances, a bond coat may be beneficial. Pour the concrete mix (as per agreed sample) in</p> |

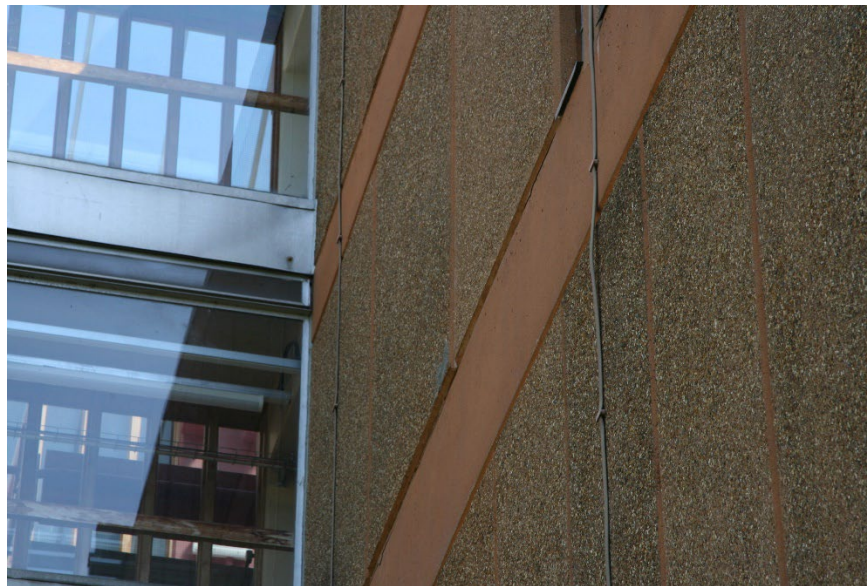
Investigations into the condition of the panel fixings and an assessment of their structural stability is in progress at the time of writing, with investigations carried out by CRL under the supervision of the Structural Engineers, Curtins. At this time it is anticipated that some grouting of the lower pins will be required, as well as some discrete additional fixings to the rear of the panels, where they have been displaced to ensure their stability. Details of these structural repairs will be prepared by the Structural Engineer for submission as part of a subsequent planning and listed building consent application.

*Example of Defect Type EI*

The Structural Engineer will review and advise on whether the extent of displacement requires the full replacement of any of the pre-cast panels. Replacement should be on the basis of like-for-like replacement with regard to form, colour, aggregate, and finish.

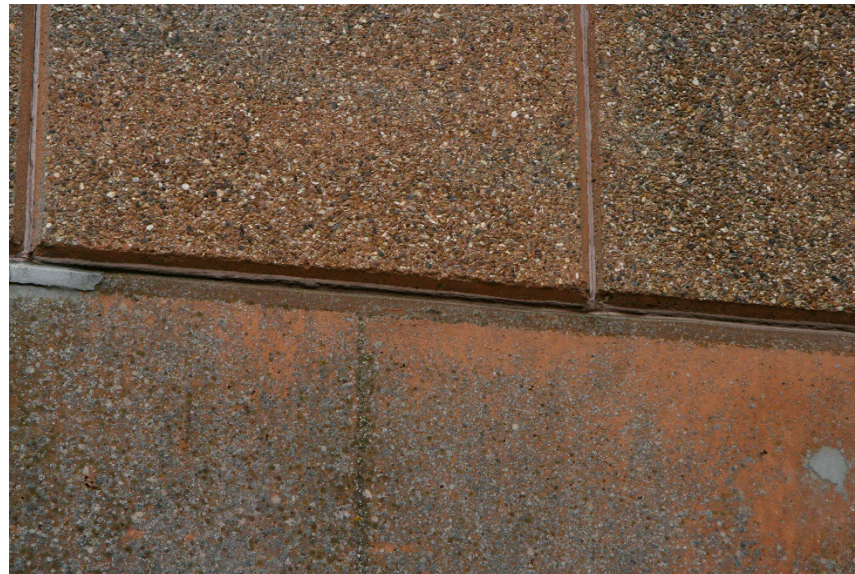
Failure of the seals will affect the performance of the building envelope, potentially causing water ingress into the building and the building structure, accelerating decay. The seals should be renewed across the building.

Where corrosion and spalling were noted to the outer corners of soffits, to the south elevation in particular, it is thought that this is a result of water ingress via the junctions between concrete beams and posts. It may be that water ingress is due to the failure of mastic seals in these locations, although the actual weathering details could not be observed due to restricted sightlines. If on closer inspection it is found that there are failing mortar weatherings to these joints or no weatherings further consideration will be required to establish the best means of weathering these joints.

*Example of Defect Type G1*

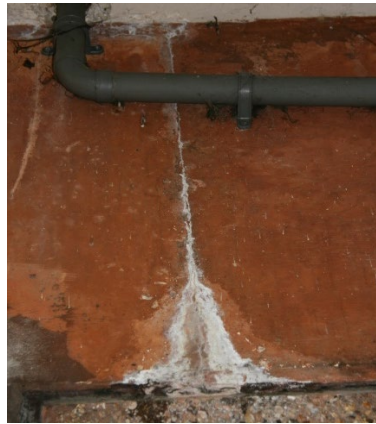
Where water has penetrated through the concrete structure it has caused the calcium hydroxide in the concrete mix to dissolve and leach out of the structure. On contact with the atmosphere the calcium hydroxide reacts with carbon dioxide to form calcium carbonate. As the water evaporates on the surface, hard white deposits are left, which in places form stalactites. At the URS Building the calcium deposits can be found in several locations to the north undercroft. The cause of the water penetration is unknown and should be investigated and remedied.

While the deposits themselves are a cosmetic issue, the process of leaching can lead to durability problems. Water ingress through the structure also risks the corrosion of the steel reinforcements.

*Example of Defect Type H1*

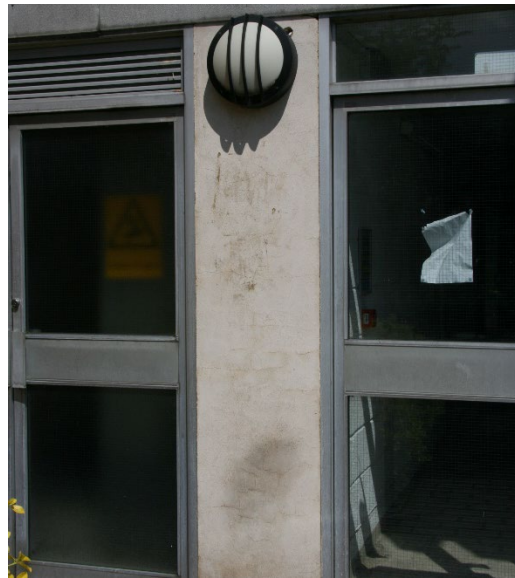
There is crazing and cracking to the render. The precise cause of the crazing and cracking is unknown but could relate to the quality of the materials and workmanship or the condition of the underlying substrate. Damaged render finishes should be cut back, the substrate inspected for defects, and the render coat renewed.

Example of Defect Type J1

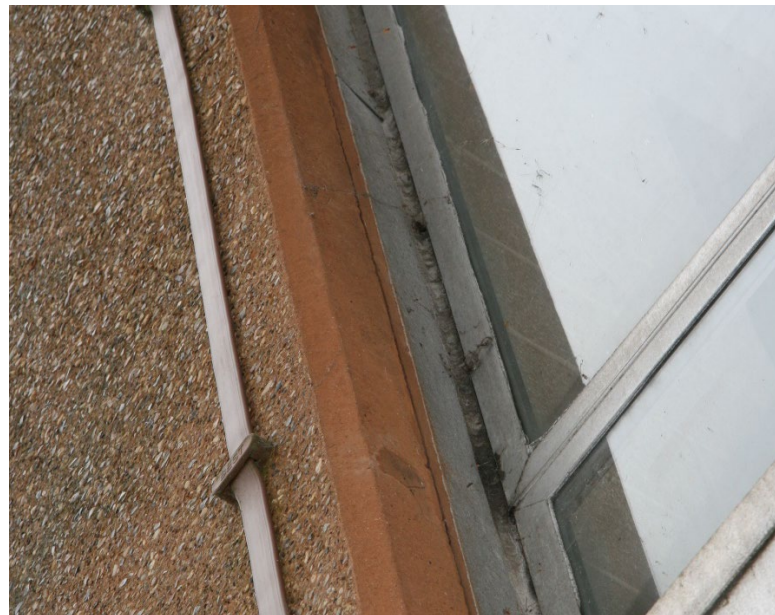
Where mortar joints are visible between concrete components or between concrete components and windows many of these are cracked and loose. In a number of locations mortar is missing from joints altogether. Open and missing joints can allow water to penetrate the fabric/structure with the risk of damage and decay to adjacent fabric. This could be observed where water has tracked in above beam ends and has caused dampness and spalling to the adjacent soffits although it is not clear without close inspection whether this is due to defective mortar or mastic joints, or the absence of weatherings altogether. The defective mortar should be raked out and the joints repointed in a suitable mortar.

Example of Defect Type K1

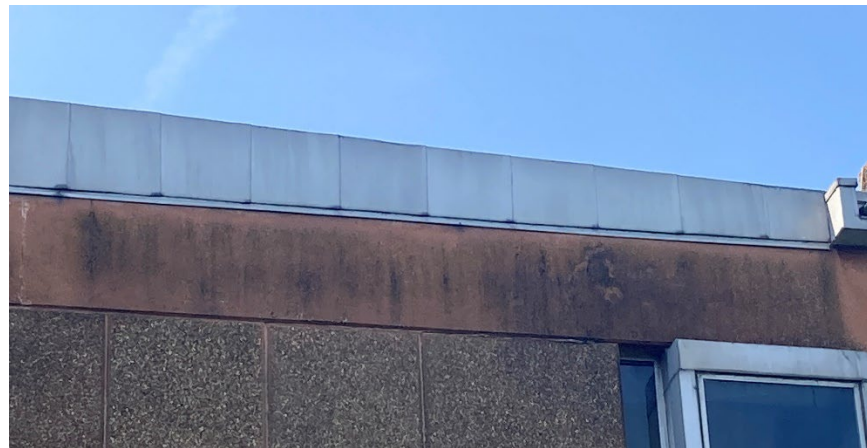
- causing water retention;
- producing organic acids; and
- for mosses and lichens, causing mechanical deterioration by anchoring to the surface with their rhizoids.

Example of Defect Type S1

Mosses, algal staining and to a lesser degree lichens, should be removed to improve the appearance of the building and to reduce the risk of deterioration of the fabric. Where the algal staining is the result of poor detailing of roofs and rainwater goods, this should be addressed by the proposals for renewal.

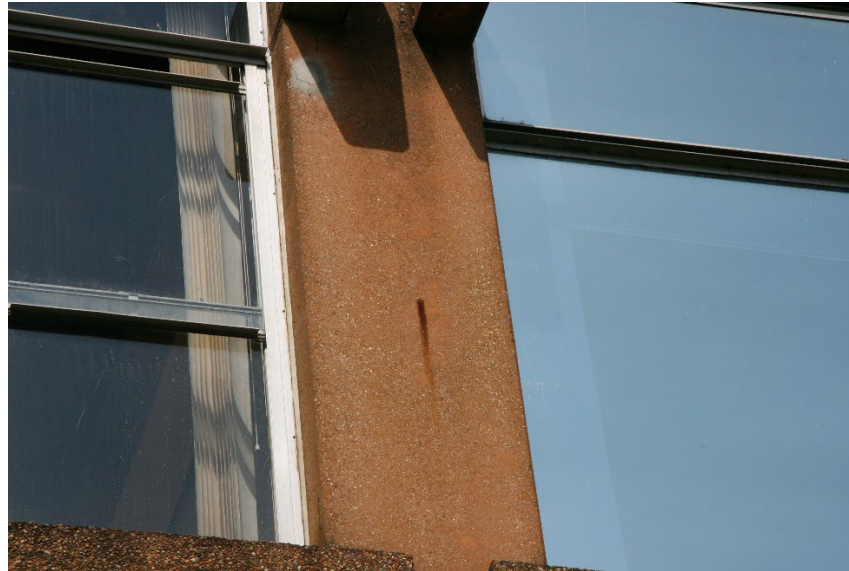
Elsewhere rust staining is the result of the corrosion of fixings or structures fixed to the building. There are a number of instances of redundant fixings which are corroding. As well as causing superficial staining, the expansion of the corroding fixings can cause cracking and spalling to the surrounding concrete which increases the risk of water ingress into the structure and corrosion of the metal reinforcements. The corroding fixings should be removed and the fixing holes made good in an appropriate mortar.

*Example of Defect S2*

| <p><b>S2</b></p> <p><b>Pyrites and rust staining</b></p> | <p><b>RS2A</b></p> | <p><b>Removal of Pyrites</b></p> <p>Provide a plywood template over the pyrite (sized to a diameter corresponding with pyrite size e.g. 30mm), Carefully drill to a suitable depth to enable defective aggregate to be extracted, ensure minimum drill depth of 15mm to allow for adequate depth of mortar repair. Remove loose material. Brush clean.</p> <p>Select appropriate mortar match from approved samples and apply mortar in situ repair taking care to protect adjacent surface from smearing and apply repair mortar to a flush finish to match the fair faced finish. Prior to full set, inspect surface finish to ensure surface finish replicates original and match prior to full curing. Ensure water content is minimised to prevent shrinkage.</p> <p><b>Removal of associated rust staining</b></p> <p>Apply acetic acid to the affected area (dilution and dwell time subject to trials). Care to be taken with the use of acid on the alkali concrete surface. Rinse with water after dwell period.</p> |
