**Fulford-Dobson Associates Ltd**  
ARBORICULTURAL CONSULTANCY

# **TREE HAZARD SURVEY**

White Hill Woods  
Remenham Church Lane  
Nr Henley-on-Thames

June 2026

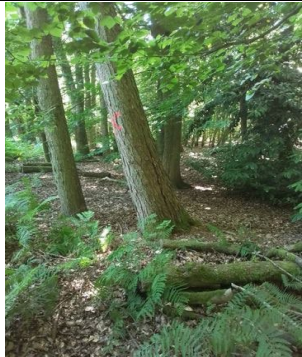
| Ref. | Species | Failure Indicators | Measurements | Overall Condition | Control Measures 1 | Threat Category | Timescale | Photo |
|---|---|---|---|---|---|---|---|---|
| T004 | European larch<br>( <i>Larix decidua</i> ) | Pink X. Primary failure has occurred and the trunk is significantly decaying and splitting from the tension side. Tree leans towards road and appears partially lodged in neighbouring trees. Wasps active in this area. | Height (m): 20<br>Crown Radius (m): 2.5<br>DBH (cm): 38<br>Life Stage: Mature<br>Life Exp.: <10 years | Poor | Fell. | 5: Significant | 1 Month | |

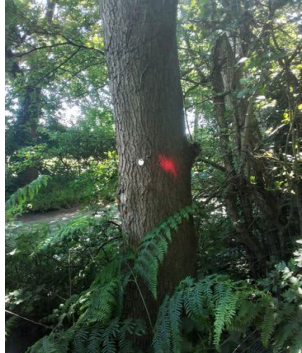
| Ref. | Species | Failure Indicators | Measurements | Overall Condition | Control Measures 1 | Threat Category | Timescale | Photo |
|---|---|---|---|---|---|---|---|---|
| T001 | Common ash<br>( <i>Fraxinus excelsior</i> ) | Pink spot (tag 0179). Roadside, ash dieback 90% defoliated with moderate deadwood over road. | Height (m): 11<br>Crown Radius (m): 3.5<br>DBH (cm): 25<br>Life Stage: Early Mature<br>Life Exp.: <10 years | Poor | Fell to 1m stump. | 4: Moderate | 3 Months | |

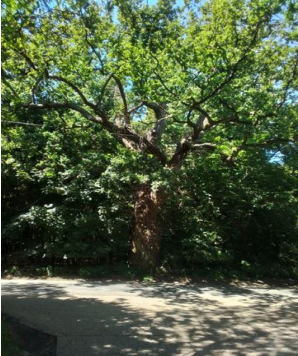
| Ref. | Species | Failure Indicators | Measurements | Overall Condition | Control Measures 1 | Threat Category | Timescale | Photo | |
|---|---|---|---|---|---|---|---|---|---|
| T003 | Pedunculate oak<br>( <i>Quercus robur</i> ) | Large ancient boundary oak opposite entrance to White Hill Farm Copas. Ganoderma applanatum brackets on lower trunk (roadside). Manual sounding suggests some basal decay and strips of cambial dysfunction and bark delamination around trunk base. Handful of moderate sized dead branches over road. | Height (m): 18.5<br>Crown Radius (m): 10<br>DBH (cm): 180<br>Life Stage: Ancient<br>Life Exp.: 40+ Years | Fair/poor | Detailed inspection required (decay mapping and QTRA) | 3: Slight | 6 Months | | |

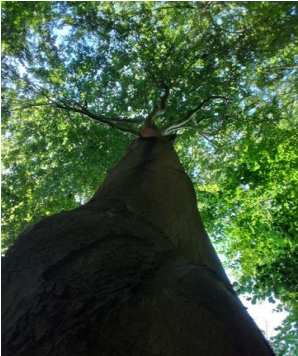
| Ref. | Species | Failure Indicators | Measurements | Overall Condition | Control Measures 1 | Threat Category | Timescale | Photo | |
|---|---|---|---|---|---|---|---|---|---|
| T007 | Common beech<br>( <i>Fagus sylvatica</i> ) | Tag 0182. Fungal fruiting bracket on trunk at 4m north side. Well sheltered by surrounding woodland canopy & crown incline and weight bias is very slightly north, away from road. Close to caravan and sheds. Outward vigour appears normal. | Height (m): 21<br>Crown Radius (m): 7.5<br>DBH (cm): 55<br>Life Stage: Mature<br>Life Exp.: 10+ Years | Fair | More detailed inspection by way of manual sounding around bracket from ladder to assess extent of decay/hollowing. | 3: Slight | 6 Months | | |

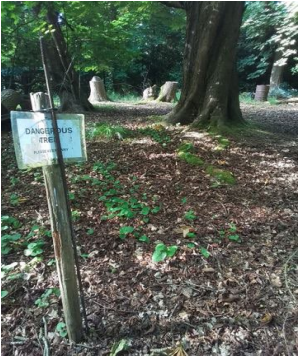
| Ref. | Species | Failure Indicators | Measurements | Overall Condition | Control Measures 1 | Threat Category | Timescale | Photo | |
|---|---|---|---|---|---|---|---|---|---|
| T008 | Horse chestnut<br>( <i>Aesculus hippocastanum</i> ) | Tag 0183. Trunk is extensively decayed and hollowing. Owner is aware and a notice is present to warn site users/visitors to keep away. | Height (m): 19<br>Crown Radius (m): 9<br>DBH (cm): 70<br>Life Stage: Mature<br>Life Exp.: 10+ Years | Poor | Maintain warning notice fit for purpose. | 2: Minimal | 1 Year | | |

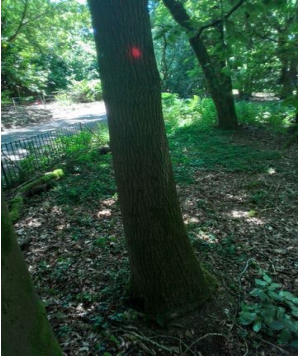
| Ref. | Species | Failure Indicators | Measurements | Overall Condition | Control Measures 1 | Threat Category | Timescale | Photo | |
|---|---|---|---|---|---|---|---|---|---|
| T005 | Common ash<br>( <i>Fraxinus excelsior</i> ) | Pink spot (tag 0180). Basal cavity between buttress. Arches out over road. Sheltered by surrounding trees and unlikely to free-fall to ground (branches of neighbouring trees likely to break or obstruct fall) . | Height (m): 16<br>Crown Radius (m): 5<br>DBH (cm): 30<br>Life Stage: Early Mature<br>Life Exp.: <10 years | Fair/poor | Fell. | 2: Minimal | 2 Years | | |

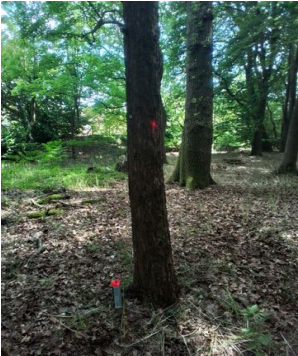
| Ref. | Species | Failure Indicators | Measurements | Overall Condition | Control Measures 1 | Threat Category | Timescale | Photo | |
|---|---|---|---|---|---|---|---|---|---|
| T006 | European larch<br>( <i>Larix decidua</i> ) | Dead standing tree within falling distance of road. Surrounded by neighbouring canopy and unlikely to free-fall to road but should ultimately be felled for safety reasons. | Height (m): 18<br>Crown Radius (m): 2<br>DBH (cm): 25<br>Life Stage: Early Mature | Poor | Fell. | 2: Minimal | 2 Years | | |
