# BS:5837 ARBORICULTURAL REPORT

## ARBORICULTURAL IMPACT ASSESSMENT

WOODLANDS FARM HOUSE  
BATH ROAD  
KNOWL HILL  
WOKINGHAM  
RG10 9UP

Ref: AIA 06571 / 2024

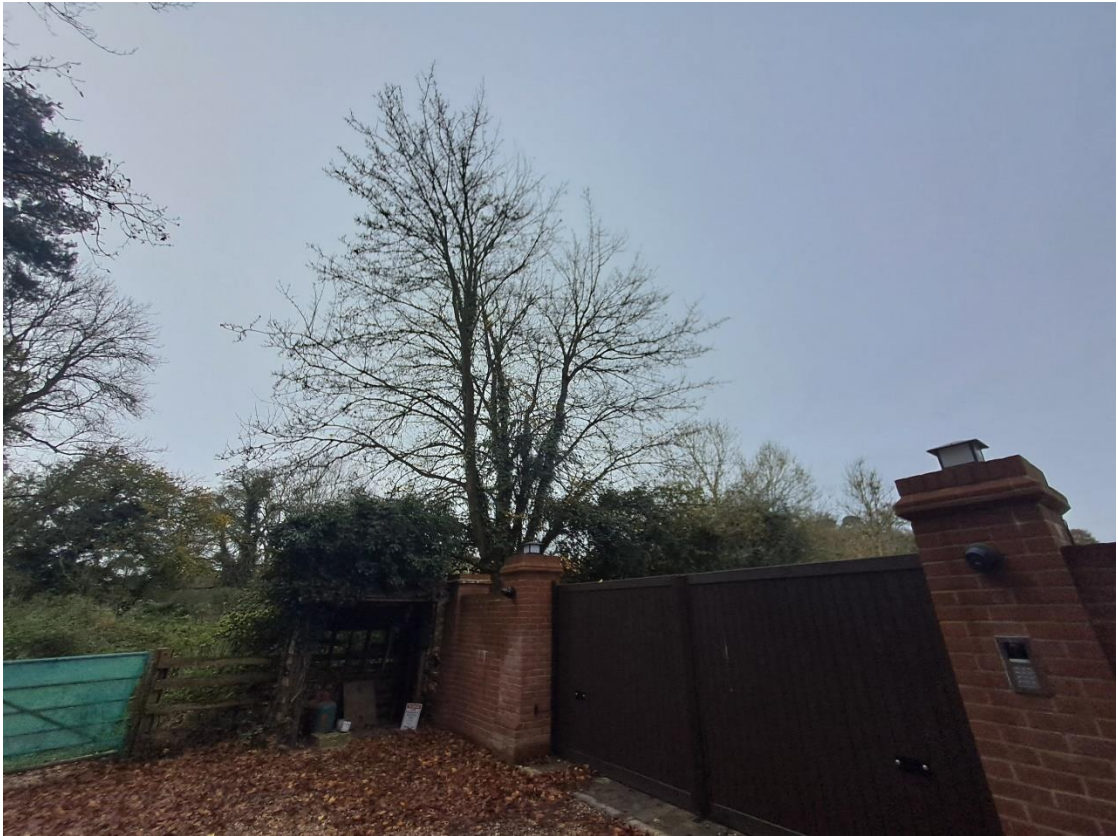
Directly west of the gate the brick walls and pillars are within 0.4m of T044 a mature, shrubby Field Maple. There has always been a culvert running north to south directly to the east of the tree therefore the tree may have been rooting preferentially to the west and away from the driveway, however due to the proximity of the pillars to the trees base significant root damage / severance during these works is a possibility.

T044 (Field Maple) is otherwise in good health and at the time of both my site visits (April 2024 & November 2024) the canopy and bud density show no indication of stress

Photo 1 – T044 (Field Maple)

It is acknowledged that recent works to construct new brick walls at the front of Woodland Farm House, Bath Road, Knowl Hill may have severed roots on the eastern side of a mature Field Maple (T044).

Although the tree is currently in good health, the works are likely to shorten its longevity. It would therefore be appropriate to plant 2x new Field Maple in a suitable location within the garden of Woodland Farm House.

In view of this, my recommendation is that 2x Field Maple (*Acer campestre*) be planted in a suitable location within Woodlands Farm House to provide continuation of tree canopy cover in the event that this tree should fail or go into decline.

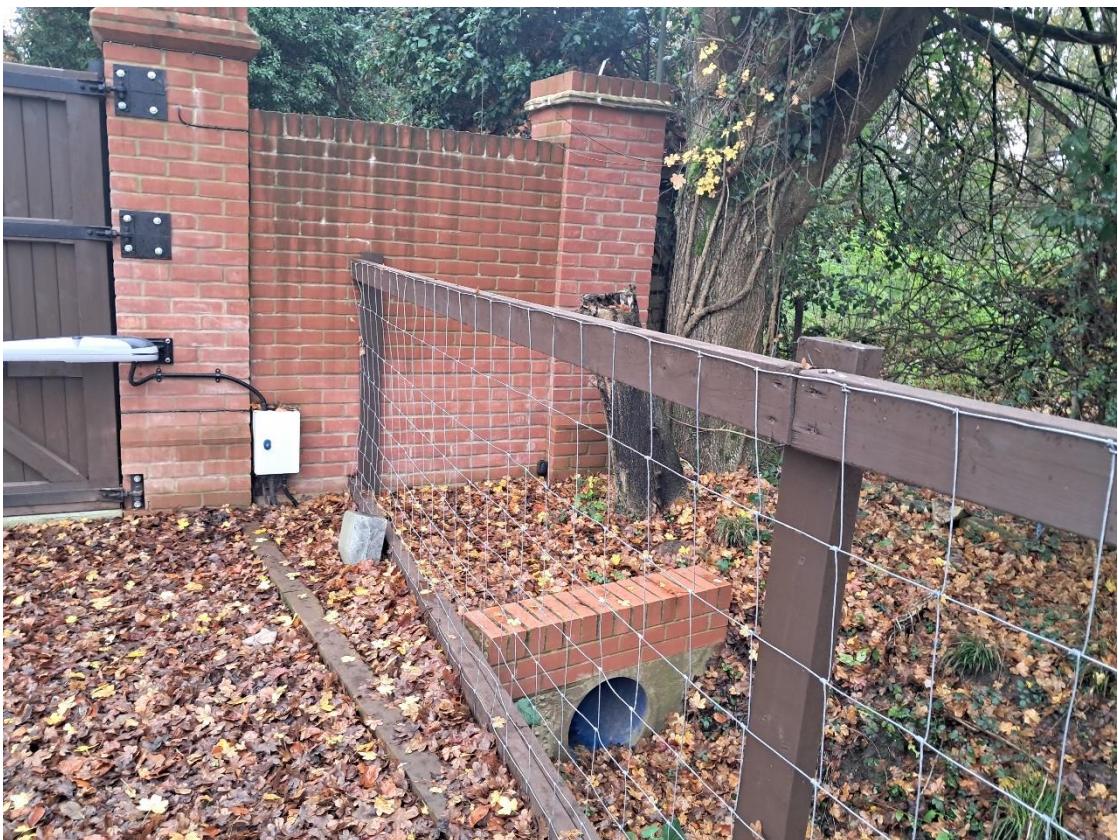
Photo 2 – Proximity of T044 (Field Maple) to new wall and replacement Culvert

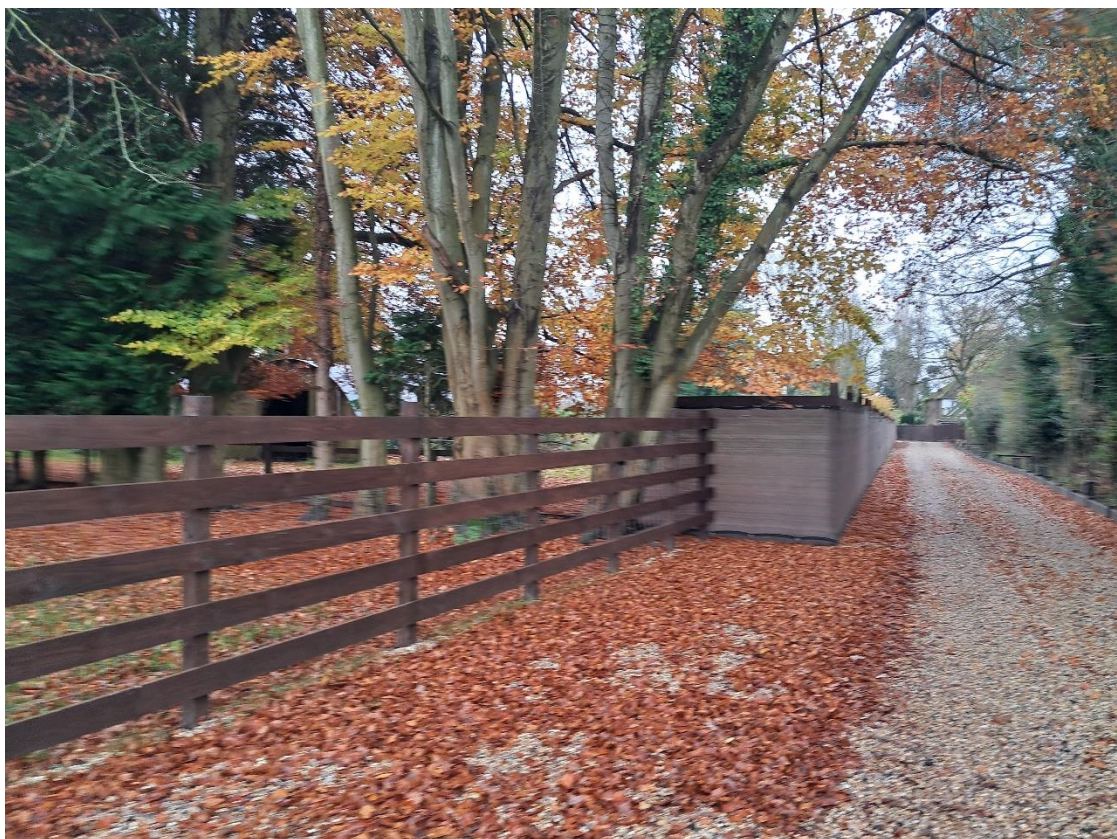
At the time of my visit, temporary boundary fencing was installed, and the proposal is to replace this with 2.1m high close board fence. It has been confirmed that the post holes for the existing temporary fence were excavated by hand and posts have been set in concrete.

There are no postholes directly adjacent to trees. The localised post holes impact a very small area of each tree's overall rooting area.

Photo 3 – Temporary slatted boundary fence at the front of Woodlands Farm House

The replacement 2.1m high boundary fence will use the existing post holes. The temporary posts and their concrete footings will be extracted. The post holes will then be lined with a non-porous plastic membrane before any new concrete is inserted in the post holes to support the new boundary fence.

The replacement higher fence will need to be cut down in height to accommodate the low, western branch of T075 (Beech). The new fence should allow for a minimum of 100mm clearance to accommodate future growth of the tree.
