## BS:5837 ARBORICULTURAL REPORT

ARBORICULTURAL SURVEY & IMPACT ASSESSMENT

WOODLANDS FARM HOUSE  
BATH ROAD  
KNOWL HILL  
WOKINGHAM  
RG10 9UP

Ref: SCD 06571 / 2024

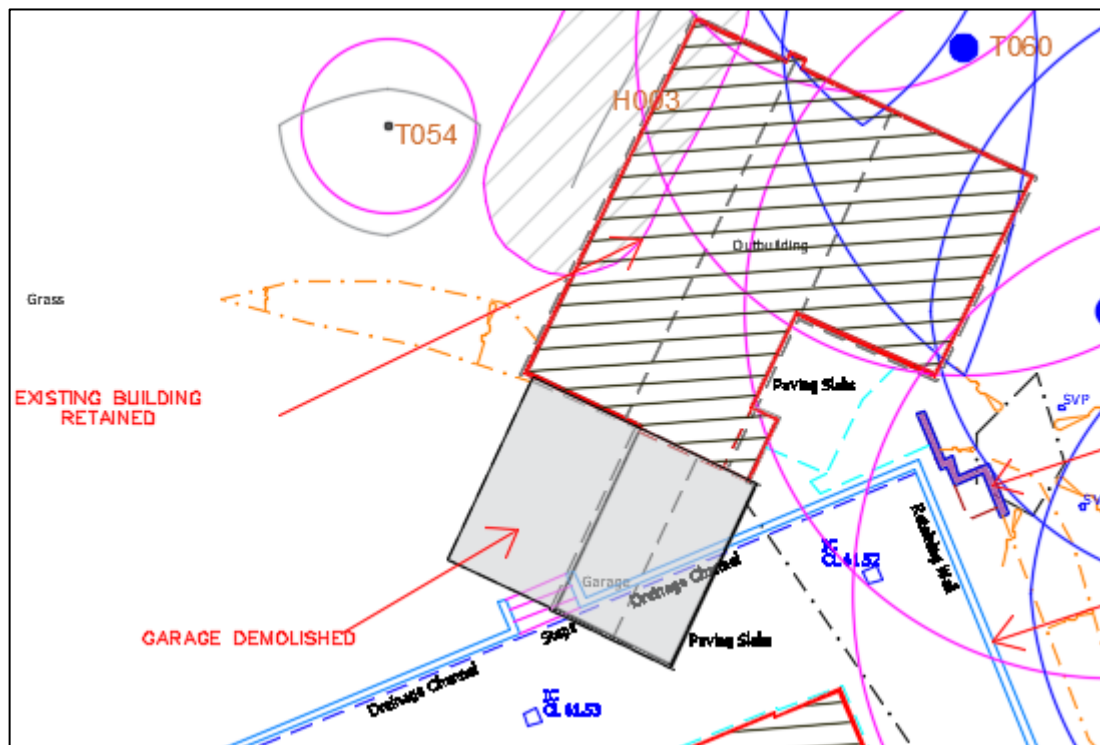
The outbuilding which has been demolished is a garage north of the property. This building is outside of the root protection areas of all trees therefore its removal will not have had any impact on trees.

Figure 1 – Site plan showing outbuildings retained and demolished

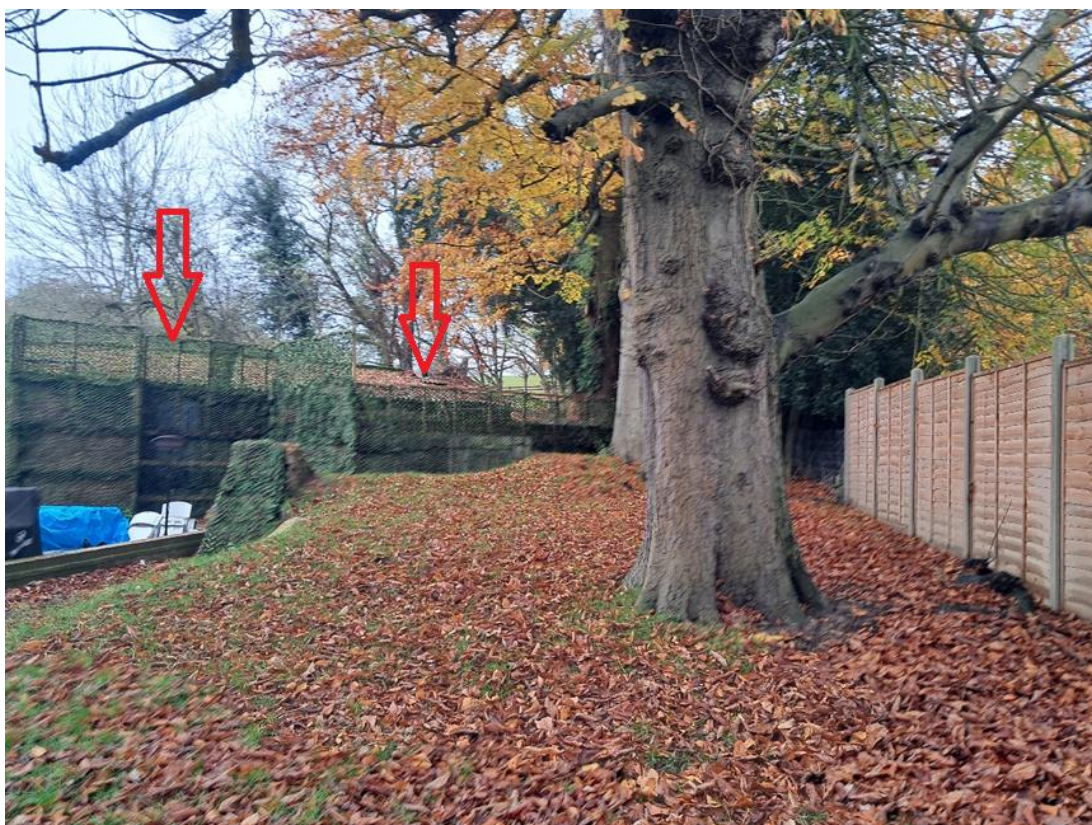
I confirmed at my site visit that the original main outbuilding which is located directly north of Woodland Farm House remains in situ.

Photo 1 – Existing outbuildings have been retained.

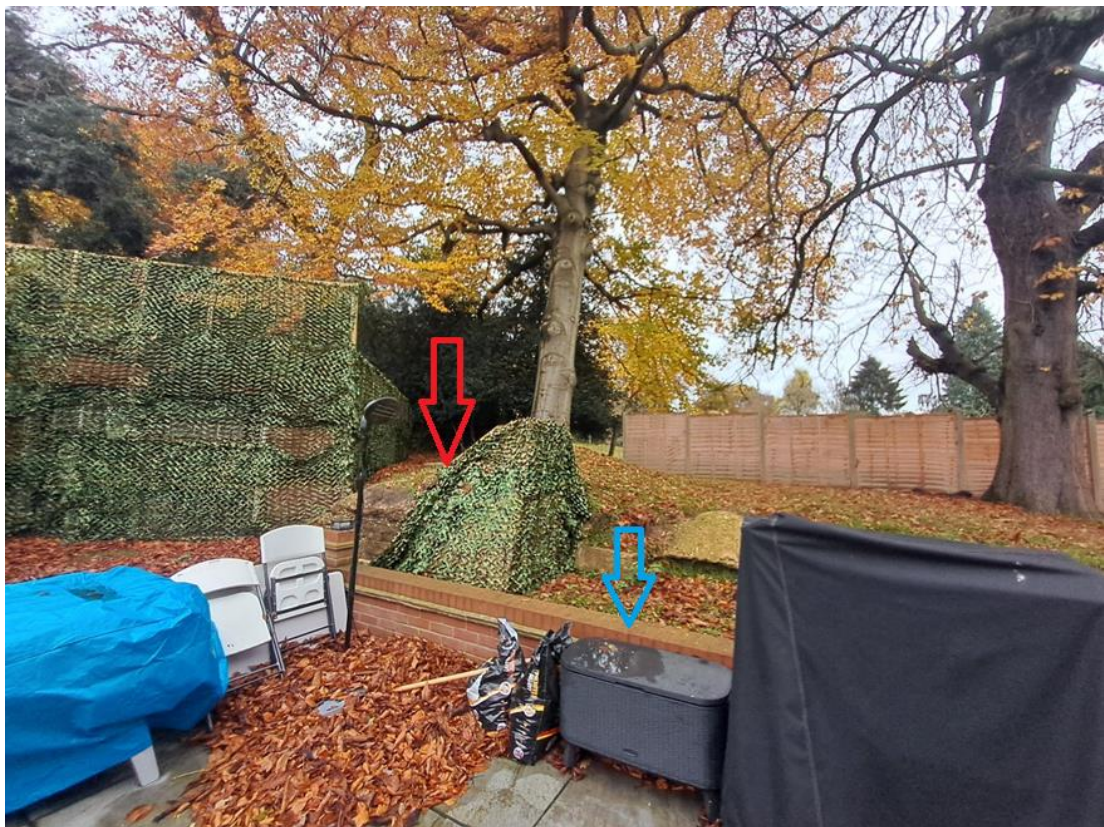
The incursion of the new patio / retaining wall into the root protection areas of T061 (Beech) and T062 (Horse Chestnut) equates to 4.7% and 10.5% respectively. However, in this location on the far side of the Air Raid Shelter, few substantial roots are likely to have been present. Furthermore, the original patio of the dwelling is also likely to have impacted on tree roots to a certain extent.

The new wall was constructed to create a formal edge to the patio. The client has confirmed the wall has very shallow footings less than 1ft / 30cm deep. Again, as mentioned previously, in this location on the far side of the Air Raid Shelter, few substantial roots are likely to have been present.

T061 (Beech) and T062 (Horse Chestnut) are mature trees in good physiological health as observed at the time of both site visits (April 2024 & November 2024). The canopy of both trees and bud density shows no indication of recent stress or decline which can occur when tree roots are damaged. I have therefore concluded that there has been no permanent harm to the adjacent trees because of this work.

Photo 2 – New low-level brick wall (blue) beyond retained historic Air Raid Shelter

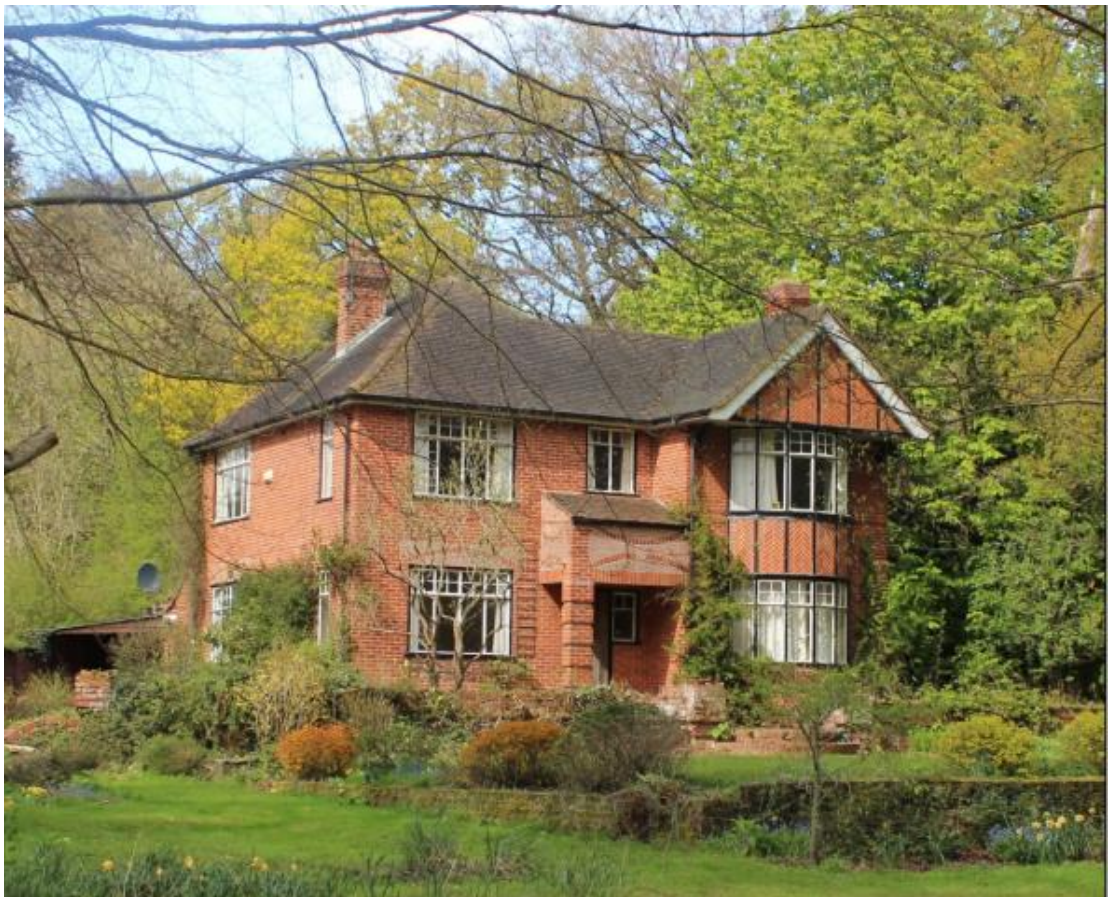
Prior to the recent renovation and associated ground works, Woodlands Farm House had a terraced front garden which stepped down to a flat lawn area and pergola. As part of the renovation the driveway has been extended along the front of the property and its width increased in order to accommodate parked vehicles.

**Photo 3 – Terracing to the front of Woodlands Farm House prior to renovation.**

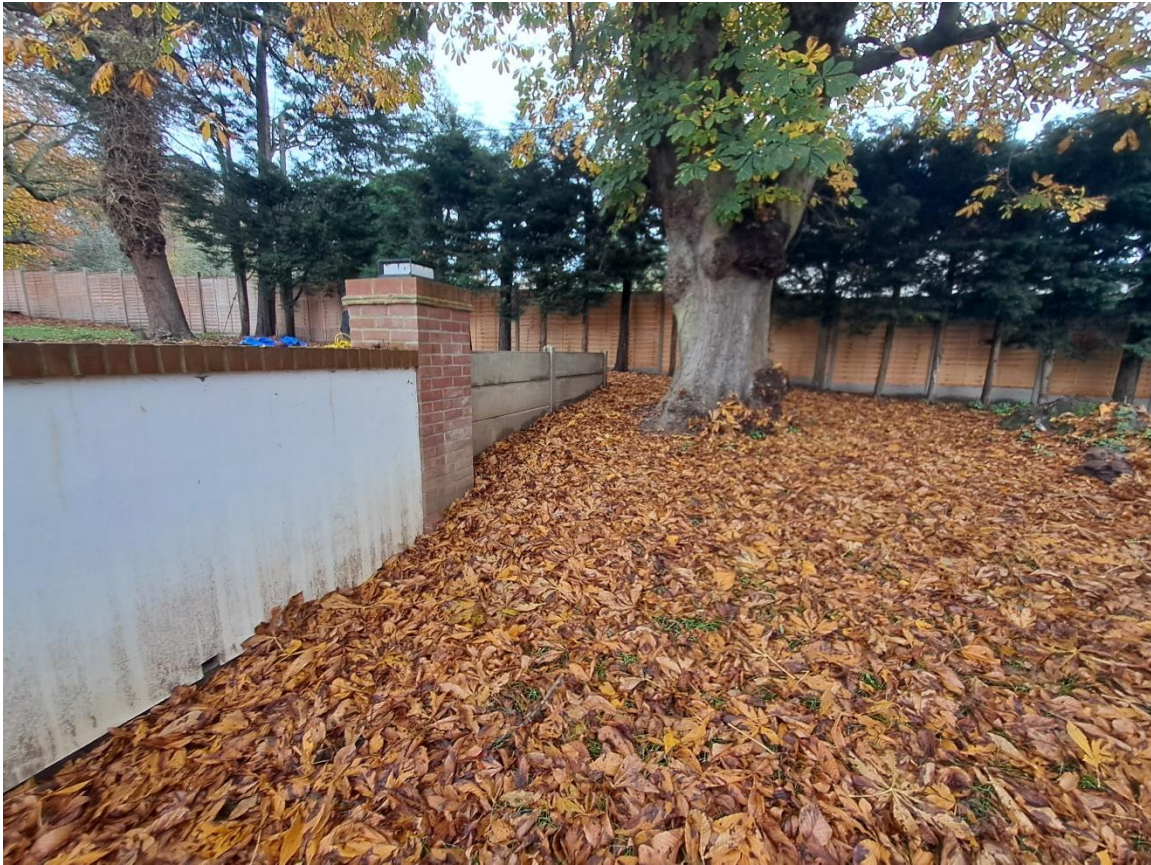
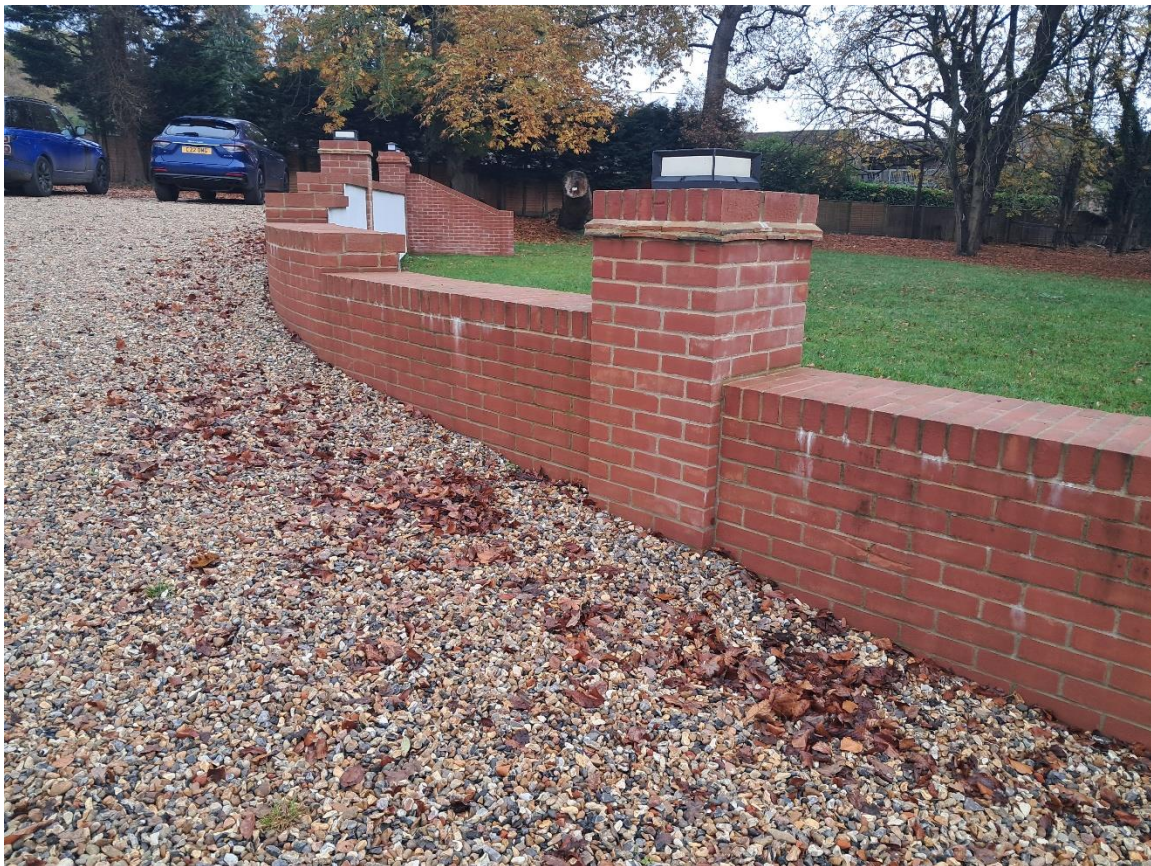
The new wall is 2.6m from the base of T064 (Horse Chestnut) beyond which a series of concrete panels have been used to continue the feature without the need for excavation near the tree.

I have noted that T064 (Horse Chestnut) is in a slightly exposed location with an asymmetrical canopy following the collapse of an adjacent Beech (stump remains).

Whilst there is no visible evidence of tree root damage it is likely that the excavation of foundations for the retaining wall within the RPA may have required tree roots to be cut. However, the orientation of the retaining wall which runs radially to the tree's base and the changes in ground level which preceded the works will have limited any harm to the tree as a result of the excavation work.

Photo 4 – Replacement retaining wall to the front of Woodlands Farm House.

Photo 5 – Replacement retaining wall to the front of Woodlands Farm House.

T064 (Horse Chestnut) is in reasonable health for a tree of this age and species. The canopy / bud density is normal, and the tree exhibits no signs of stress or decline which can occur when tree roots are damaged. At this point the tree can regrow and adapt to the changes within its rooting area. Removing the retaining wall and infill would cause more ground disturbance and potential harm for tree roots and would not necessarily benefit the tree.
