DUCKWORTHS  
ARBORICULTURE LTD.

## TREE CONDITION SURVEY

336 FINCHAMPSTEAD ROAD  
WOKINGHAM  
BERKSHIRE  
RG40 3JP

NOVEMBER 2024  
Ref: 06561 / 2024

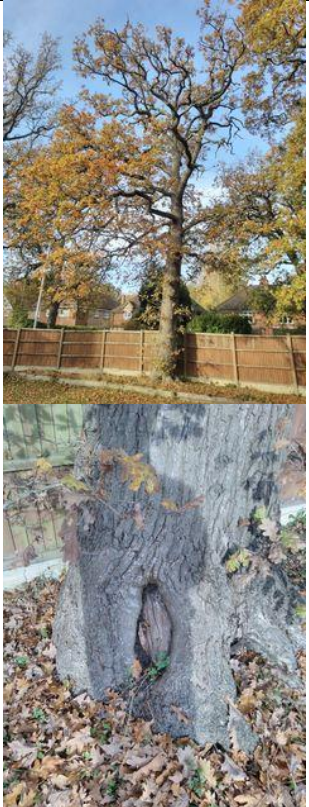
| Ref: | Species | Measurements | Survey Notes | Condition | Recommendations | Photo |
|---|---|---|---|---|---|---|
| T001 | Pedunculate oak<br>(Quercus robur) | Height (m): 16<br>Crown Radius (m):<br>6N, 6.5E, 5.5S, 5.5W<br>DBH (cm): 66<br>Life Stage: Mature<br>Life Exp.: 20+ Years | <p>Behind low raised sleeper retaining wall. Broad base with pronounced buttress roots on northeast side. Historic wounds on aforementioned buttress roots fully occluded. Historic wounding at base on south side. Very small cavity 30mm diameter at ground level. Larger wound 300mm high and 150mm wide 150mm above ground level. Desiccated heartwood exposed. Build-up of frass and organic matter. Good wound wood formation. Slight bulging around wound area from adaptive growth. Hammer test even and satisfactory. No audible decay. Metal probe cannot be inserted far into either wound site. Elsewhere base clear, bark intact. No significant defects. Epicormic shoots on trunk from 0.5m. branching from 5m. 3m canopy clearance over garden. Single stem swept slightly to north. Canopy slightly sparse, lacking vitality. Major dead branches on northern half of crown including dead branches over highway. Asymmetrical crown. Upper canopy sparse and stunted.</p> <p>Wildlife Value: Good</p> | Fair | <p>Remove deadwood.<br/>Tip reduce low branches to create 5.5m canopy clearance over road.</p> <p><b>Timescale:</b><br/>11-Feb-2025<br/>(3 Months)</p> | |

| Ref: | Species | what3words<br>(Location Identifier) | Recommendations | Work Timescale |
|---|---|---|---|---|
| T001 | Pedunculate oak<br>( <i>Quercus robur</i> ) | ///soap.then.engine | Remove deadwood.<br>Tip reduce low branches to create 5.5m canopy clearance over road. | 11-Feb-2025<br>(3 Months) |

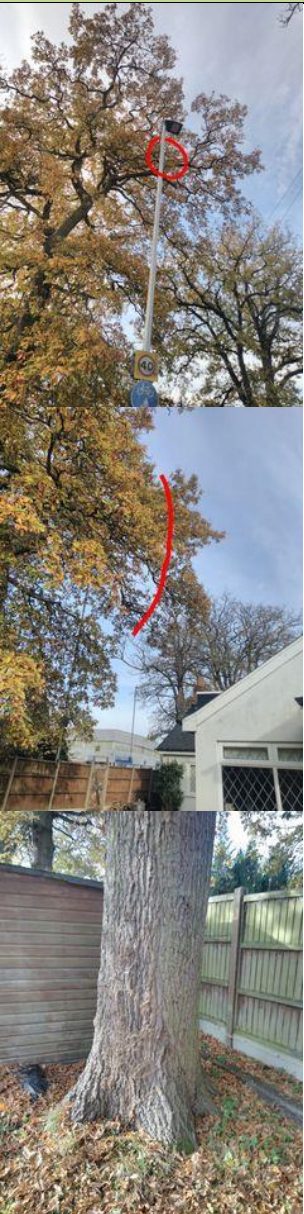
| Ref: | Species | Measurements | Survey Notes | Condition | Recommendations | Photo |
|---|---|---|---|---|---|---|
| T002 | Pedunculate oak<br>(Quercus robur) | Height (m): 17<br>Crown Radius (m): 6.5N, 7E, 7S, 6W<br>DBH (cm): 70<br>Life Stage: Mature<br>Life Exp.: 40+ Years | <p>Two large buttress roots of northeast and East side at base, elsewhere around trunk 6 smaller buttress roots evenly distributed.<br/>Base clear, bark intact.<br/>No fungal fruiting bodies evident. Small area of potential decay on east side between buttress roots but very small and not considered significant.<br/>Hammer test elsewhere even and satisfactory, no audible decay.<br/>Historic scars from where ivy has previously been removed.<br/>Single vertical stem to approximately 7.5m where trunk forks. Epicormic growth on trunk from 2m. Historic pruning cuts on trunk from previous branch removal around 100mm diameter. Good wound wood formation.<br/>Broad crown slightly overhanging property.<br/>Small to medium sized deadwood including a dead branch 1.5m long and around 80mm diameter over patio.<br/>Foliage dense. Good vitality.</p> <p>Wildlife Value: Good</p> | Good | <p>Remove deadwood.<br/>Cut back branch tips on east side of crown by 1-1.5m to reduce overhang of property.<br/>Cut back tips of small branch under streetlight by 1m to remove future obstruction.<br/>Tip reduce low branches to create 5.5m canopy clearance over road and 3.5m over pavement.<br/>Crown lift to create 3m canopy clearance over garden.</p> <p><b>Timescale:</b><br/>11-Feb-2025<br/>(3 Months)</p> | |

| Ref: | Species | what3words<br>(Location Identifier) | Recommendations | Work Timescale |
|---|---|---|---|---|
| T002 | Pedunculate oak<br>( <i>Quercus robur</i> ) | ///assist.lance.alert | Remove deadwood.<br>Cut back branch tips on east side of crown by 1-1.5m to reduce overhang of property.<br>Cut back tips of small branch under street light by 1m to remove future obstruction.<br>Tip reduce low branches to create 5.5m canopy clearance over road and 3.5m over pavement.<br>Crown lift to create 3m canopy clearance over garden. | 11-Feb-2025<br>(3 Months) |

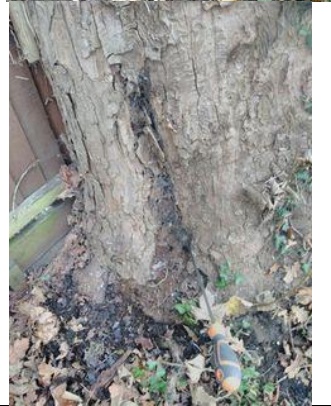
| Ref: | Species | Measurements | Survey Notes | Condition | Recommendations | Photo |
|---|---|---|---|---|---|---|
| T003 | Sycamore<br>( <i>Acer pseudoplatanus</i> ) | Height (m): 15<br>Crown Radius (m): 3.5N, 5E, 6S, 3.5W<br>DBH (cm): 64<br>Life Stage: Over Mature<br>Life Exp.: <10 years | Swept lower trunk. Historic sound on south side in a crack 0.6m long. Frass from wood decay. Fungal fruiting bodies evident of <i>Kretzschmaria deusta</i> around wound site. Prolific fruiting bodies on larger tension buttress roots in east side of trunk. Metal probe can be pushed into trunk up to 120mm. 1.8m from side of house. Dead ivy stems and fairy lights on trunk. Longer branches over roof. Upper crown mostly dead and decaying. Lower canopy foliage slightly sparse.<br>Fungus:<br><i>Kretzschmaria deusta</i> (Brittle Cinder)<br><br>Wildlife Value: Moderate<br>Inspection Limitations: Fence | Potentially hazardous | Fell to ground level.<br><br><b>Timescale:</b><br>11-Dec-2024<br>(1 Month) | |

| Ref: | Species | what3words<br>(Location Identifier) | Recommendations | Work Timescale |
|---|---|---|---|---|
| T003 | Sycamore<br>( <i>Acer pseudoplatanus</i> ) | ///fast.bound.fame | Fell to ground level. | 11-Dec-2024<br>(1 Month) |

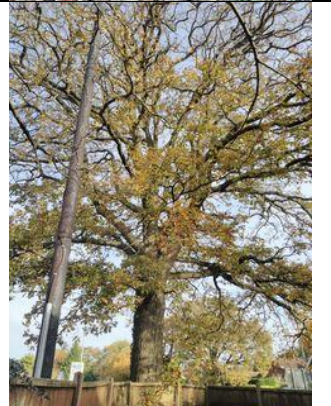
| Ref: | Species | Measurements | Survey Notes | Condition | Recommendations | Photo |
|---|---|---|---|---|---|---|
| T004 | Pedunculate oak<br>( <i>Quercus robur</i> ) | Height (m): 18<br>Crown Radius (m): 8N, 8.5E, 7S, 10W<br>DBH (cm): 90<br>Life Stage: Mature<br>Life Exp.: 40+ Years | Off-site tree. Responsibility for tree condition rests with tree owner / highways authority. Single stem to 5m. Forks and branch unions appear well formed and satisfactory. Individual branches on North side lack vitality. Small to medium sized dead branches over the garden of 336 Finchampstead Road.<br><br>Wildlife Value: High | Good | No action required. | |
