Ref:MW.2502.SRW.AIA

**Re: Arboricultural Impact Assessment for carport installation at Alyeska, Sandhurst Road, Wokingham, RG40 3JG**

BS5837 Tree Survey Plan  
 Alyeska, Sandhurst Road, Wokingham, RG40 3JG

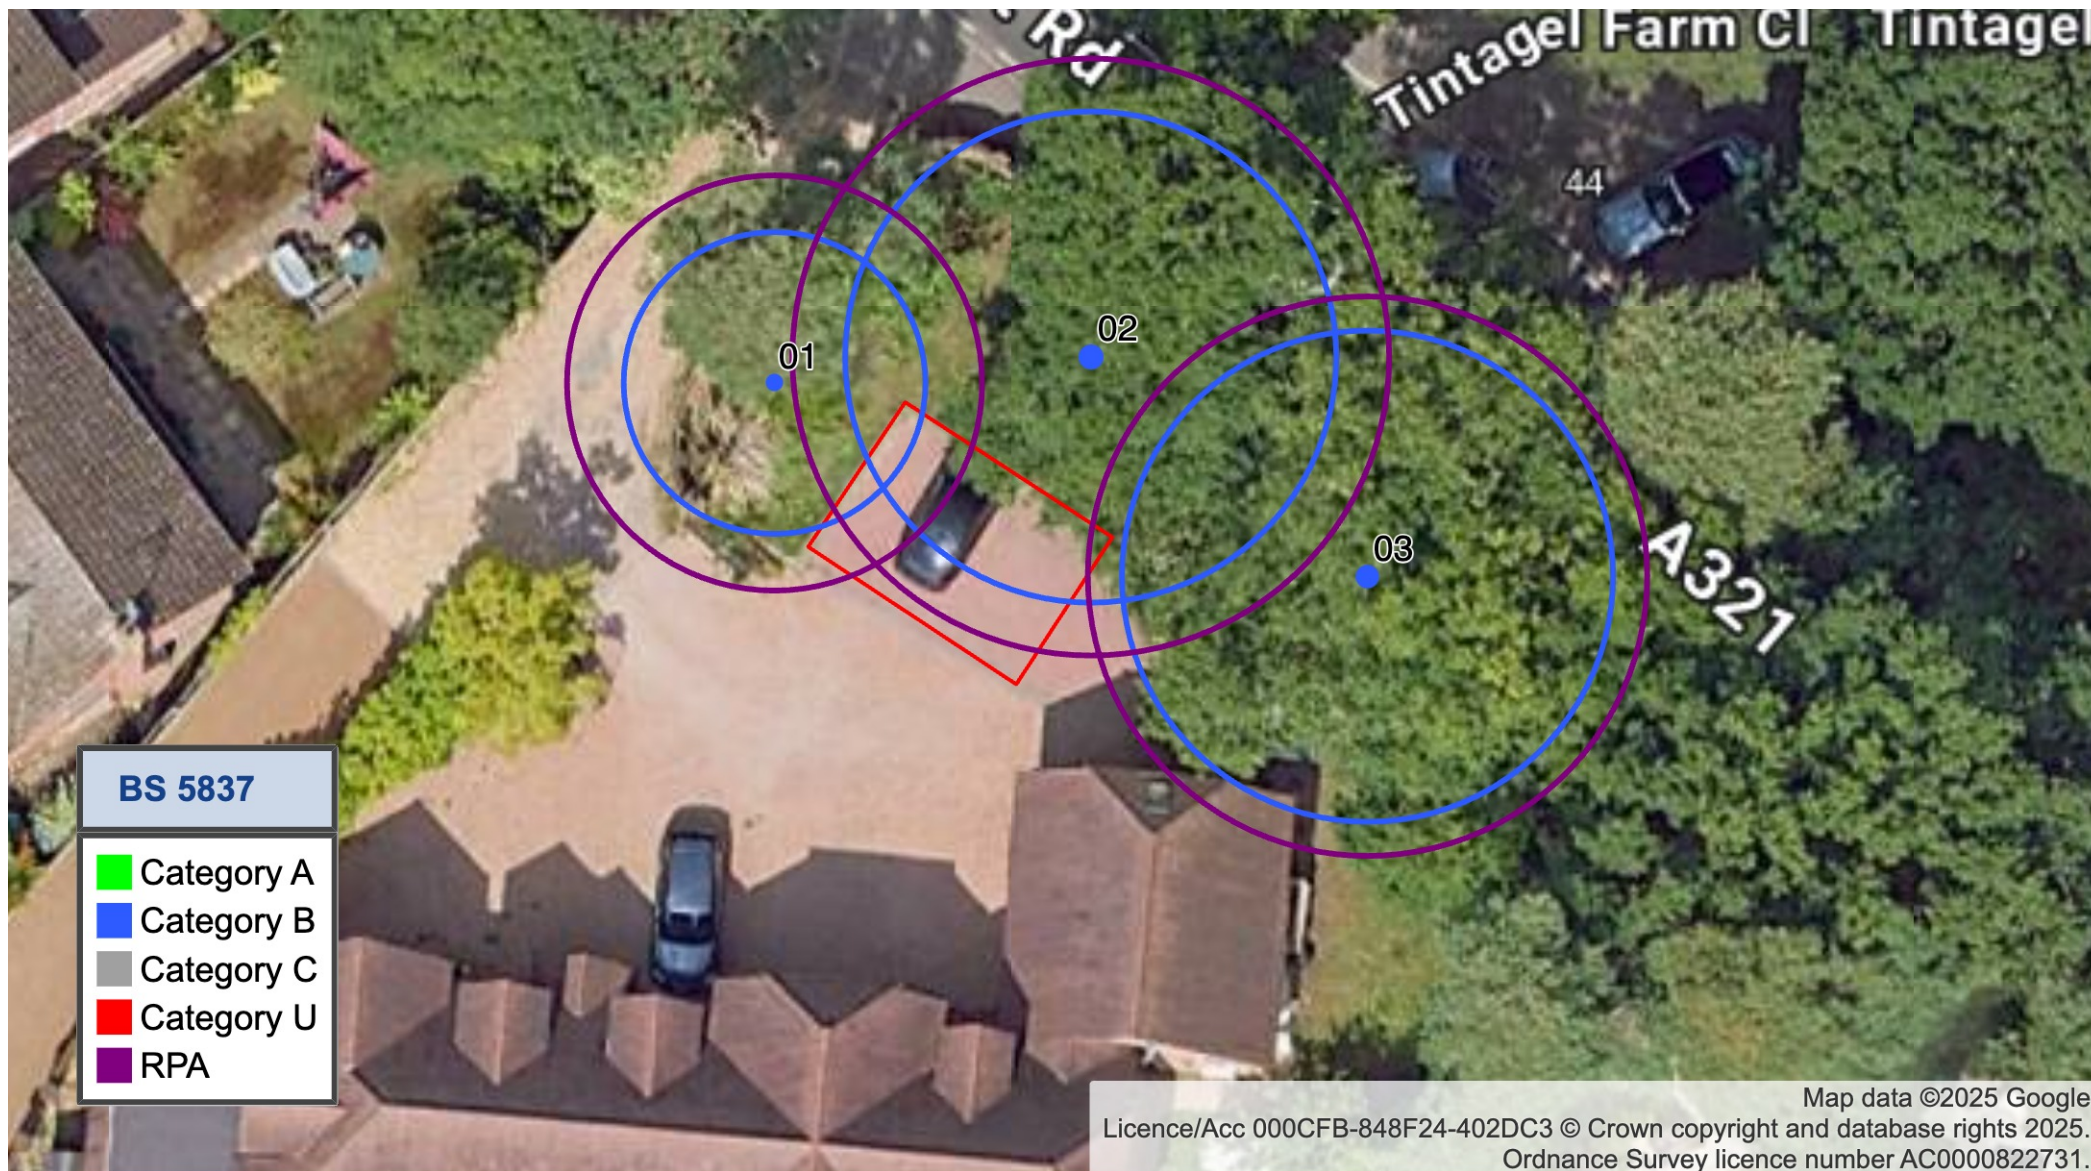
It can be seen on the plan that carport has been installed within the circular root protection areas (RPAs) of the three trees.

The enclosed plan shows the approximate locations of 7No. posts that are located within the circular RPAs.

Six of these are within the paving, and the seventh is within the lawn.

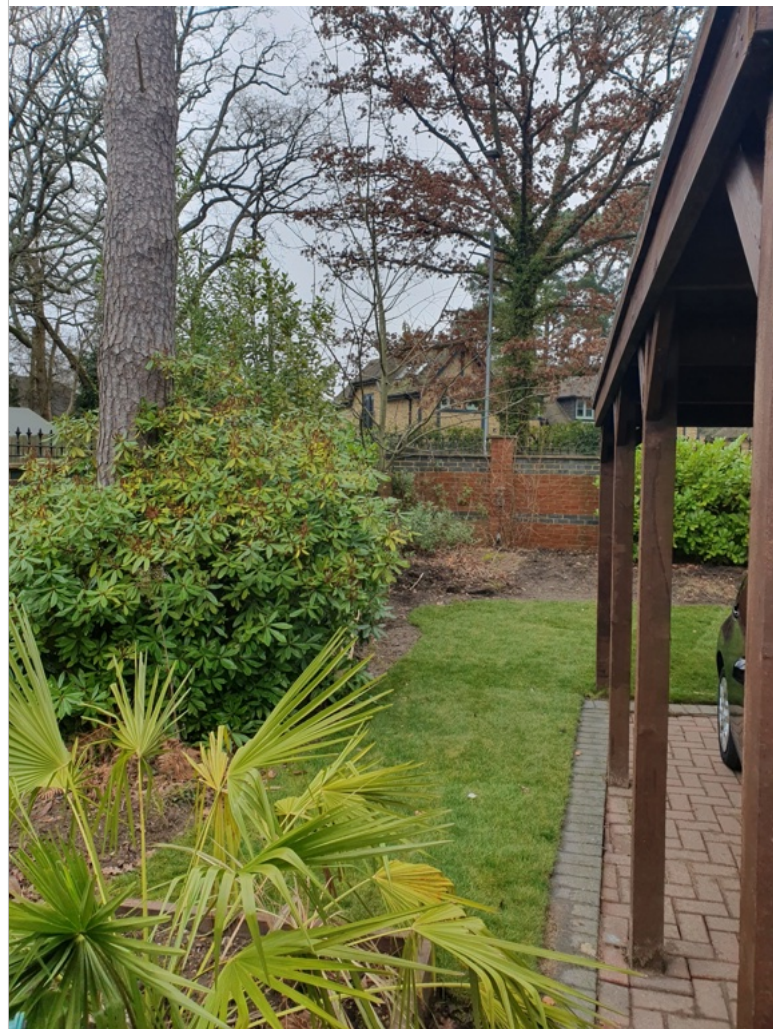
01 P001

Pine #01 has four posts within its RPA. This totals 0.36m<sup>2</sup>- <4% of the overall 95m<sup>2</sup> RPA.

| Ref | Species | Height | Measurements | Comments | Observations & Recommendations | RPA | Recommendations | BS Category |
|---|---|---|---|---|---|---|---|---|
| 01 | Scots pine<br>( <i>Pinus sylvestris</i> ) | 15 | Height (m): 15<br>Stem Diam(mm): 460<br>Spread (m): 4N, 4E, 4S, 4W<br>Crown Clearance (m): 7<br>Life Stage: Mature<br>Rem. Contrib.: 20+ Years | | Fair overall physiological and structural condition. | Radius: 5.5m.<br>Area: 95 sq m. | | B1 |

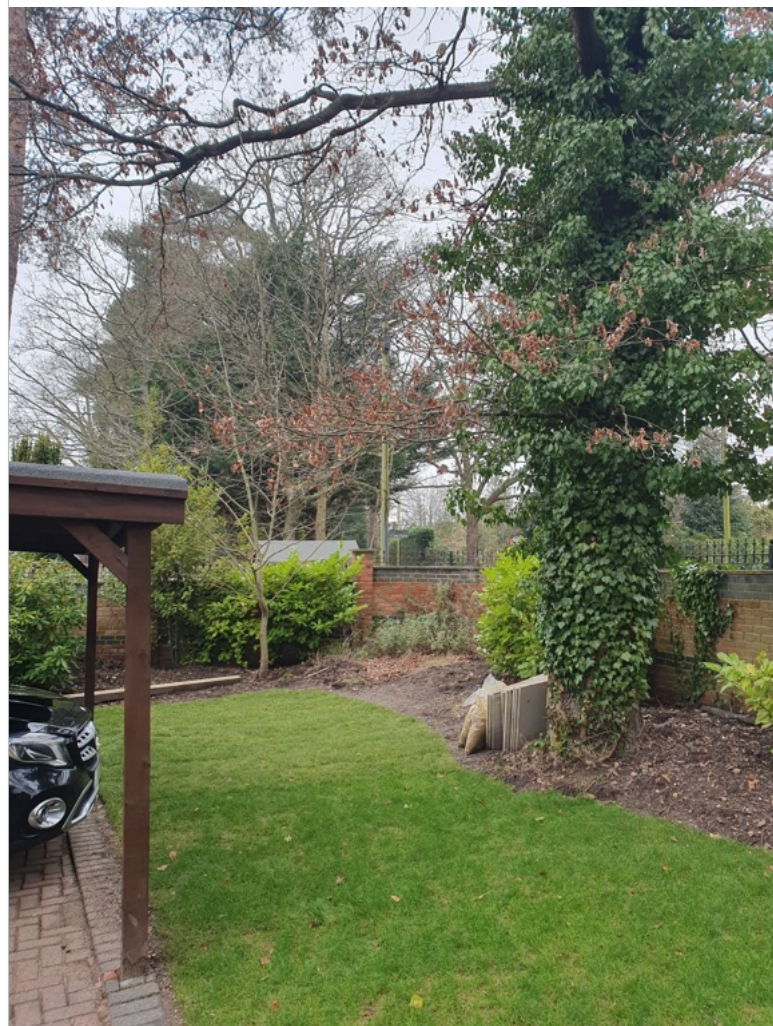
02 P001

The trees comprise 2No. oak (*Quercus robur*) and 1No. Scots pine (*Pinus sylvestris*). All three trees appear to be in good health and condition. Ivy is becoming established on the two oaks and it would be prudent to sever this at ground level to avoid it becoming too dominant.

Oak #02 has six posts within its RPA. This totals 0.54m<sup>2</sup>- <3% of the overall 196m<sup>2</sup> RPA.

| Ref | Species | Height | Measurements | Comments | Observations & Recommendations | RPA | Recommendations | BS Category |
|---|---|---|---|---|---|---|---|---|
| 02 | Pedunculate oak<br>( <i>Quercus robur</i> ) | 14 | Height (m): 14<br>Stem Diam(mm): 660#<br>Spread (m): 6.5N, 6.5E, 6.5S, 6.5W<br>Crown Clearance (m): 3<br>Life Stage: Mature<br>Rem. Contrib.: 20+ Years | | Fair overall physiological and structural condition. | Radius: 7.9m.<br>Area: 196 sq m. | | B1 |

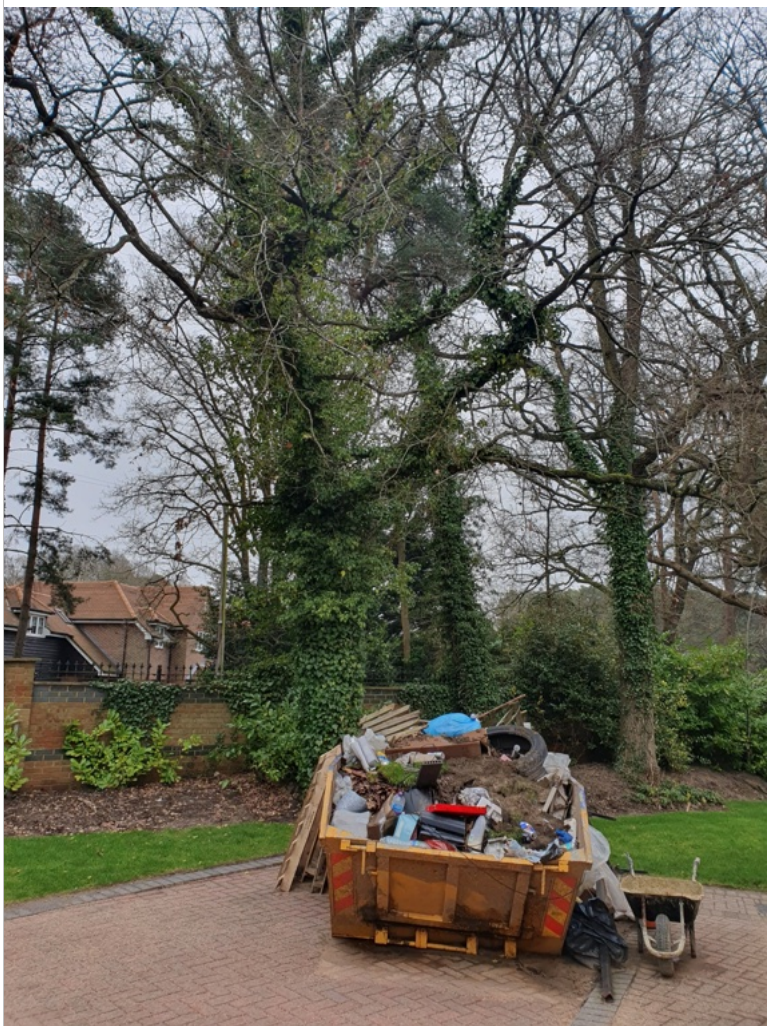
03 P001

Oak #03 has one post within its RPA. This totals 0.09m<sup>2</sup>- <0.5% of the overall 172m<sup>2</sup> RPA.

| Ref | Species | Height | Measurements | Comments | Observations & Recommendations | RPA | Recommendations | BS Category |
|---|---|---|---|---|---|---|---|---|
| 03 | Pedunculate oak<br>( <i>Quercus robur</i> ) | 14 | Height (m): 14<br>Stem Diam(mm): 620<br>Spread (m): 6.5N, 6.5E, 6.5S, 6.5W<br>Crown Clearance (m): 3<br>Life Stage: Mature<br>Rem. Contrib.: 20+ Years | | Fair overall physiological and structural condition. | Radius: 7.4m.<br>Area: 172 sq m. | | B1 |
