## **CCTV Investigation Report**

**Shinfield Community Church, Fairmead Road, Shinfield, Reading,  
RG2 9DL**

**Project No.:** CT 4830093

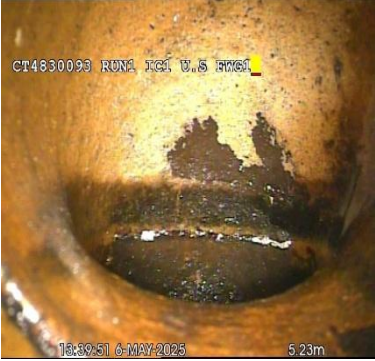
No defects identified within the drain run. The material of the drain changes from pitch fibre to Vitrified clay at 2.92 metres.

Photo 1 refers to the gully trap for FWG 1.

| 5.23 | FH: | | | | | | FWG 1, Photo 1 |

Geocore would advise that all the pitch fibre pipe identified from the CCTV should be excavated and replaced. The drain runs affected are runs 1, 2 and 5.

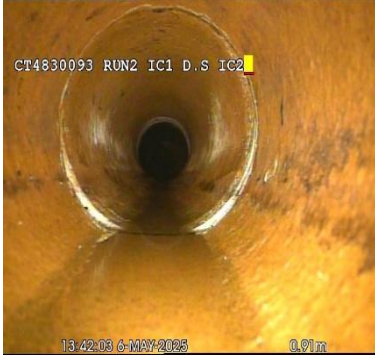
Defects identified within the Vitrified clay section of pipe. The pitch fibre section of the drain run shows signs of deformation.

| 0.91 | CC: 12 o'clock to 12 o'clock | | | | | Grade 2 | Photo 2 |

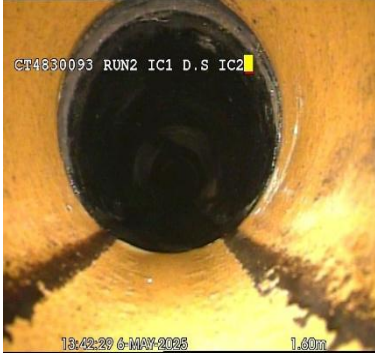
| 1.6 | JDM: | | | | | Grade 2 | Photo 3 |
| 1.6 | MC: V/C to Pitch fibre | | | | | | Photo 3 |

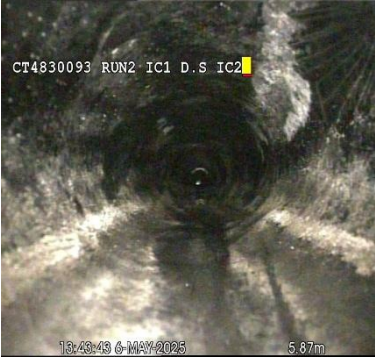
| 5.87 | D: 10% deformation | | | | | | Photo 4 |

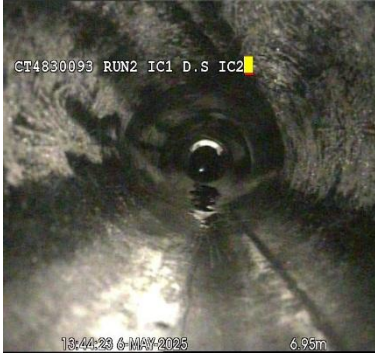
| 6.9 | D: 10% deformation | | | | | | Photo 5 |

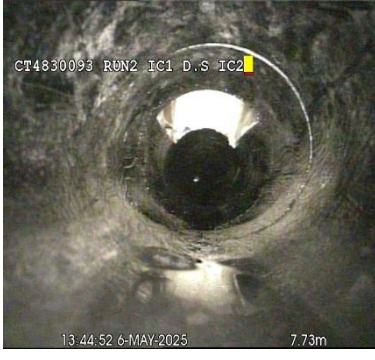
| 7.73 | D: 20% deformation | | | | | | Photo 6 |

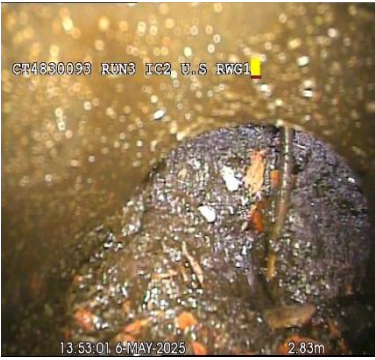
No defects were identified within the drain run. RWG 1 was found to be blocked with silt. Please refer to photo 7 within the report. The gully was cleared and was cleared using the rod and plunger.

| 2.83 | FH: | | | | | Grade 1 | RWG 1, Photo 7 |

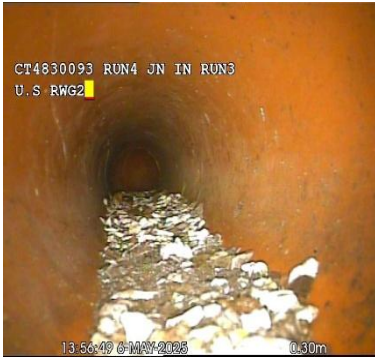
There is debris gravel within the drain run which could not be cleared due to the access restrictions caused by trying to thread the jetting hose upstream of the junction.

| 0.3 | DES: 10% diameter loss in pipe | | | | | | Photo 8 |

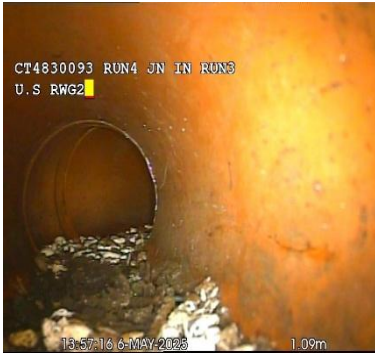
| 1.09 | DES: 10% diameter loss in pipe | | | | | | Photo 9 |

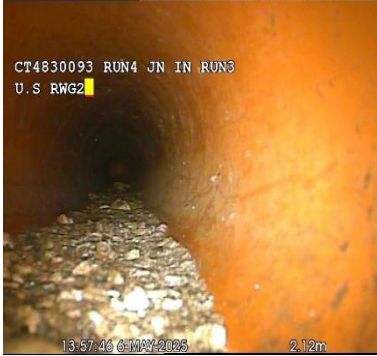
| 2.12 | DES: 10% diameter loss in pipe | | | | | | Photo 10 |

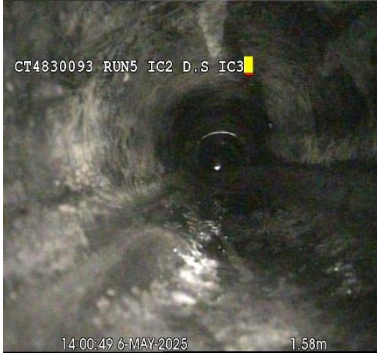
The CCTV surveyed identified that the pitch fibre pipe is deformed along the entire length of the drain run. Please refer to photos 11 to 17 within the report.

| 1.58 | D: 10% deformation | | | | | | Photo 11 |

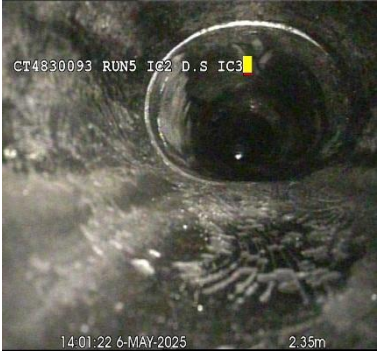
| 2.35 | D: 20% deformation | | | | | | Photo 12 |

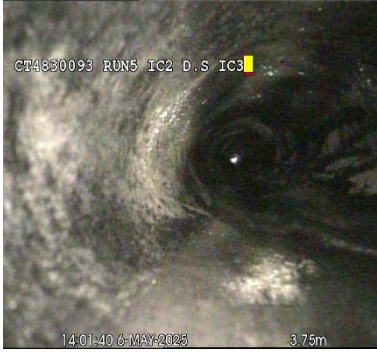
| 3.75 | D: 10% deformation | | | | | | Photo 13 |

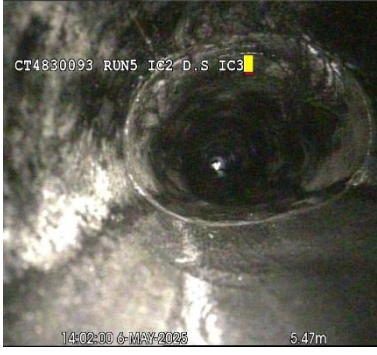
| 5.47 | D: 20% deformation | | | | | | Photo 14 |

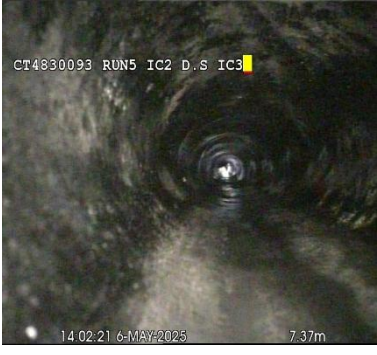
| 7.39 | D: 10% deformation | | | | | | Photo 15 |

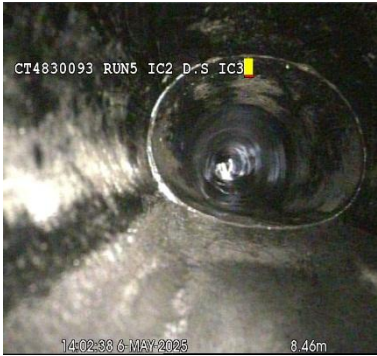
| 8.46 | D: 25% deformation | | | | | | Photo 16 |

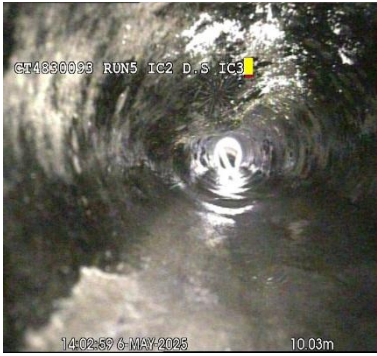
| 10.03 | D: 25% deformation | | | | | | Photo 17 |

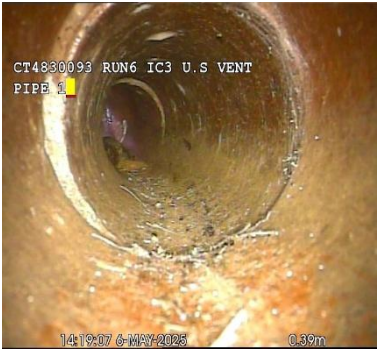
Fine roots were observed at 0.39 metres.

| 0.39 | RF: | | | | | | Photo 18 |

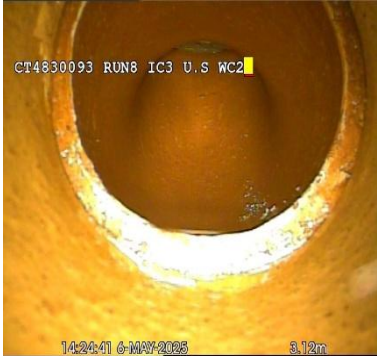
Defect identified within the Vitrified clay section of pipe.

| 3.12 | JDM: | | | | | Grade 2 | Photo 19 |

Remove W/C 2 for access to install a specialist pencil patch repair. Excavate and replace FWG 2, pipe and junction that links run 9 to run 8.

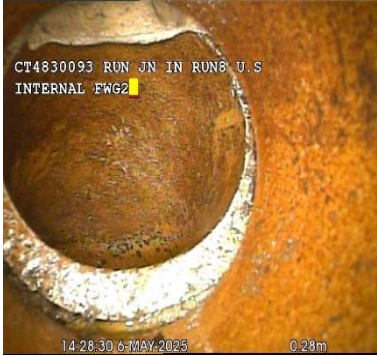
Defect identified within the drain run.

| 0.28 | JDL: | | | | | Grade 3 | Photo 20 |

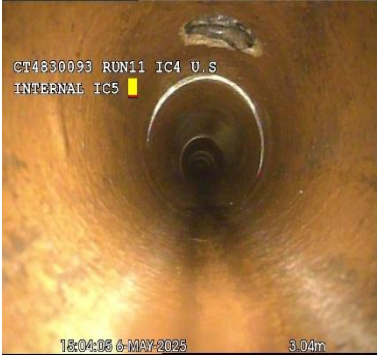
There is a connection at 3.04 metres which looks to be 50mm diameter. The operatives were unable to locate where the connection is coming from.

| 3.04 | CN: 12 o'clock | | | | | | Unable to identify, Photo 21 |

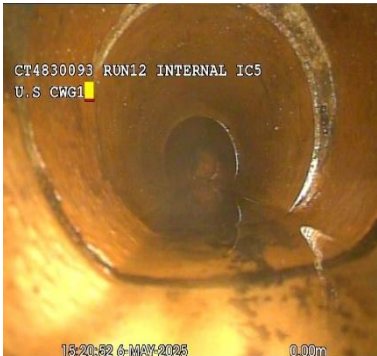
Defect identified within the drain run.

| 0.02 | FC: 10 o'clock to 5 o'clock | | | | | Grade 3 | Photo 22 |

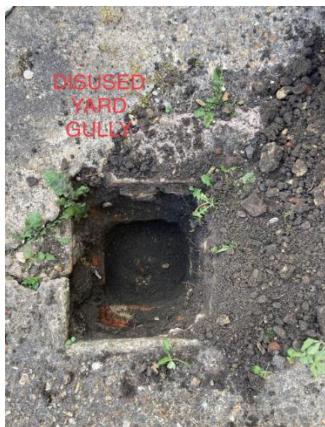
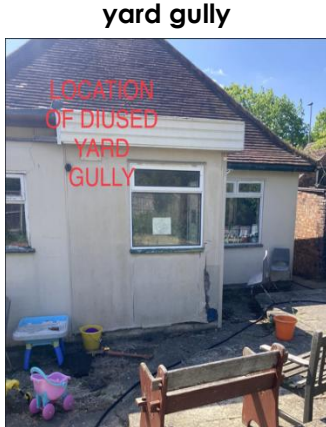
At 10.35 metres, there is a junction within the drain run which the operatives suspect is coming from the disused yard gully.

The operatives found that the disused yard gully has been capped off with concrete.
