# ARBORICULTURAL REPORT

TREE CONDITION SURVEY

LAND AT SYLVESTER CLOSE  
WINNERSH  
BERKSHIRE  
RG41 5LL

Ref: 06759 / 2025

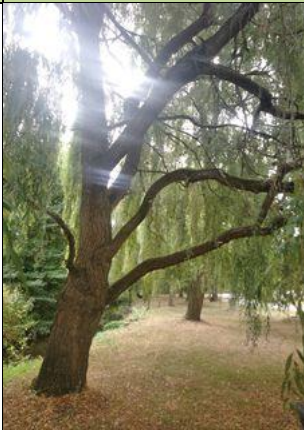
| Ref: | Species | Measurements | Survey Notes | Condition | Other Data | Recommendations | Photo |
|---|---|---|---|---|---|---|---|
| T001 | Weeping willow<br>( <i>Salix babylonica</i> ) | Height (m): 14<br>Crown Radius (m): 9<br>DBH (cm): 64<br>Life Stage: Mature<br>Life Exp.: 40+ Years | Base clear, bark intact. Sound intonation even. No fungal fruiting bodies evident or audible decay. Smooth even for collar. Slight widening around 1.3m associated with first low branch and area where small branches have previously been removed.<br>Asymmetrical crown to south with all large branches on this side of the crown. Twin stem from 3m. Fork structure satisfactory. No major structural defects visible. Small to medium sized dead branches and dead branch stubs in lower central canopy. Some shot hole fungal infection and anthracnose on leaves. Foliage density normal. | Fair | Wildlife Value:<br>Good | Recommendations 1:<br>Remove deadwood<br><b>Timescale:</b><br>Optional<br><br>Recommendations 2:<br>Crown lift to create 2.5m canopy clearance over amenity verge.<br><br><b>Timescale:</b><br>14-Feb-2026<br>(6 Months) | |

| Ref: | Species | Recommendations | Work Timescale |
|---|---|---|---|
| T001 | Weeping willow | Crown lift to create 2.5m canopy clearance over amenity verge. | 14-Feb-2026<br>(6 Months) |

| Ref: | Species | Recommendations | Work Timescale |
|---|---|---|---|
| T001 | Weeping willow | Remove deadwood. | Optional |

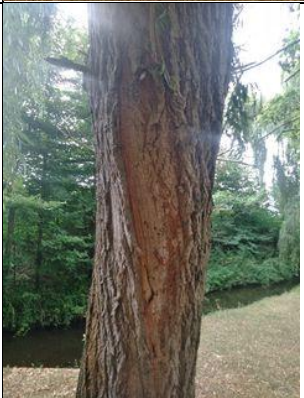
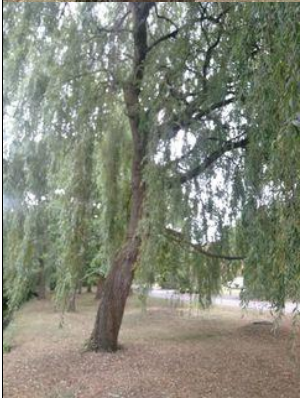
| Ref: | Species | Measurements | Survey Notes | Condition | Other Data | Recommendations | Photo |
|---|---|---|---|---|---|---|---|
| T002 | Weeping willow<br>( <i>Salix babylonica</i> ) | Height (m): 15<br>Crown Radius (m): 8<br>DBH (cm): 64<br>Life Stage: Mature<br>Life Exp.: 40+ Years | Drainage / manhole cover within 5m of base. Base of trunk clear, bark intact. Sound intonation even. No fungal fruiting bodies evident or audible decay. Helical growth around lower trunk. Swept stem south. Adaptive growth on buttress roots at base. Smooth area of bark 1m long 30cm side on south side from 1.2m. cause unclear - may be historic wound. Small area of later superficial bark damage in this area.<br>Asymmetrical crown to south and west with all large branches on these sides of the crown. Twin stem from 6m. Fork structure is good - under tension and satisfactory. No major structural defects visible. Small to medium sized dead branches and dead branch stubs in lower and central canopy. Some shot hole fungal infection and anthracnose on leaves. Foliage density normal. | Fair | Wildlife Value:<br>Good | Recommendations 1:<br>Consider relocating bench mid-way between T001 & T002.<br>Remove deadwood.<br><br><b>Timescale:</b><br>General recommendation<br><br>Recommendations 2:<br>Crown lift to create 2.5m canopy clearance over amenity verge.<br><br><b>Timescale:</b><br>14-Feb-2026<br>(6 Months) | <br> |

| Ref: | Species | Recommendations | Work Timescale |
|---|---|---|---|
| T002 | Weeping willow | Crown lift to create 2.5m canopy clearance over amenity verge. | 14-Feb-2026<br>(6 Months) |

| Ref: | Species | Recommendations | Work Timescale |
|---|---|---|---|
| T002 | Weeping willow | Consider relocating bench mid-way between T001 & T002.<br>Remove deadwood. | Recommendation |

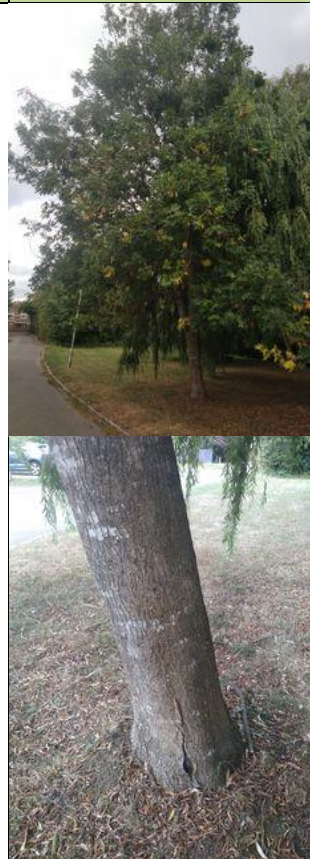
| Ref: | Species | Measurements | Survey Notes | Condition | Other Data | Recommendations | Photo |
|---|---|---|---|---|---|---|---|
| T003 | Common ash<br>( <i>Fraxinus excelsior</i> ) | Height (m): 15<br>Crown Radius (m): 5<br>DBH (cm): 32<br>Life Stage: Mature<br>Life Exp.: 20+ Years | 3m from road. Manhole cover / drainage 2.5m from base. Base clear. Linear bark wound on east side of lower trunk. Some active wound wood forming. Smooth root collar. Sound intonation even and satisfactory. Exposed surface root 0.4m from base. Swept trunk to south - adaptive growth at base. Single stem to 2m. Small area of included bark in fork and area of ruptured bark on more upright, vertical trunk. Rapid growth bark cracks on trunk. Asymmetrical crown to south over highway. Small to medium sized dead branches in lower crown. Live foliage density normal. Tips chlorotic / early autumnal. Low crown to 1.6m over roadway. | Fair | Ash Dieback<br>Level: Infection<br>Level 1: 0% to 25%<br>Wildlife Value:<br>Moderate | Crown lift to create 4.5m canopy clearance over road. 2.5m over amenity verge.<br>Remove deadwood.<br><br><b>Timescale:</b><br>14-Feb-2026<br>(6 Months) | |

| Ref: | Species | Recommendations | Work Timescale |
|---|---|---|---|
| T003 | Common ash | Crown lift to create 4.5m canopy clearance over road. 2.5m over amenity verge.<br>Remove deadwood. | 14-Feb-2026<br>(6 Months) |

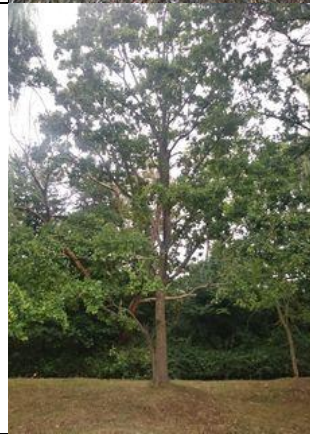
| Ref: | Species | Measurements | Survey Notes | Condition | Other Data | Recommendations | Photo |
|---|---|---|---|---|---|---|---|
| T004 | Pedunculate oak<br>( <i>Quercus robur</i> ) | Height (m): 12<br>Crown Radius (m): 4<br>DBH (cm): 25<br>Life Stage: Early Mature<br>Life Exp.: 40+ Years | Base clear, bark intact. Low small branch off lower trunk. Main trunk grows more or less vertical. Asymmetrical crown, potentially due to presence of off-site Willow which has since died. Foliage healthy but clustered. Gaps through crown. Epicormic shoots on branches - all symptoms of physiological stress. Potential to recover. | Fair | Wildlife Value:<br>Moderate | No works identified. | |

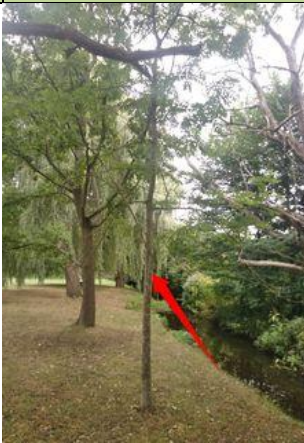
| Ref: | Species | Measurements | Survey Notes | Condition | Other Data | Recommendations | Photo |
|---|---|---|---|---|---|---|---|
| T005 | Common ash<br>( <i>Fraxinus excelsior</i> ) | Height (m): 8.5<br>Crown Radius (m): 1.5<br>DBH (cm): 9<br>Life Stage: Young<br>Life Exp.: <10 years | Small tree, canopy suppressed by adjacent oaks. Single stem. Dead branches throughout crown. Tree 25% defoliated. Limited long-term potential.<br><br>Pests and Diseases:<br>Ash Dieback Infection Level 2: 25% to 50% | Poor | Wildlife Value:<br>Low | No works identified. | |

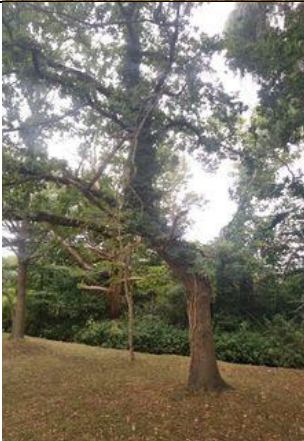
| Ref: | Species | Measurements | Survey Notes | Condition | Other Data | Recommendations | Photo |
|---|---|---|---|---|---|---|---|
| T006 | Pedunculate oak<br>( <i>Quercus robur</i> ) | Height (m): 13<br>Crown Radius (m): 6.5<br>DBH (cm): 44<br>Life Stage: Mature<br>Life Exp.: 40+ Years | 6m from drive. Base clear, bark intact. Hammer test even and satisfactory. No fungal fruiting bodies evident or audible decay. Single trunk vertical to 2m above which it links to the west from an area associated with previous branch removal. Ivy clad trunk resumes vertical growth 3m above ground level. Large dead branches in lower crown, smaller dead branches in upper crown. Epicormic growth on branches. Foliage slightly gappy. Low canopy to 1m above ground level over verge and 2m over highway. | Fair | Wildlife Value:<br>Good<br>Inspection Limitations: Ivy on trunk from 2m. | Reduce low lateral branch on south side over road by 2m to clear access drive.<br>Remove deadwood.<br>Crown lift canopy to ensure 2.5m canopy clearance over verge.<br>Sever ivy at base.<br><br><b>Timescale:</b><br>14-Nov-2025<br>(3 Months) | |

| Ref: | Species | Recommendations | Work Timescale |
|---|---|---|---|
| T006 | Pedunculate oak | Reduce low lateral branch on south side over road by 2m to edge of access drive.<br>Remove deadwood.<br>Crown lift canopy to ensure 2.5m canopy clearance over verge.<br>Sever ivy at base. | 14-Nov-2025<br>(3 Months) |

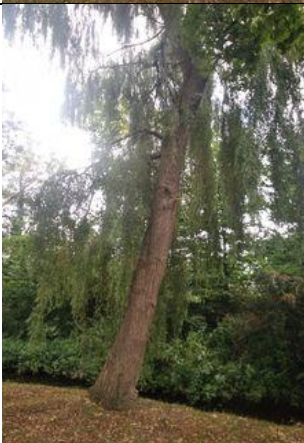
| Ref: | Species | Measurements | Survey Notes | Condition | Other Data | Recommendations | Photo |
|---|---|---|---|---|---|---|---|
| T007 | Weeping willow<br>( <i>Salix babylonica</i> ) | Height (m): 16<br>Crown Radius (m): 6<br>DBH (cm): 54<br>Life Stage: Mature<br>Life Exp.: 40+ Years | Swept stem to northeast. Pronounced buttress roots and adaptive growth around base and lower trunk. Base clear, bark intact. Hammer test even and satisfactory. No audible decay. Twin stem from 7m. Stems above initially grow more or less vertical. Fork structure as viewed from ground level appears satisfactory. High, symmetrical canopy. Small to medium sized dead branches in crown over low occupancy area. Symptoms of shot hole fungus and anthracnose in crown. Foliage density normal. | Fair | Wildlife Value:<br>Good | Recommendations 1:<br>Remove deadwood.<br><b>Timescale:</b><br>Optional<br><br>Recommendations 2:<br>Crown lift to create 2.5m canopy clearance over amenity verge.<br><br><b>Timescale:</b><br>14-Feb-2026<br>(6 Months) | |

| Ref: | Species | Recommendations | Work Timescale |
|---|---|---|---|
| T007 | Weeping willow | Crown lift to create 2.5m canopy clearance over amenity verge. | 14-Feb-2026<br>(6 Months) |

| Ref: | Species | Recommendations | Work Timescale |
|---|---|---|---|
| T007 | Weeping willow | Remove deadwood. | Optional |

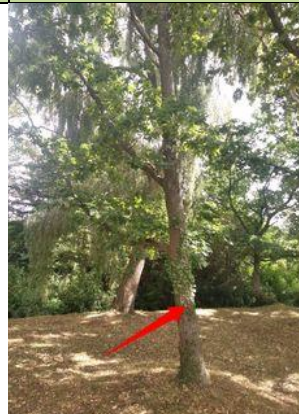
| Ref: | Species | Measurements | Survey Notes | Condition | Other Data | Recommendations | Photo |
|---|---|---|---|---|---|---|---|
| T008 | Pedunculate oak<br>( <i>Quercus robur</i> ) | Height (m): 12<br>Crown Radius (m): 3.5<br>DBH (cm): 30<br>Life Stage: Mature<br>Life Exp.: 40+ Years | 4.5m from drive. Base clear, bark intact. Light ivy growth on trunk. No fungal fruiting bodies evident or audible decay. Single trunk swept slightly to the north. Small area of ruptured bark and bleeding canker on west side at base. Slender crown. Foliage density normal. Two larger dead branches in crown and dead branch tips. | Fair | Wildlife Value:<br>Good<br>Inspection<br>Limitations:<br>Light ivy growth | Remove deadwood.<br><br><b>Timescale:</b><br>14-Nov-2025<br>(3 Months) | |

| Ref: | Species | Recommendations | Work Timescale |
|---|---|---|---|
| T008 | Pedunculate oak | Remove deadwood. | 14-Nov-2025<br>(3 Months) |

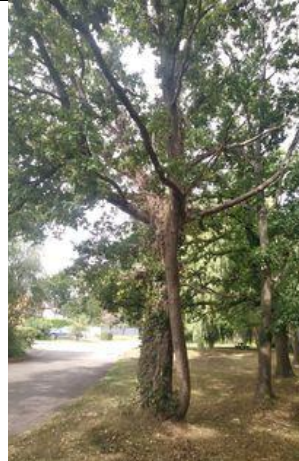
| Ref: | Species | Measurements | Survey Notes | Condition | Other Data | Recommendations | Photo |
|---|---|---|---|---|---|---|---|
| T009 | Pedunculate oak<br>( <i>Quercus robur</i> ) | Height (m): 13<br>Crown Radius (m): 6.5<br>DBH (cm): 62<br>Life Stage: Mature<br>Life Exp.: 40+ Years | Girdling root on south side. Twin stem from 0.4m with smaller trunk around 200mm diameter, fused to side branch off larger trunk around 4m above ground level. Base of main stem partially obscured by prolific ivy. Historic pruning cut on base west side of trunk 100mm diameter. Small cavity. Good wound wood formation, cavity appears well compartmentalised. Where accessible hammer test even and satisfactory. No fungal fruiting bodies evident or audible decay. Dead ivy stems obscure trunk. Asymmetrical crown biased south over road. Major deadwood in north side of crown over verge. Foliage slightly sparse but within the parameters of normal. | Fair | Wildlife Value:<br>Good<br>Inspection<br>Limitations:<br>Prolific ivy | Remove deadwood.<br>Crown lift canopy to ensure 4.5m canopy clearance over roadway.<br>Sever ivy at base and 1.5m and remove from lower trunk.<br><br><b>Timescale:</b><br>14-Nov-2025<br>(3 Months) | |

| Ref: | Species | Recommendations | Work Timescale |
|---|---|---|---|
| T009 | Pedunculate oak | Remove deadwood.<br>Crown lift canopy to ensure 4.5m canopy clearance over roadway.<br>Sever ivy at base and 1.5m and remove from lower trunk. | 14-Nov-2025<br>(3 Months) |

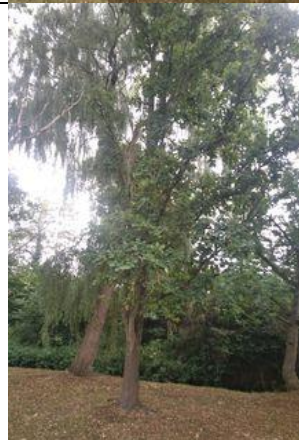
| Ref: | Species | Measurements | Survey Notes | Condition | Other Data | Recommendations | Photo |
|---|---|---|---|---|---|---|---|
| T010 | Pedunculate oak<br>( <i>Quercus robur</i> ) | Height (m): 11<br>Crown Radius (m): 3<br>DBH (cm): 20<br>Life Stage: Mature<br>Life Exp.: 40+ Years | Small tree. Historical damage to exposed surface roots. Base clear, bark intact. Light ivy growth on trunk. No fungal fruiting bodies evident or audible decay. Single trunk. Two vertical side branches on south side from 1.2m. Slender crown. Epicormic growth on branches Foliage density normal. Small dead branch tips in central canopy. | Fair | Wildlife Value:<br>Good | No works identified. | |

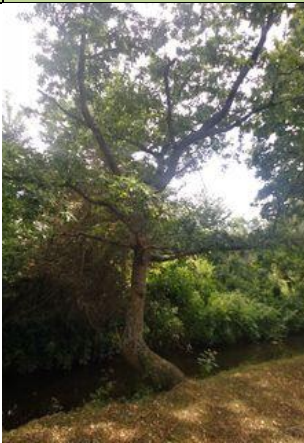
| Ref: | Species | Measurements | Survey Notes | Condition | Other Data | Recommendations | Photo |
|---|---|---|---|---|---|---|---|
| T011 | Pedunculate oak<br>( <i>Quercus robur</i> ) | Height (m): 9.5<br>Crown Radius (m): 3.5<br>DBH (cm): 30<br>Life Stage: Mature<br>Life Exp.: 40+ Years | Small bankside tree. Kinked lower trunk over stream before assuming vertical growth. Base clear, bark intact. Light ivy growth on trunk. No fungal fruiting bodies evident or audible decay. Single stem to 3m. Canopy formed of slender long branches. Short dead branch stubs in central canopy over low occupancy area. | Fair | Wildlife Value:<br>Good | No works identified. | |

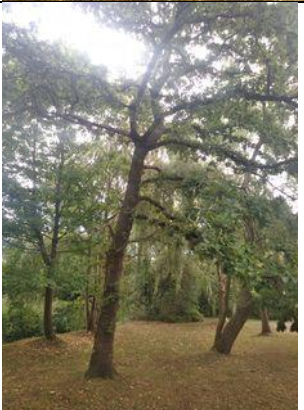
| Ref: | Species | Measurements | Survey Notes | Condition | Other Data | Recommendations | Photo |
|---|---|---|---|---|---|---|---|
| T012 | Pedunculate oak<br>( <i>Quercus robur</i> ) | Height (m): 13<br>Crown Radius (m): 6.5<br>DBH (cm): 39<br>Life Stage: Mature<br>Life Exp.: 40+ Years | 6m from drive. Base clear, bark intact. Hammer test even and satisfactory. No fungal fruiting bodies evident or audible decay. Early emerging epicormic shoots on trunk. Historic wound on North side of trunk, 1m above ground level, fully occluded. Single trunk swept to the south. At 6m the trunk main stem kinks and several side branches grow. Asymmetrical crown to south. Prolific epicormic shoots on branches. Foliage density normal. Small to large dead branches over verge Low canopy to 1m above ground level over verge. | Fair | Wildlife Value:<br>Good | Remove deadwood.<br>Crown lift canopy to ensure 2.5m canopy clearance over verge.<br><br><b>Timescale:</b><br>14-Nov-2025<br>(3 Months) | |

| Ref: | Species | Recommendations | Work Timescale |
|---|---|---|---|
| T012 | Pedunculate oak | Remove deadwood. Crown lift canopy to ensure 2.5m canopy clearance over verge. | 14-Nov-2025<br>(3 Months) |

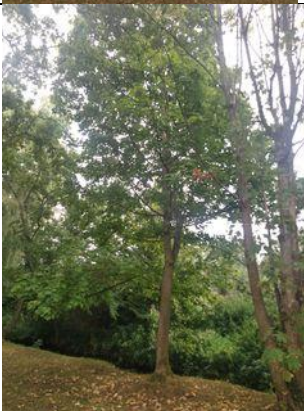
| Ref: | Species | Measurements | Survey Notes | Condition | Other Data | Recommendations | Photo |
|---|---|---|---|---|---|---|---|
| T013 | Norway maple<br>( <i>Acer platanoides</i> ) | Height (m): 15<br>Crown Radius (m): 5<br>DBH (cm): 31<br>Life Stage: Early Mature<br>Life Exp.: 40+ Years | Swept lower trunk. Girdling root restricts trunk growth on west side. Base clear, bark intact. Single stem to 2.5m. Fork structure satisfactory. Minor dead branch tips in crown - squirrel damage? Foliage dense and even. Good vitality. | Good | Wildlife Value:<br>Moderate | No works identified. | |

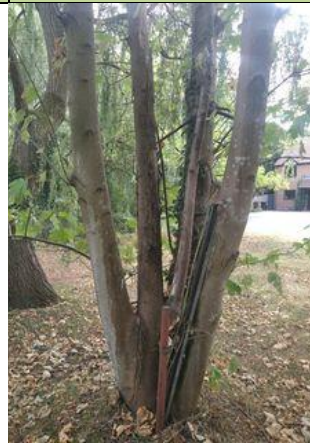
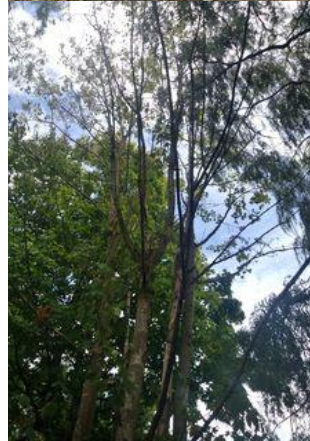
| Ref: | Species | Measurements | Survey Notes | Condition | Other Data | Recommendations | Photo |
|---|---|---|---|---|---|---|---|
| T014 | Sycamore<br>( <i>Acer pseudoplatanus</i> ) | Height (m): 15<br>Crown Radius (m): 4<br>DBH (cm): 20<br>Stems: 5<br>Life Stage: Over Mature<br>Life Exp.: <10 years | <p>Multi-stem from ground level. Light ivy growth. Metal posts and old wire fence occluded into trunks. Two of five stems dead. Remaining three have dead side branches, foliage on live growth stunted and extremely sparse. Tree in advanced decline and beyond the point from which recovery might be expected.</p> <p>Pests and Diseases:<br/>Sooty Bark Disease (<i>Cryptostroma corticale</i>)</p> | Poor | Wildlife Value:<br>Moderate | <p>Fell to 2m high stump - beware metal and wire occluded into lower trunk.</p> <p><b>Timescale:</b><br/>14-Aug-2026<br/>(1 Year)</p> | |

| Ref: | Species | Recommendations | Work Timescale |
|---|---|---|---|
| T014 | Sycamore | Fell to 2m high stump - beware metal and wire occluded into lower trunk. | 14-Aug-2026<br>(1 Year) |

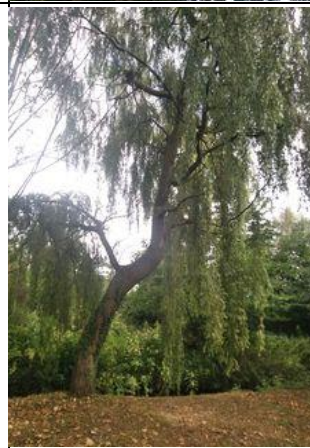
| Ref: | Species | Measurements | Survey Notes | Condition | Other Data | Recommendations | Photo |
|---|---|---|---|---|---|---|---|
| T015 | Weeping willow<br>( <i>Salix babylonica</i> ) | Height (m): 15<br>Crown Radius (m): 5.5<br>DBH (cm): 55<br>Life Stage: Mature<br>Life Exp.: 40+ Years | Bankside tree. Light ivy growth. Swept lower trunk to the north which then curves around to the east from 2.5m. trunk assumes vertical from 3m, 1m east of lower trunk. Helical growth on older trunk common for species. Small to medium sized deadwood throughout the canopy. Foliage density normal. Some shot hole fungus. One or two low branches grow down to ground level. | Fair | Wildlife Value:<br>Good | <p>Recommendations 1:<br/>Remove deadwood.</p> <p><b>Timescale:</b><br/>Optional</p> <p>Recommendations 2:<br/>Crown lift to create 2.5m canopy clearance over amenity verge.</p> <p><b>Timescale:</b><br/>14-Feb-2026<br/>(6 Months)</p> | |

| Ref: | Species | Recommendations | Work Timescale |
|---|---|---|---|
| T015 | Weeping willow | Crown lift to create 2.5m canopy clearance over amenity verge. | 14-Feb-2026<br>(6 Months) |

| Ref: | Species | Recommendations | Work Timescale |
|---|---|---|---|
| T015 | Weeping willow | Remove deadwood. | Optional |

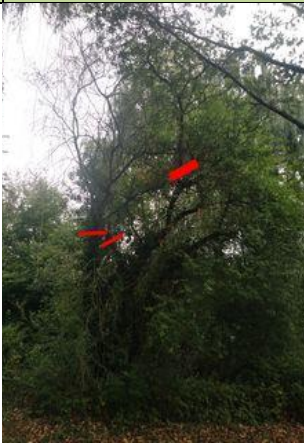
| Ref: | Species | Measurements | Survey Notes | Condition | Other Data | Recommendations | Photo |
|---|---|---|---|---|---|---|---|
| T016 | Blackthorn<br>( <i>Prunus spinosa</i> ) | Height (m): 8<br>Crown Radius (m): 3.5<br>DBH (cm): 12<br>Stems: 4<br>Life Stage: Over Mature<br>Life Exp.: 10+ Years | Ivy clad shrubby tree. Restricted access to base due to dense vegetation. Ivy obscures trunks. Two of four stems close to steam area dead. Remaining two stems on south side are arching south. | Poor | Wildlife Value: Good<br>Inspection Limitations: Dense Vegetation | Top dead stems to around 2.5m in height. Reduce elongated vertical spur of remaining stems by 3m back to around 4m and to within lower canopy to reduce exposure / wind loading.<br><br><b>Timescale:</b><br>14-Feb-2026<br>(6 Months) | |

| Ref: | Species | Recommendations | Work Timescale |
|---|---|---|---|
| T016 | Blackthorn | Top dead stems to around 2.5m in height. Reduce elongated vertical spur of remaining stems by 3m back to around 4m and to within lower canopy to reduce exposure / wind loading. | 14-Feb-2026<br>(6 Months) |

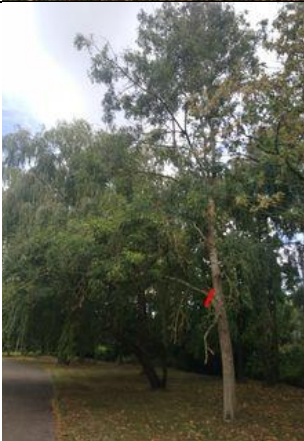
| Ref: | Species | Measurements | Survey Notes | Condition | Other Data | Recommendations | Photo |
|---|---|---|---|---|---|---|---|
| T017 | Common ash<br>( <i>Fraxinus excelsior</i> ) | Height (m): 14<br>Crown Radius (m): 4<br>DBH (cm): 32<br>Life Stage: Mature<br>Life Exp.: 10+ Years | 4.5m from road. Superficial bark damage to small girdling root on southeast side of trunk. Base clear, bark intact. No fungal fruiting bodies evident or audible decay. Elongated low branch approx. 80mm diameter from 3m on south side of tree extends over road. Vehicle strike damage on tips of branch. Asymmetrical crown to south. Foliage density normal. Dead branches and branch tips throughout crown.<br><br>Pests and Diseases:<br>Ash Dieback Infection Level 1: 0% to 25% | Fair | Wildlife Value: Moderate | Remove deadwood. Remove low branch over roadway to prevent further vehicle strike damage.<br><br><b>Timescale:</b><br>14-Nov-2025<br>(3 Months) | |

| Ref: | Species | Recommendations | Work Timescale |
|---|---|---|---|
| T017 | Common ash | Remove deadwood.<br>Remove low branch over roadway to prevent further vehicle strike damage. | 14-Nov-2025<br>(3 Months) |

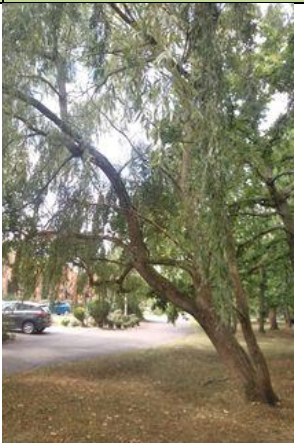
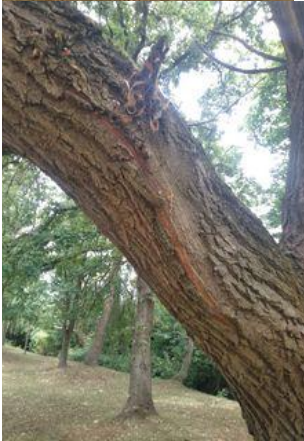
| Ref: | Species | Measurements | Survey Notes | Condition | Other Data | Recommendations | Photo |
|---|---|---|---|---|---|---|---|
| T018 | Weeping willow<br>( <i>Salix babylonica</i> ) | Height (m): 14<br>Crown Radius (m): 7<br>DBH (cm): 45<br>Life Stage: Mature<br>Life Exp.: 20+ Years | 4m from road. Twin stem from ground level. Smaller trunk 150mm diameter. Bark intact. No fungal fruiting bodies evident or audible decay. Swept stems south towards road. Main stem forks 2m above ground level. Dead branch stubs in central canopy. Lower spur off fork has raised ridge which can indicate shear of wood fibres. Defect not carried through to far side of branch. Shot hole fungus and anthracnose on foliage. Canopy slightly sparser in upper crown. 1.5m canopy clearance over road. | Fair | Wildlife Value:<br>Moderate | <p>Reduce lateral spread on south side over road by 3m - lower branches to edge of verge to reduce weight of branch over split limb.</p> <p>Crown lift smaller branches to create 4.5m canopy clearance over road. 2.5m over amenity verge.</p> <p>Remove deadwood.</p> <p><b>Timescale:</b><br/>14-Nov-2025<br/>(3 Months)</p> | |

| Ref: | Species | Recommendations | Work Timescale |
|---|---|---|---|
| T018 | Weeping willow | Reduce lateral spread on south side over road by 3m - cutting lower branches back to the edge of the verge to reduce weight of branch over split limb.<br>Crown lift smaller branches to create 4.5m canopy clearance over road and 2.5m over amenity verge.<br>Remove deadwood. | 14-Nov-2025<br>(3 Months) |

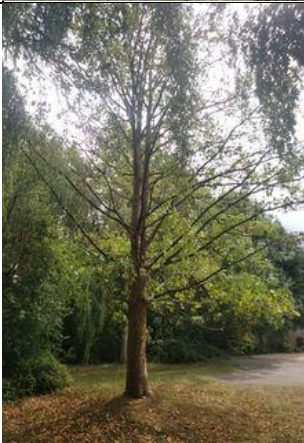
| Ref: | Species | Measurements | Survey Notes | Condition | Other Data | Recommendations | Photo |
|---|---|---|---|---|---|---|---|
| T019 | Sycamore<br>( <i>Acer pseudoplatanus</i> ) | Height (m): 16<br>Crown Radius (m): 3.5<br>DBH (cm): 44<br>Life Stage: Mature<br>Life Exp.: 40+ Years | Base clear, bark intact. Broad buttress roots mostly on south side historic wound on northwest side of trunk has caused linear scar from ground level to 3m. Wound fully occluded. Sound intonation even, no audible decay. Superficial bark wound on south side of trunk, 1.5m above ground level. Twin stem from 4m. Fork structure satisfactory. Feathered form with multiple slender branches off main trunks. Many dead branches throughout crown. Physiological state poor. Foliage sparse. | Poor | Wildlife Value:<br>Moderate | <p>Recommendations 1:<br/>Remove deadwood.</p> <p><b>Timescale:</b><br/>14-Feb-2026<br/>(6 Months)</p> <p>Recommendations 2:<br/>Monitor tree for any further decline in vitality.</p> <p><b>Timescale:</b><br/>Optional</p> | |

| Ref: | Species | Recommendations | Work Timescale |
|---|---|---|---|
| T019 | Sycamore | Remove deadwood. | 14-Feb-2026<br>(6 Months) |

| Ref: | Species | Recommendations | Work Timescale |
|---|---|---|---|
| T019 | Sycamore | Monitor tree for any further decline in vitality. | Recommendation |

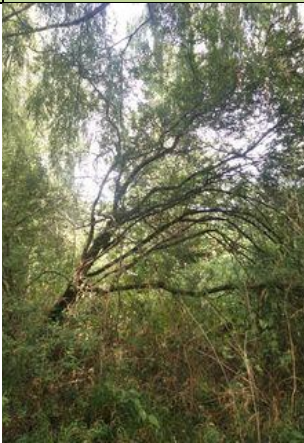
| Ref: | Species | Measurements | Survey Notes | Condition | Other Data | Recommendations | Photo |
|---|---|---|---|---|---|---|---|
| T020 | Blackthorn<br>( <i>Prunus spinosa</i> ) | Height (m): 6<br>Crown Radius (m): 4<br>DBH (cm): 12<br>Life Stage: Over Mature<br>Life Exp.: 10+ Years | Ivy clad shrubby tree. Partially collapsed. Canopy low to ground. Low occupancy area. | Poor | Wildlife Value:<br>Good<br>Inspection Limitations:<br>Dense Vegetation | No works identified. | |

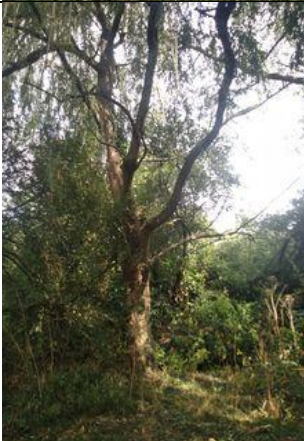
| Ref: | Species | Measurements | Survey Notes | Condition | Other Data | Recommendations | Photo |
|---|---|---|---|---|---|---|---|
| T021 | Weeping willow<br>( <i>Salix babylonica</i> ) | Height (m): 14<br>Crown Radius (m): 6<br>DBH (cm): 42<br>Life Stage: Mature<br>Life Exp.: 40+ Years | Light ivy growth on trunk. Single stem. Small habitat hole in old branch cut 1.7m above ground level. Small to medium sized dead branches in crown over low occupancy area. Symptoms of shot hole fungus and anthracnose in crown. Foliage density normal. Sound intonation even and satisfactory. No audible decay. Kinked trunk. Asymmetrical crown biased to west. Dead branches in crown over low occupancy area. Foliage density normal. | Fair | Wildlife Value:<br>Good | Crown lift to create 2.5m canopy clearance over amenity verge.<br><br><b>Timescale:</b><br>14-Feb-2026<br>(6 Months) | |

| Ref: | Species | Recommendations | Work Timescale |
|---|---|---|---|
| T021 | Weeping willow | Crown lift to create 2.5m canopy clearance over amenity verge. | 14-Feb-2026<br>(6 Months) |

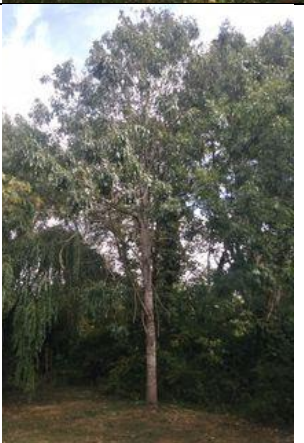
| Ref: | Species | Measurements | Survey Notes | Condition | Other Data | Recommendations | Photo |
|---|---|---|---|---|---|---|---|
| T022 | Common ash<br>( <i>Fraxinus excelsior</i> ) | Height (m): 14<br>Crown Radius (m): 5<br>DBH (cm): 35<br>Life Stage: Mature<br>Life Exp.: 10+ Years | Base clear, bark intact. No fungal fruiting bodies evident or audible decay. Vertical trunk forks around 7m above ground level. Asymmetrical crown to southwest. Foliage slightly sparse and clustered at tips. Minor dead branches and secondary branch tips throughout crown.<br><br>Pests and Diseases:<br>Ash Dieback Infection Level 1: 0% to 25% | Fair | Wildlife Value:<br>Moderate | Remove deadwood.<br><br><b>Timescale:</b><br>Optional | |

| Ref: | Species | Recommendations | Work Timescale |
|---|---|---|---|
| T022 | Common ash | Remove deadwood. | Optional |

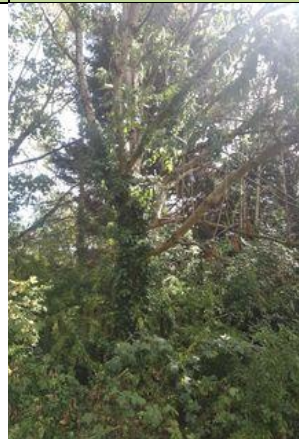
| Ref: | Species | Measurements | Survey Notes | Condition | Other Data | Recommendations | Photo |
|---|---|---|---|---|---|---|---|
| T023 | Common ash<br>( <i>Fraxinus excelsior</i> ) | Height (m): 14<br>Crown Radius (m): 6<br>DBH (cm): 35<br>Life Stage: Mature<br>Life Exp.: 10+ Years | <p>Ivy clad tree. Restricted access to base due to dense vegetation. Dead epicormic shoots on dead low branches in lower crown. Further epicormic growth on higher branches in central crown. - symptomatic of early Ash Dieback Disease. Remaining foliage in crown appears healthy. Asymmetrical crown to southwest over vehicle turning head. Deadwood higher in crown but over low occupancy area.</p> <p>Pests and Diseases:<br/>Ash Dieback Infection Level 1: 0% to 25%</p> | Fair | Wildlife Value:<br>Moderate<br>Inspection<br>Limitations: Ivy<br>and dense<br>vegetation | <p>Cut back lower branches to create 4.5m canopy clearance over road / turning head.<br/>Sever ivy<br/>Prune out dead low branches.</p> <p><b>Timescale:</b><br/>14-Nov-2025<br/>(3 Months)</p> | |

| Ref: | Species | Recommendations | Work Timescale |
|---|---|---|---|
| T023 | Common ash | Cut back lower branches to create 4.5m canopy clearance over road / turning head.<br>Sever ivy.<br>Prune out dead low branches. | 14-Nov-2025<br>(3 Months) |
