Structural Engineer's report on the condition and damage to the  
existing garage building due to fire and its suitability for refurbishment

North Wing High Chimneys, RG10 0TH

Ref. 0848

Date. October 2024

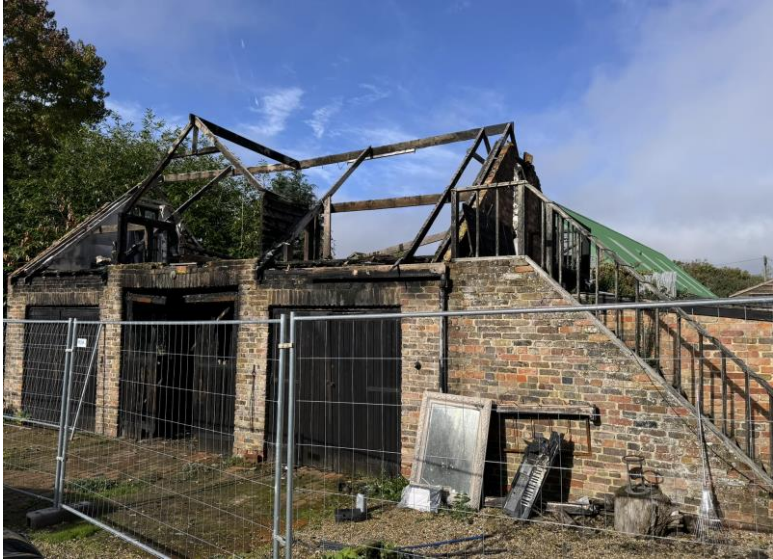
| REF. | PHOTOGRAPH | COMMENT |
|---|---|---|
| A.1 | | View of front elevation from the parking area. |

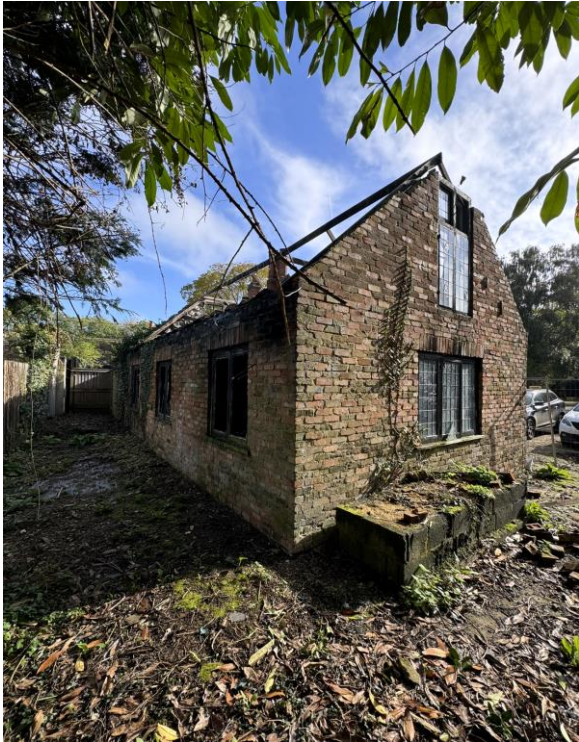
| REF. | PHOTOGRAPH | COMMENT |
|---|---|---|
| A.2 | | Side view from the rear corner of the building. |

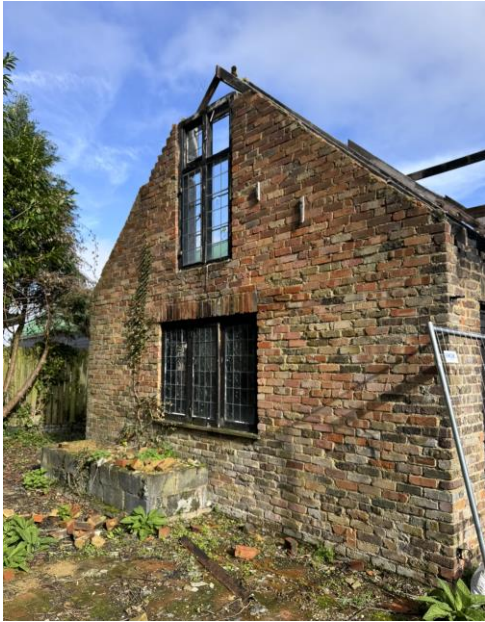
| A.3 | | Side view of gable wall from the front corner. |

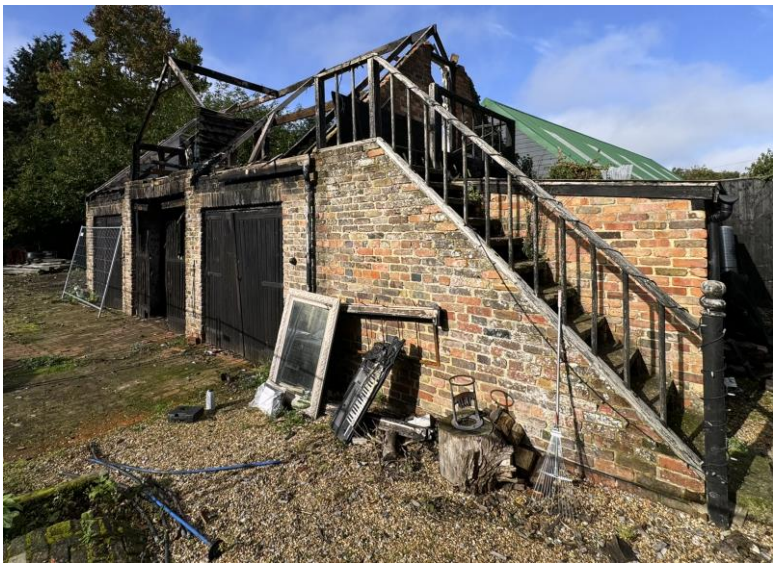
| A.4 | | View from front with side staircase access to the floor above. |

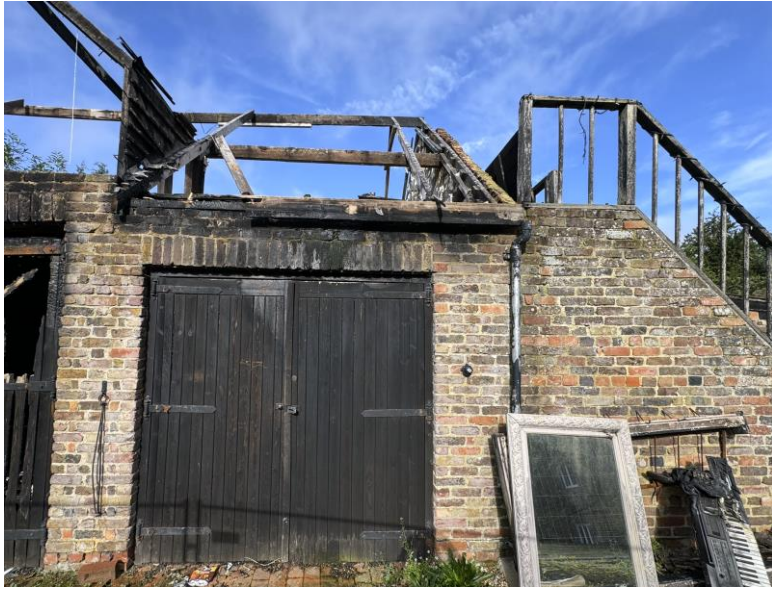
| A.5 | | View of roof rafters and doors from parking area. |

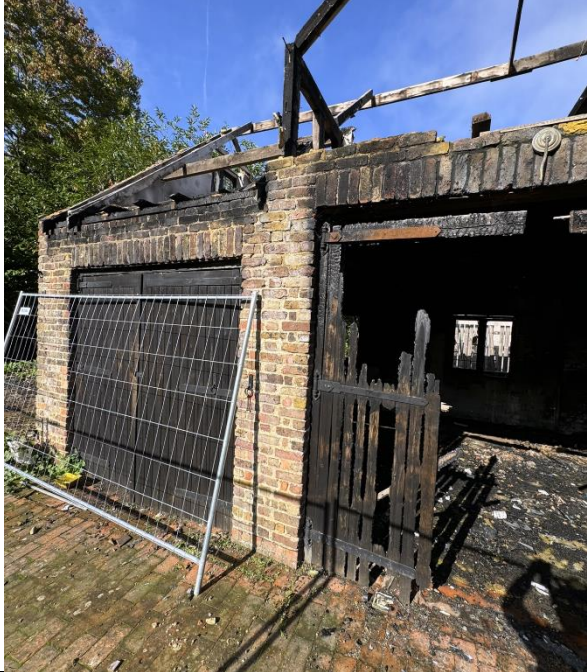
| A.6 | | Same as above. |

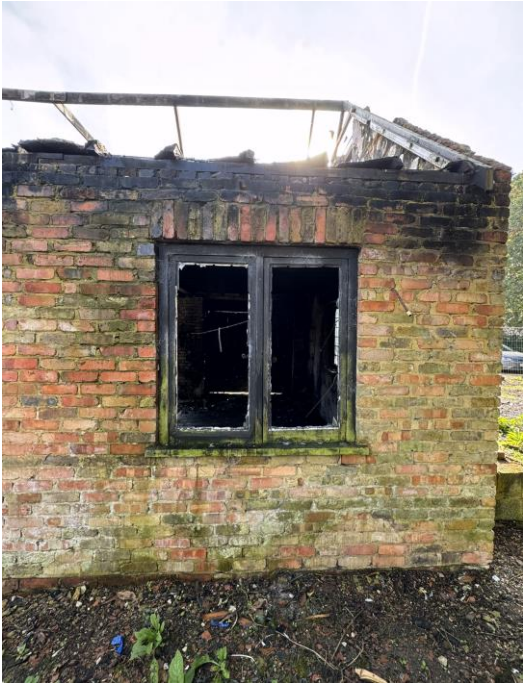
| A.7 | | Rear Elevation of building with broken and damaged window. |

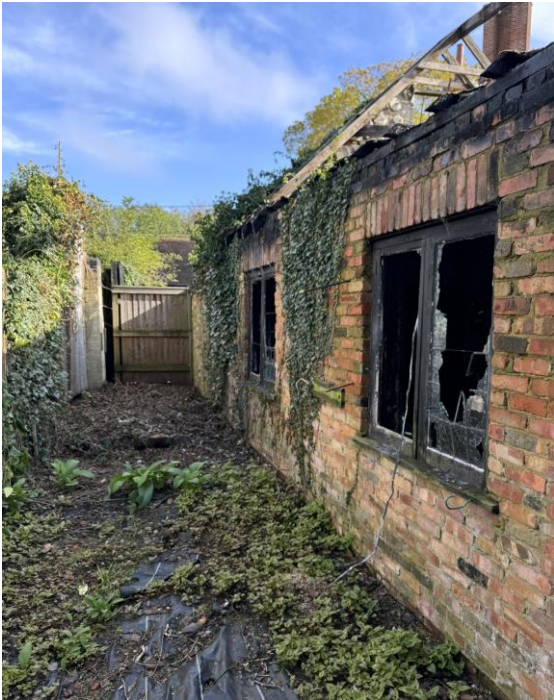
| A.8 | | Rear view of building along with vegetation. |

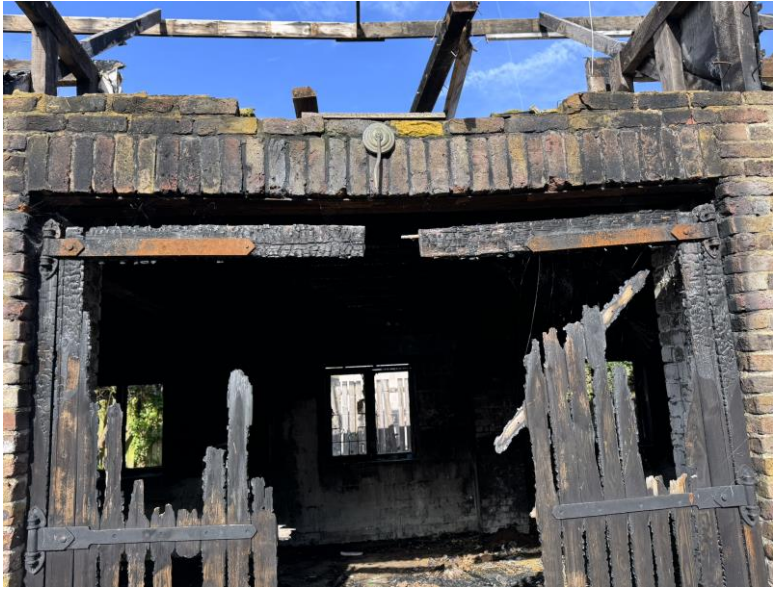
| A.9 | | View of damaged front door and lintel is sagging. |

- Existing lintels to the all windows and doors needs to be replaced.
- It is considered that gables above the first floor and the remaining roof rafters and ridge board are dangerous in their current state. And these need to be taken down as soon as possible before carrying out any construction work.

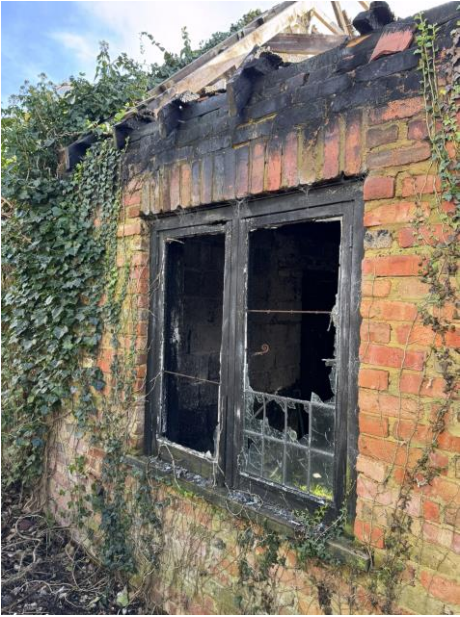
| A.10 | | Same as A.8 |

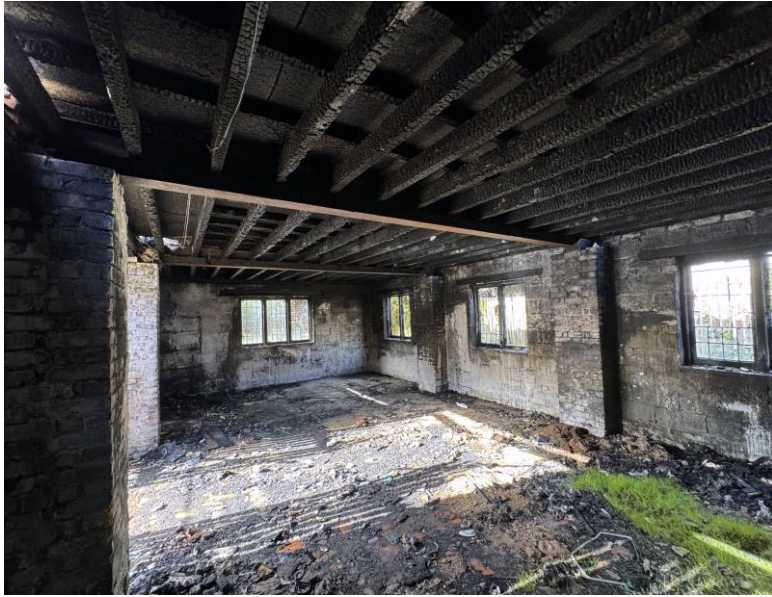
Due to fire, timber joists were exposed to intense heat, which caused charring on their surfaces. This charring reduces the effective cross-sectional area of the joist, weakening its load-bearing capacity. As the damage is severe, the joist will no longer be able to support the weight of the floors or partition walls above it.

Timber loses strength as it heats up. While charring acts as an insulating layer to some extent, prolonged exposure to high temperatures has weakened the wood fibres beneath, compromising the joist's overall strength and durability.

Fire-damaged timber joists are more susceptible to moisture absorption, rot, and insect infestation. When the protective outer layer is compromised, the inner parts of the wood become more vulnerable, accelerating further deterioration. Heat causes timber joists to warp, twist, or crack, impacting their alignment and stability. This leads to uneven floor, misalignment of structural components, and potential failure under load. Existing floor joists have been damaged and required to be replaced completely.

| A.11 | | Internal View of ground floor ceiling with damaged floor joists due to fire. |

- Existing damaged floor cannot be re-used and needs to be replaced with new floor structures following planning permission.
- Existing floor steel beams must be cleaned, wire brushed, treated, and re-used. No adequate fire protection was observed for the steelwork elements in the form of appropriate fireboarding and/or intumescent paint coatings. All these steel elements must be treated, painted and fire-protected as appropriate.

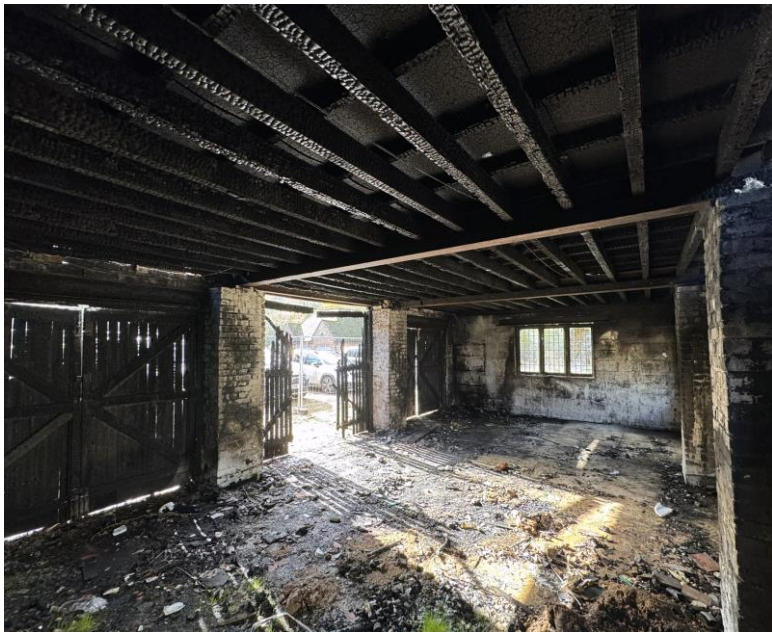
| A.12 | | Same as above. |

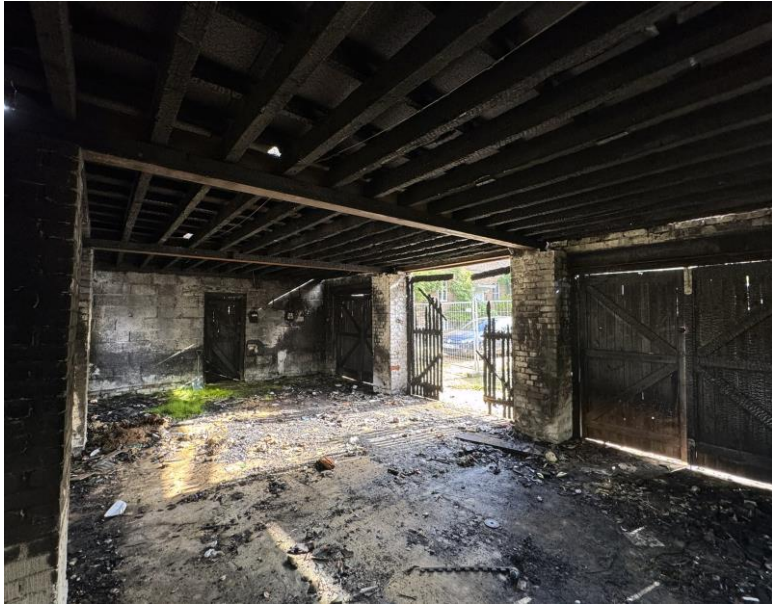
| A.13 | | Same as A.11 |

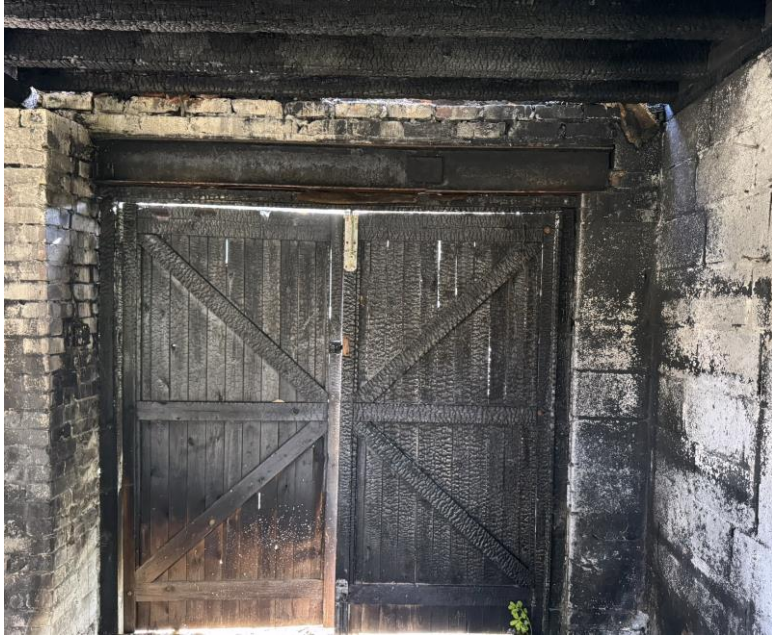
| A.14 | | Internal View of damaged front door and lintel. |

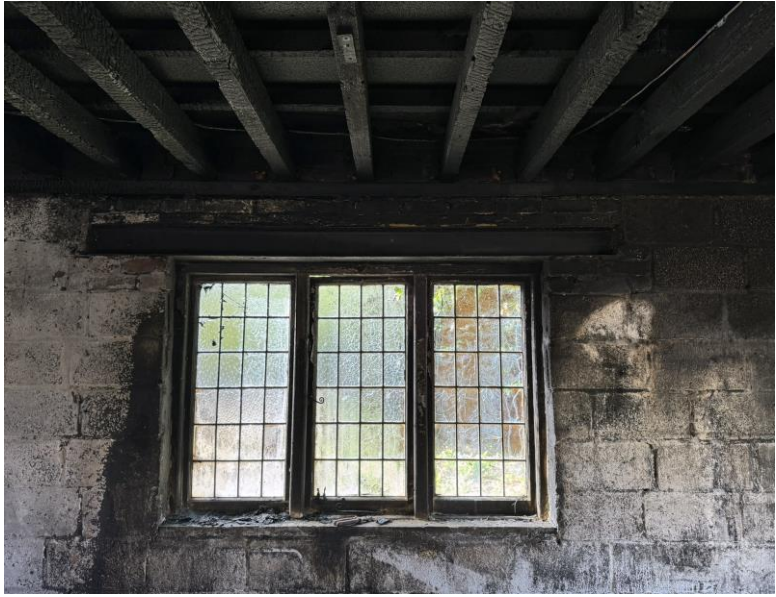
| A.15 | | Internal View of rear window lintel. |

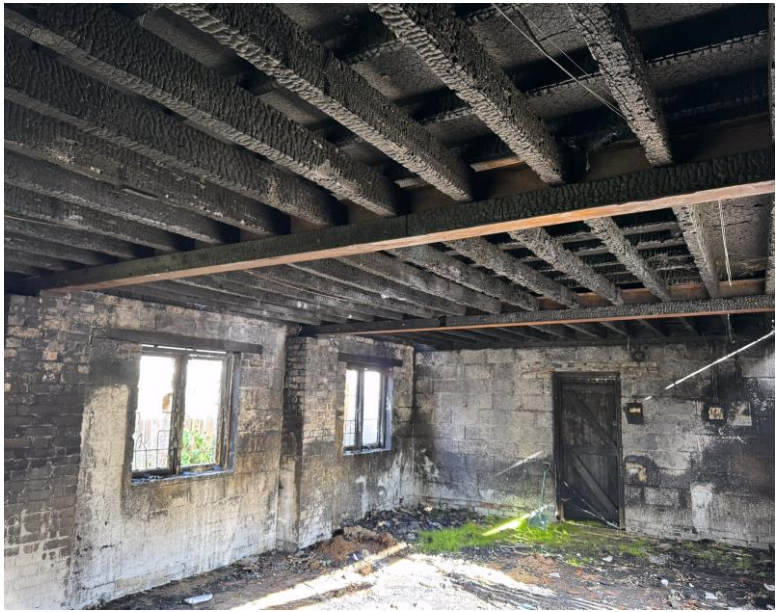
| A.16 | | Same as A.11 |

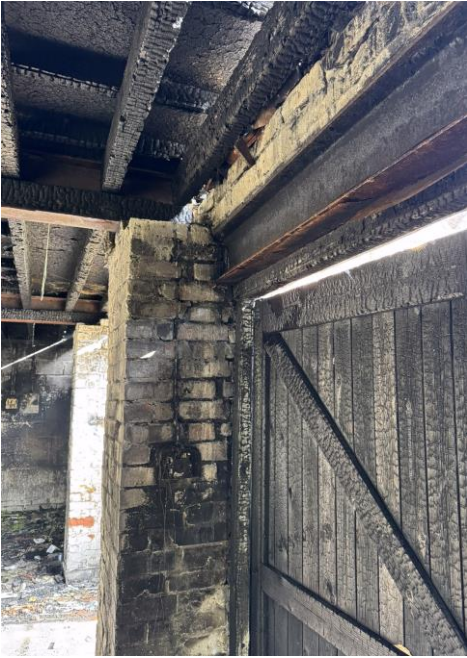
| A.17 | | View front brick pier and lintel above door. |

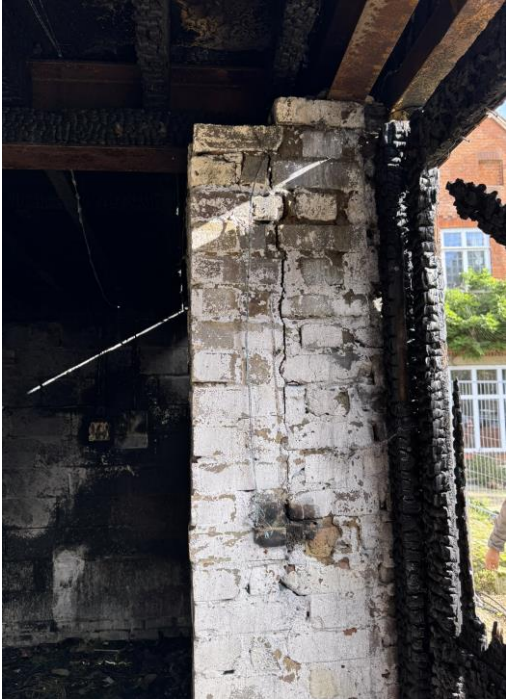
In structural terms, this internal cracking in the existing brick piers falls into Category 1 to 2 of Table 1, Building Research Establishment Digest 251, which describes the damage as “very slight to slight.”

| A.18 | | Slight Cracking to the existing brick pier supporting steel beam. |

- It is considered that remedial works to the noted cracks are required. Repairing and strengthening works will be carried out to the existing cracks, where necessary, to the existing walls internally using helifix repairing techniques or similar as recommended in section 3.

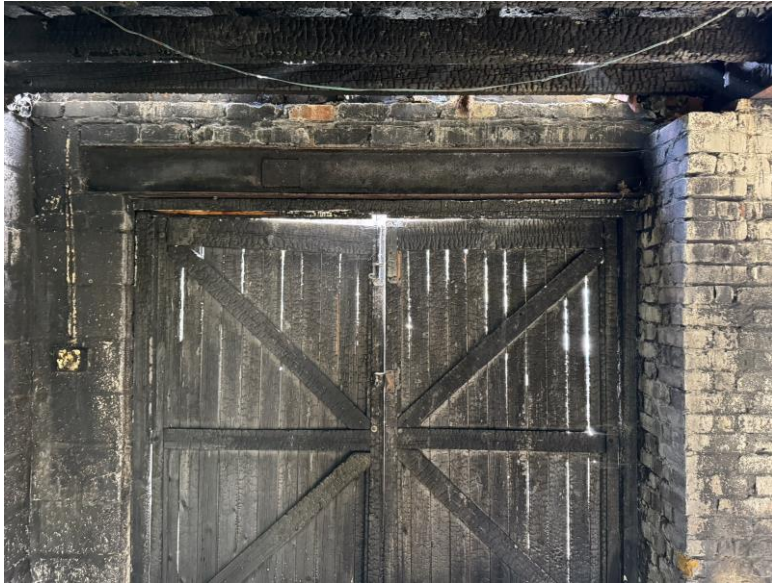
| A.19 | | View of lintel above the door from inside. |

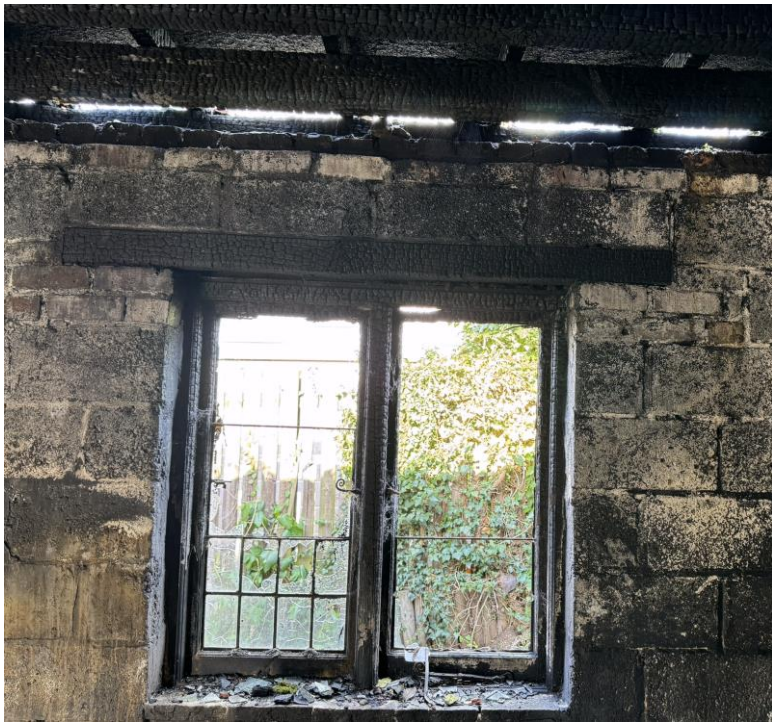
| A.20 | | View of timber lintel above window to the rear elevation. |

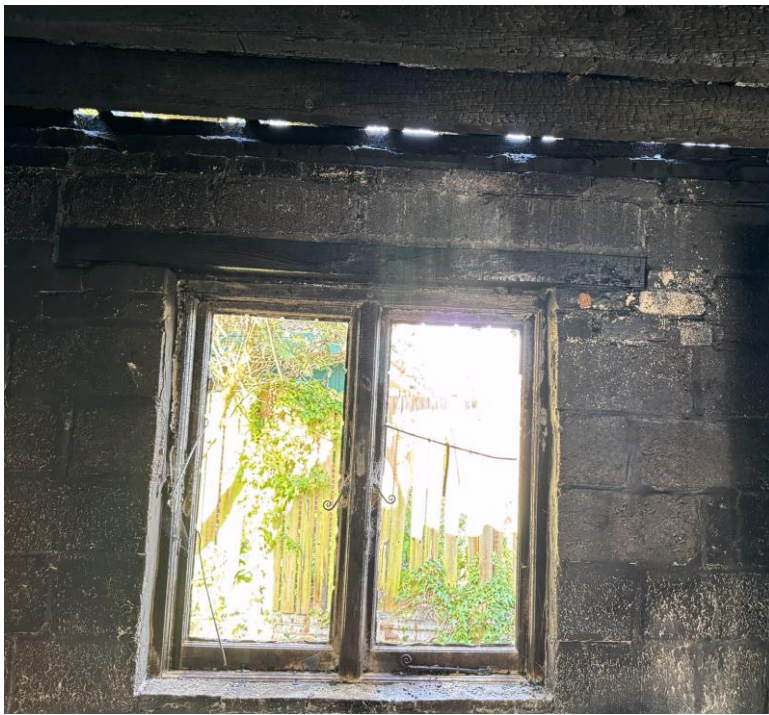
| A.21 | | Same as above. |

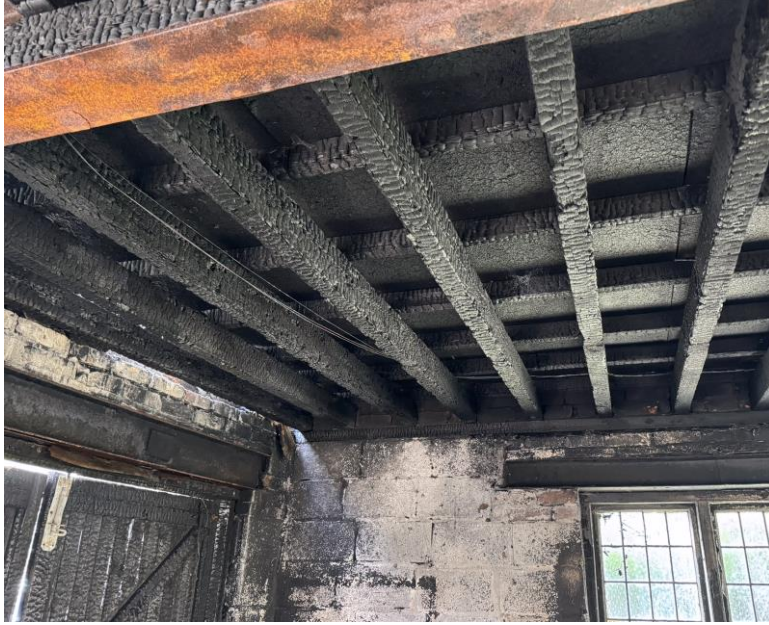
| A.22 | | View of damaged floor joists along with rusted steel beam and lintels behind. |

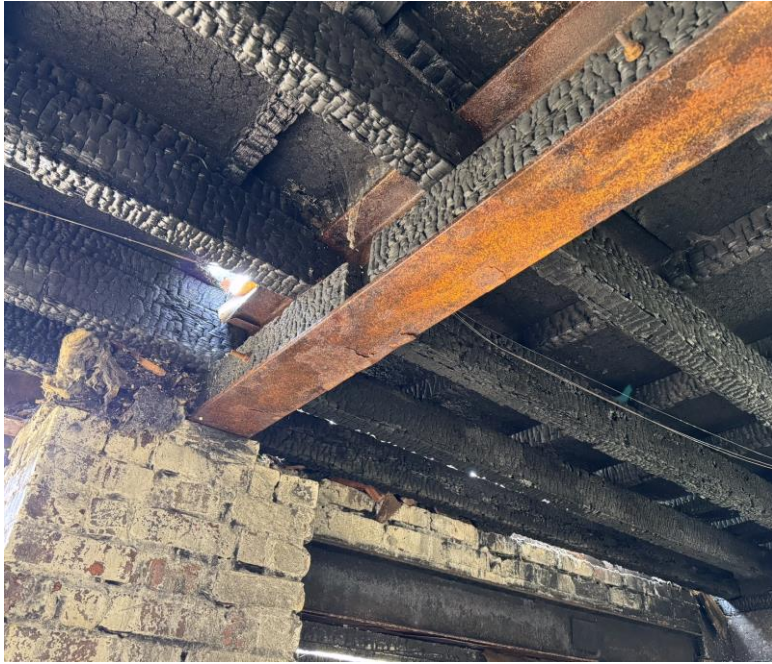
| A.23 | | View of damaged floor joists along with rusted steel beam supporting at existing brick piers. |

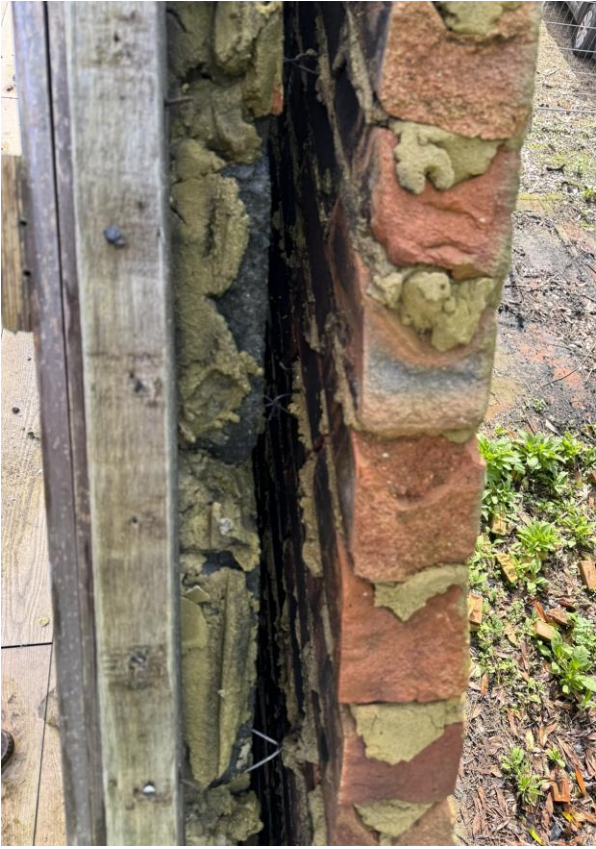
| A.25 | | View of wall showing the wall ties between brick and block. |

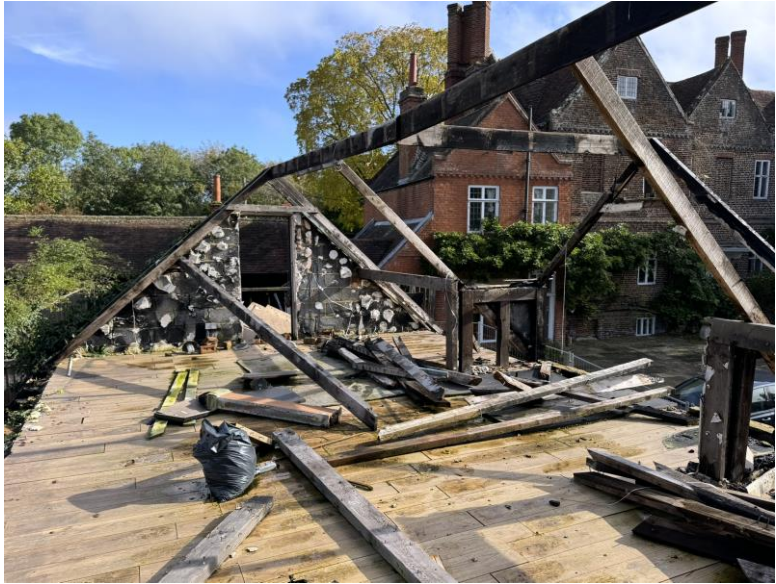
| A.26 | | View of remaining roof rafters and ridge board with laminated timber floor. |

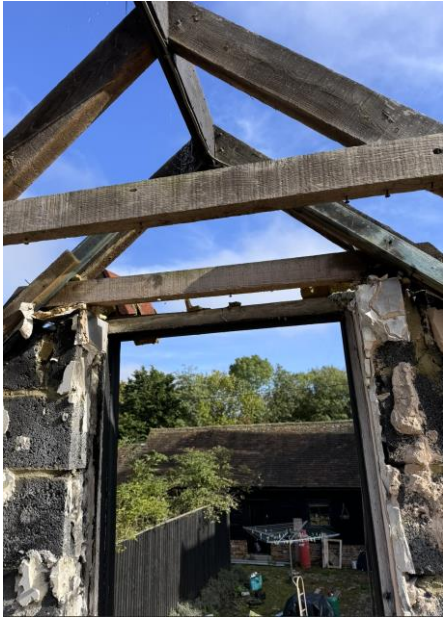
| A.27 | | Same as above. |

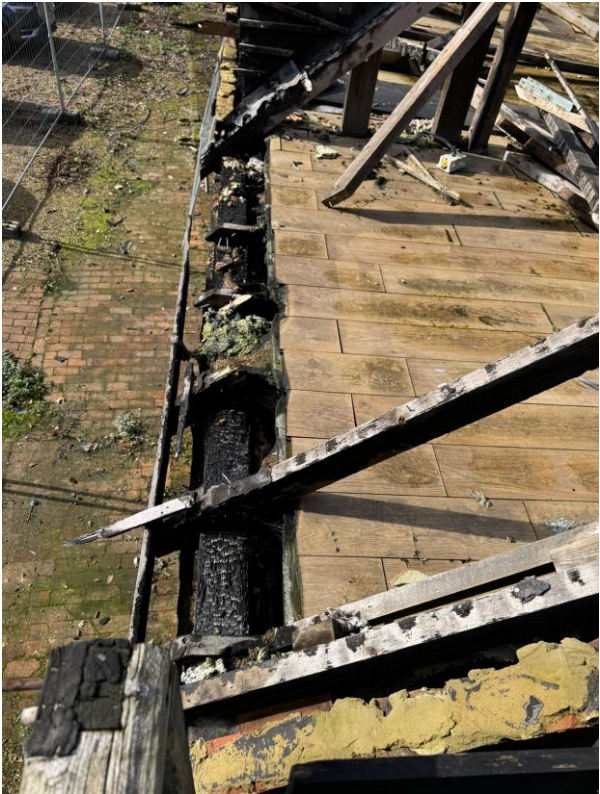
| A.28 | | View of damaged timber plate on existing wall. |

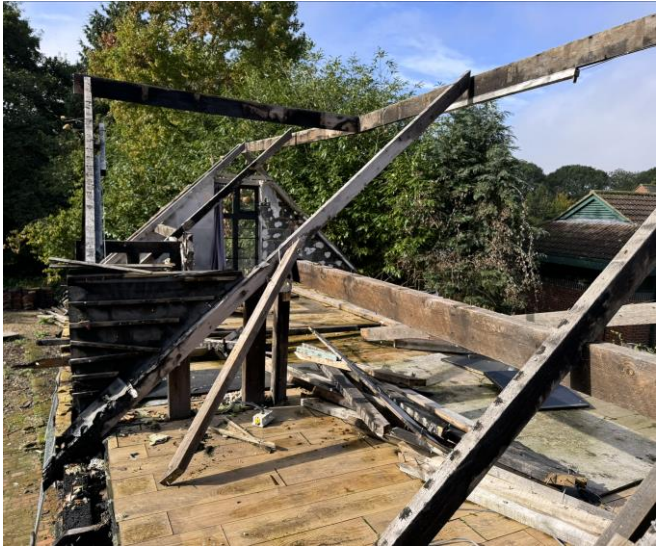
| A.29 | | View of remaining roof rafters/ridge board from loft floor. |

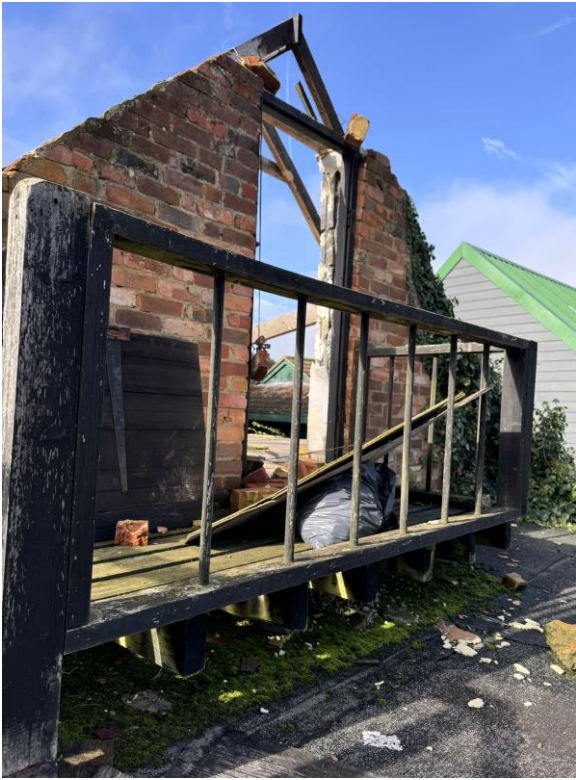
The structural defects encountered, requiring urgent attention, immediately threaten the structural integrity of the gable wall above the first floor.

| A.30 | | View of the gable wall from the roof of the side extension. |

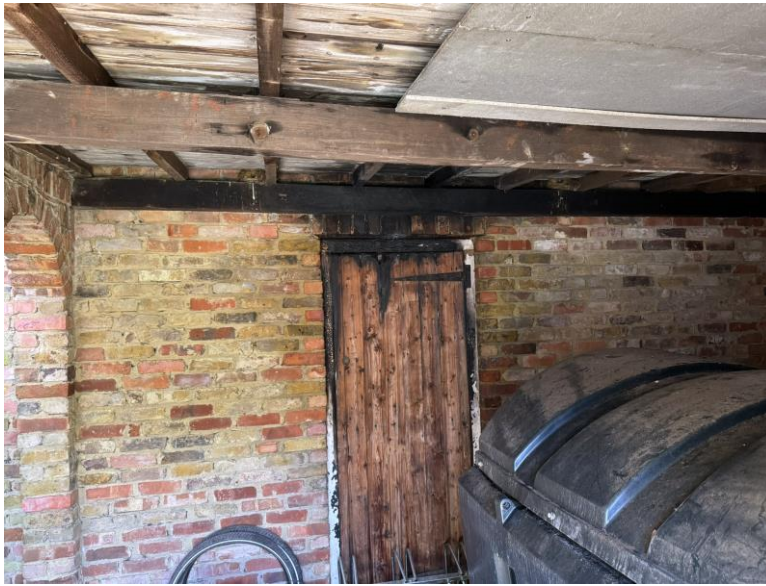
A.31

Oil tank in the side single storey extension.

An assessment and concentration of contamination are to be carried out due to an existing Oil Tank in the existing extension area to identify the level of contamination present.
