### **INSURANCE CLAIM: ENGINEERING APPRAISAL REPORT**

Out Ref: 10834637

Situation of Damage: 14 Fakenham Close, Lower Earley, READING, Berkshire, RG6 4AB

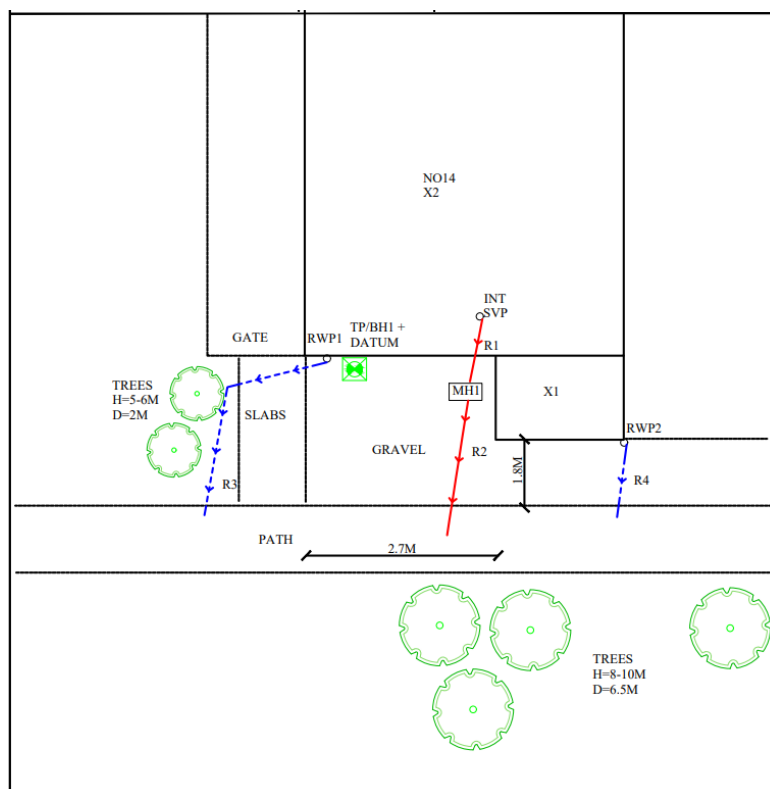
A site investigation was undertaken by CET in October 2025. This comprised a single trial pit and borehole on the front elevation, and a CCTV survey of the proximate drainage. See the site plan below for location and layout.

The CCTV survey assessed 4 drainage runs, with defects only noted on the most remote, run 4.

Whilst not considered a causal factor in the foundation movement, we will also instruct repair of the minor defect noted on run 4 out of an abundance of caution.
