# Tree Management, Duty of Care Report©

Site: Woodley Rectory, 36 Church Road, Woodley, RG5 4QJ

Client: Oxford Diocese    Date: 24/04/25    Surveyor: Danny Konstantinidis

## HERITAGE TREE SERVICES ABORICULTURAL DUTY OF CARE & MAINTINANCE SURVEY

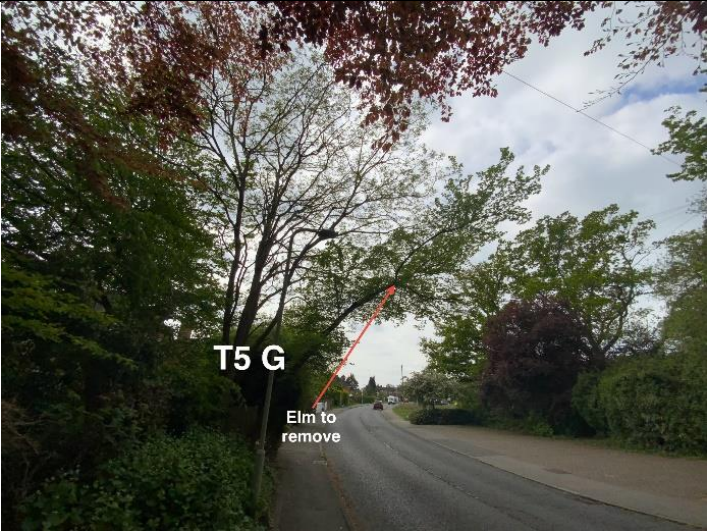
| T5 G<br>105 | Robinia | EM | L | G | F | <p>To include neighbouring Robinia &amp; Elm forming a communal crown.</p> <p>Elm is suppressed with a pronounced lean over the highway. Some low branches are below statutory height clearance over the highway &amp; public footpath. Tips of top branches are in contact with overhead services (BT).</p> <p>Non tagged Robinia has moderate sized deadwood over the public footpath.</p> <p>Some branch tips from tagged tree will soon be in contact with overhead services.</p> | <p>Remove significant sized deadwood that can strike public footpath &amp; highway.</p> <p>Remove Elm due to ongoing prolonged maintenance over highway, footpath &amp; overhead services.<br/>(See image)</p> | 2<br>2<br>3 | 7 | B | |

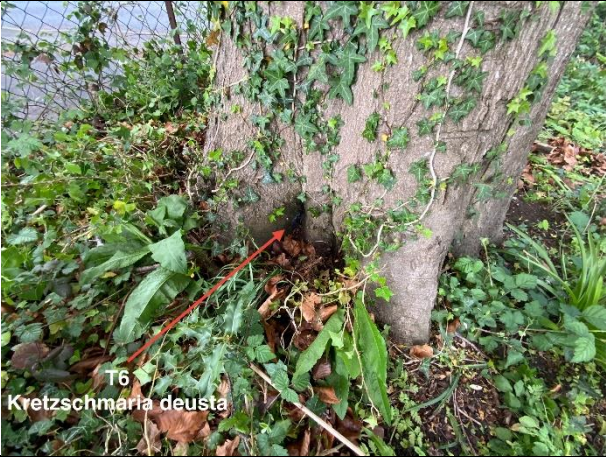
| T6<br>106 | Copper Beech | Em | L | G | G | <p>Kretzschmaria deusta in buttress furrow on the eastern aspect. Not noted in any other areas around the buttress or main stem. (See image for future reference to colonisation)</p> <p>Nylon hammer struck around all buttresses &amp; main stem up to a height of approximately 2.5m, returning good resonance. This suggests that the trees outer shell is sound at present.</p> <p>Some major &amp; moderate sized deadwood throughout the tree, not in great abundance. Some within striking distance of the public footpath.</p> <p>Some branch tips are in contact with overhead service cable (BT)</p> | <p>Remove significant sized deadwood.</p> <p>Prune tertiary branch tips to achieve a clearance of up to 500mm from overhead service cable</p> | 2<br>2<br>3 | 7 | B |

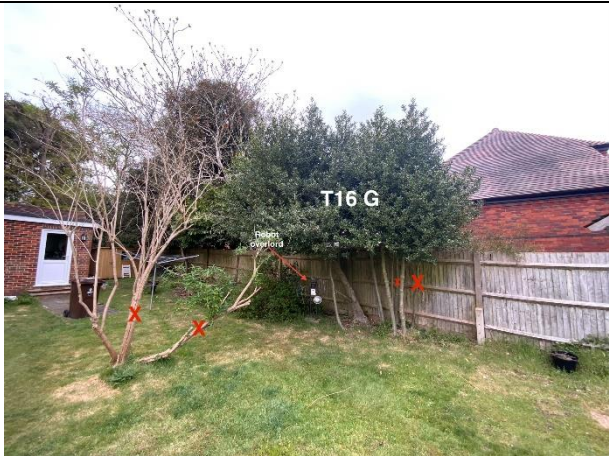
| T16 G<br>116 | Holly | Sm | S | G | G | Some stems are in contact with the boundary fence.<br><br>Beware of robot overlord.<br><br>Low branches in contact with neighbouring built structure.<br><br>Buddleia opposite is mainly dead. | Remove smaller stems that are close to the neighbouring fence.<br>(See image)<br><br>Prune low branches to achieve a clearance of up to 1m from built structures.<br><br>Remove Buddleia | 2<br>1<br>3 | 6 | B |
