# Arboricultural Consultancy for Aviva

| Insured | | Address | 5 Sharphorpe Close, Lower Earley, Reading, RG6 4DB | | |
| Report Date | 04/10/2024 | | | | |

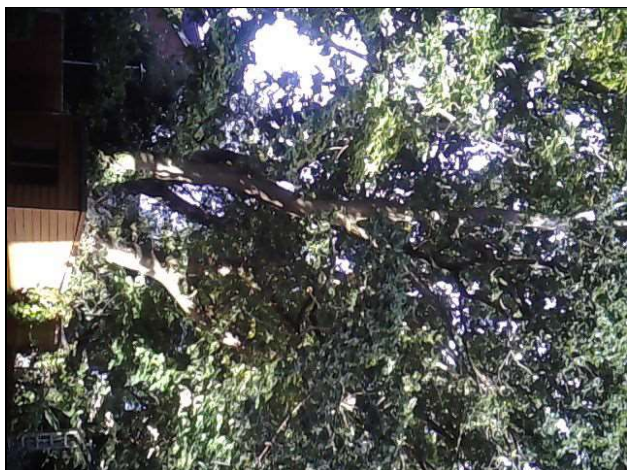
T1 - Oak & T2 - Oak

However, whilst not positively implicated by root analysis, the Oaks (T1, T2 and T3) are clearly the dominant feature proximate to the rear elevation and are therefore also considered to retain a significant contributory influence.

Given the above, we have identified the collective / cohesive influence of T1, T2, T3 & T4 as the primary cause of the subsidence damage.

| Tree No. | Species | Age Cat | Approx. Height (m) | Distance to Building (m) * | Ownership | Action | Requirement |
|---|---|---|---|---|---|---|---|
| T1 | Oak | 2 | 16.5 | 10.9 | A - Third Party | Remove | Remove close to ground level; do not treat stump due to translocation risk. Where such a risk exists, we advise that any emergent regrowth is removed annually.<br>Note: possibly established sucker or subordinate stem likely to derive from rootstock of T2. |
| T2 | Oak | 2 | 20 | 11.9 | B - Local Authority | Maintain as detailed | Undertake appropriate management so as to effectively mitigate the long-term subsidence risk posed by this tree. |

The primary causal vegetation has been noted to be under the ownership / control of the Local Authority, who should be notified of the current building damage and requested to implement a programme of effective vegetation management to mitigate soil drying (from T2 & T3) below the subject property.

With regards to T1 and T4, we have advocated their complete removal as it will offer the most certain arboricultural solution likely to restore long-term stability.

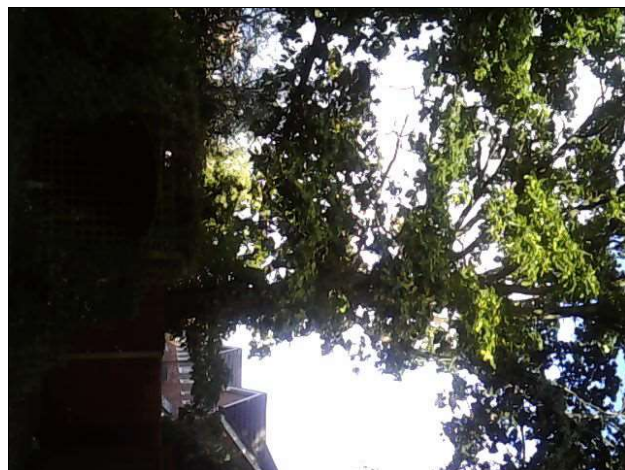
T3 - Oak

| Tree No. | Species | Age Cat | Approx. Height (m) | Distance to Building (m) * | Ownership | Action | Requirement |
|---|---|---|---|---|---|---|---|
| T3 | Oak | 2 | 17.6 | 12 | B - Local Authority | Maintain as detailed | Undertake appropriate management so as to effectively mitigate the long-term subsidence risk posed by this tree. |

Our advice would be to remove the implicated trees and consider replacement planting with smaller specimens; this will give the most reliable arboricultural solution and is arguably the most environmentally friendly outcome.

However, we accept it is for third parties (who have the expertise) to determine how they should prevent ongoing damage and nuisance. Alternative options could include crown reducing in accordance with BRE IP7/06 followed by re-pruning on a maximum three yearly cycle (but frequently biennially).

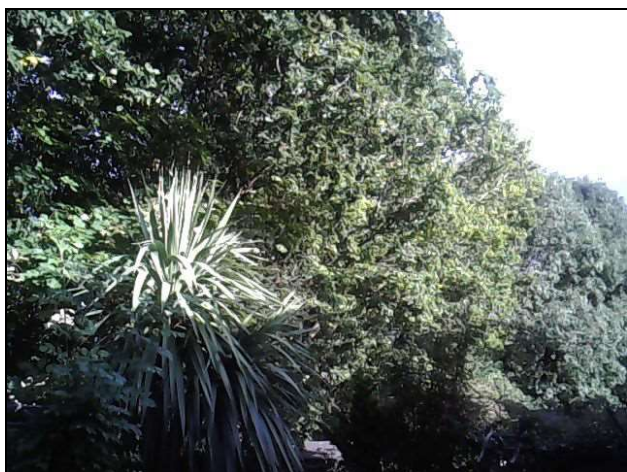
TG1 - Mixed species group

| Tree No. | Species | Age Cat | Approx. Height (m) | Distance to Building (m) * | Ownership | Action | Requirement |
|---|---|---|---|---|---|---|---|
| TG1 | Mixed Species Group: Primarily Field Maple and Oak | 2 | 15.2 | 15.8 | B - Local Authority | Action to avoid future risk | Maintain those trees within recognised influencing distance of the property (based on species, size and proximity) at, or below current dimensions by way of regular pruning so as to effectively mitigate subsidence risk. Any pruning undertaken should be in accordance with BRE IP7/06 and repeated on a 3-year (max) basis to be deemed as effective. Coppicing, pollarding and targeted / selective removal, followed by replacement planting with lower water demand species may also be deemed as appropriate. |

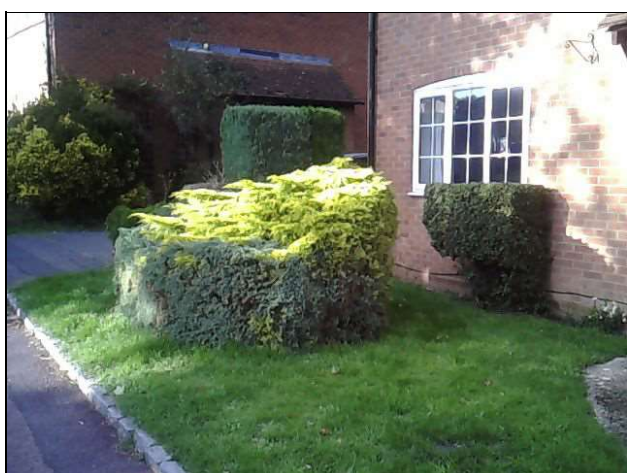
SG1 - Mixed shrub group

Note: the source of the Pomoideae spp. group roots will be vegetation within SG1 and proximate to the location of TP/BH2 (front elevation); these roots are not deemed material to the current claim.

| Tree No. | Species | Age Cat | Approx. Height (m) | Distance to Building (m) * | Ownership | Action | Requirement |
|---|---|---|---|---|---|---|---|
| SG1 | Mixed species shrubs: includes Pyracantha, Juniper and Cypress. | 1 | 2 | 0.2 | C - Insured | Action to avoid future risk | Subject to regular management; maintain at broadly current dimensions by way of regular pruning. |

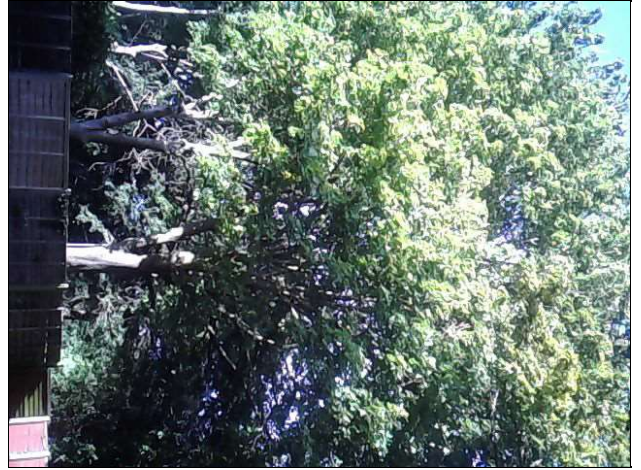
T4 - Maple (Norway)

Our survey of the site identified T4 (Maple (Norway)) which, in our opinion, will be the source of the Acer spp. roots recovered in TP/BH1.

| Tree No. | Species | Age Cat | Approx. Height (m) | Distance to Building (m) * | Ownership | Action | Requirement |
|---|---|---|---|---|---|---|---|
| T4 | Maple (Norway) | 1 | 15.8 | 10.7 | A - Third Party | Remove | Remove close to ground level; do not treat stump due to translocation risk. Where such a risk exists, we advise that any emergent regrowth is removed annually. |

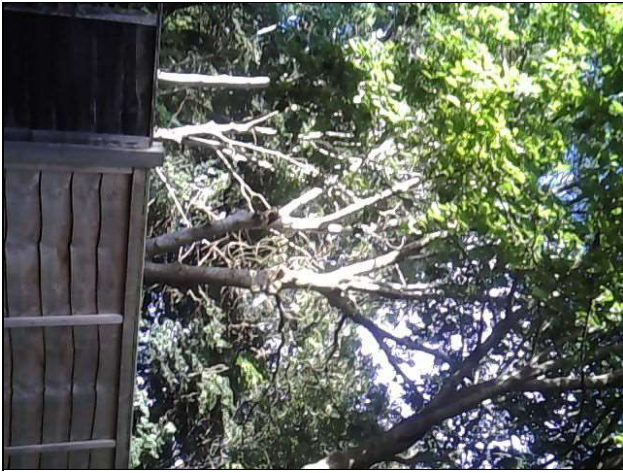
T5 - Ash

| Tree No. | Species | Age Cat | Approx. Height (m) | Distance to Building (m) * | Ownership | Action | Requirement |
|---|---|---|---|---|---|---|---|
| T5 | Ash | 1 | 15.8 | 13.8 | A - Third Party | Action to avoid future risk | Maintain at, or below current dimensions by way of regular pruning. |
