# ARBORICULTURAL REPORT

## TREE CONDITION SURVEY

86 & 86A ELLIS ROAD  
CROWTHORNE  
BERKSHIRE  
RG45 6PW

SEPTEMBER 2025  
Ref: 06769 / 2025

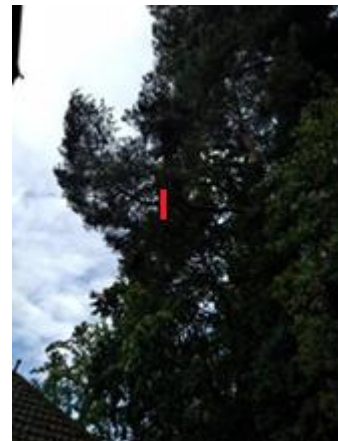
| Ref: | Species | Measurements | Survey Notes | Condition | Other Data | Recommendations | Photo |
|---|---|---|---|---|---|---|---|
| T003 | Scots pine<br>( <i>Pinus sylvestris</i> ) | Height (m): 17<br>Crown Radius (m): 1N, 3E, 6S, 4W<br>DBH (cm): 60<br>Life Stage: Mature<br>Life Exp.: 40+ Years | Deep leaf litter built up around base. Mature ivy stem on trunk. Swept stem south adaptive growth at base. Where accessible bark intact. Sound intonation slightly variable but this could be due to ivy / thick corky bark. No other indicators of decay. No fungal fruiting bodies evident. Trunk obscured by ivy. Elongated low lateral branch extends over roof of 86 Ellis Road beyond surrounding canopy. Dog-legged kink along branch length. Heavily weighted at tips and exposed. Needles very brown - cause unclear. | Fair | Wildlife Value: Good<br>Inspection Limitations: Prolific ivy | Sever ivy.<br><br>Remove elongated low limb leaving 1m stump to prevent ingress of decay into trunk.<br><br>Monitor base for decay fungi<br><br><b>Timescale:</b><br>10-Mar-2026<br>(6 Months) | |

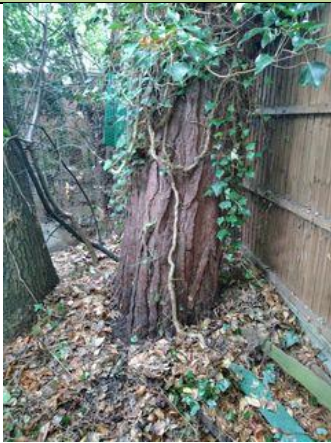
| Ref: | Species | Measurements | Survey Notes | Condition | Other Data | Recommendations | Photo |
|---|---|---|---|---|---|---|---|
| T004 | Scots pine<br>( <i>Pinus sylvestris</i> ) | Height (m): 17<br>Crown Radius (m): 1N, 3E, 5S, 2W<br>DBH (cm): 74<br>Life Stage: Mature<br>Life Exp.: 40+ Years | Deep leaf litter built up around base. Concrete block and ironwork in ground on west side of trunk. Mature ivy on trunk. Root flare partially obscured suggesting possible ground level changes at base. Slightly swept stem south with adaptive growth at base. Where accessible bark intact. Sound intonation even. No sign of rootplate movement or instability. No fungal fruiting bodies evident. Trunk obscured by ivy. High, asymmetrical crown. Needle density good. | Fair | Wildlife Value: Good<br>Inspection Limitations: Prolific ivy | Sever ivy.<br><br>Monitor base for decay fungi.<br><br><b>Timescale:</b><br>10-Sep-2026<br>(1 Year) | |

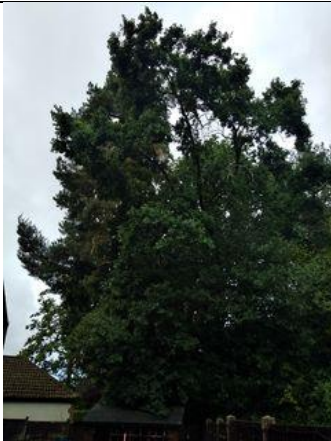
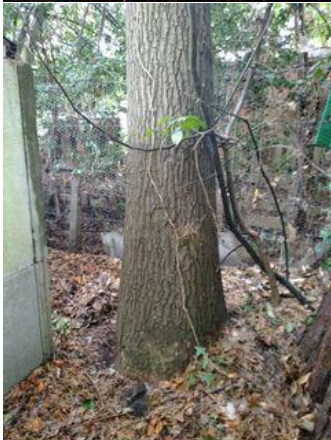
| Ref: | Species | Measurements | Survey Notes | Condition | Other Data | Recommendations | Photo |
|---|---|---|---|---|---|---|---|
| T005 | Pedunculate oak<br>( <i>Quercus robur</i> ) | Height (m): 12<br>Crown Radius (m): 9N, 5E, 4S, 1W<br>DBH (cm): 52<br>Life Stage: Mature<br>Life Exp.: 40+ Years | Soil level built up around base. Root collar obscured. Swept stem northeast. Base clear, bark intact. Sound intonation even. No fungal fruiting bodies evident or audible decay. Very asymmetrical crown with long etiolated branches extending over neighbouring residential gardens. Low crown to 1.8m resting on roof of neighbours shed. One dead branch over neighbouring garden. Foliage slightly clustered towards tips. Moderate vitality. | Fair | Wildlife Value: Good | Crown lift to create 4m canopy clearance over garden of 86a Ellis Road.<br><br>Selectively reduce tips of elongated branch over garden of 86a Ellis Road by between 1 and 2m due to stem proximity to dwelling. Works are required to reduce etiolated limb and excessive movements of branch in high winds<br><br><b>Timescale:</b><br>10-Mar-2026<br>(6 Months) | <br> |

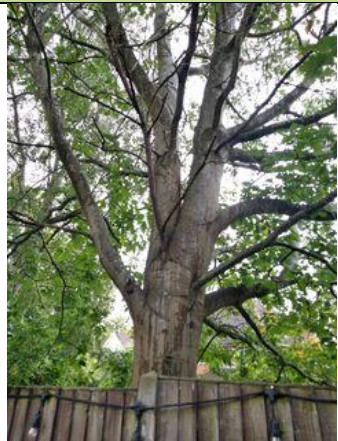
| Ref: | Species | Measurements | Survey Notes | Condition | Other Data | Recommendations | Photo |
|---|---|---|---|---|---|---|---|
| T006 | Red oak<br>( <i>Quercus rubra</i> ) | Height (m): 16<br>Crown Radius (m): 6.5N, 5.5E, 6S, 7W<br>DBH (cm): 58<br>Life Stage: Mature<br>Life Exp.: 20+ Years | Off-site tree, no access to base. Single stem to 3m. Tight fork with significant area of included bark. Weak structure. Broad crown. Foliage sparse. Minor deadwood throughout canopy branch tips touching chimney stack and overhanging glass roof | Fair | Wildlife Value:<br>Moderate<br>Inspection Limitations:<br>Access | Reduce west to north quadrant of tree's canopy by up to 2.5m to create reasonable clearance to 86a Ellis Road and reduce extent of canopy overhang to conservatory.<br><br><b>Timescale:</b><br>10-Mar-2026<br>(6 Months) | |
