## ARBORICULTURAL REPORT

TREE CONDITION SURVEY & MITIGATION STRATEGY

WATERLOO COTTAGE  
BATH ROAD  
KNOWL HILL  
WOKINGHAM  
BERKSHIRE  
RG10 9UP

Ref: 06408/2024 0.3

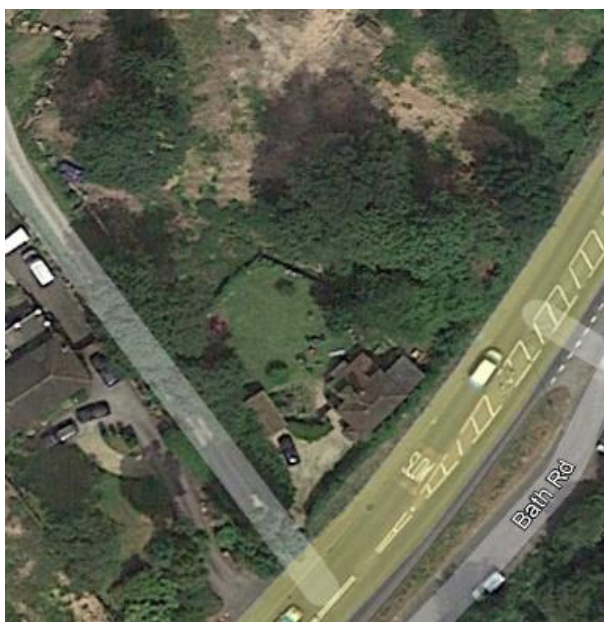
A comparison of aerial photographs taken in June 2018 and June 2024 confirms the same trees as being present. During my recent visit I did not find any visible evidence of recent tree pruning work having been undertaken. I am therefore satisfied that no trees have been removed or pruned since the Tree Preservation Order was served.

Fig. 2 – Aerial Photos (Google Earth Pro) from 06/2018

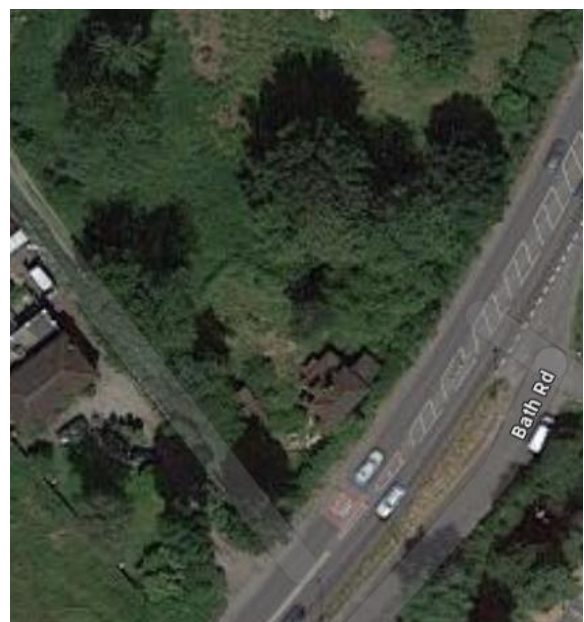
Fig. 3 – Aerial Photos (Google) from 2024
