**Structural Survey**

**Ashridge Farm**

**Warren House Road, RG40 5QB**

**Document Ref:** NA/667422/RP  
**Revision:** 2  
**Date:** 26 July 2016

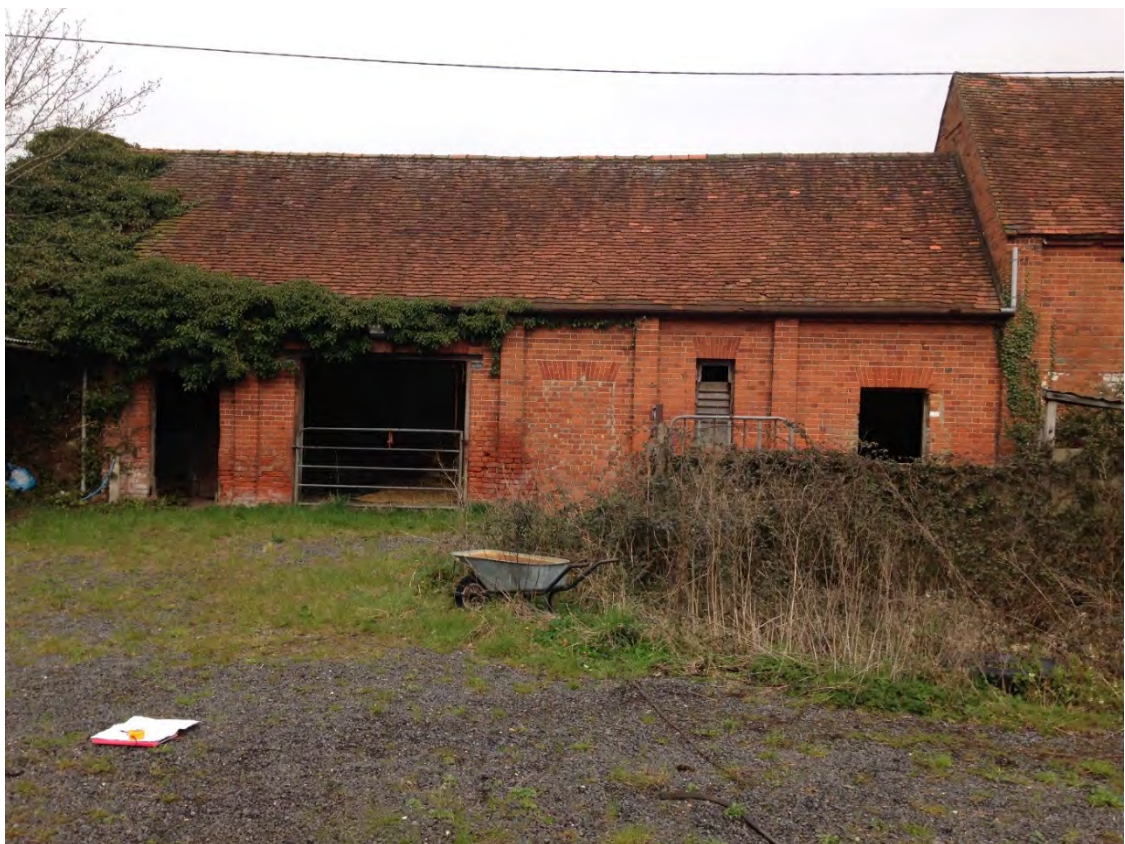
**BUILDINGS 'D' & 'E'**

**Walls:** Load bearing brickwork walls. The walls are weathered and the mortar joints required re-pointing and repairing in some areas. The faces of some bricks in the external walls are eroded and some bricks are missing in several locations due to vehicular impact, building alterations, erosion and weathering effects over the years. There are several pockets formed in the walls due to missing bricks. The walls do not appear to have damp proof course.

The flank wall appears to have two leaves of bricks and one of the leaf is not constructed up to and underside of the roof. The flank wall has been severely cracked and shows signs of bowing. It appears that the one of the flank wall leaf had been repaired but the repair works does not appear to be carried out appropriately while the other leaf has been covered up with 2 ply sheets and that restricted our inspection but the exposed brick work appeared to be in very poor state and was potentially unstable.

The walls around the entrance of the building 'E' appear to have been repaired but these works appear to be of poor standard.

The entrance to the fodder store has steel framed opening. The steelwork is not galvanised and appears to have no significant coating to protect it. The steel frame appears to have been hit by a vehicle at some stage and has been damaged, the vehicular impact has also displaced the bricks over the opening leaving the wall damaged and potentially in an unstable condition.

**Roof:** The main building structure is formed from timber trusses, the pitched roof is covered with 'rosemary' type clay tiles. Part of the roof is covered by the over grown vegetation, as such we could not survey the full roof. The roof does not appear to have a felt layer under the tiles in line with what would be expected with modern construction. There are a number of tiles that are missing or displaced allowing water to ingress into the building.

**Other:** The guttering is missing leaving the water to drain on the structure. The ceilings are lath and plaster ceilings. The ceilings are largely missing from various location.

In summary the building is considered to be in a generally poor condition and repairs are necessary to ensure the longevity of the building and prevent continued decay of the building fabric.

Due to the form and construction of the building we believe that it could be refurbished as part of a redevelopment / conversion to domestic use. The structural issues noted above would need to be addressed plus any works to the building fabric necessary for the building to comply with the Building Regulations and other design standards.
