### ASBESTOS - Present

<b>Address</b>	READING WOODLEY TP, WOODLEY GREEN, CHURCH ROAD, RG5 4QP		
<b>Site ID</b>	3278	<b>Site Name</b>	READING WOODLEY TP
<b>Location ID</b>	EN02842	<b>Room / Area</b>	Consumable storage area
<b>Floor</b>	1st Floor	<b>Building</b>	Travis Perkins main building
<b>Description</b>	Insulating Boards - Void above Kitchen

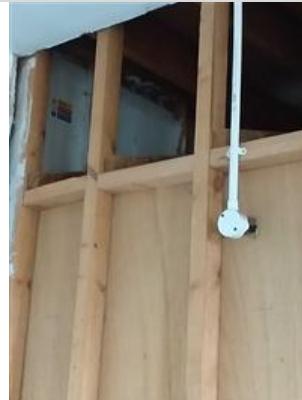
<b>Action</b>	Manage	<b>Material Assessment</b> Priority	6	<b>Combined Risk Score</b>	11
<b>Comments:</b>	Reverse side of store 2 visible from above kitchen ceiling only, the kitchen wall is overclad with timber sheets and kitchen and the sink unit are fitted up to it ceramic tiles to wall inbetween units.				
<b>Recommendations:</b>	.

<b>Product Type</b>	Insulating Board	2	<b>Surface Treatment</b>	Enclosed or encapsulated AIB	1
<b>Extent of Damage / Deterioration</b>	Low damage	1	<b>Asbestos Type</b>	Amosite	2
<b>Quantity</b>	= 9 Sq m

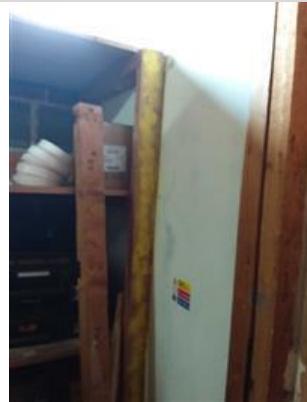
<b>Address</b>	READING WOODLEY TP, WOODLEY GREEN, CHURCH ROAD, RG5 4QP		
<b>Site ID</b>	3278	<b>Site Name</b>	READING WOODLEY TP
<b>Location ID</b>	Loc6317	<b>Room / Area</b>	Consumable storage area
<b>Floor</b>	1st Floor	<b>Building</b>	Travis Perkins main building
<b>Description</b>	Insulating Board - Store Wall to Kitchen

<b>Action</b>	Manage & Label	<b>Material Assessment</b> Priority Assessment	6 4	<b>Combined Risk Score</b>	10
<b>Comments:</b>	.				
<b>Recommendations:</b>	.

<b>Product Type</b>	Insulating Board	2	<b>Surface Treatment</b>	Enclosed or encapsulated AIB	1
<b>Extent of Damage / Deterioration</b>	Low damage	1	<b>Asbestos Type</b>	Strongly Presumed Amosite	2
<b>Quantity</b>	= 9 Sq m

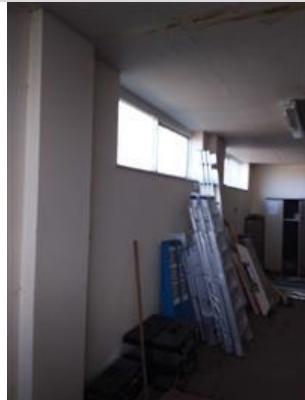
<b>Address</b>	READING WOODLEY TP, WOODLEY GREEN, CHURCH ROAD, RG5 4QP		
<b>Site ID</b>	3278	<b>Site Name</b>	READING WOODLEY TP
<b>Location ID</b>	Loc6320	<b>Room / Area</b>	Boxing
<b>Floor</b>	All Areas	<b>Building</b>	Travis Perkins main building
<b>Description</b>	No access to boxing

Action	N/A	Material Assessment Priority Assessment	0	Combined Risk Score
<b>Comments:</b>	No access to boxing, Presumed asbestos until proven otherwise.			
<b>Recommendations:</b>	.

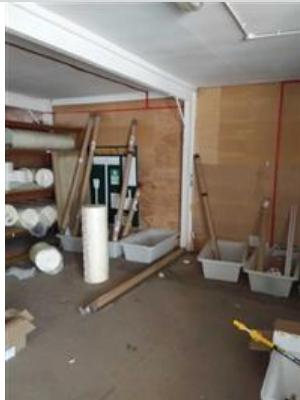
<b>Address</b>	READING WOODLEY TP, WOODLEY GREEN, CHURCH ROAD, RG5 4QP		
<b>Site ID</b>	3278	<b>Site Name</b>	READING WOODLEY TP
<b>Location ID</b>	Loc6321	<b>Room / Area</b>	Timber cladding to walls
<b>Floor</b>	All Areas	<b>Building</b>	Travis Perkins main building
<b>Description</b>	No access to timber cladding to walls

Action	N/A	Material Assessment Priority Assessment	0	Combined Risk Score
<b>Comments:</b>	No access to timber cladding to walls, Presumed asbestos until proven otherwise.			
<b>Recommendations:</b>	.

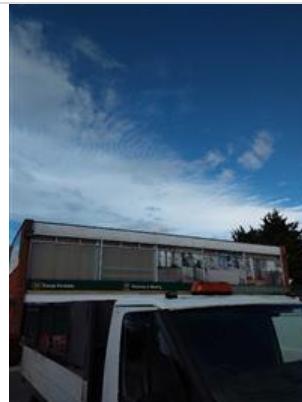
<b>Address</b>	READING WOODLEY TP, WOODLEY GREEN, CHURCH ROAD, RG5 4QP		
<b>Site ID</b>	3278	<b>Site Name</b>	READING WOODLEY TP
<b>Location ID</b>	Loc6322	<b>Room / Area</b>	Roofs
<b>Floor</b>	Roof access	<b>Building</b>	Travis Perkins main building
<b>Description</b>	No access to roofs TP

Action	N/A	Material Assessment Priority Assessment	0	Combined Risk Score
<b>Comments:</b>	No access to roofs, Presumed asbestos until proven otherwise.			
<b>Recommendations:</b>	.
