## Visual inspection at :

**Hartley Court, Hartley Court Road, Three Mile Cross, RG 7 1NW**

### 1. Introduction

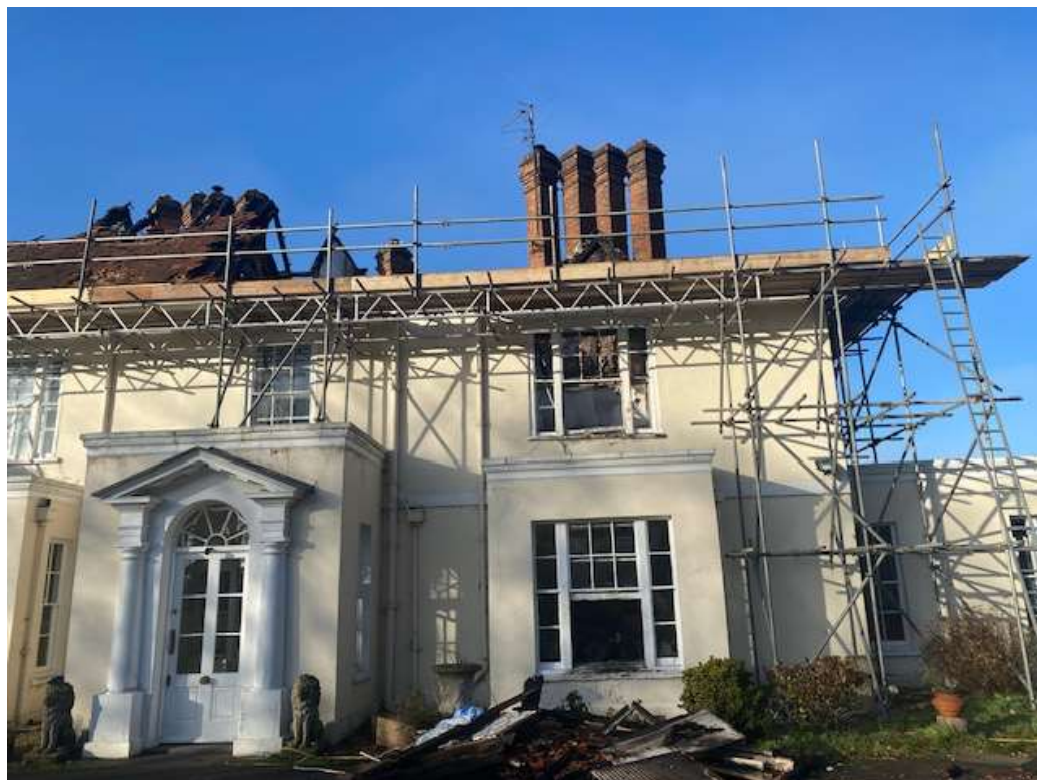
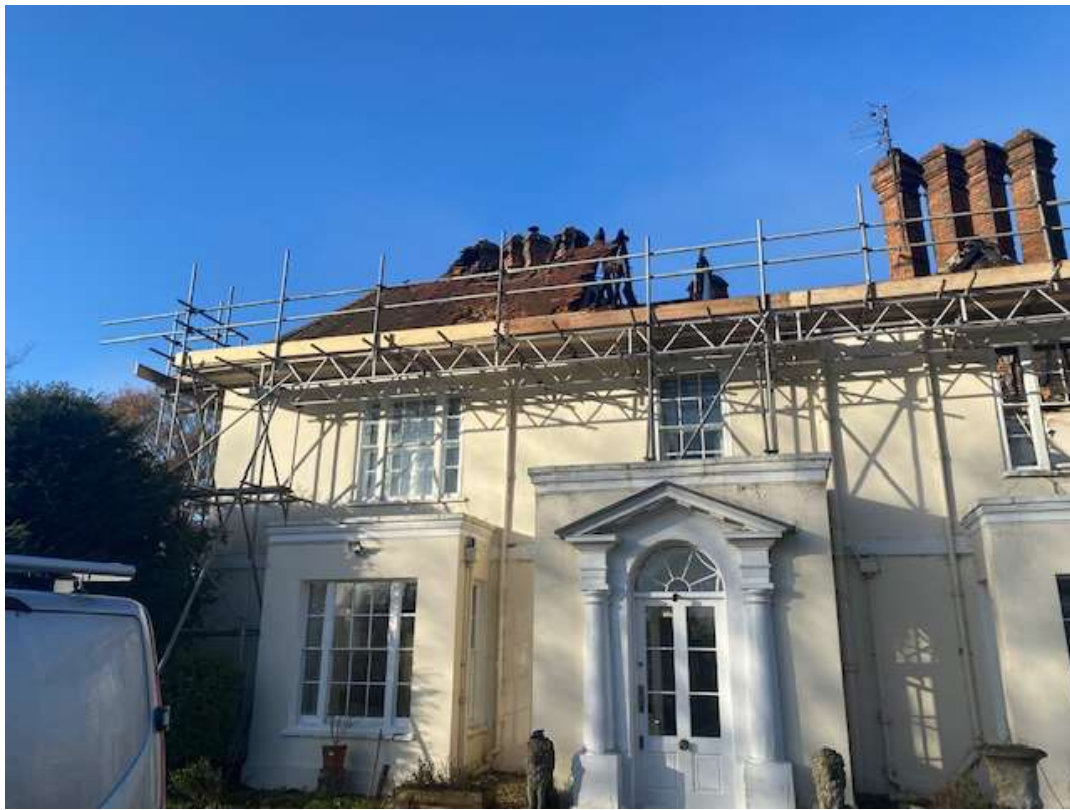
The external walls up to roof level appeared not to have been badly damaged with no visible cracks or stress to the fabric; the first floor and roof structure had all gone. But generally, the ground to first first-floor external walls was in a stable condition. (Photographs 1 & 2)

Photograph 1 & 2 -Front elevation (East Facing)

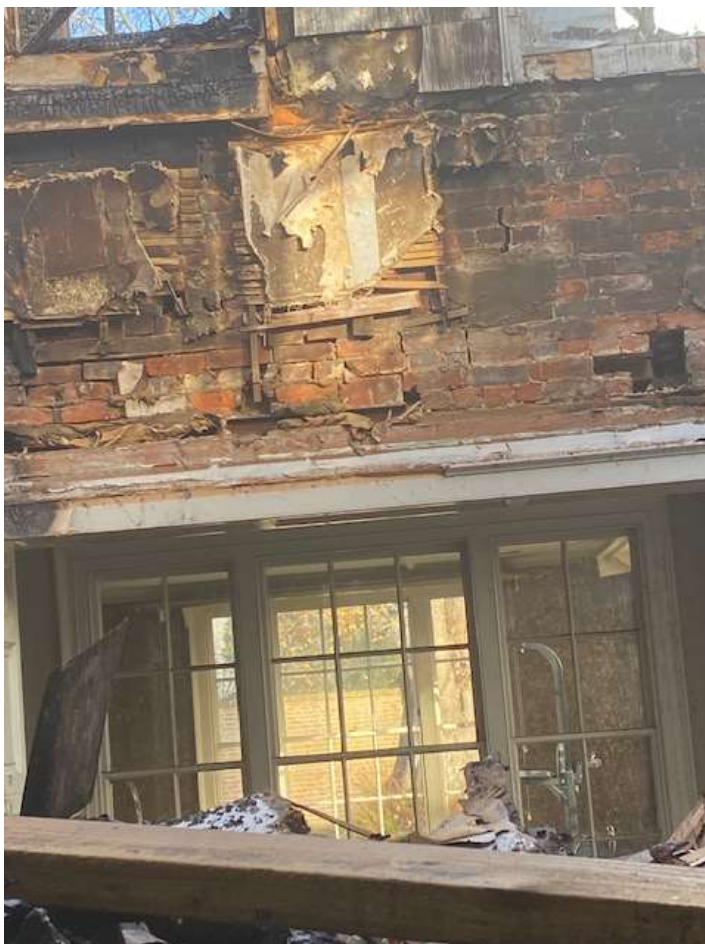
It was noted that there was a crack in the internal surface of the North Facing external wall at first-floor level over an existing opening alcove; however, this crack is thought to have predated the fire and was caused by deflection in the timber lintel over the alcove. (Photograph 3)

Photograph 3 – Possible historic crack in wall over alcove

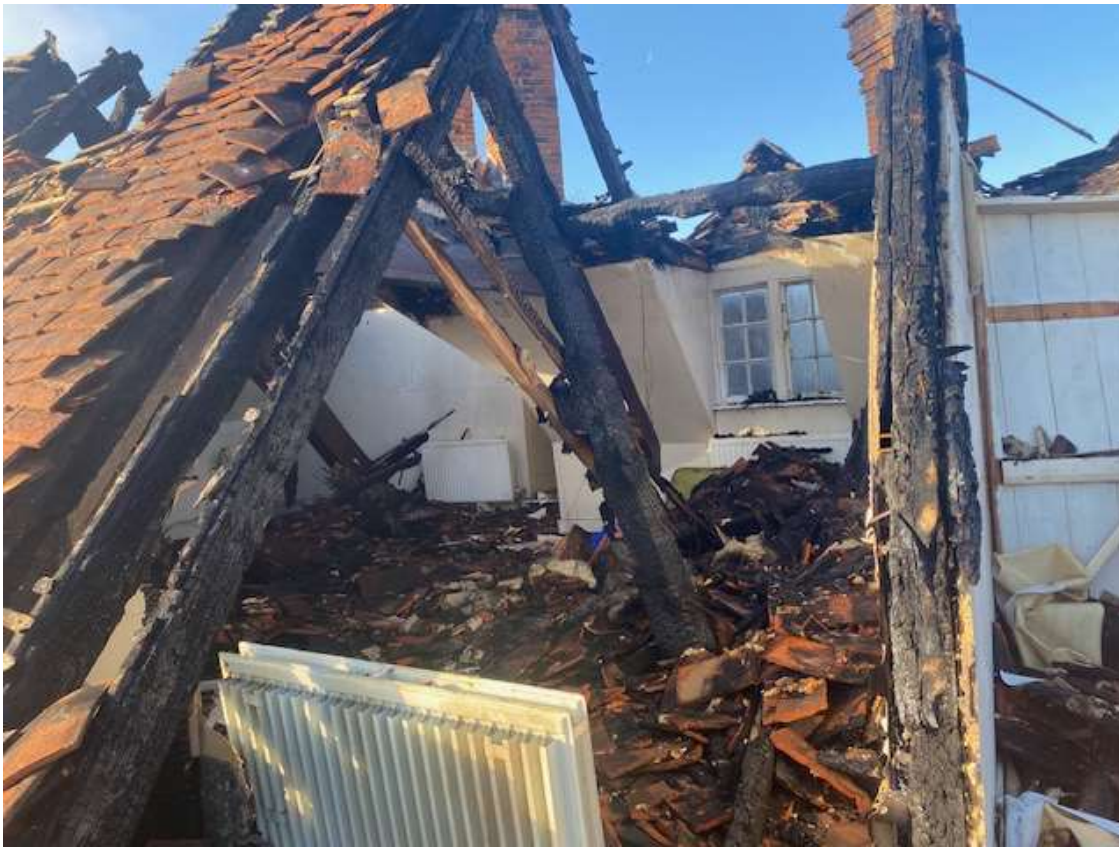
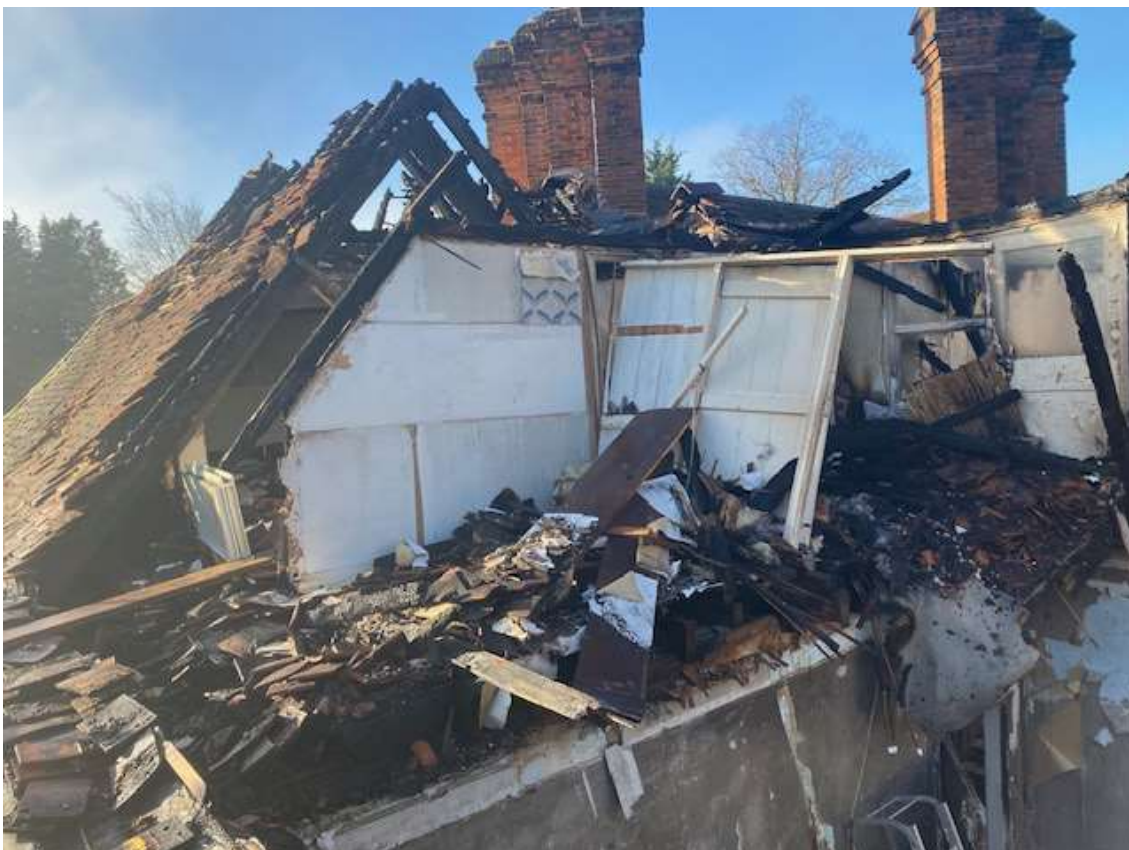
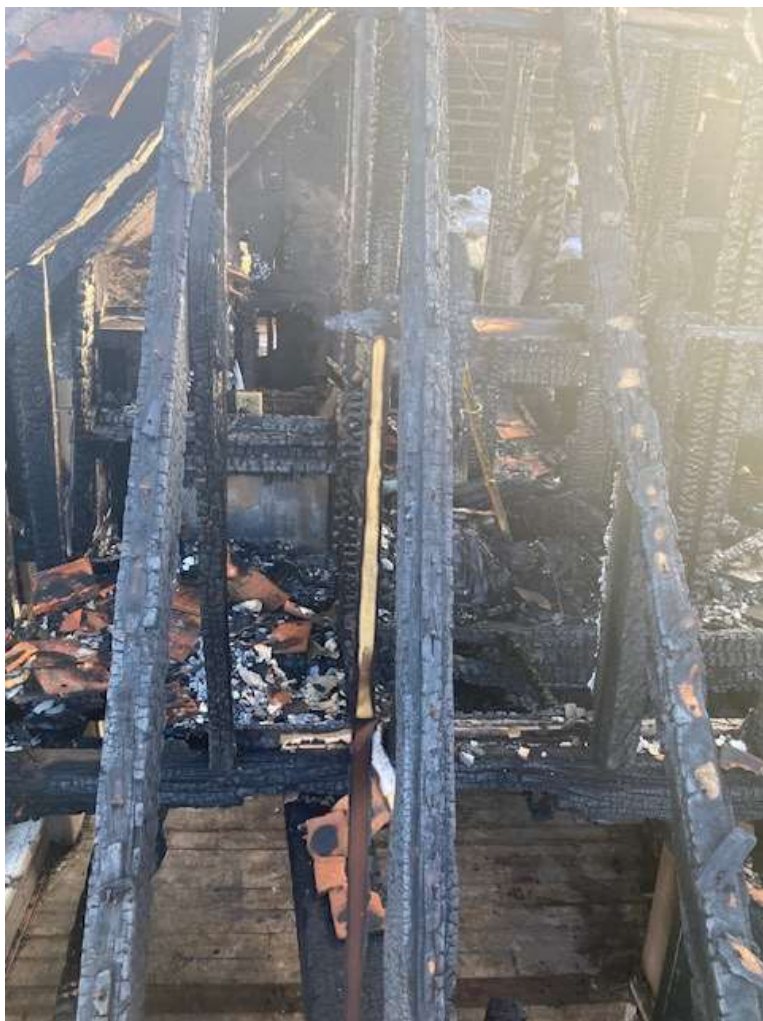
As stated, the roof construction over the point of the fire was all gone; however, the roof structure over the South East and North West rooms was badly charred, and some of the rafters, ceiling joists and purlins were missing. These remaining parts of the damaged roof structure still supported areas of roof tiles. (Photographs 4, 5 & 6)

Looking at the damage to the roof structure, it is very unlikely that any of the fire-affected roof areas can be salvaged and should be removed together with the remaining areas of plain tiles/ battens.

Photograph 4, 5 & 6—fire damaged roof structure

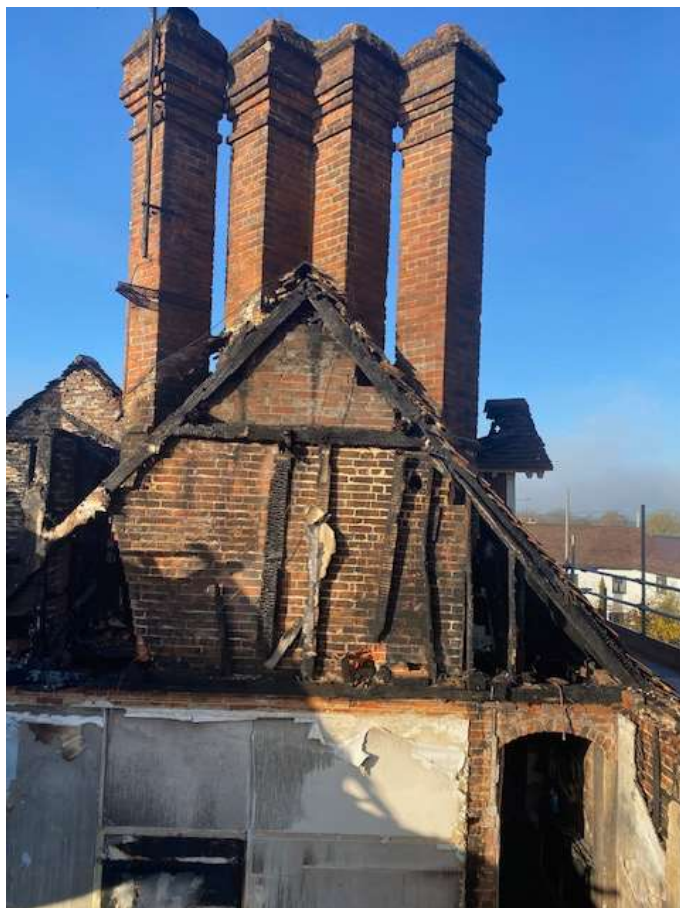
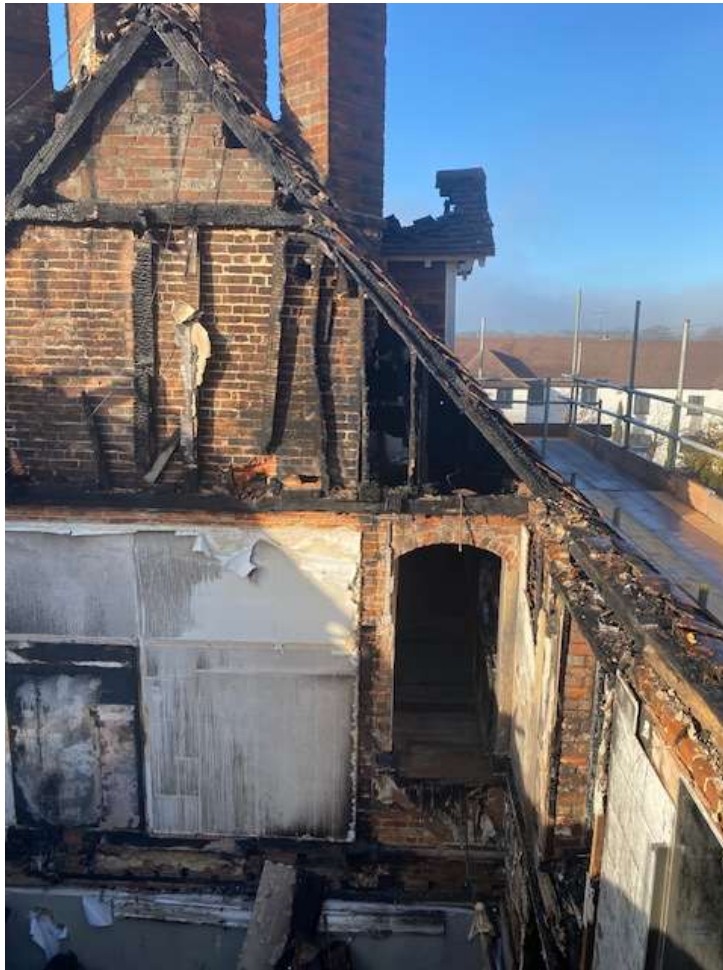
There are four tall chimney stacks remaining, which are built within the internal wall between the North East / West rooms. These stacks appeared to be true and vertical with no noticeable signs of cracking within the face brickwork or heat damage. (Photographs 7 & 8)

Photograph 7 & 8- Four chimney stacks

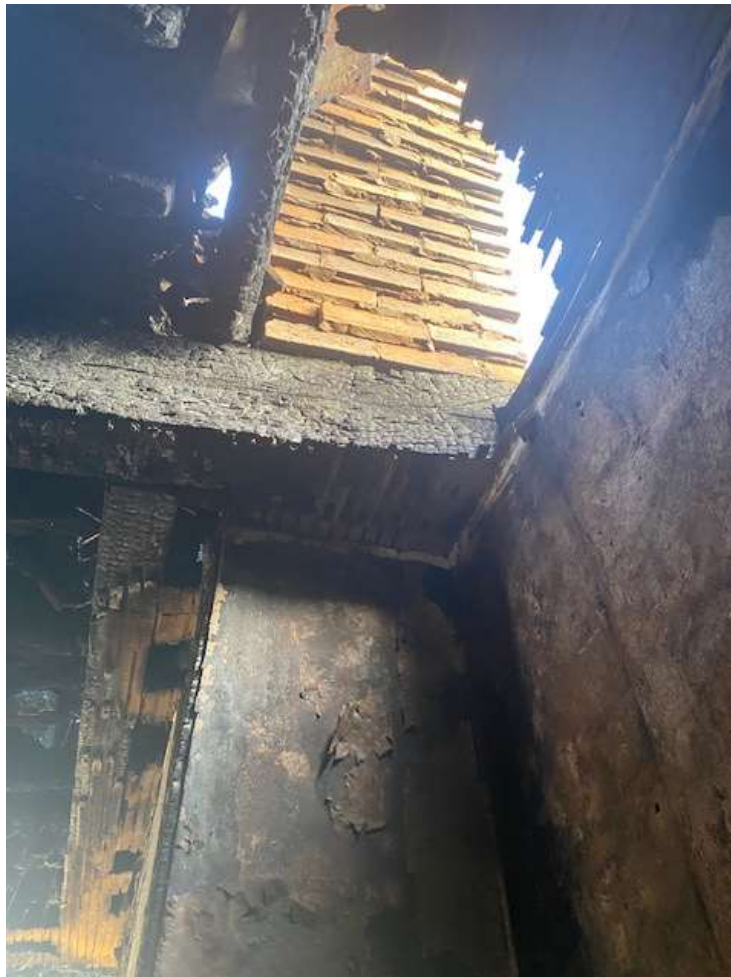
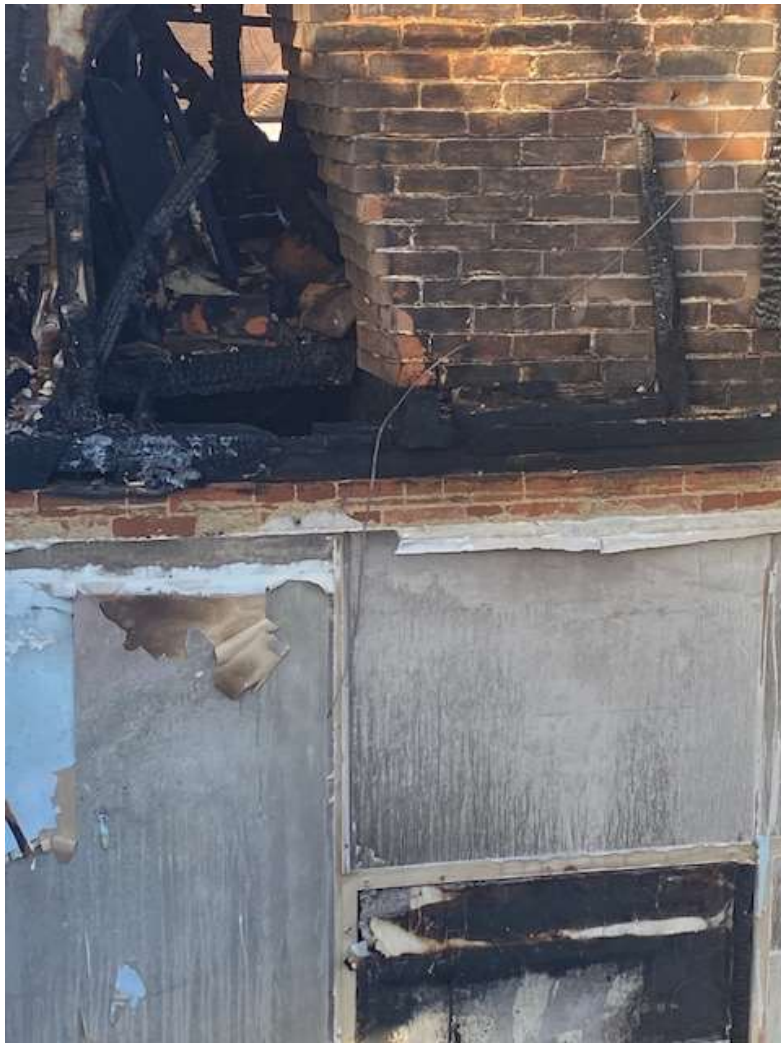
The main entrance hall and ground to the first-floor staircase had minor damage due to the fire. However, the first-to-second-floor staircase is badly damaged, and the second-floor landing was also badly affected. The first and second floor rooms West of the four main chimney stacks were badly damaged, the timber beams being very badly damaged. It was noted that one of the oak charred beams is built within and below the end chimney stack, and the stack above this beam corbels outwards. It is thought that this beam, although badly charred, probably has some integrity within the oak beam, but how much is difficult to determine, as access was not possible. (Photographs 9 & 10)

When safe access is available, the badly charred beam below the chimney stack should be tested to see how much timber core remains; however, due to the extent of the damage, it is likely that this beam will be replaced.

Photograph 9 & 10- Oak beam – corbel chimney stack

Provide temporary propping via acrow-type struts from the internal wall below the corbel stack up to and above the charred beam, as suggested to stabilise the projecting stack structure. The small gable wall to the staircase well should be demolished down to the roof wall plate level. The first to second floor staircase is to be removed, and possibly the second floor landing and replaced with scaffolding and a temporary staircase to allow access to the second floor.

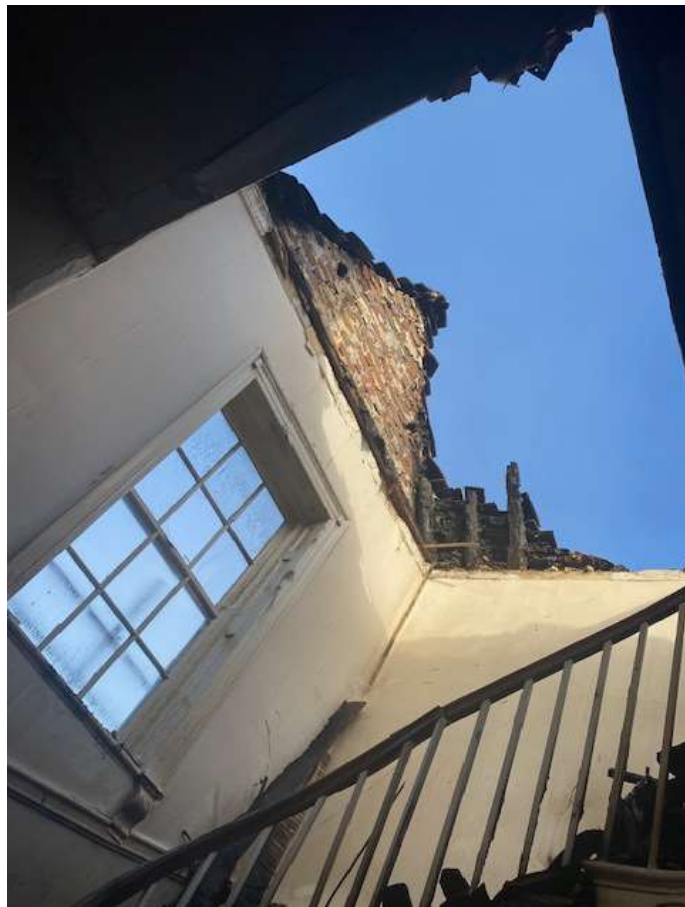
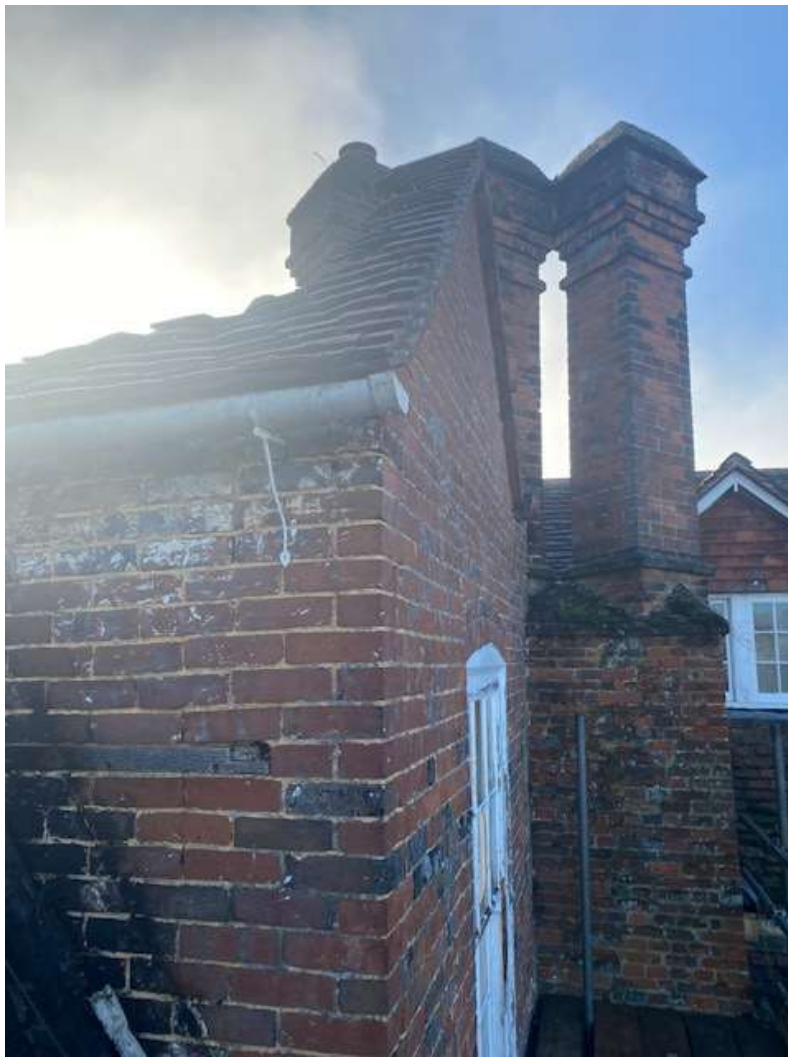
There is a single brick skin gable wall above the first to second floor staircase, which is now not supported laterally due to the whole section of the roof having been destroyed. (Photographs 11 & 12)

It will be difficult to brace the exposed single skin gable wall above the first to second floor staircase; this gable wall, being unsupported, is dangerous in its current situation and could fall during the clean-up stage.

Photograph 11 & 12- Gable to stair well

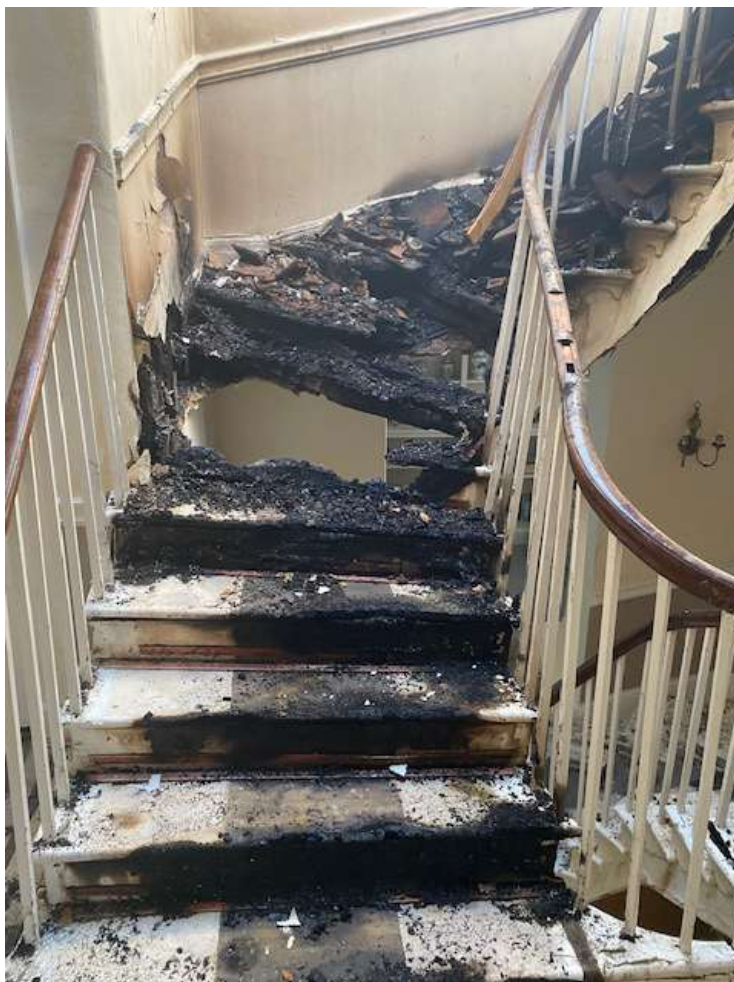
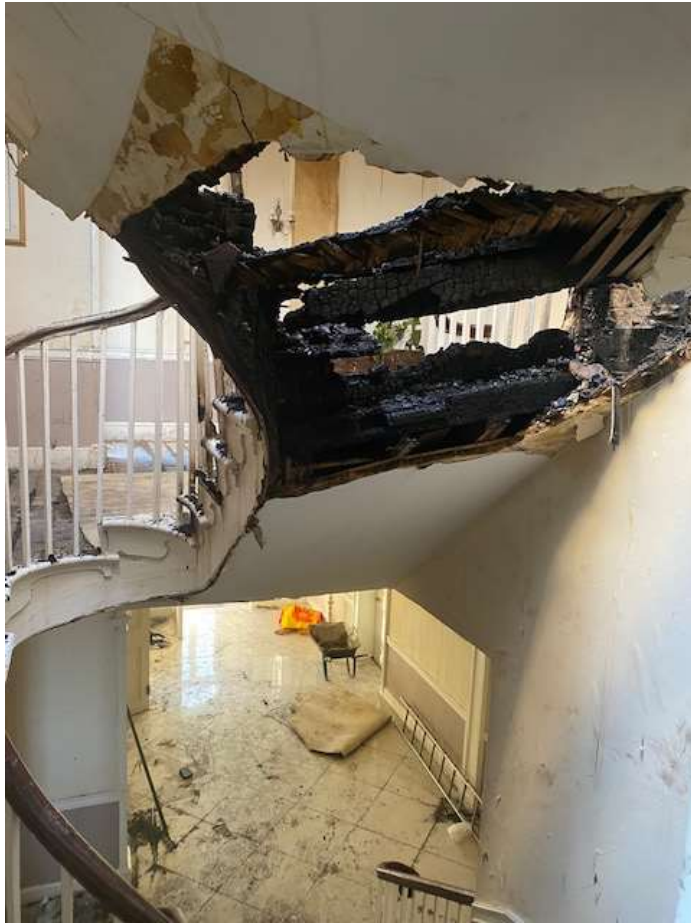
First to Second floor staircase damage

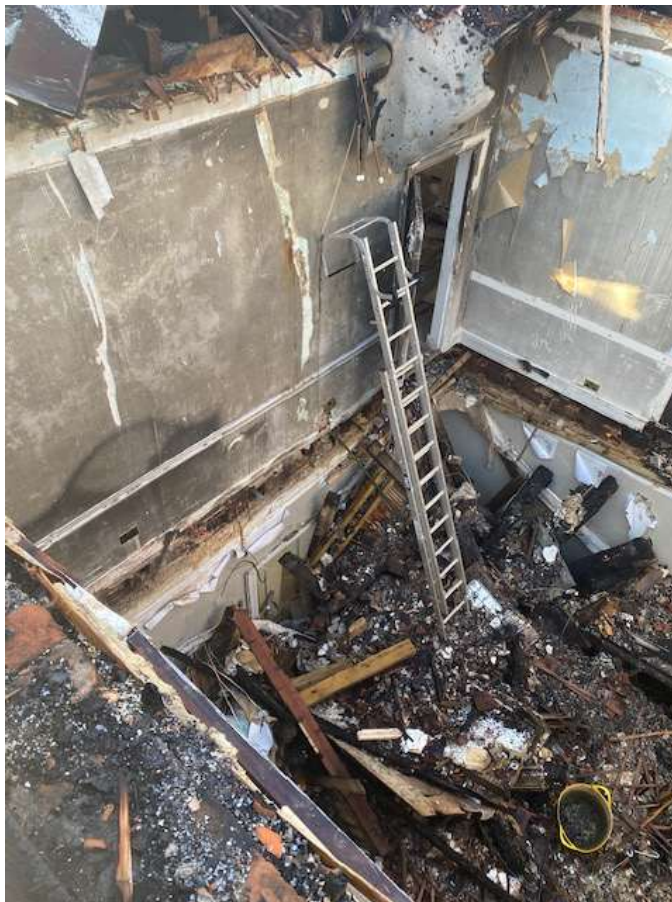
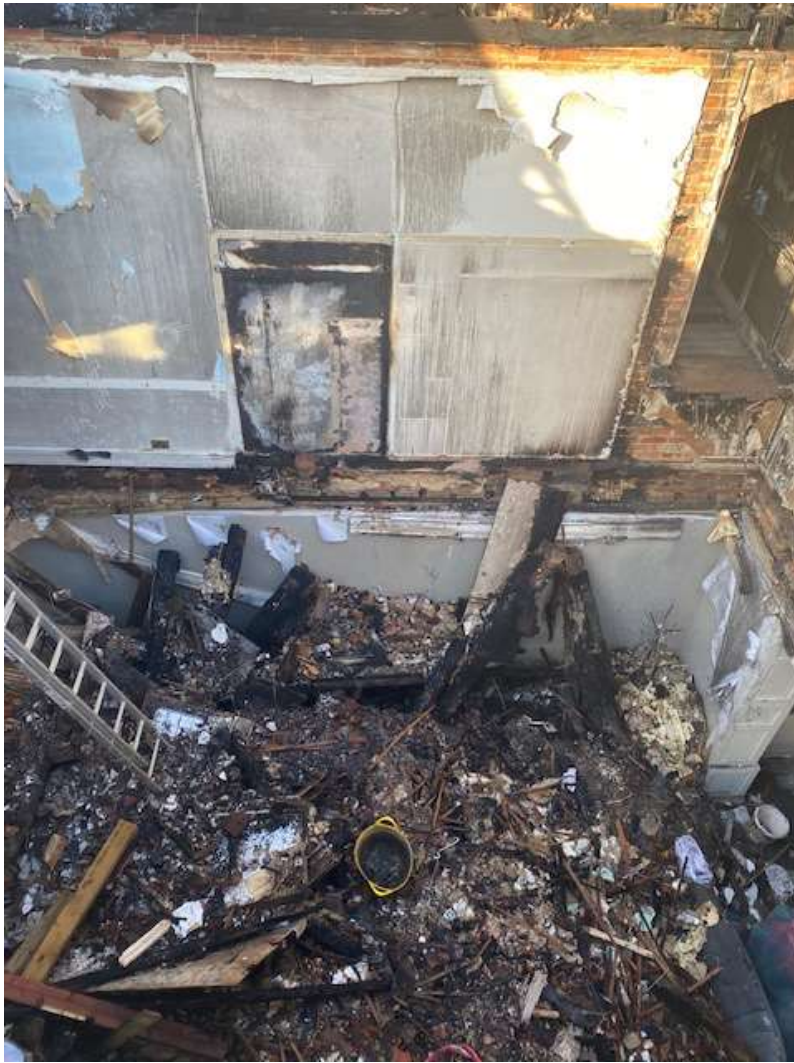
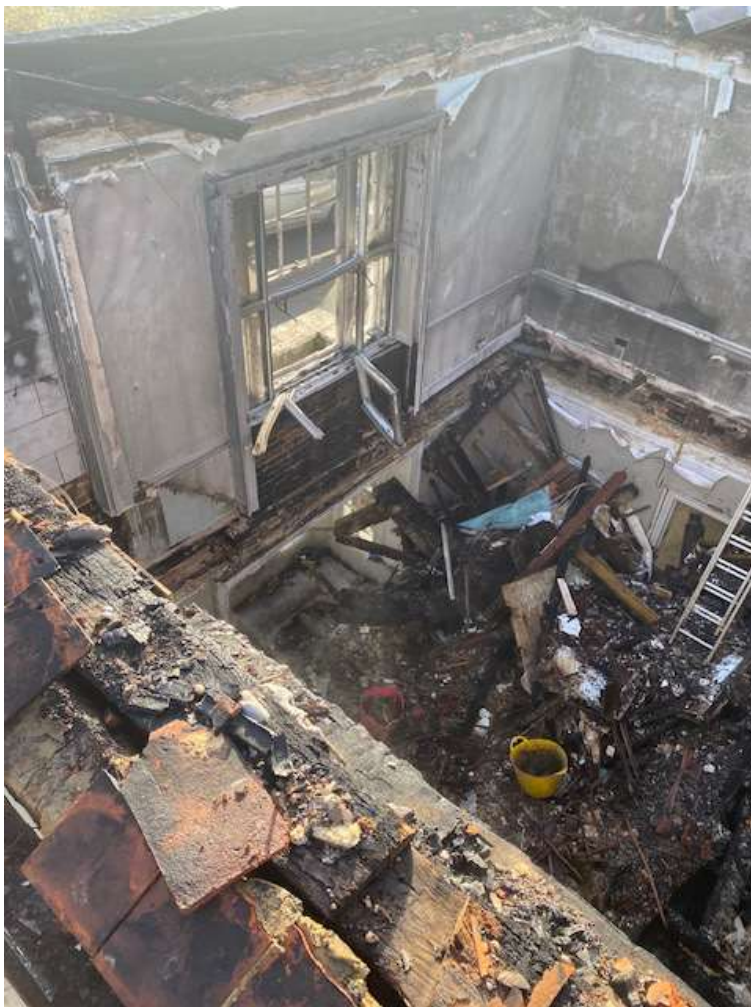
External walls and point of fire damage
