Ref:MW.2502.SRW.AIA

**Re: Arboricultural Impact Assessment for carport installation at Alyeska, Sandhurst Road, Wokingham, RG40 3JG**

BS5837 Tree Survey Plan  
Alyeska, Sandhurst Road, Wokingham, RG40 3JG

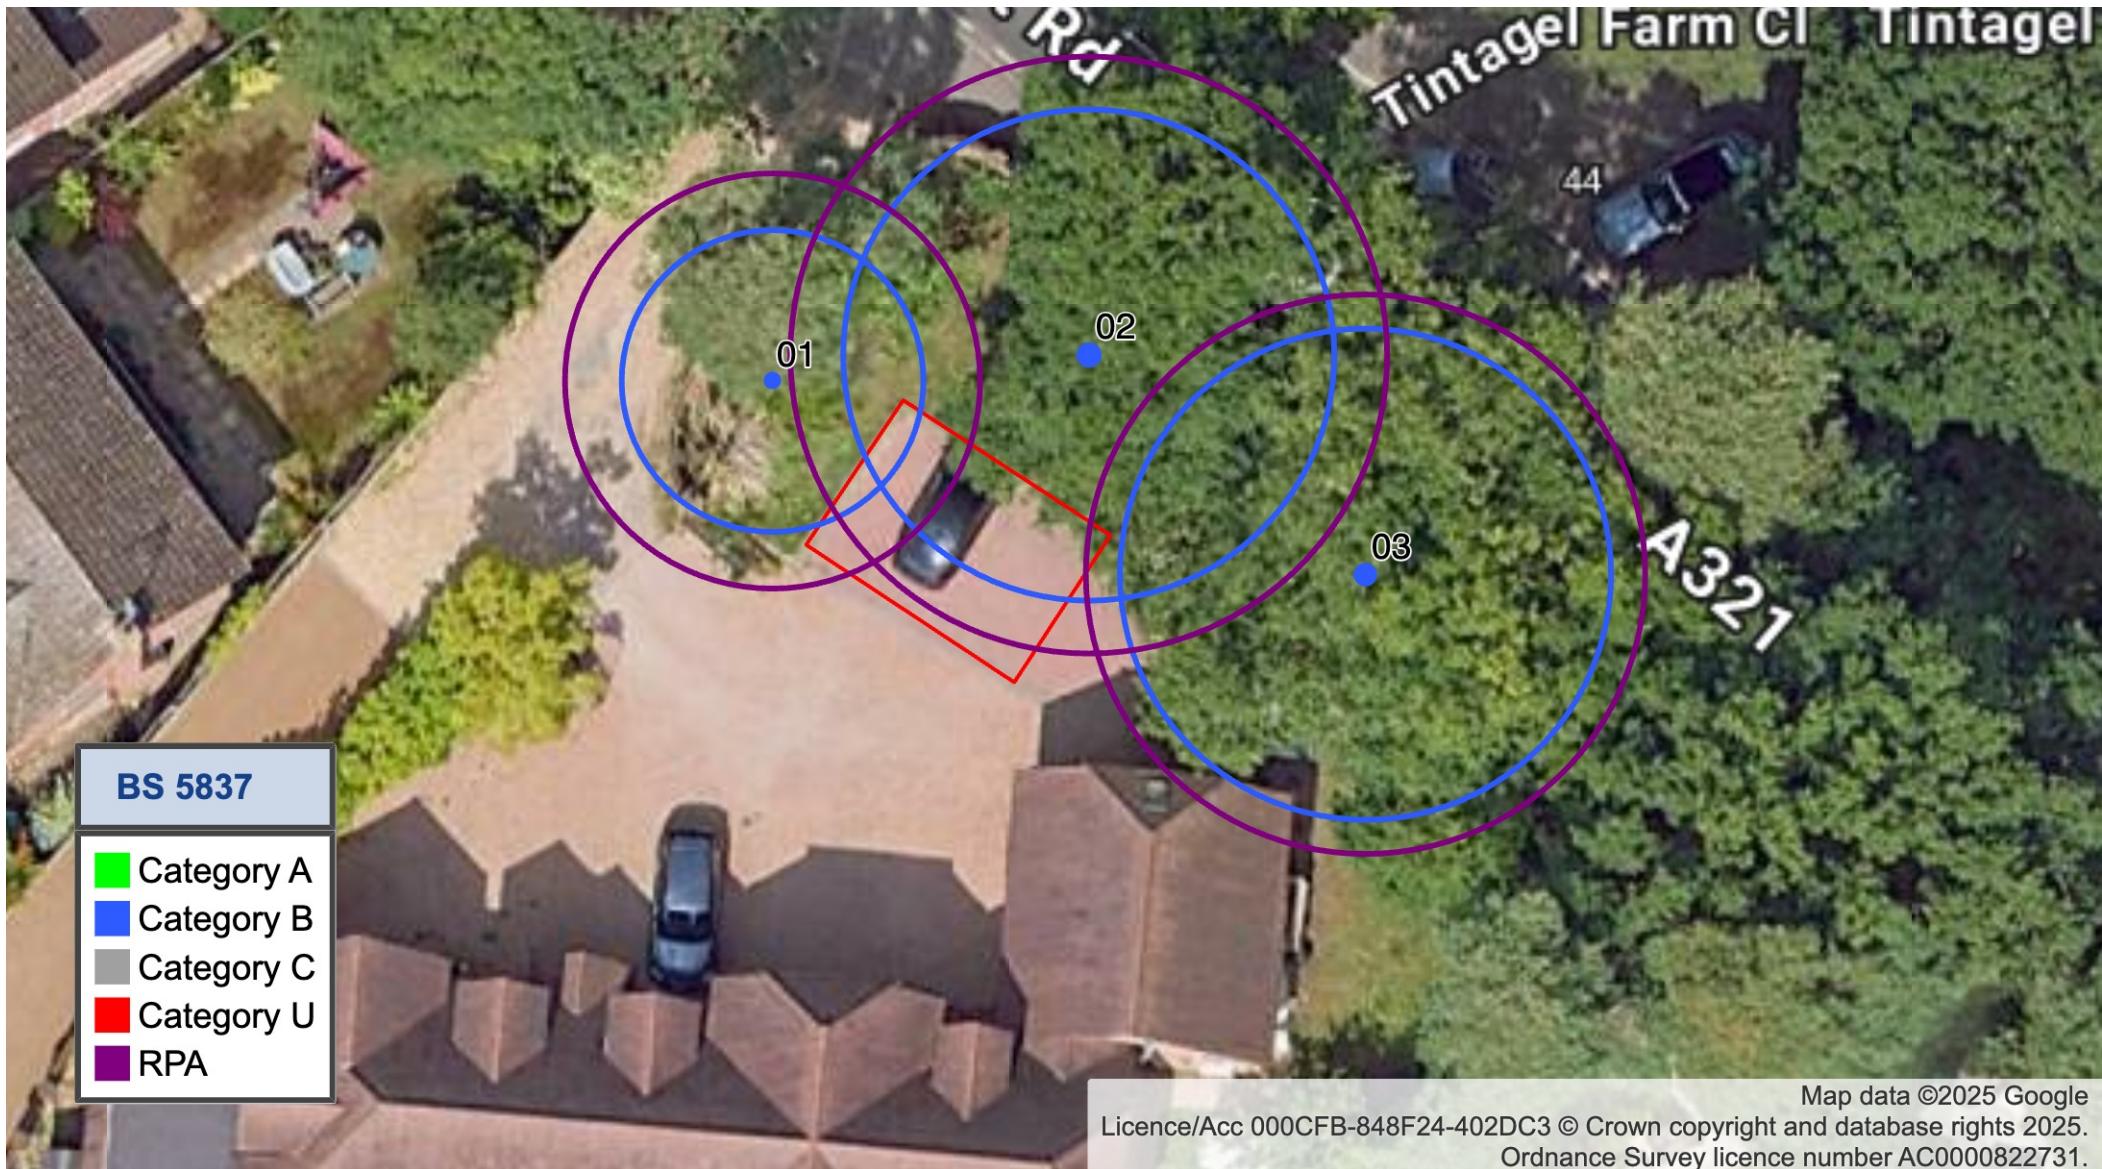
It can be seen on the plan that carport has been installed within the circular root protection areas (RPAs) of the three trees.

The enclosed plan shows the approximate locations of 7No. posts that are located within the circular RPAs.

Six of these are within the paving, and the seventh is within the lawn.

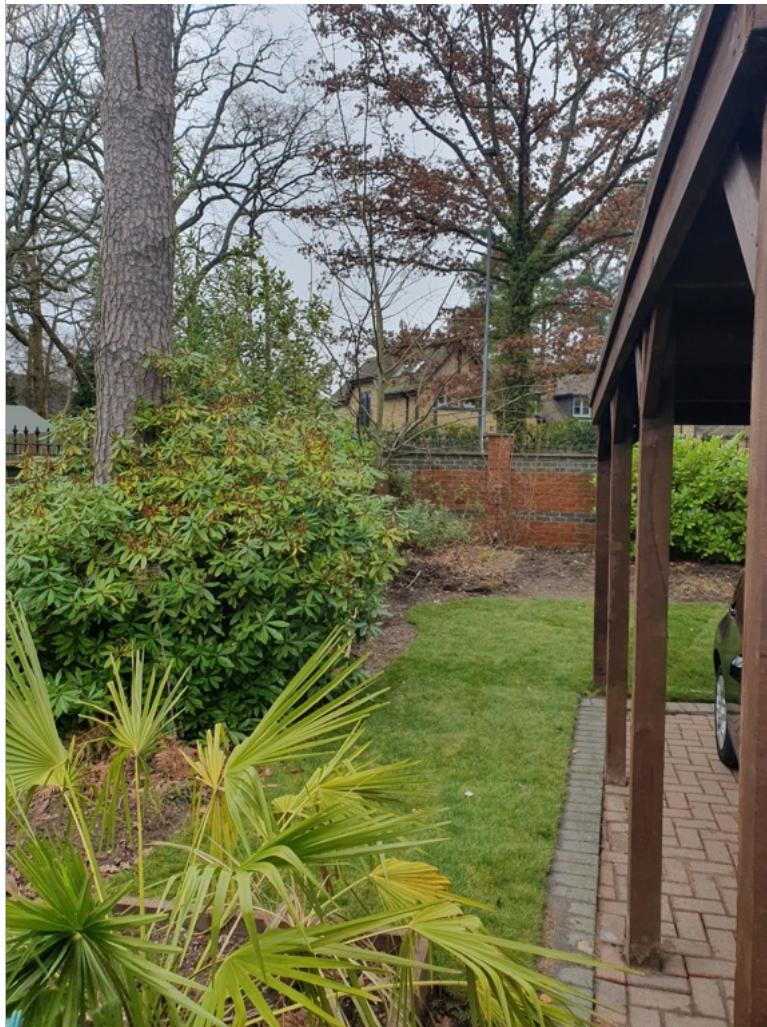
01 P001

Pine #01 has four posts within its RPA. This totals 0.36m<sup>2</sup>- <4% of the overall 95m<sup>2</sup> RPA.

Ref	Species	Height	Measurements	Comments	Observations & Recommendations	RPA	Recommendations	BS Category
01	Scots pine ( <i>Pinus sylvestris</i> )	15	Height (m): 15 Stem Diam(mm): 460 Spread (m): 4N, 4E, 4S, 4W Crown Clearance (m): 7 Life Stage: Mature Rem. Contrib.: 20+ Years		Fair overall physiological and structural condition.	Radius: 5.5m. Area: 95 sq m.		B1
02	Pedunculate oak ( <i>Quercus robur</i> )	14	Height (m): 14 Stem Diam(mm): 660# Spread (m): 6.5N, 6.5E, 6.5S, 6.5W Crown Clearance (m): 3 Life Stage: Mature Rem. Contrib.: 20+ Years		Fair overall physiological and structural condition.	Radius: 7.9m. Area: 196 sq m.		B1

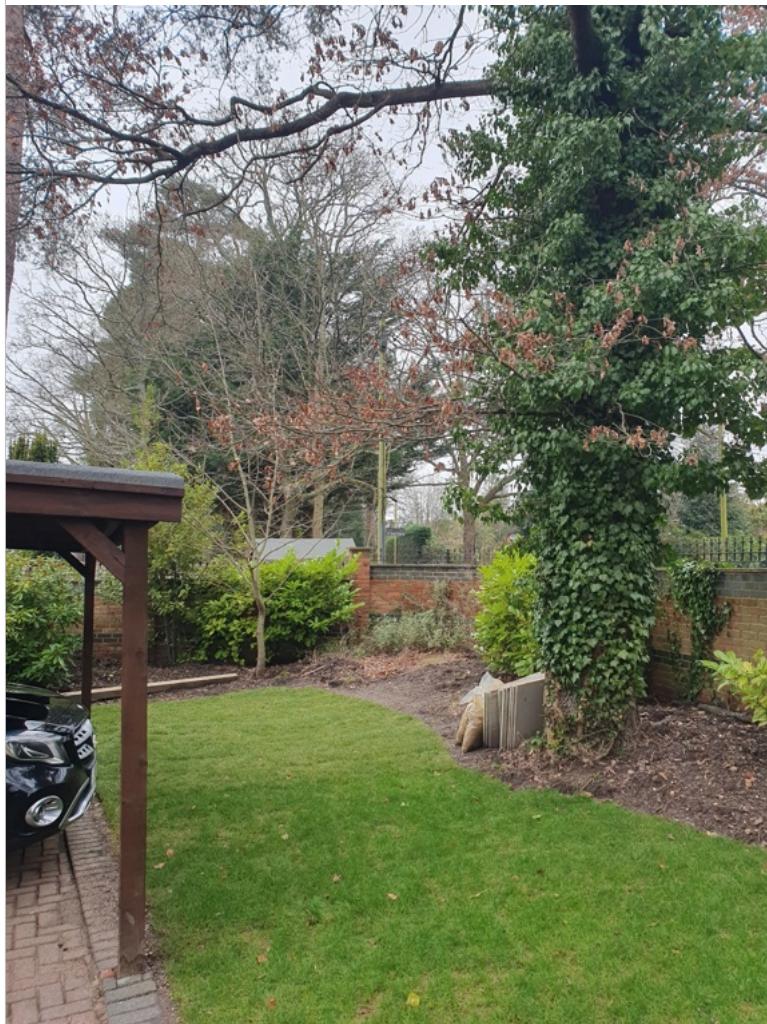
02 P001

Oak #02 has six posts within its RPA. This totals 0.54m<sup>2</sup>- <3% of the overall 196m<sup>2</sup> RPA.

The trees comprise 2No. oak (*Quercus robur*) and 1No. Scots pine (*Pinus sylvestris*). All three trees appear to be in good health and condition. Ivy is becoming established on the two oaks and it would be prudent to sever this at ground level to avoid it becoming too dominant.

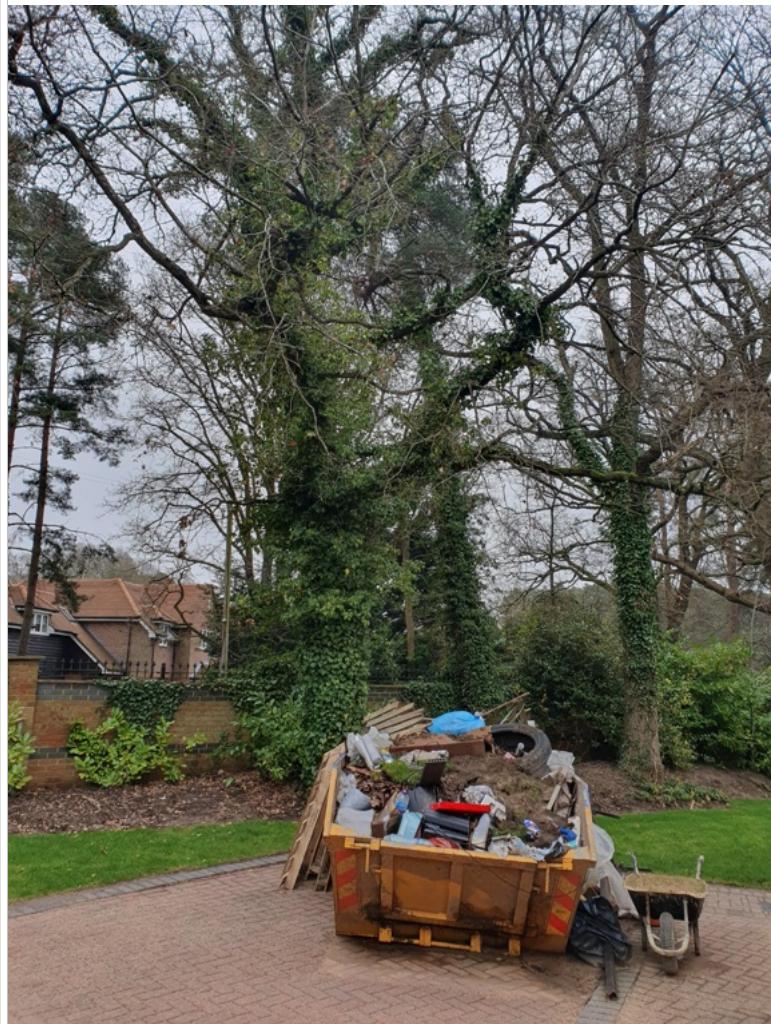
03 P001

Oak #03 has one post within its RPA. This totals 0.09m<sup>2</sup>- <0.5% of the overall 172m<sup>2</sup> RPA.

Ref	Species	Height	Measurements	Comments	Observations & Recommendations	RPA	Recommendations	BS Category
03	Pedunculate oak ( <i>Quercus robur</i> )	14	Height (m): 14 Stem Diam(mm): 620 Spread (m): 6.5N, 6.5E, 6.5S, 6.5W Crown Clearance (m): 3 Life Stage: Mature Rem. Contrib.: 20+ Years		Fair overall physiological and structural condition.	Radius: 7.4m. Area: 172 sq m.		B1
