## **TREE REPORT**

Relating to a large mature oak at: -

10 Buckhurst Grove  
Wokingham  
Berkshire  
RG40 2JR

December 2025

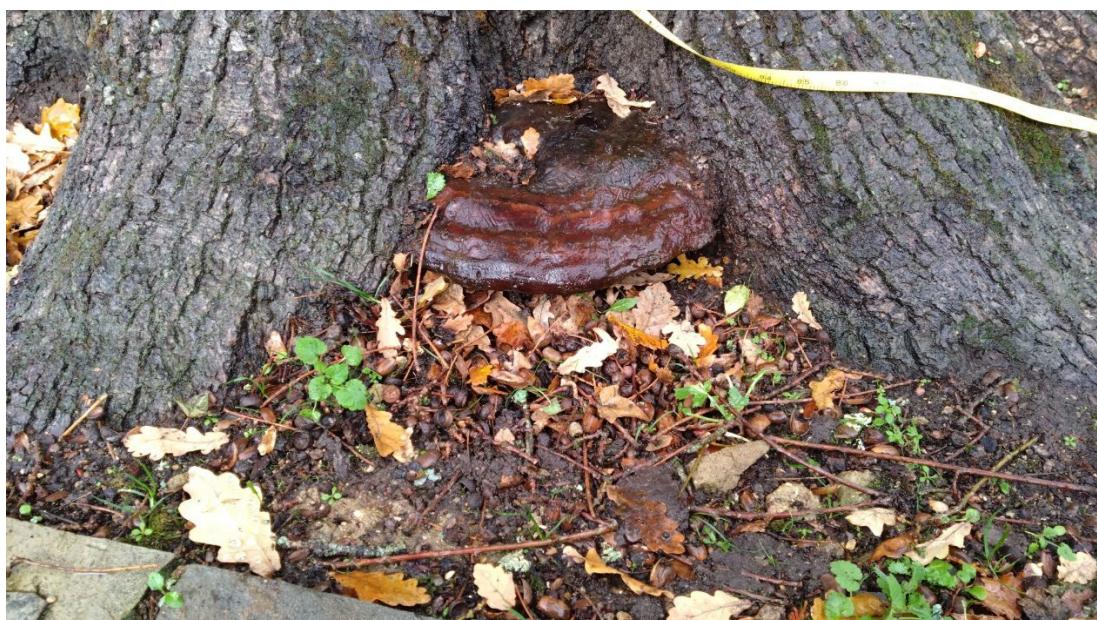
*Ganoderma resinaceum* bracket on the south side.

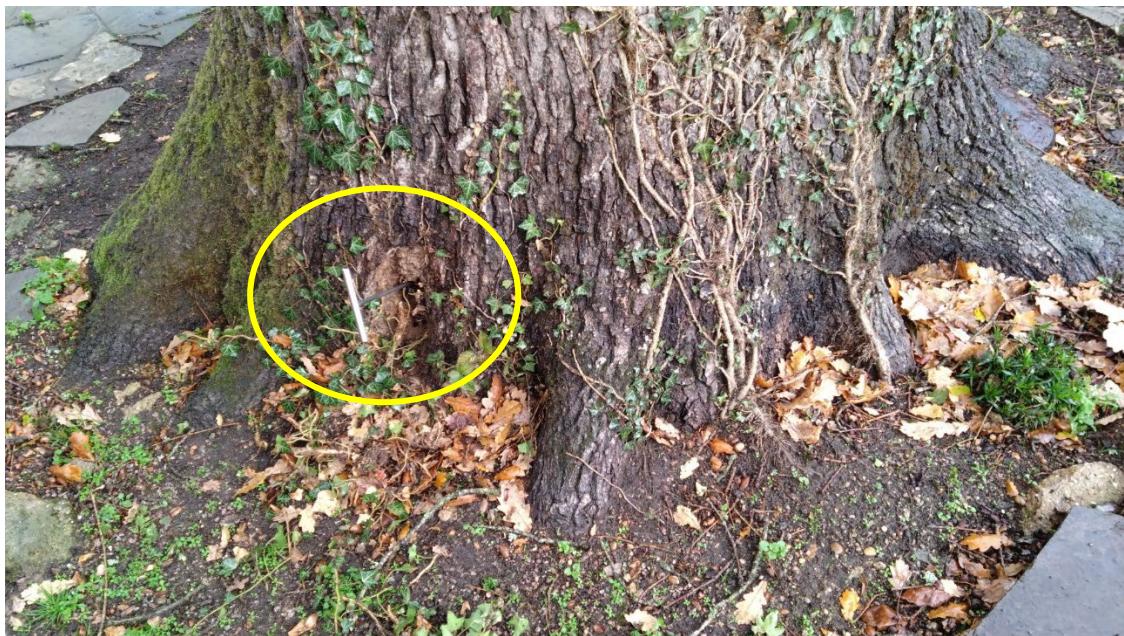
60cm long steel probe inserted into void on the west side.

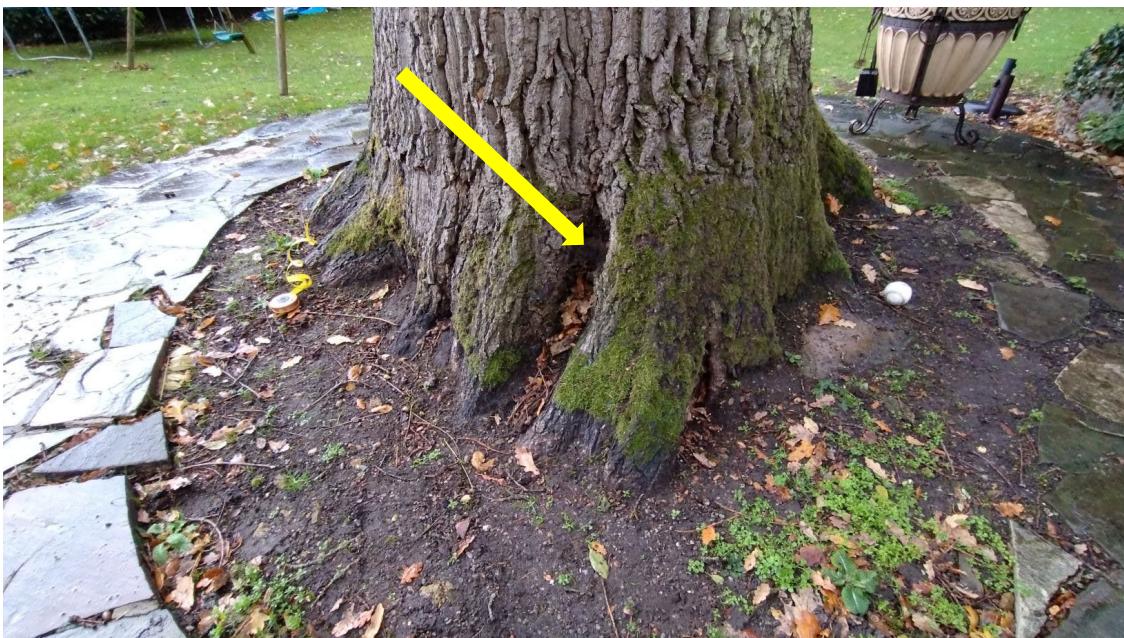
Attachment point of another fungal bracket (removed by others prior to this assessment) – north-east corner

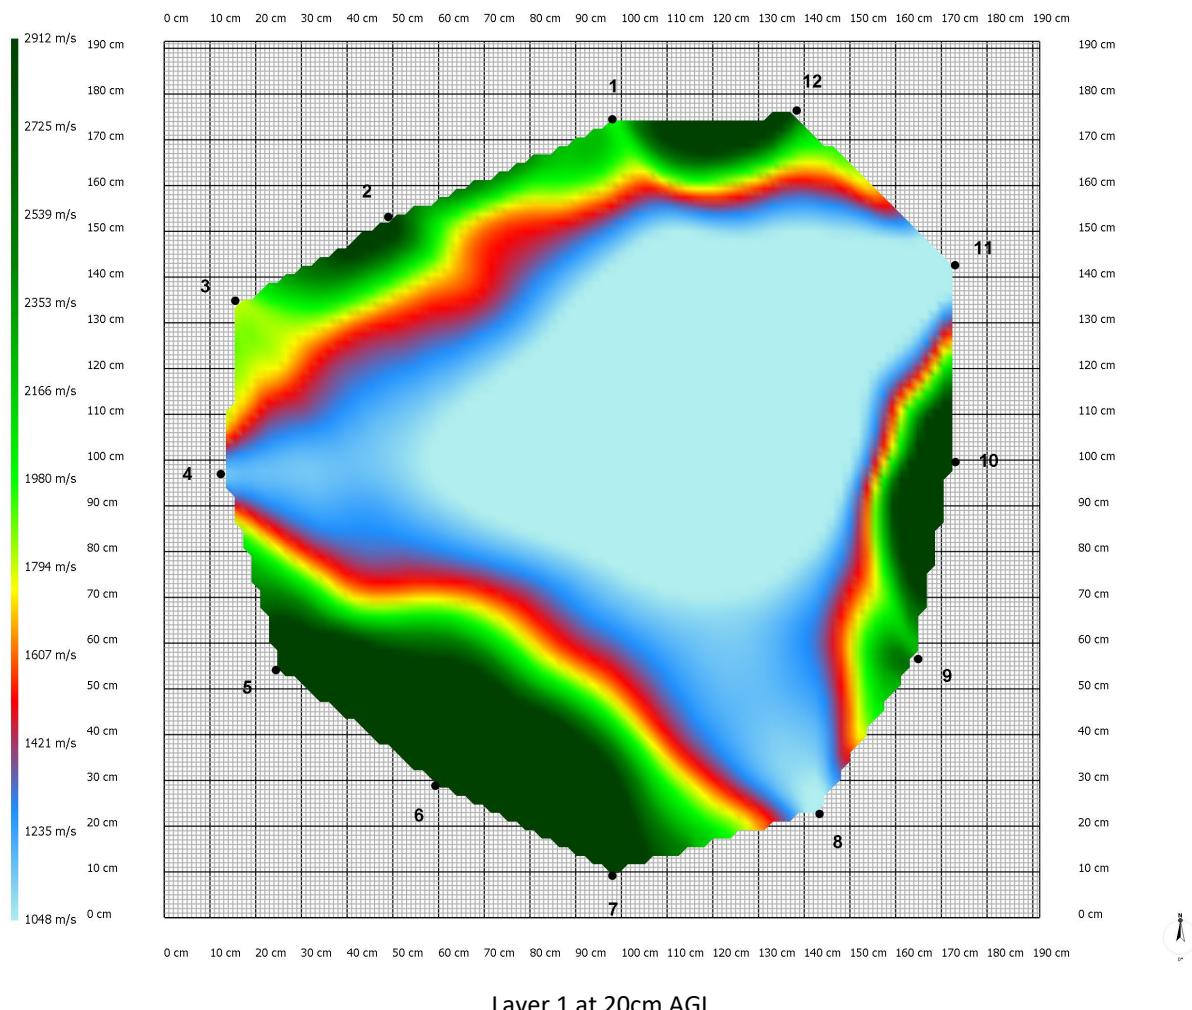
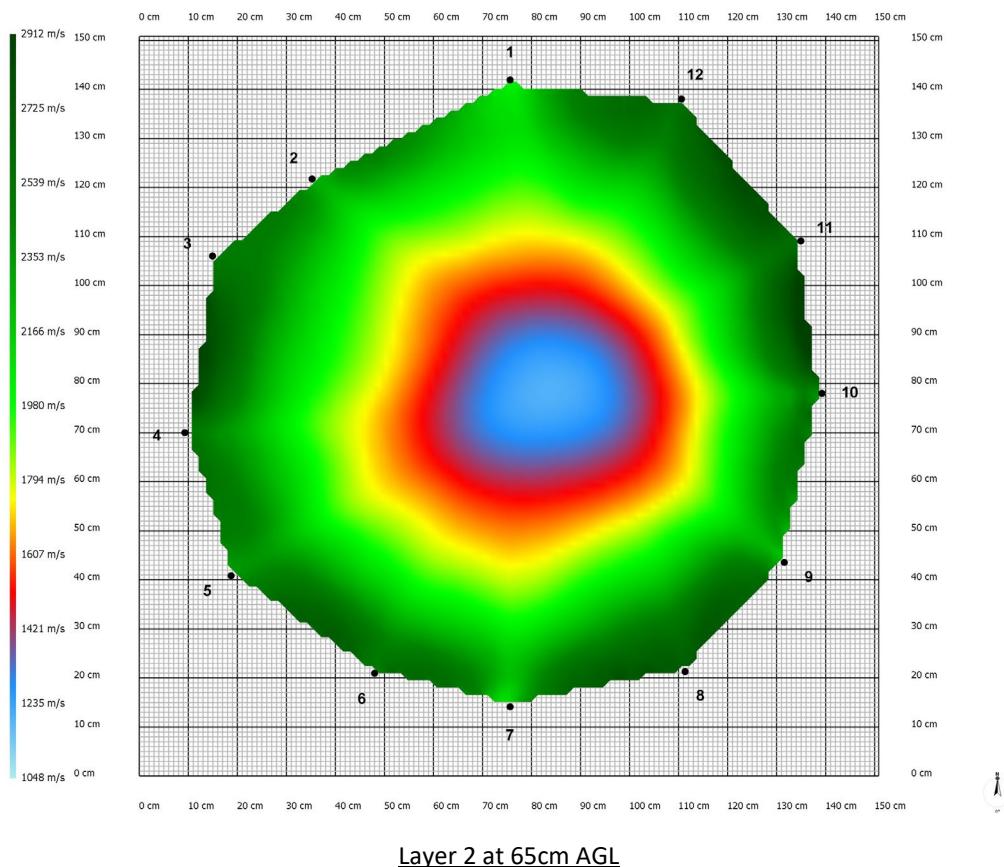
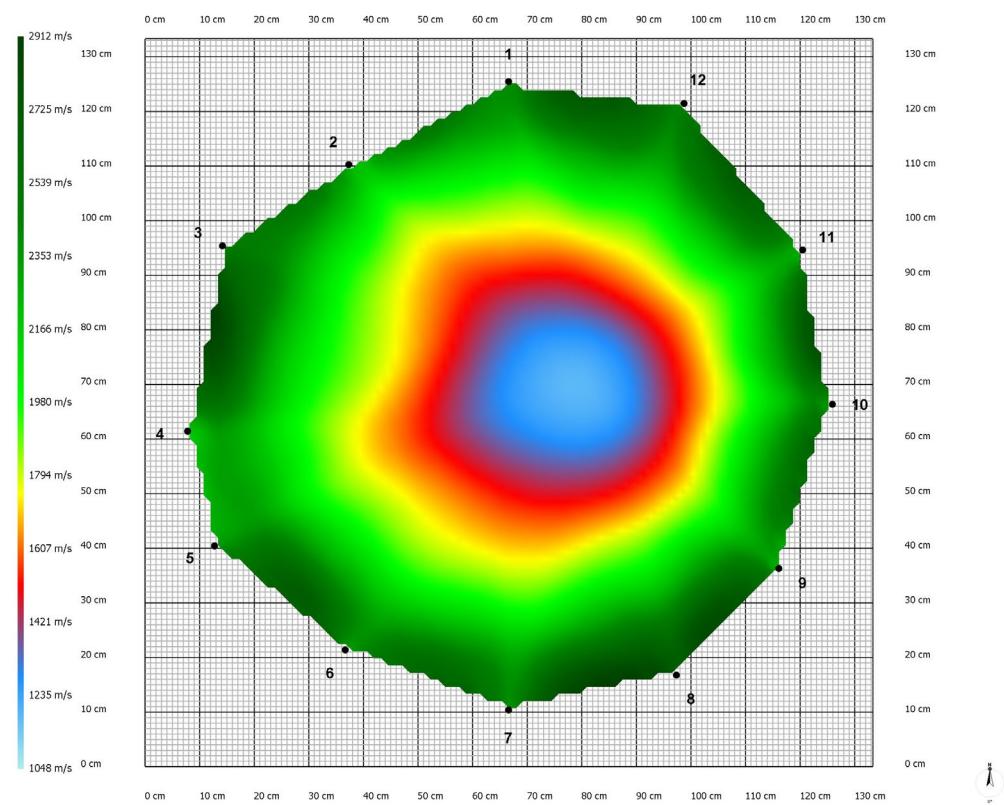
Since the tomogram for Layer 1 shows a breach of the sapwood region at sensors 4, 8 and 11 (where the small opening/void and fungal brackets are located respectively), the biomechanical calculated safety factor is not applicable in this case.

Layer 1 shows significant internal decay/hollowing, consistent with visual observation, fungal bracket locations, manual sounding and probing with the 60cm steel rod. The Arborsonic software has calculated the decayed area to be 69% of the total cross-sectional area with an average thickness of the residual shell of solid wood equal to 17cm ( $t/R = 0.2$ ). However, the decay/hollowing appears to have breached the residual shell of solid wood at sensors 4 (void), 8 (bracket) and 11 (absent bracket attachment point).

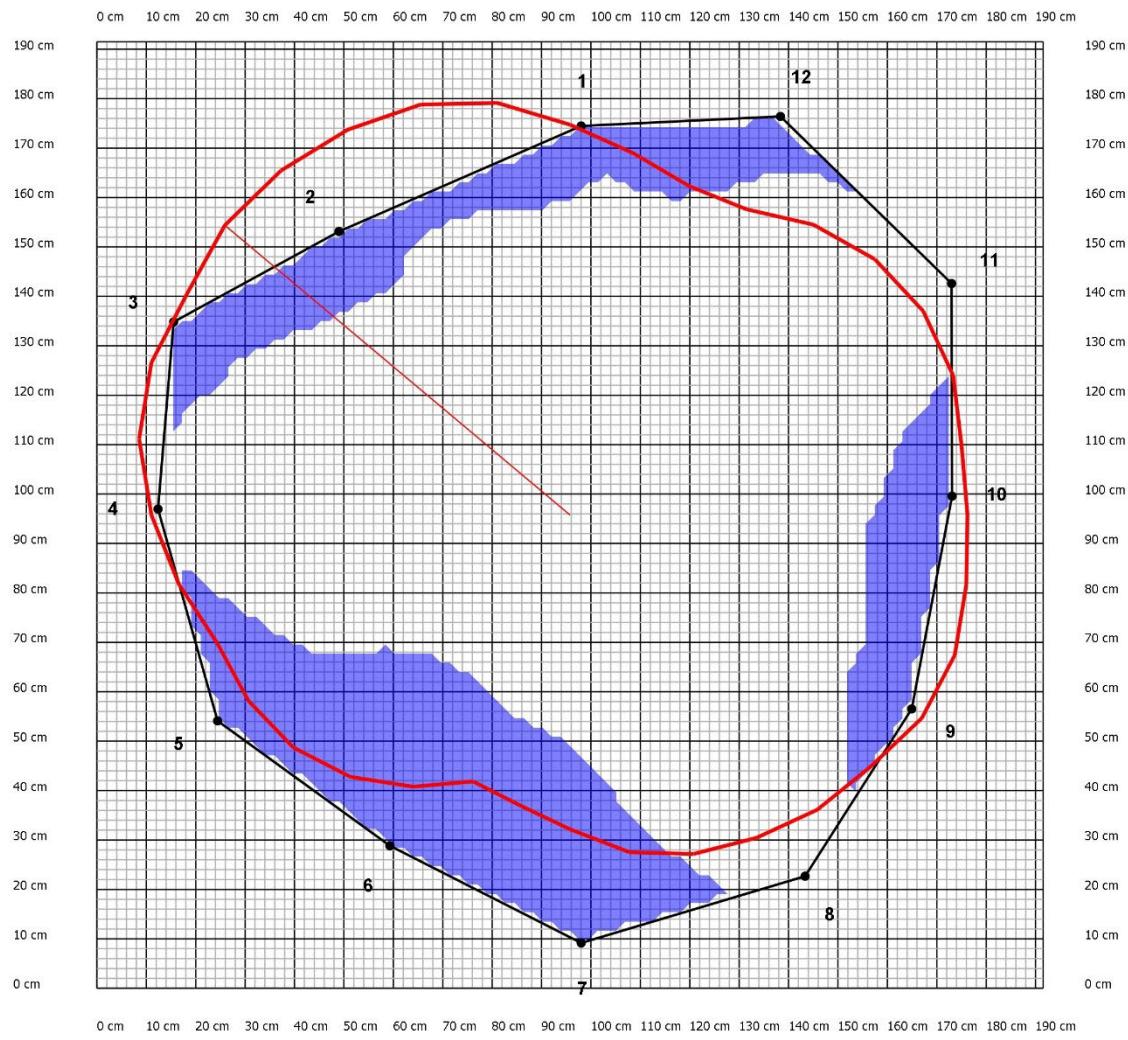
### 3.3 Layer map

The blue and white “layer” map is of notable concern, suggesting that the structural condition of the stem base is quite severely compromised.

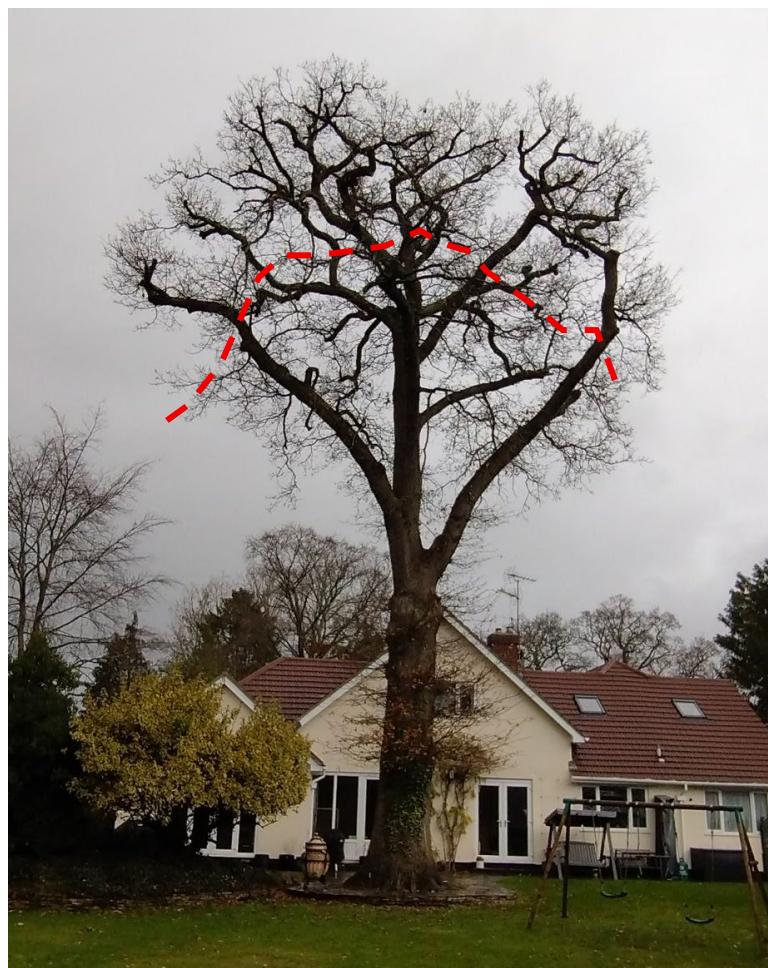
The visual appearance of an approximate 30% height reduction

Since PBA Consulting Solutions and Wokingham Borough Council’s Trees and Landscape Team Manager agreed that a 30% reduction was suitable in 2020, a further 30% reduction feels like a sensible starting point – albeit where a percentage is open to interpretation (of height/dimensions, crown area or foliage-bearing branches??). A 30% height reduction (which equates to 5.7m), would bring about a 60% wind-load reduction and leave a final post-pruning height of just over 13m. This would cost somewhere in the region of £1500, result in excessively large pruning wounds of around 20cm diameter (contrary to best practice), have a significantly detrimental impact on amenity value and could trigger a further spiral of physiological decline.
