# Arboricultural Consultancy for Aviva

## 1. Case Details

| Insured | | Address | 5 Sharphorpe Close, Lower Earley, Reading, RG6 4DB | | |

**Scope of Report:** To survey the property and determine significant vegetation contributing to subsidence damage, make recommendation for remedial action and assess initial mitigation and recovery prospects. The survey does not make an assessment for decay or hazard evaluation.

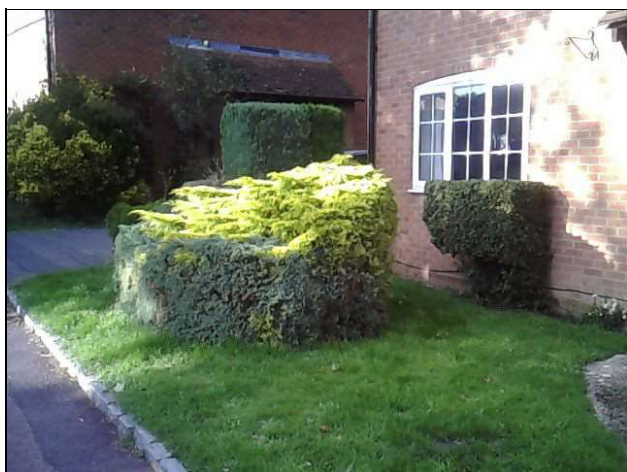
Note: the source of the Pomoideae spp. group roots will be vegetation within SG1 and proximate to the location of TP/BH2 (front elevation); these roots are not deemed material to the current claim.

| Tree No. | Species | Age Cat | Approx. Height (m) | Distance to Building (m) * | Ownership | Action | Requirement |
|---|---|---|---|---|---|---|---|
| SG1 | Mixed species shrubs: includes Pyracantha, Juniper and Cypress. | 1 | 2 | 0.2 | C - Insured | Action to avoid future risk | Subject to regular management; maintain at broadly current dimensions by way of regular pruning. |

SG1 - Mixed shrub group

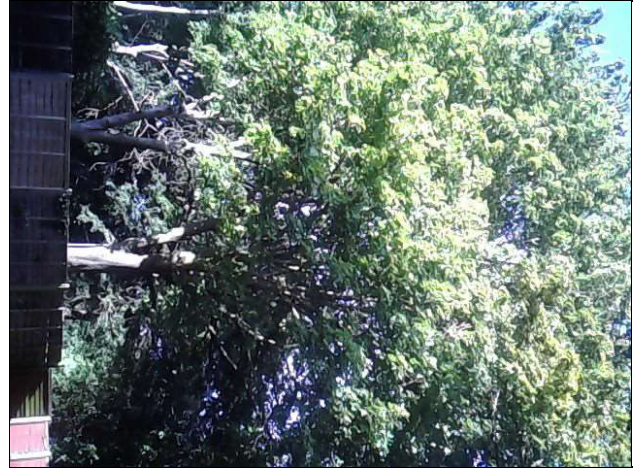
Our survey of the site identified T4 (Maple (Norway)) which, in our opinion, will be the source of the Acer spp. roots recovered in TP/BH1.

| Tree No. | Species | Age Cat | Approx. Height (m) | Distance to Building (m) * | Ownership | Action | Requirement |
|---|---|---|---|---|---|---|---|
| T4 | Maple (Norway) | 1 | 15.8 | 10.7 | A - Third Party | Remove | Remove close to ground level; do not treat stump due to translocation risk. Where such a risk exists, we advise that any emergent regrowth is removed annually. |

T4 - Maple (Norway)

With regards to T1 and T4, we have advocated their complete removal as it will offer the most certain arboricultural solution likely to restore long-term stability.

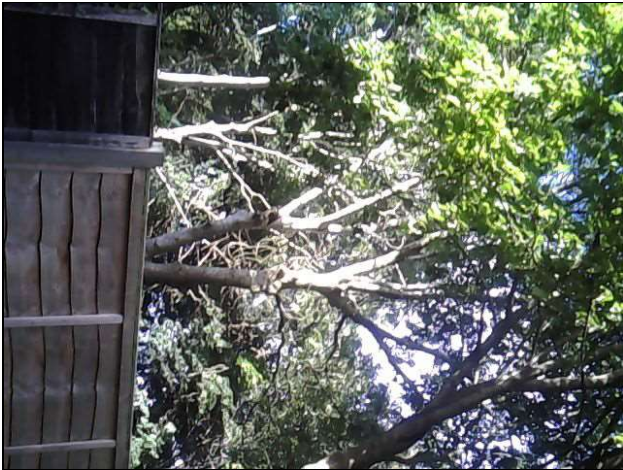
| Tree No. | Species | Age Cat | Approx. Height (m) | Distance to Building (m) * | Ownership | Action | Requirement |
|---|---|---|---|---|---|---|---|
| T5 | Ash | 1 | 15.8 | 13.8 | A - Third Party | Action to avoid future risk | Maintain at, or below current dimensions by way of regular pruning. |

T5 - Ash
