## Castlemans Cottage Roof

## Structural Appraisal

225131 - MNP - XX - XX - RP - S - 0001

April 2025

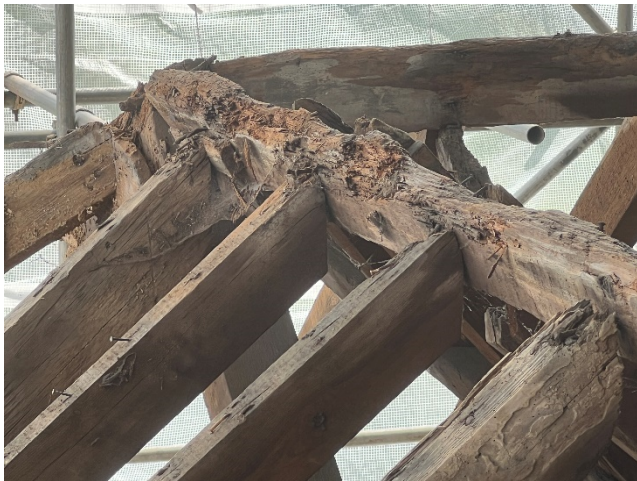
The tops of both front and rear trusses over bedrooms 2 and 3 were both affected by decay at their ridge.

Truss over bedroom 2. (decay at apex)

The truss over bedroom 2 is a high collared truss (over vaulted ceiling) with the apex formed by a pegged tenon and open-ended mortice joint. As can be seen in the photo, access to this joint is restricted by adjacent timbers (ridge boards and hip rafter) which will need to be removed to affect the repair. As works are needed to these members anyway, their removal will allow access for a glued and screwed spliced-timber repair to reconstruct the decayed joint.

The recommended repair glue is a high-build epoxy resin by Wests Ltd. The bonding strength exceeds the tensile and shear capacity of timber, meaning the adjacent timber will fail under load before the bond. The screws are used to hold the joint in position while the glue cures.

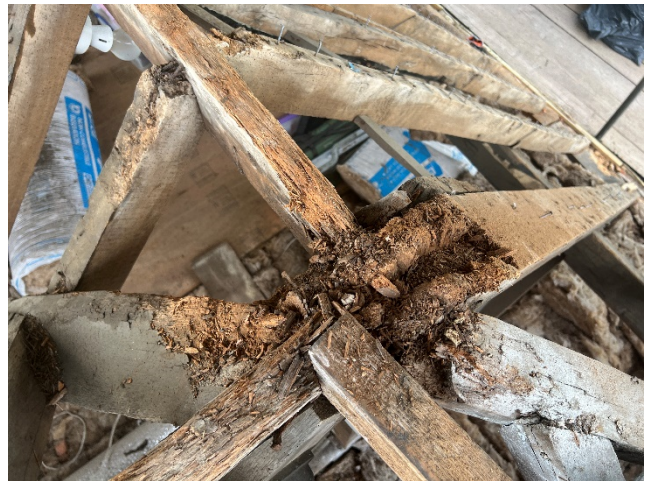
Truss over bedroom 3. (decay to end of king post).

The truss over bedroom 3 is a tied truss with king post and two diagonal struts. The top of the king post (actually a tensile member, whose outwardly tapered end bears onto the principal rafters) is highly decayed. The joint should be reconstructed using glued and screwed spliced-timber repairs. Adjacent timbers can be eased out of position to allow access.

The bottom end of the king post is also outwardly tapered to receive the diagonal struts. Repair to the bottom of the same king post is required. If sound, glue and screw the fractured piece back on. If not then replace the affected section.
