## The Swan, Three Mile Cross

## Drainage Strategy

September 2024

241836/DS/AG/KBL/01

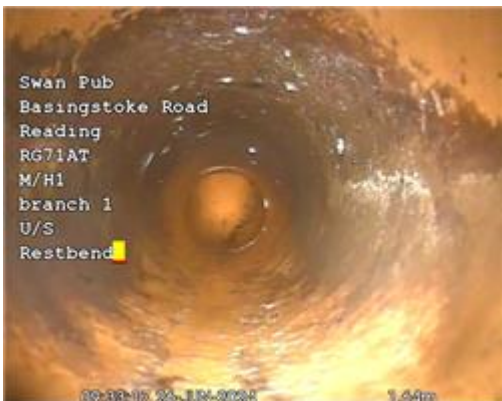
| Pos | Video Ref | Code | Description | Image |
|---|---|---|---|---|
| 01.64m | | REM | General remark<br>We would advise cleaning<br>works to be undertaken at this<br>location | Image Provided - Ref: 0_1<br> |

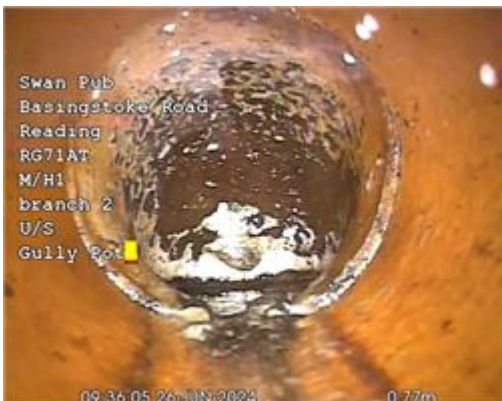
| Pos | Video Ref | Code | Description | Image |
|---|---|---|---|---|
| 00.77m | | REM | General remark<br>Small deposits identified.<br>Advisory - cleaning works<br>required in this location. | Image Provided - Ref: 1_1<br> |

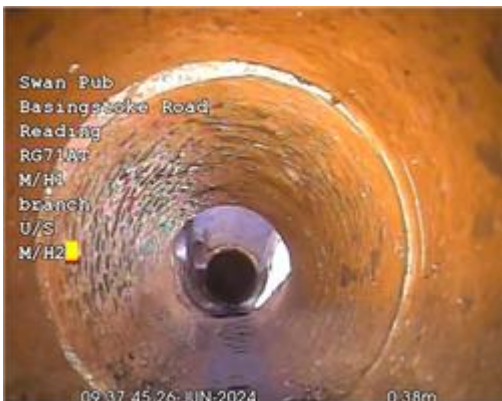
| Pos | Video Ref | Code | Description | Image |
|---|---|---|---|---|
| 00.40m | | JDM | Joint displaced medium -<br>Severity 3<br>Displaced Joint identified, with<br>no evidence to suggest that<br>this is resulting in any issues at<br>present however the condition<br>of this may deteriorate over a<br>period of time. | Image Provided - Ref: 2_1<br> |

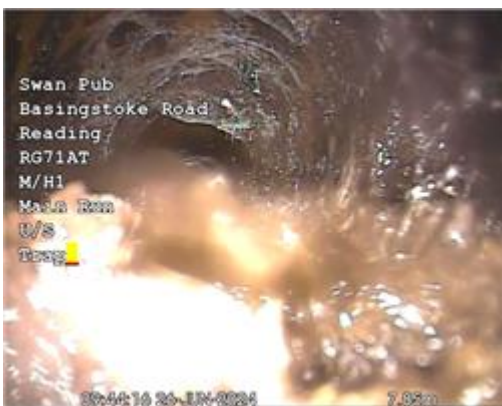
| Pos | Video Ref | Code | Description | Image |
|---|---|---|---|---|
| 07.85m | 0:00:39 | REM | General remark<br>ADVISORY - CLEANING<br>WORKS REQUIRED IN THIS<br>LOCATION | Image Provided - Ref: 4_4<br> |

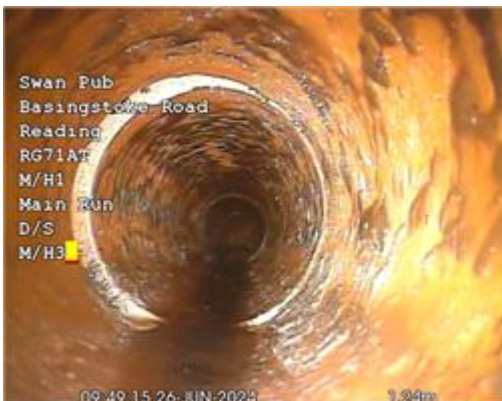
| Pos | Video Ref | Code | Description | Image |
|---|---|---|---|---|
| 01.20m | | JDM | Joint displaced medium -<br>Severity 3<br>Displaced Joint identified, with<br>no evidence to suggest that<br>this is resulting in any issues at<br>present however the condition<br>of this may deteriorate over a<br>period of time. | Image Provided - Ref: 5_1<br> |

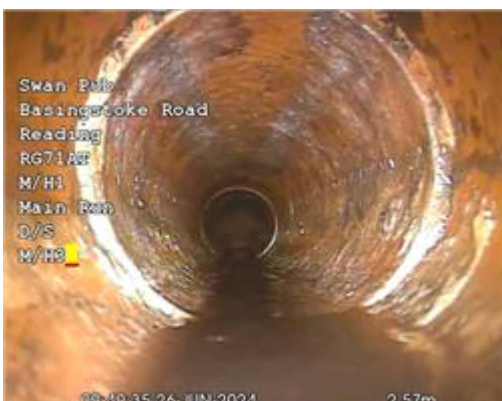
| Pos | Video Ref | Code | Description | Image |
|---|---|---|---|---|
| 02.60m | 0:00:24 | JDM | Joint displaced medium -<br>Severity 3<br>Displaced Joint identified, with<br>no evidence to suggest that<br>this is resulting in any issues at<br>present however the condition<br>of this may deteriorate over a<br>period of time. | Image Provided - Ref: 5_2<br> |

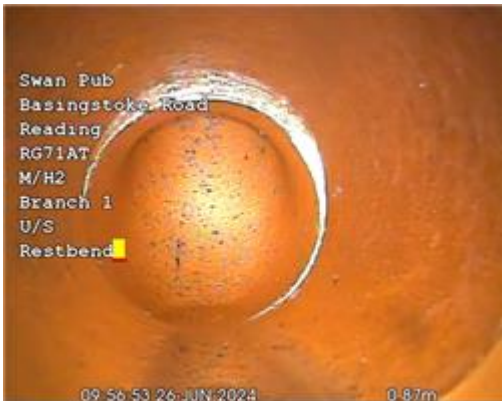
| Pos | Video Ref | Code | Description | Image |
|---|---|---|---|---|
| 00.90m | 0:00:12 | JDM | Joint displaced medium -<br>Severity 3<br>Displaced Joint identified, with<br>no evidence to suggest that<br>this is resulting in any issues at<br>present however the condition<br>of this may deteriorate over a<br>period of time. | Image Provided - Ref: 6_2<br> |

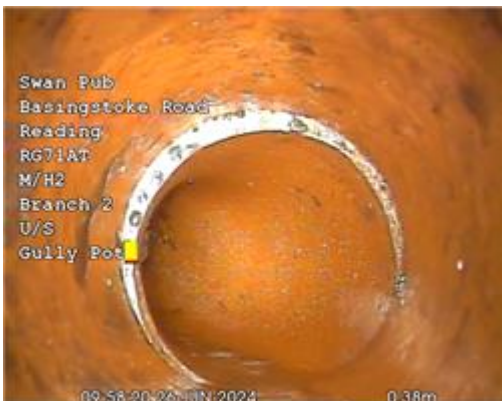
| Pos | Video Ref | Code | Description | Image |
|---|---|---|---|---|
| 00.40m | | JDM | Joint displaced medium -<br>Severity 3<br>Displaced Joint identified, with<br>no evidence to suggest that<br>this is resulting in any issues at<br>present however the condition<br>of this may deteriorate over a<br>period of time. | Image Provided - Ref: 7_1<br> |

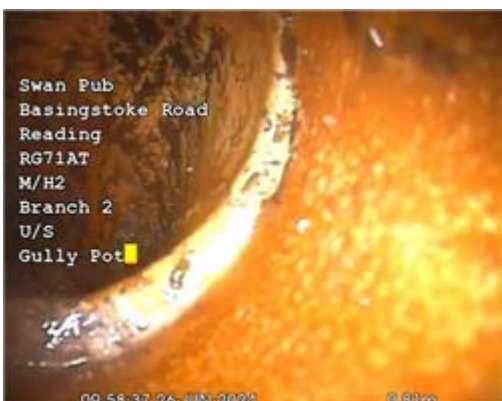
| Pos | Video Ref | Code | Description | Image |
|---|---|---|---|---|
| 00.80m | 0:00:20 | JDM | Joint displaced medium -<br>Severity 3<br>Displaced Joint identified, with<br>no evidence to suggest that<br>this is resulting in any issues at<br>present however the condition<br>of this may deteriorate over a<br>period of time. | Image Provided - Ref: 7_2<br> |

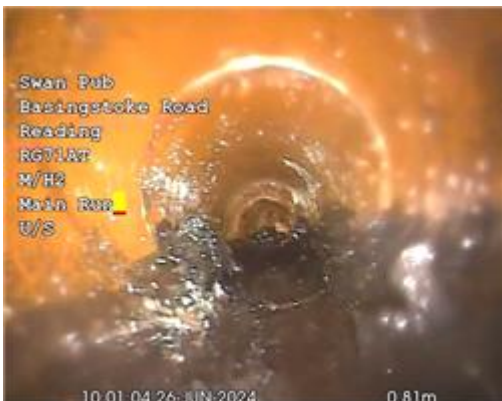
| Pos | Video Ref | Code | Description | Image |
|---|---|---|---|---|
| 00.81m | | REM | General remark<br>ADVISORY - CLEANING<br>WORKS REQUIRED AT THIS<br>LOCATION | Image Provided - Ref: 8_1<br> |

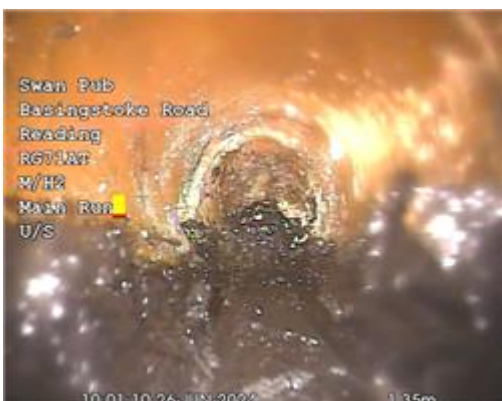
| Pos | Video Ref | Code | Description | Image |
|---|---|---|---|---|
| 01.35m | 0:00:16 | REM | General remark<br>ADVISORY - CLEANING<br>WORKS REQUIRED AT THIS<br>LOCATION | Image Provided - Ref: 8_2<br> |

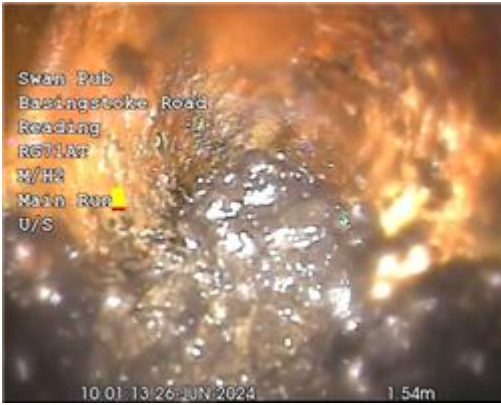
| Pos | Video Ref | Code | Description | Image |
|---|---|---|---|---|
| 01.54m | 0:00:20 | REM | General remark<br>ADVISORY - CLEANING<br>WORKS REQUIRED AT THIS<br>LOCATION | <p>Image Provided - Ref: 8_3</p> |

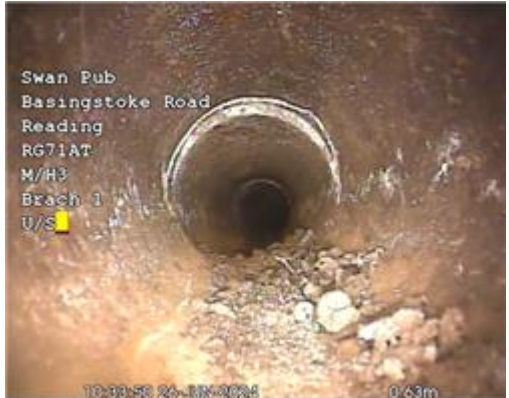
| Pos | Video Ref | Code | Description | Image |
|---|---|---|---|---|
| 00.63m | | REM | General remark<br>ADVISORY - CLEANING<br>WORKS REQUIRED | Image Provided - Ref: 9_1<br> |

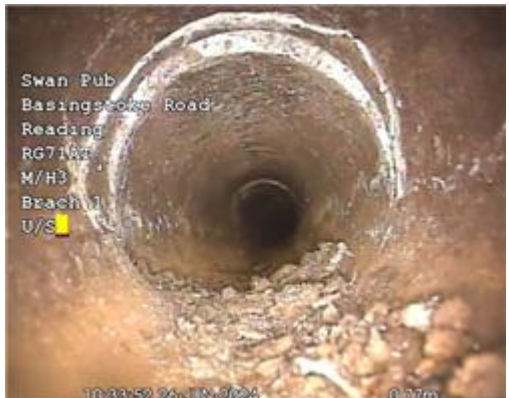
| Pos | Video Ref | Code | Description | Image |
|---|---|---|---|---|
| 00.77m | 0:00:09 | CC | Crack, circumferential -<br>Severity 1<br>CIRCUMFERENTIAL CRACK<br>FROM 9 O' CLOCK TO 3 O'<br>CLOCK | Image Provided - Ref: 9_2<br> |

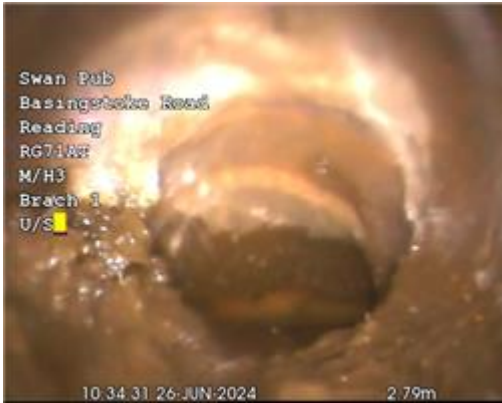
| Pos | Video Ref | Code | Description | Image |
|---|---|---|---|---|
| 02.79m | 0:00:42 | REM | General remark<br>ADVISORY - CLEANING<br>WORKS REQUIRED AT THIS<br>LOCATION | <p>Image Provided - Ref: 9_3</p> |

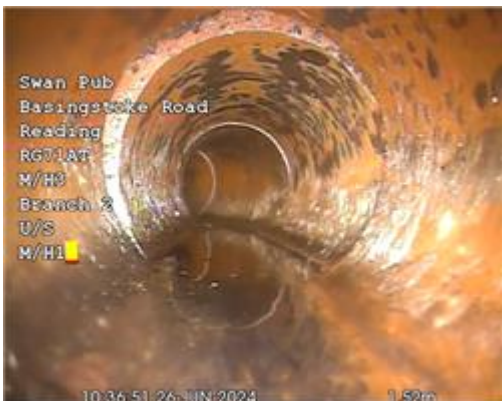
| Pos | Video Ref | Code | Description | Image |
|---|---|---|---|---|
| 01.50m | | JDM | Joint displaced medium -<br>Severity 3<br>Displaced Joint identified, with<br>no evidence to suggest that<br>this is resulting in any issues at<br>present however the condition<br>of this may deteriorate over a<br>period of time. | Image Provided - Ref: 10_1<br> |

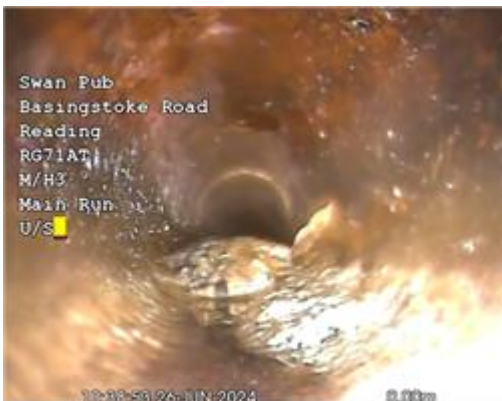
| Pos | Video Ref | Code | Description | Image |
|---|---|---|---|---|
| 00.00m | 0:00:00 | REM | General remark<br>DEPOSITS IDENTIFIED<br>THEREFORE RESTRICTING<br>FLOW | Image Provided - Ref: 11_2<br> |

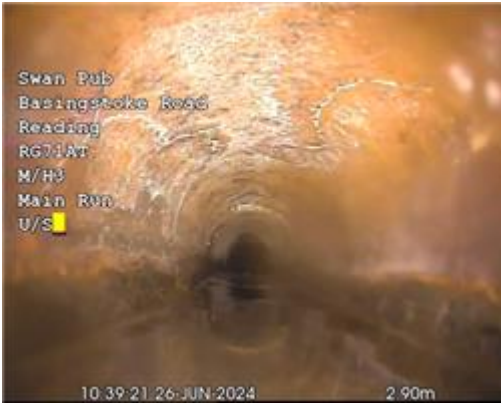
| Pos | Video Ref | Code | Description | Image |
|---|---|---|---|---|
| 02.90m | | CC | Crack, circumferential - Severity 1<br>CIRCUMFERENTIAL CRACK IDENTIFIED FROM 9 O'CLOCK TO 3 O'CLOCK | Image Provided - Ref: 11_1<br> |

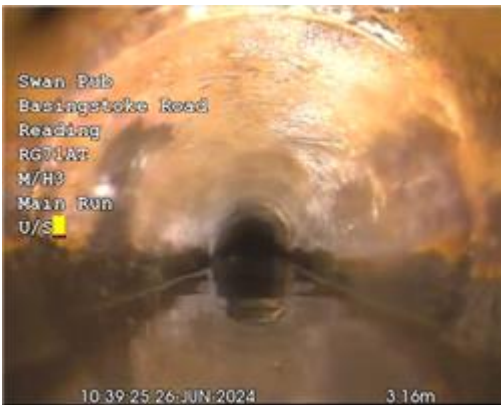
| Pos | Video Ref | Code | Description | Image |
|---|---|---|---|---|
| 03.16m | 0:00:32 | REM | General remark<br>ADVISORY - CLEANING WORKS REQUIRED | Image Provided - Ref: 11_4<br> |

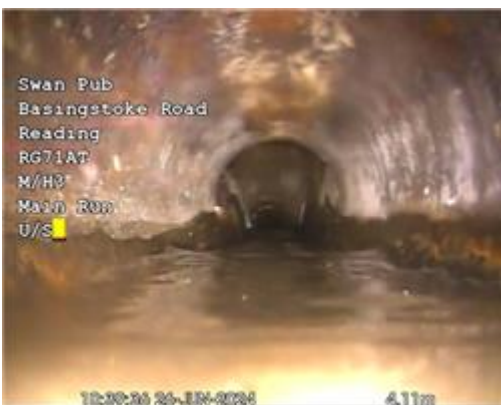
| Pos | Video Ref | Code | Description | Image |
|---|---|---|---|---|
| 04.10m | 0:00:43 | WL | Water level: 60% Height/Diameter<br>WATER RETENTION | Image Provided - Ref: 11_5<br> |

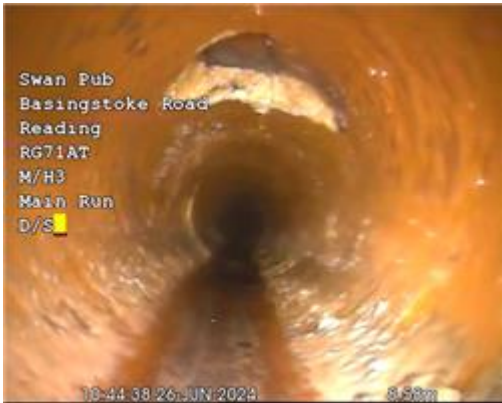
| Pos | Video Ref | Code | Description | Image |
|---|---|---|---|---|
| 08.58m | | B | Broken pipe from 11 o'clock to<br>02 o'clock - Severity 4<br>DAMAGE TO DRAIN<br>IDENTIFIED | Image Provided - Ref: 12_1<br> |

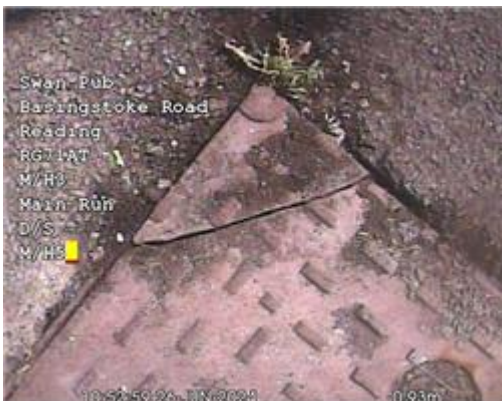
| Pos | Video Ref | Code | Description | Image |
|---|---|---|---|---|
| 00.00m | 0:00:00 | REM | General remark<br>DAMAGE TO INSPECTION<br>CHAMBER COVER | Image Provided - Ref: 13_3<br> |

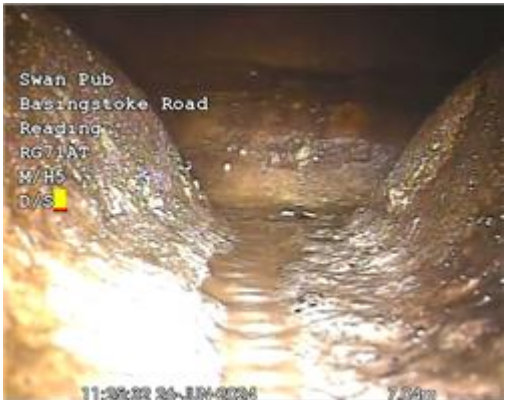
| Pos | Video Ref | Code | Description | Image |
|---|---|---|---|---|
| 07.04m | | REM | General remark<br>ADVISORY - CLEANING<br>WORKS REQUIRED | Image Provided - Ref: 15_1<br> |

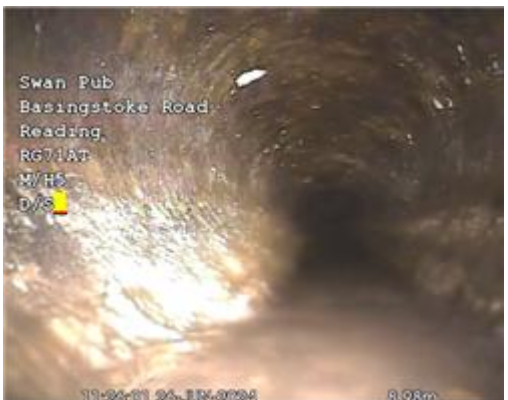
| Pos | Video Ref | Code | Description | Image |
|---|---|---|---|---|
| 08.98m | 0:01:19 | REM | General remark<br>ADVSORY - CLEANING<br>WORKS REQUIRED | Image Provided - Ref: 15_2<br> |

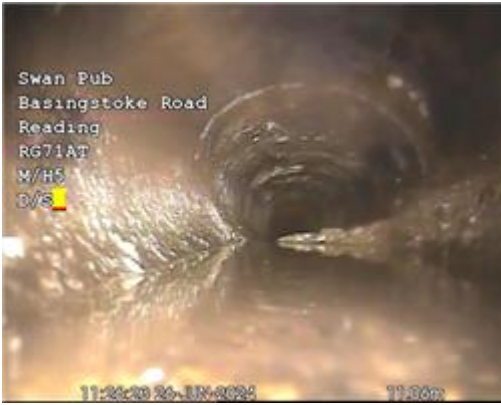
| Pos | Video Ref | Code | Description | Image |
|---|---|---|---|---|
| 11.06m | 0:01:41 | REM | General remark<br>ADVISORY - CLEANING<br>WORKS REQUIRED | <p>Image Provided - Ref: 15_3</p> |

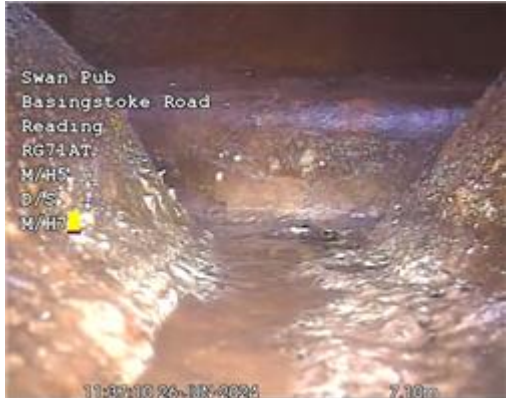
| Pos | Video Ref | Code | Description | Image |
|---|---|---|---|---|
| 07.10m | | REM | General remark<br>ADVISORY - CLEANING<br>WORKS REQUIRED | Image Provided - Ref: 16_1<br> |

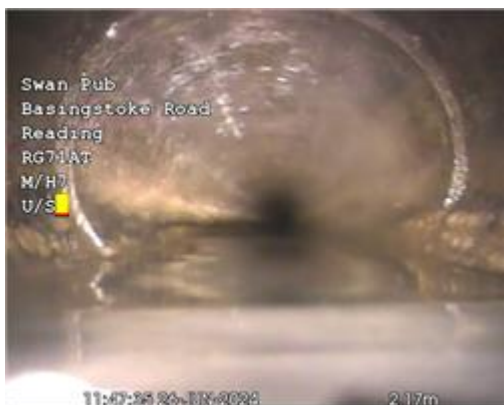
| Pos | Video Ref | Code | Description | Image |
|---|---|---|---|---|
| 02.17m | | REM | General remark<br>ADVISORY - CLEANING<br>WORKS REQUIRED | Image Provided - Ref: 17_1<br> |

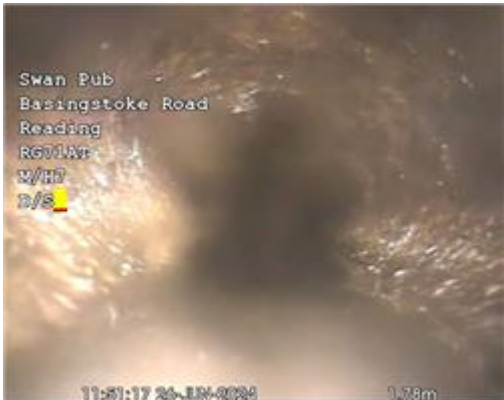
| Pos | Video Ref | Code | Description | Image |
|---|---|---|---|---|
| 01.78m | | REM | General remark<br>ADVISORY - CLEANING<br>WORKS REQUIRED | Image Provided - Ref: 18_1<br> |

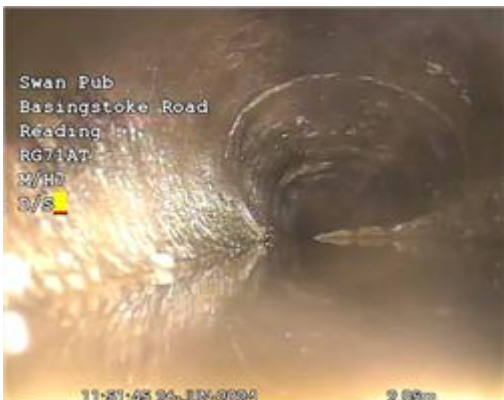
| Pos | Video Ref | Code | Description | Image |
|---|---|---|---|---|
| 02.95m | 0:00:54 | REM | General remark<br>ADVISORY - CLEANING<br>WORKS REQUIRED | Image Provided - Ref: 18_2<br> |

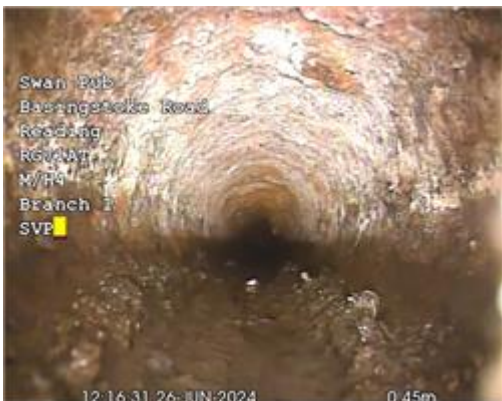
| Pos | Video Ref | Code | Description | Image |
|---|---|---|---|---|
| 00.45m | | REM | General remark<br>ADVISORY - CLEANING<br>WORKS REQUIRED | Image Provided - Ref: 19_1<br> |

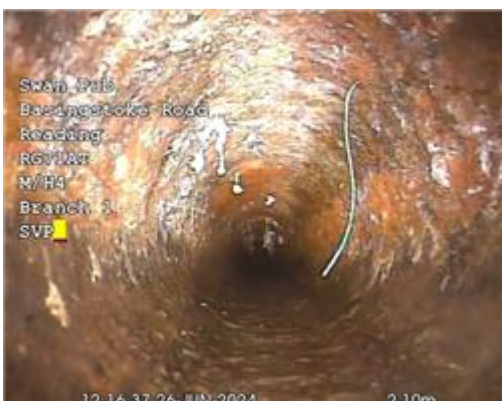
| Pos | Video Ref | Code | Description | Image |
|---|---|---|---|---|
| 02.10m | 0:00:12 | REM | General remark<br>ADVISORY - CLEANING<br>WORKS REQUIRED | Image Provided - Ref: 19_2<br> |

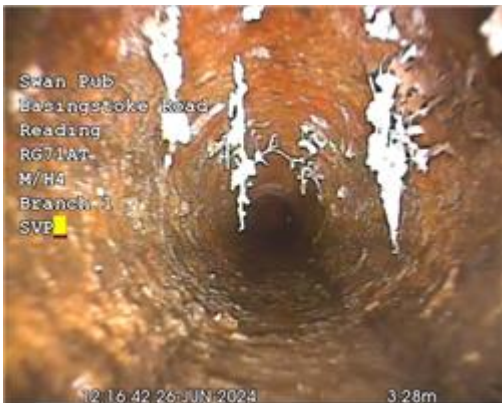
| Pos | Video Ref | Code | Description | Image |
|---|---|---|---|---|
| 03.28m | 0:00:17 | REM | General remark<br>ADVISORY - CLEANING<br>WORKS REQUIRED | Image Provided - Ref: 19_3<br> |

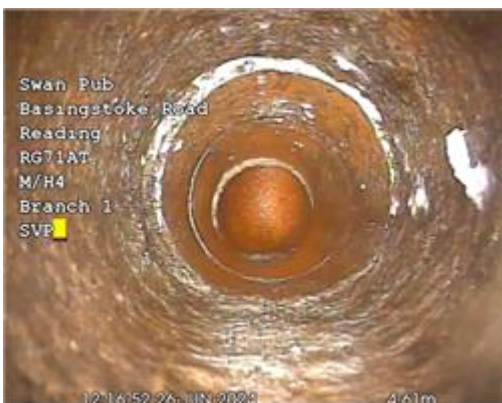
| Pos | Video Ref | Code | Description | Image |
|---|---|---|---|---|
| 04.60m | 0:00:26 | JDM | Joint displaced medium -<br>Severity 3<br>Displaced Joint identified, with<br>no evidence to suggest that<br>this is resulting in any issues at<br>present however the condition<br>of this may deteriorate over a<br>period of time. | Image Provided - Ref: 19_4<br> |

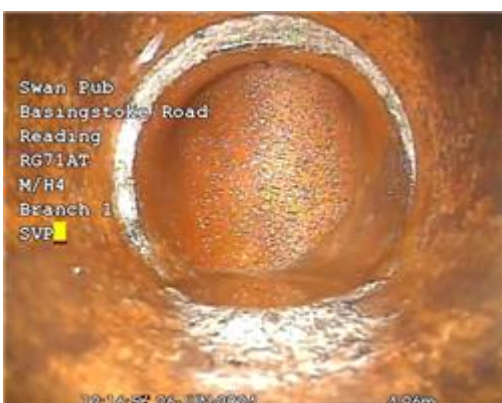
| Pos | Video Ref | Code | Description | Image |
|---|---|---|---|---|
| 05.00m | 0:00:30 | JDM | Joint displaced medium -<br>Severity 3<br>Displaced Joint identified, with<br>no evidence to suggest that<br>this is resulting in any issues at<br>present however the condition<br>of this may deteriorate over a<br>period of time. | Image Provided - Ref: 19_5<br> |

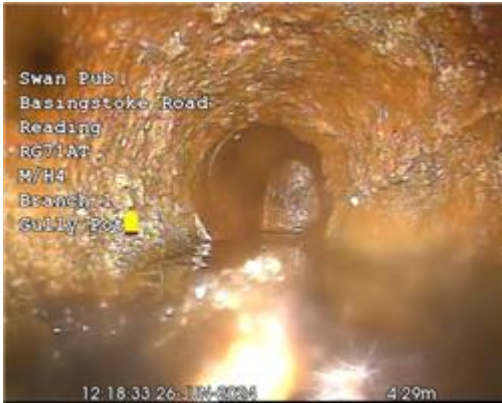
| Pos | Video Ref | Code | Description | Image |
|---|---|---|---|---|
| 04.29m | 0:00:32 | REM | General remark<br>ADVISORY - CLEANING<br>WORKS REQUIRED | <p>Image Provided - Ref: 20_3</p> <p>Swan Pub<br/>Basingstoke Road<br/>Reading<br/>RG71AT<br/>M/H4<br/>Branch 1<br/>Gully Pot</p> <p>12.18.33.26 JUN 2024 4.29m</p> |
