**Arboricultural Implications  
Assessment  
for a proposed development  
at  
The Old Thatch  
Lower Sandhurst Road  
Finchampstead  
RG40 3TH  
Rev A**

**Client: Robert & Lucy Westell  
The Old Thatch  
Lower Sandhurst Road  
Finchampstead  
RG40 3TH**

**Prepared by**  
Simon Hawkins Dip Arb L6 (ABC) N.D Arbor M. Arbor. A.

**Date**  
09/10/2025

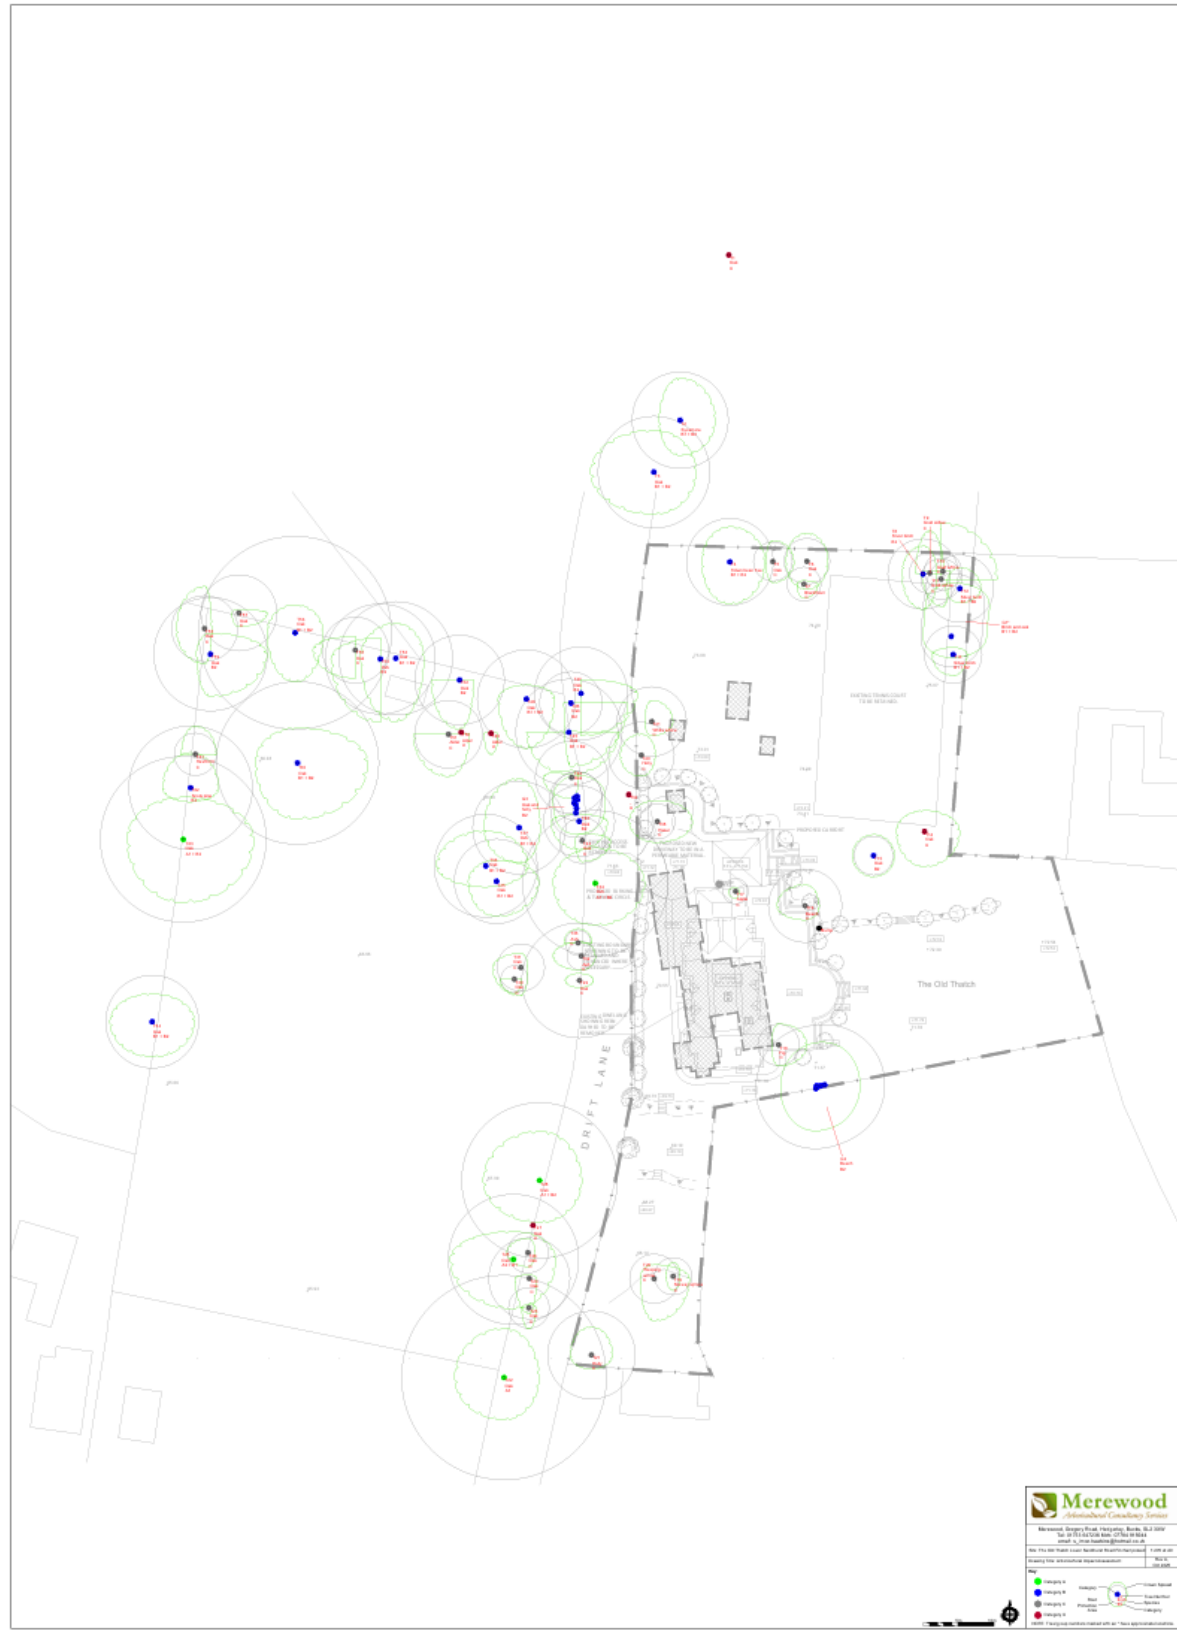
### **Impact Assessment Plan**

- 3.2.1 The proposals require the removal of a total of 5 category 'C' trees and one category 'B' group. These are T16, T17, T18, T38, T40 and G2.
- 3.2.2 In addition, dead and diseased trees with a limited life expectancy (category U) are to be removed in the interests of sound arboricultural management.

- 3.6.1 The proposed driveway takes a different shape and position to the existing driveway but would create only a very minimal impact on the RPA of the oak (T34). This conclusion is reached taking into account the existing driveway and the existing building, the footprint of which will be partly occupied by the new driveway following demolition.
