## **TREE HAZARD SURVEY**

King George's Field  
Pound Lane  
Sonning  
Berkshire  
RG4 6XE

**May 2026**

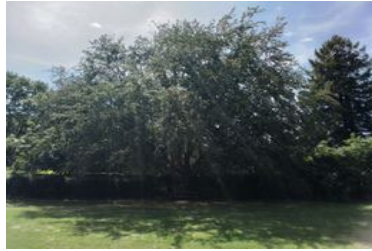
| Ref. | Species | Survey notes | Measurements | Recommendation | Work Timescale | Photo |
|---|---|---|---|---|---|---|
| T019 | Common beech<br>( <i>Fagus sylvatica</i> ) | Large, long, loaded & rubbing lateral branches over bench on north side. Light tip-reduction would be prudent for safety reasons and result in negligible visual impact. | Est height (m): 18<br>Est average crown radius (m): 12<br>Est trunk diameter (cm): 75<br>Life Stage: Mature<br>Life Exp.: 20+ Years | Tip-reduce the noted lateral branches on the north side by no more than 1.5m. Post-pruning canopy spread on the north side will be no less than 9.5m (+/- 0.5m). REASON: safety. | 28-Aug-2026<br>(3 Months) | |
