Annex D: Ground Gas Protection

Main Contractor Name: MCS		Date: 03/01/2025		
Site Name: Headley Road East, Woodley, Reading.		Temp: 8 °C		
		Installer: UK Membranes.		
Postcode: RG5 4SJ.	Surveyor: Adam McDermott (TGPV)			
Building Reference/Unit No:	Units 1,2 & 3.			
Area Inspected:	Line out to communal areas. (See Marked Up Plan).			
Description of Works:	MEC Environmental carried out a thorough inspection of the Juta GP5 gas membrane that has been laid upon a well rolled fine aggregate substrate floor to the communal areas in units 1,2 3. All membrane laps have been hand welded together using a hot air gun and rolled using a neoprene roller with pressure applied. All detailing work to the steel Stanchions, pipe penetrations, perimeter steel cladding rail and precast concrete lift pit has been successfully completed using Juta GP SAM.			
Sub-Grade Preparation:	The subgrade consists of graded coarse aggregate down to dust that has been well rolled and compacted and is acceptable to lay the membrane on

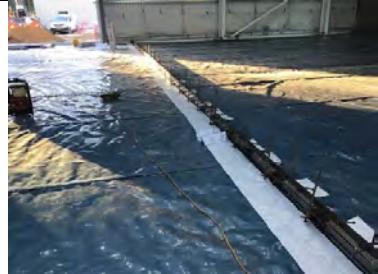
A strip of Juta GP SAM has been heat sealed to the Juta GP5 gas membrane across the armoured joint due to excessive holes found in the membrane due to follow on trades.

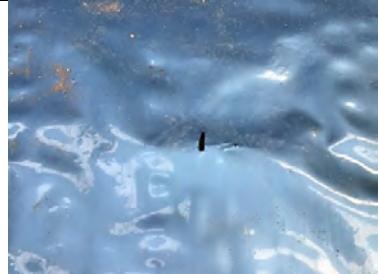
A hole found in the membrane upon our inspection.

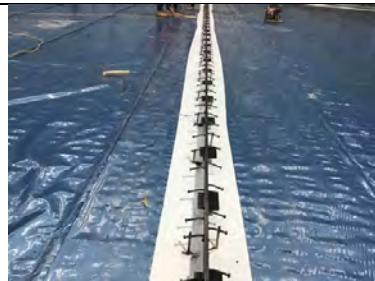
A strip of Juta GP SAM has been heat sealed to the Juta GP5 gas membrane across the armoured joint due to excessive holes found in the membrane due to follow on trades.

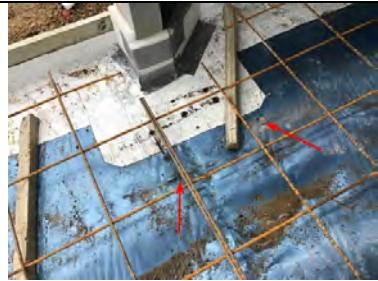
Damaged found to the membrane
upon our inspection.

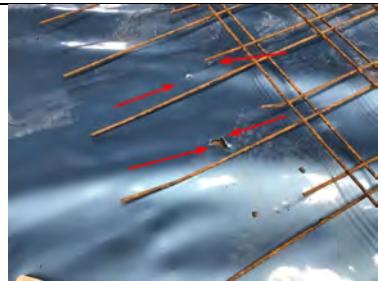
Hole found in the membrane.

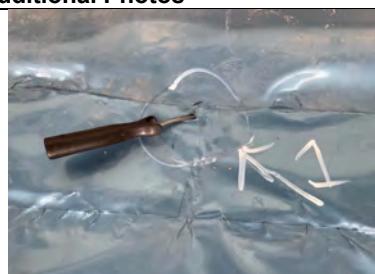
Defect recorded.

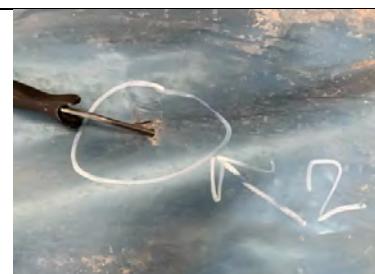
Defect recorded.

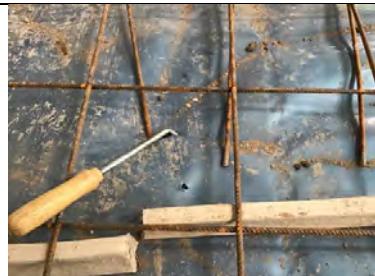
Damaged found in the membrane at the time of our inspection.
