# ARBORICULTURAL REPORT TREE SAFETY INSPECTION

A survey of trees within the grounds of  
32 Warren Road, Woodley, Reading RG5 3AR

September 2026

| SITE DETAILS | |
|---|---|
| Job Title | CAS698-Warren Road Tree Inspection, 32 Warren Road, Woodley, Reading RG5 3AR |

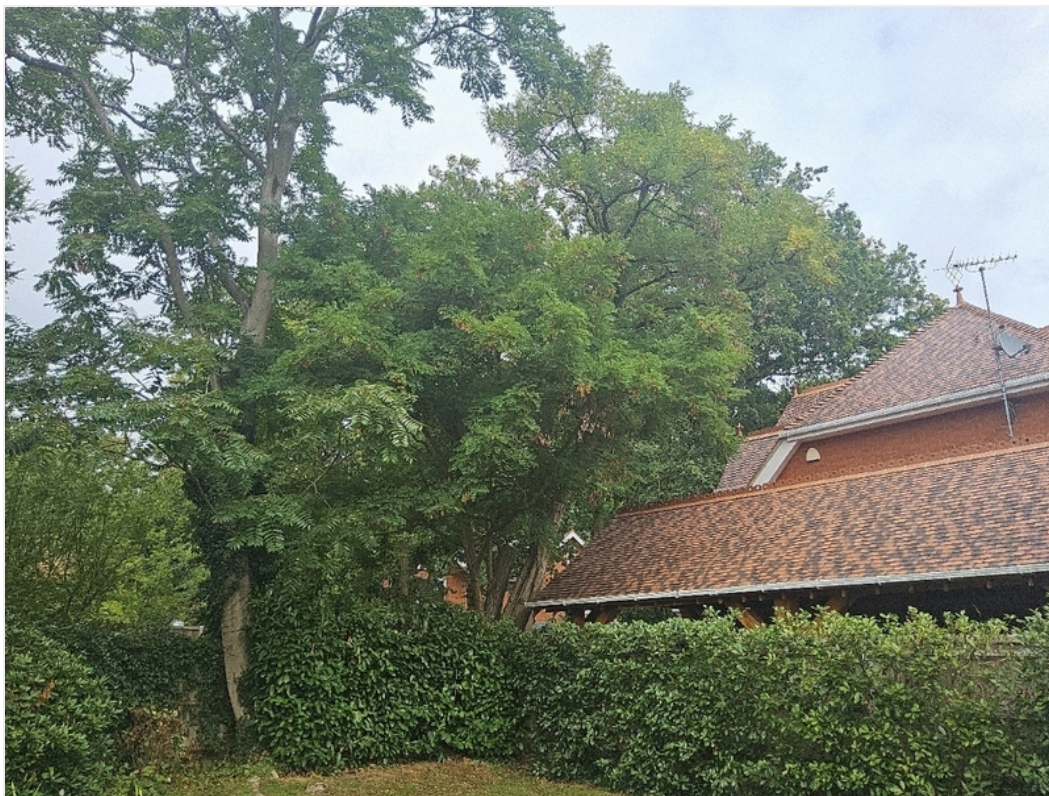
| Observations/Condition notes | <p>Weight bias to north over front of neighbouring property.<br/> Large limb removed historically.<br/> New growth circa. 1m from roof.<br/> Adaptive growth restricted on south side base.<br/> Large cavity (no decay detected) on south at base.<br/> Girdling root on tension side of base.<br/> Visible evidence of stem movement to north pushing fence post and panel significantly out of line.<br/> Movement at base due to insufficient support on tension side.</p> |

*T01 - Overview of tree (Garden of 32)*

| Tree works required | <p>Reduce tree by 30% (3-4m) to reduce load and sail weight at base.<br/> Prune to give minimum 2m clearance from building.</p> |

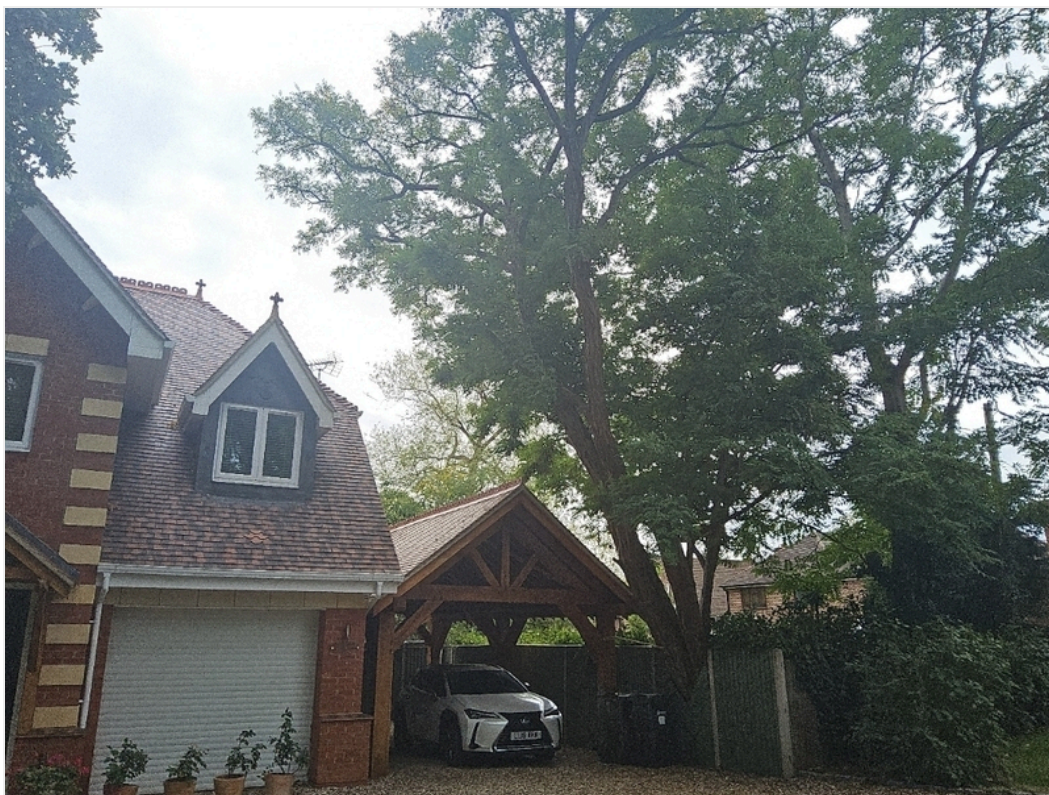
*T01 - Overview of tree (Front of 32a)*

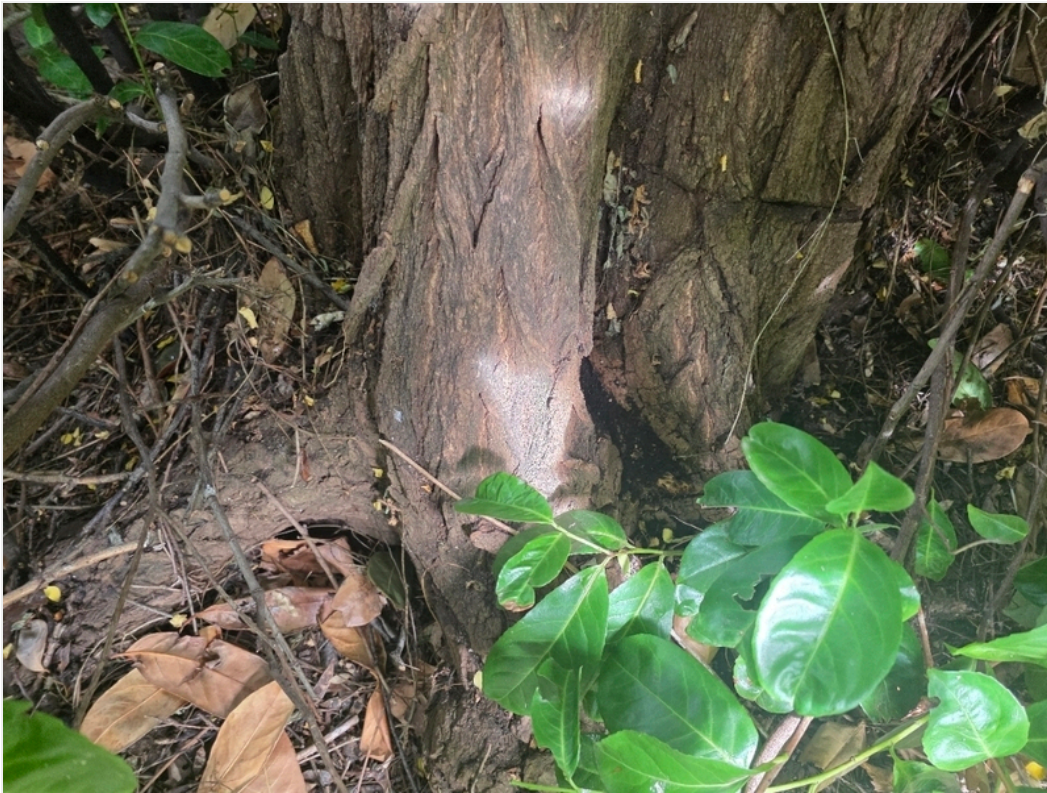
*T01 - Cavity at base restricting adaptive growth on tension side*

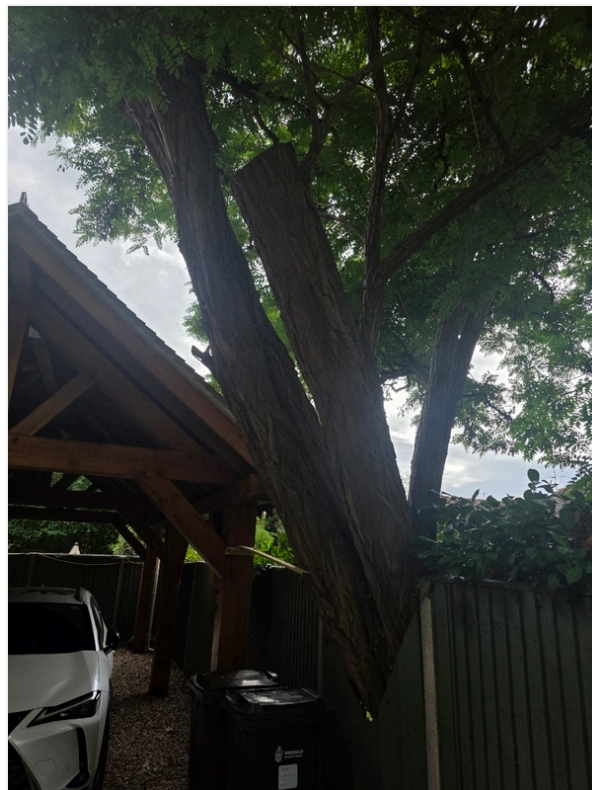
| Defects to be remediated | <p>Movement at base due to insufficient support on tension side.<br/> Early encroachment to 32a.</p> |

*T01 - Visible evidence of stem movement*

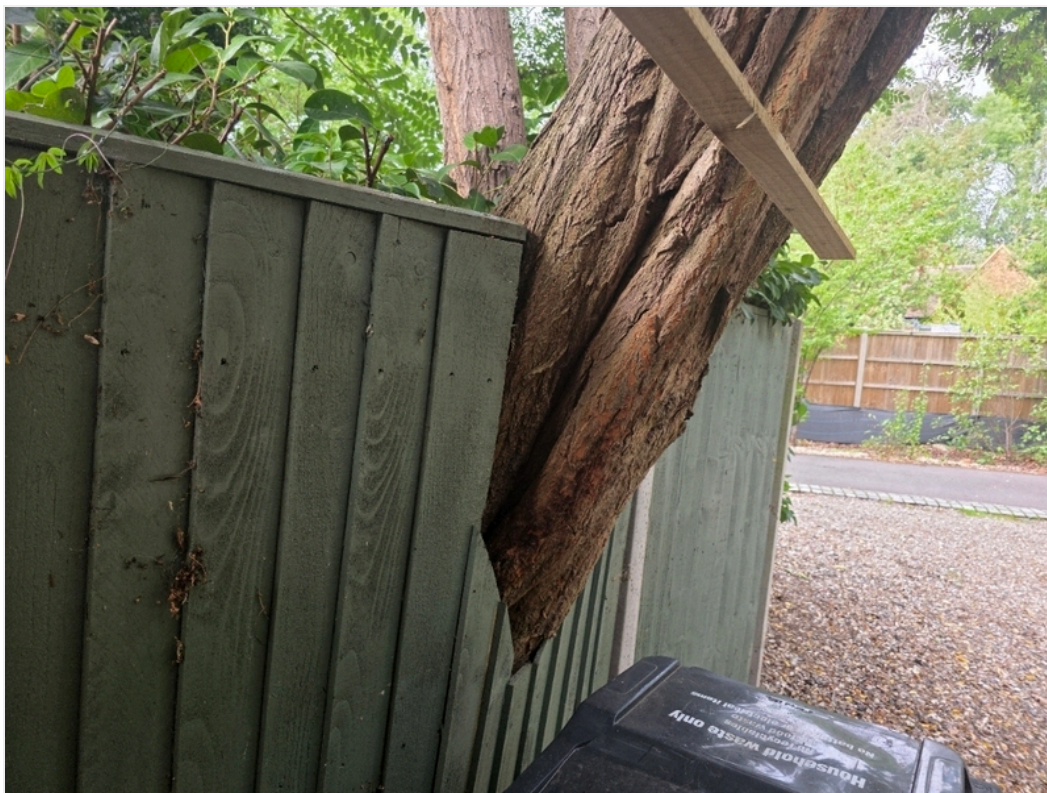
*T01 - Moving stem visibly pushing fence out of line*

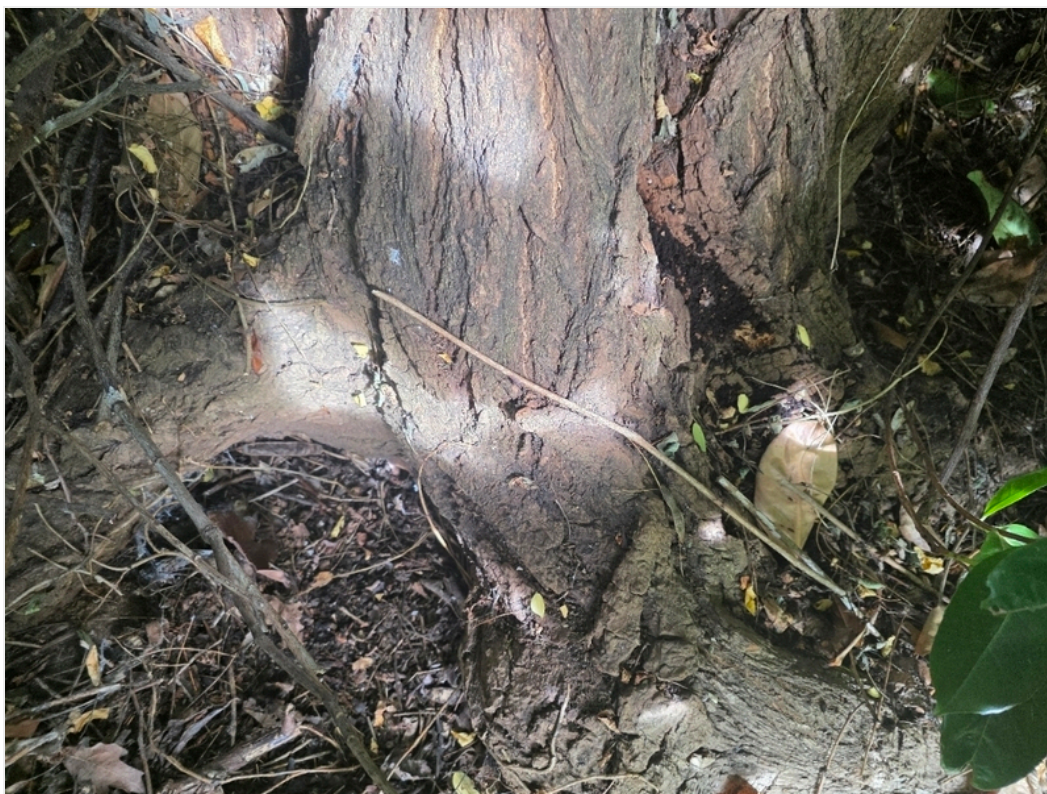
*T01 - Cavity at base (no decay detected)*

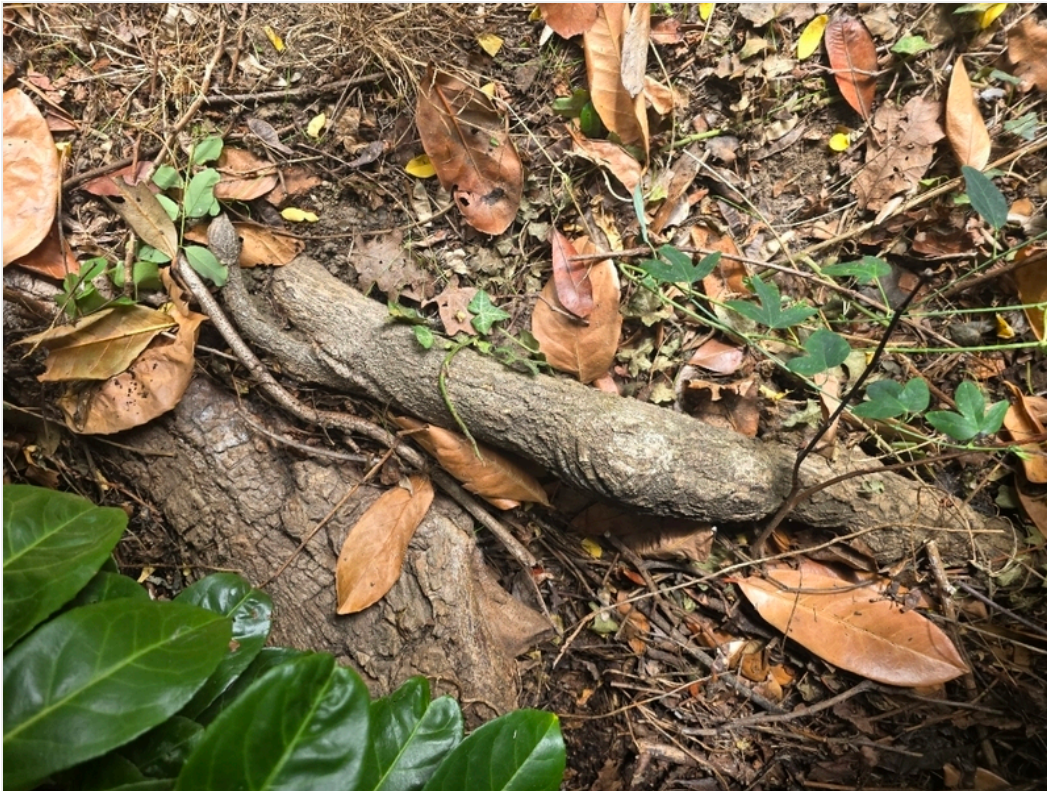
*T01 - Girdling root at tension side of base*

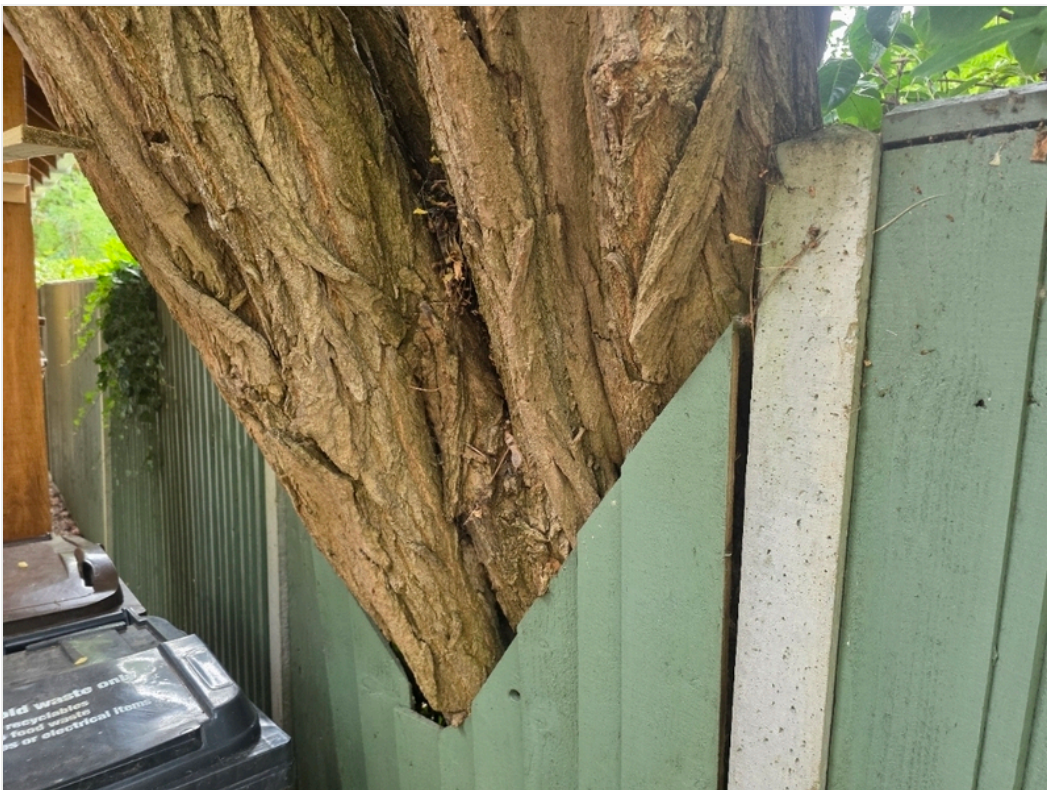
*T01 - Visible damage to fence and post*
