**KENNETH R. PAUL**  
**CONSULTING ENGINEERS**

## ENGINEERS SITE INSPECTION REPORT

**SITE:-** South Lodge  
Stanbury Park  
Wellington Court  
Spencers Wood  
Reading  
Berkshire, RG7 1BN

**JOB No.:- 15144**

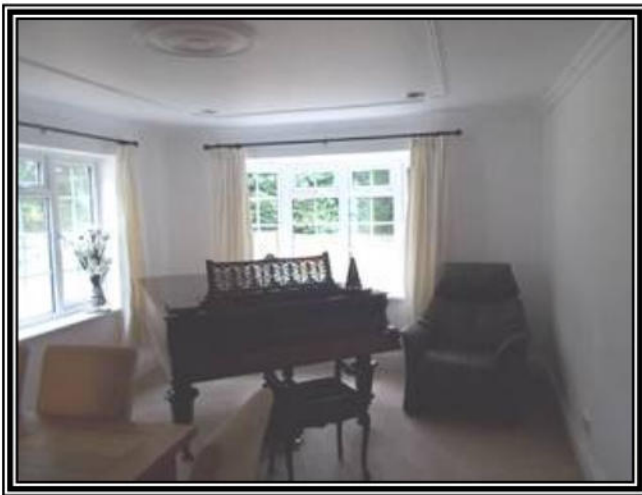
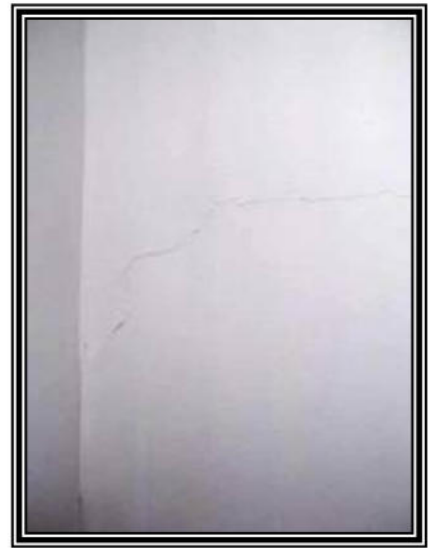
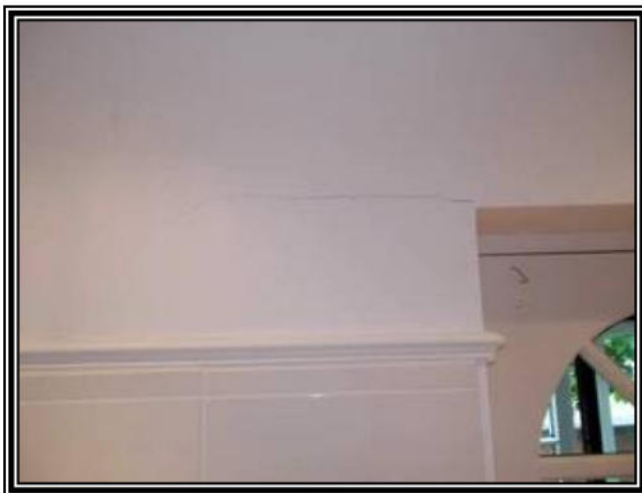
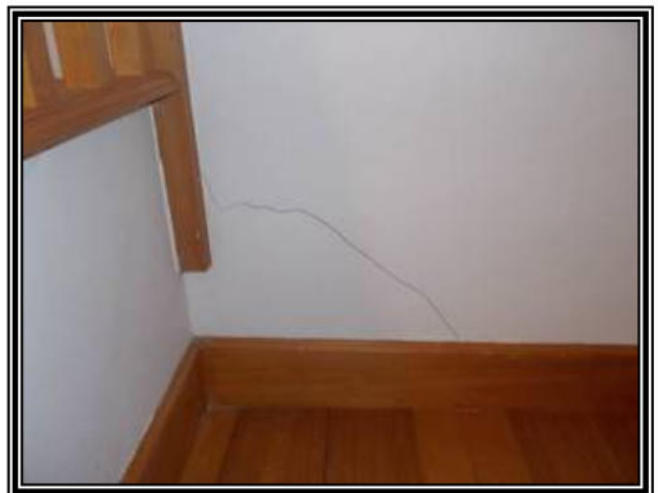
- The attached drawing indicates the site layout, together with locations where cracking was noted to the internal and external walls.
- Slight signs of movement were noted internally in several locations, and in particular to the Music / Dining Room partition walls adjacent to the Kitchen annex and adjacent to the mezzanine, the Kitchen annex wall adjacent to the Porch, and the partition between the mezzanine and Boiler Room.

- These cracks were generally not noted externally, except for a light vertical crack adjacent to the porch. This crack however had been painted over.

- 2) The cracking noted in various locations and as indicated in the attached drawing are all of a minor nature, and in the majority of instances could be attributed to one or a combination of shrinkage cracking and differential material movement. As the last repairs were carried out in 2010, we presume these 'new' cracks have all appeared since that time.

- d) The cracking to the internal walls particularly in the Music / Dining Room area should be investigated further by initially carrying out a monitoring exercise to check for progressive movement, followed by appropriate remedial works, preferably via stitching using masonry reinforcement. The monitoring should also include the floor slab and gap evident below the Bedroom skirting.
- e) It is likely that the 102mm thick brick boundary wall will need partial reconstruction, possibly on new foundations. Cracks in other boundary and retaining wall locations could be re-stitched or movement joints incorporated.
- f) We also recommend the below ground drainage around the building be checked via CCTV survey.

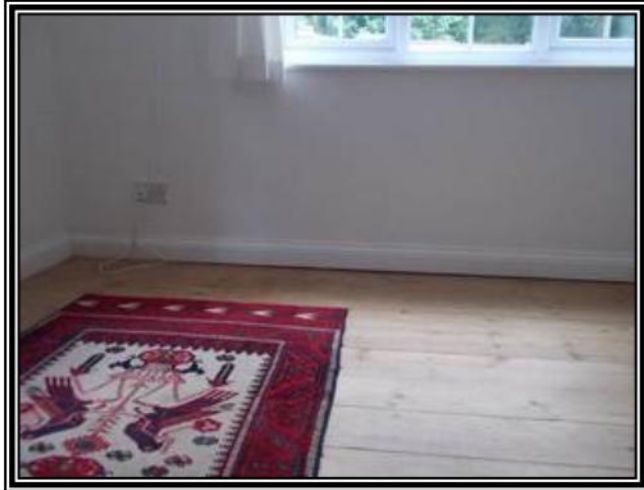
- Walls generally appear to be plumb and bed joints level. Floors also appear to be reasonably level and without gaps below skirting's except to the skirting in the North West corner bedroom, which showed a slight gap.

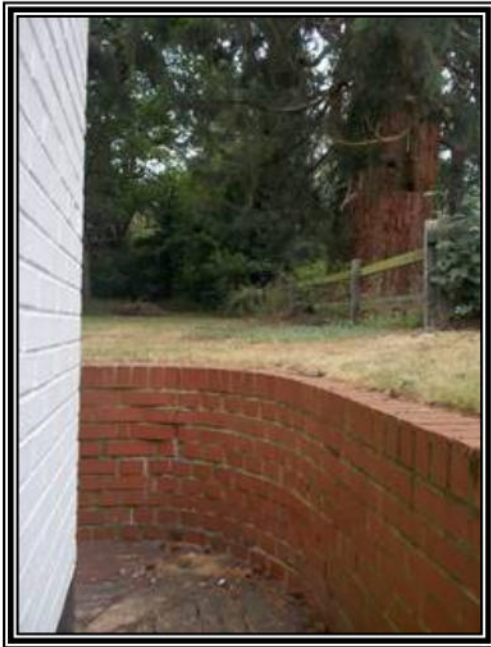
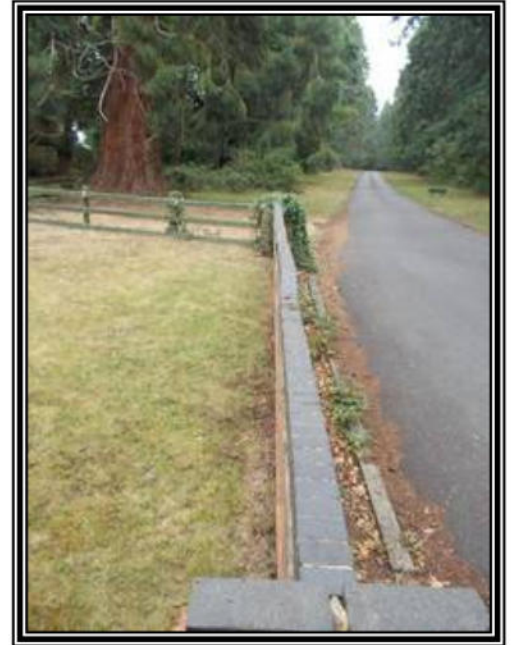
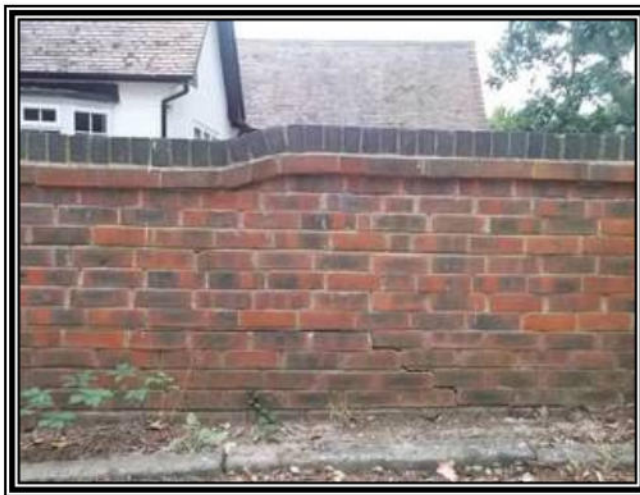
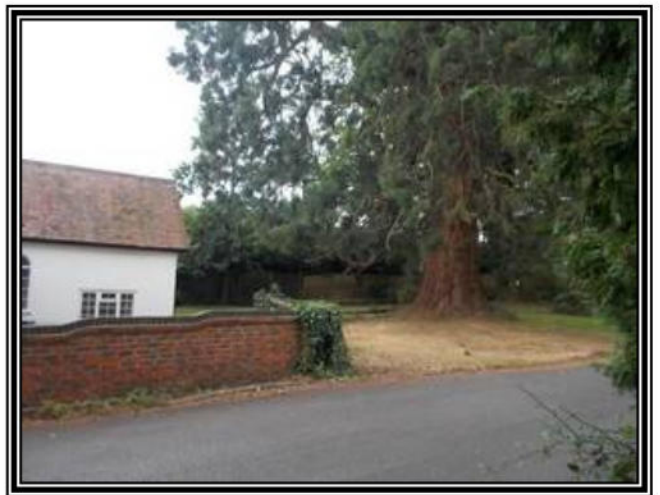
- Cracking was also noted to the curved section of retaining wall nearest to the giant Redwood, and also to the brickwork boundary walls, particularly the 102mm thick pierced wall nearest to the giant Redwood.

- b) A copy of the underpinning warranty should be obtained.
  - c) It has already been established that the giant Redwood cannot be removed, however to reduce the risk of further movement as a result of moisture abstraction by other nearby trees, we suggest that trees nearest to the house are either removed or regularly maintained at a height not greater than their distance from the building. Arboricultural advice should be sought particularly with respect to potential heave following removal of these trees.

Details of the previously installed root barrier should be obtained if possible and consideration given to installing a further more effective root barrier. We recommend that Arboricultural advice first be sought with regard to the extent of the root protection area, and therefore the location, depth and form of construction of the root barrier.
