## **ARBORICULTURAL REPORT AND SITE INVESTIGATION AT SOUTH LODGE**

**South Lodge  
Wellington Court  
Spencers Wood  
Berkshire  
RG7 1BN**

**30<sup>th</sup> June 2015**

**Ref: AS/BL/TS-01/30.06**

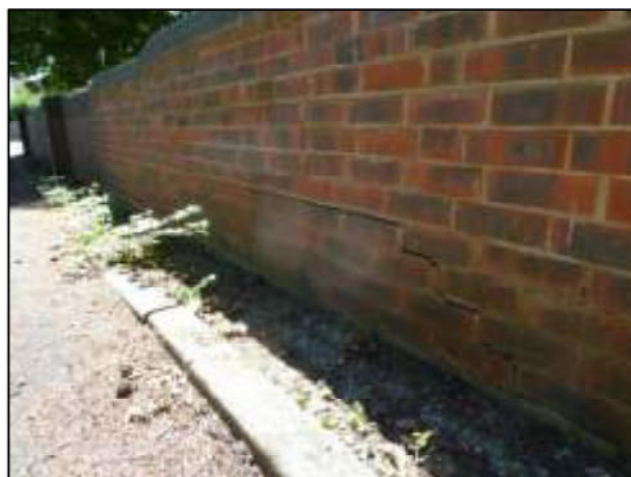
- 4.3 The retaining wall adjacent to Tree 2 is distressed and cracking was observed close to ground level and in a vertical axis.

Photograph 1:  
Cracking at base of wall,  
South Lodge. 30.6.2015.

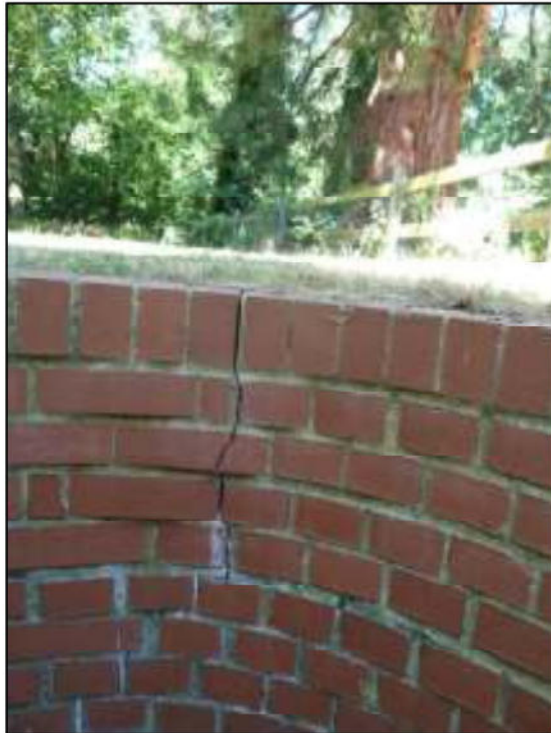
Photograph 2: Vertical crack, north west side, South Lodge, 30.6.2015.
