# BS5837:2012

## Tree Survey

Grove Service Station  
Old Bath Road, Charvil  
Reading, RG10 9QJ

Report reference: TGA.2688.TreeSurvey

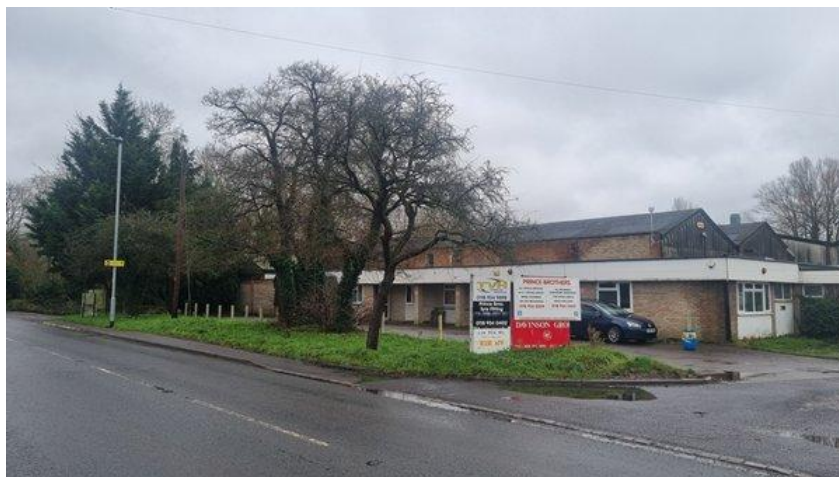
**Trees on site frontage T1 – T10**

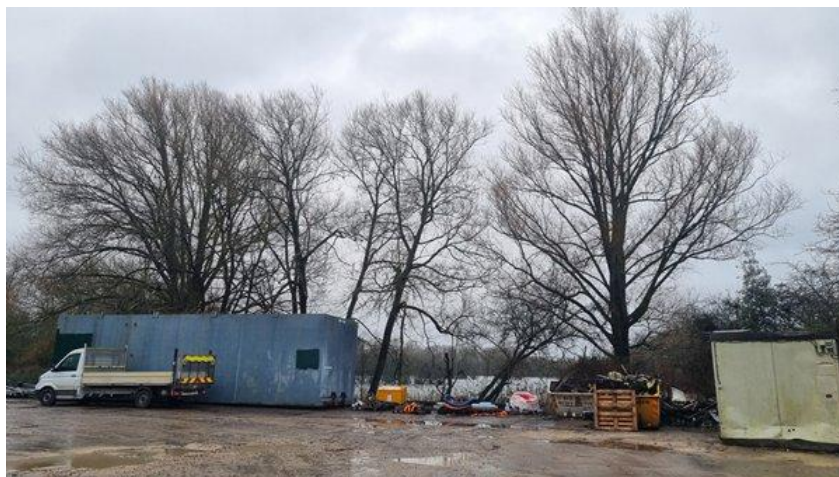
**Offsite trees to south of site T14 – T20**

| No. | Species | Ht<br>(crown) | Dia<br>(stems) | Crown spread<br>(NESW) | Life<br>stage | ERC | Comments & preliminary<br>recommendations | BS<br>Cat |
|---|---|---|---|---|---|---|---|---|
| T15 | Salix alba (White Willow) | 21(4) | 390,<br>380,<br>400(3) | 7.5, 7.5, 7.5, 7.5 | M | 20+ | Multi stem from ground level. Deadwood in crown. Offsite tree. Rooted in area of wet ground. Northern stem leans at an unsustainable angle into site. Recommend this is reduced by 50% of height to boundary line to reduce risk of collapse. | C2 |
| T17 | Salix alba (White Willow) | 21(4) | 300,<br>400(2) | 7.5, 7.5, 7.5, 7.5 | M | 20+ | Twin stem from ground level. Stem inaccessible diameter estimated. Deadwood in crown. Offsite tree. Rooted in area of wet ground. Northern stem leans at an unsustainable angle into site. Recommend this is reduced to boundary line to reduce risk of collapse. | C2 |

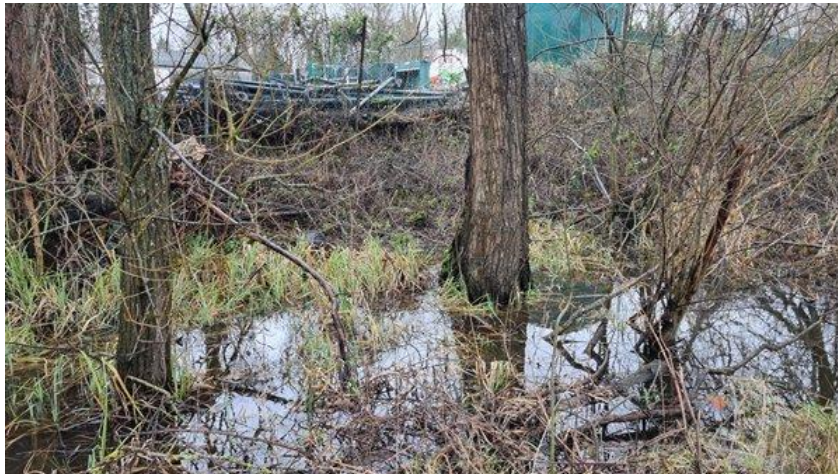
**Offsite trees to south at lower level to site within  
waterlogged ground**

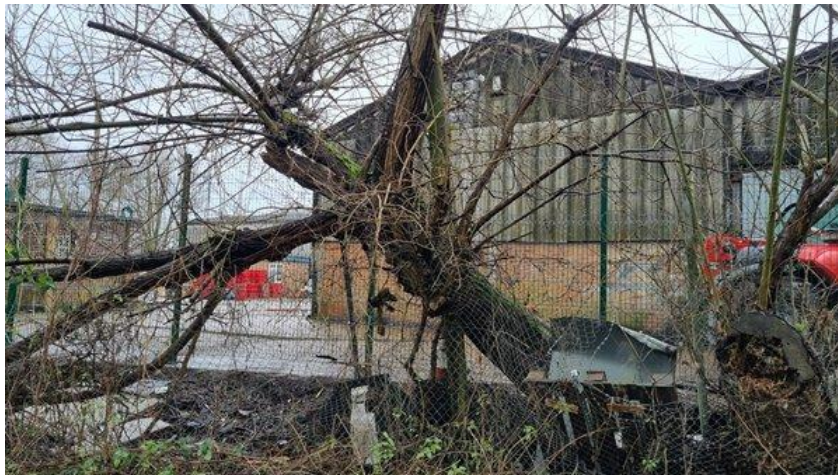
**Collapsed U category tree T32**

| No. | Species | Ht<br>(crown) | Dia<br>(stems) | Crown spread<br>(NESW) | Life<br>stage | ERC | Comments & preliminary<br>recommendations | BS<br>Cat |
|---|---|---|---|---|---|---|---|---|
| T32 | Salix caprea (Goat Willow) | 13(1) | 500(1) | 4, 4, 8, 4 | M | <10 | Located between two fences diameter estimated. Main stem leans at 45 degrees from past collapse. Top of main stem cut off and a few former side branches now form crown. Poor quality and not suitable for retention. Removal recommended. | U |

- 4.4. U category trees are in such a condition that they are unlikely to contribute beyond 10 years, and may be removed as good arboricultural practice.

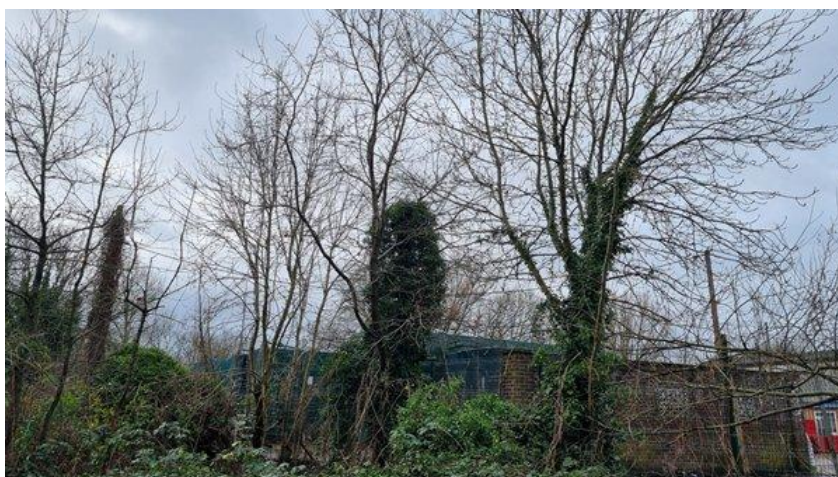
**Self-seeded ash trees on eastern boundary**

| No. | Species | Ht (crown) | Dia (stems) | Crown spread (NESW) | Life stage | ERC | Comments & preliminary recommendations | BS Cat |
|---|---|---|---|---|---|---|---|---|
| T26 | Fraxinus excelsior (Ash) | 10(3) | 300(1) | 4, 4, 4, 4 | EM | 10+ | Limited life expectancy due to Ash dieback disease. Ivy throughout crown. Self-seeded between shed and chain link fence. Stem diameter estimated due to fence | C2 |
| T28 | Fraxinus excelsior (Ash) | 10(3) | 190, 120, 120(3) | 3, 3, 3, 3 | SM | 10+ | Limited life expectancy due to Ash dieback disease. Consistent with having self-seeded. Low quality and not a development constraint. Multi-stem with two stems absorbed into chain link fence. | C2 |

| No. | Species | Ht<br>(crown) | Dia<br>(stems) | Crown spread<br>(NESW) | Life<br>stage | ERC | Comments & preliminary<br>recommendations | BS<br>Cat |
|---|---|---|---|---|---|---|---|---|
| T31 | Fraxinus excelsior (Ash) | 10(3) | 250(1) | 3, 3, 3, 3 | SM | 10+ | Limited life expectancy due to Ash dieback disease. Consistent with having self-seeded. Stem diameter estimated. Ivy throughout crown. Low quality and not a development constraint. | C2 |
| T33 | Fraxinus excelsior (Ash) | 10(3) | 250(1) | 1, 0, 3, 3 | SM | <10 | Limited life expectancy due to Ash dieback disease. Consistent with having self-seeded. Stem diameter estimated. Low quality and not a development constraint. Previously topped at 3m. Stems absorbed in chain link fence. Not suitable for retention. | U |
