## Tree Inspection and Description of Works

**Site:** 65 Hilmanton, Lower Earley, RG6 4HN

**Tree Reference:** T5 (Ash) - TPO 672/1994

**Ref:** ASHT5\_2026

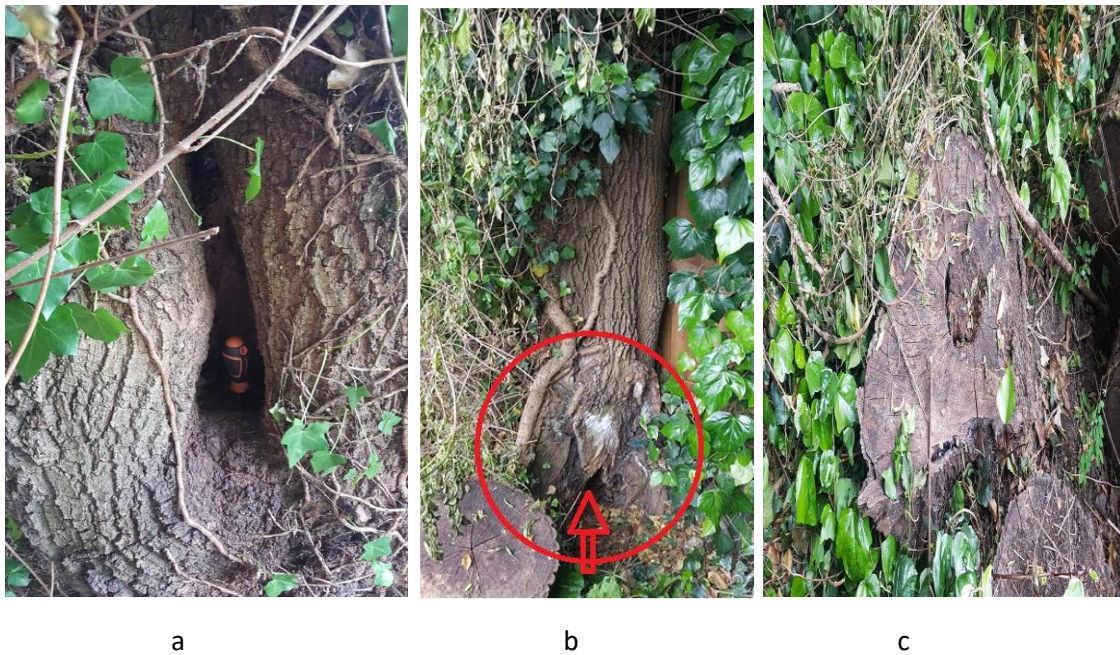
Figure 2:

At that time, the arborist identified significant defects (Figures 2 in the Appendix) and recommended the tree be removed, but the previous owner advised retaining the tree as a reduced "monolith" (approx. 6–8m height) to preserve habitat value. This advice was followed, and the tree has been managed as a standing habitat feature since then (Please see Historic Tree Works Applications: 202248 ref: 05386 / 2020).

- **Extensive Basal Decay:** The report noted a "central column of decay" and a large wound at the base.
- **Deep Cavities:** At the time of the survey, a metal probe could be inserted over 500mm upwards into the cavity under the tree, and 400mm downwards into a wound on the south side.
- **Root Plate Instability:** The report confirmed the base was "undermined" by the previous failure and bark inclusion.

- a) Cavity on the south side with metal probe (2020 Inspection)
- b) Basal wound and cavity (2020 Inspection)
- c) Cross-section of wood from fallen trunks (2020 Inspection)

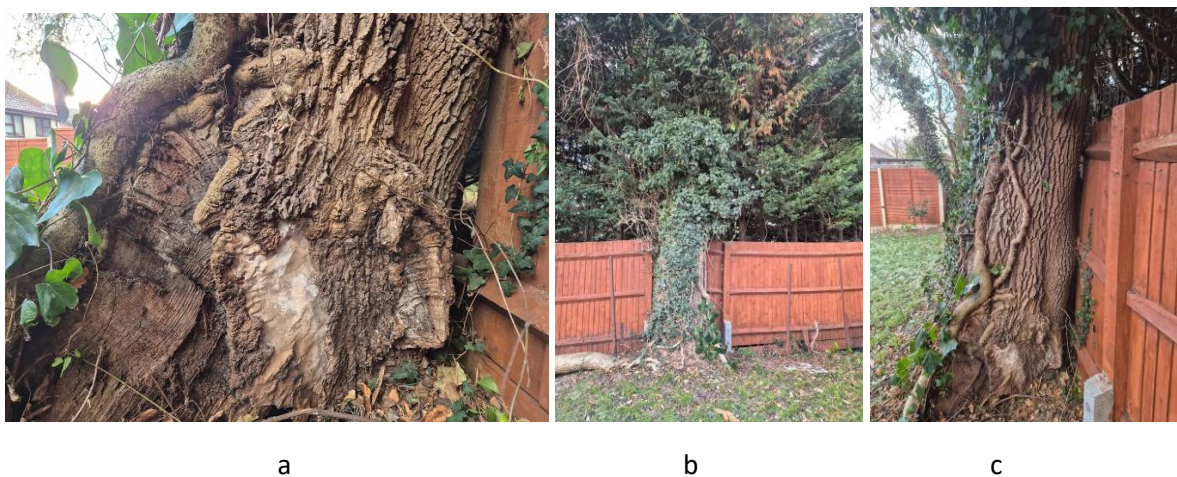
Figure 3:

The tree has been looked at in detail recently using the Visual Tree Assessment. While the reduction to a monolith initially mitigated the safety risk, the basal decay identified in the 2020 report has continued to spread (Figures 3 in the Appendix), as was predicted by the specialist. The structural integrity of the remaining stump is now severely compromised, and I believe complete removal is necessary to prevent an uncontrolled collapse.

The specialist explicitly warned that "decay is expected to progress within the tree's base over time further weakening the tree. This progression has now reached a point where retaining the monolith is no longer safe.

- a) Current Basal wound and cavity (2026 Inspection)
- b) Current tree canopy and vine (2026 Inspection)
- c) Current lean of the tree (2026 Inspection)

Complete removal is necessary to prevent an uncontrolled collapse.
