# Tree Surveys

**Re: Oaks to the rear of The Hawthorns, Charvil – Visual Inspection and Decay Detection.**

Thank you for your instructions to carry a visual inspection and decay detection as may be required upon two oak trees on land to the rear of The Hawthorns, Charvil, RG10 9TS.

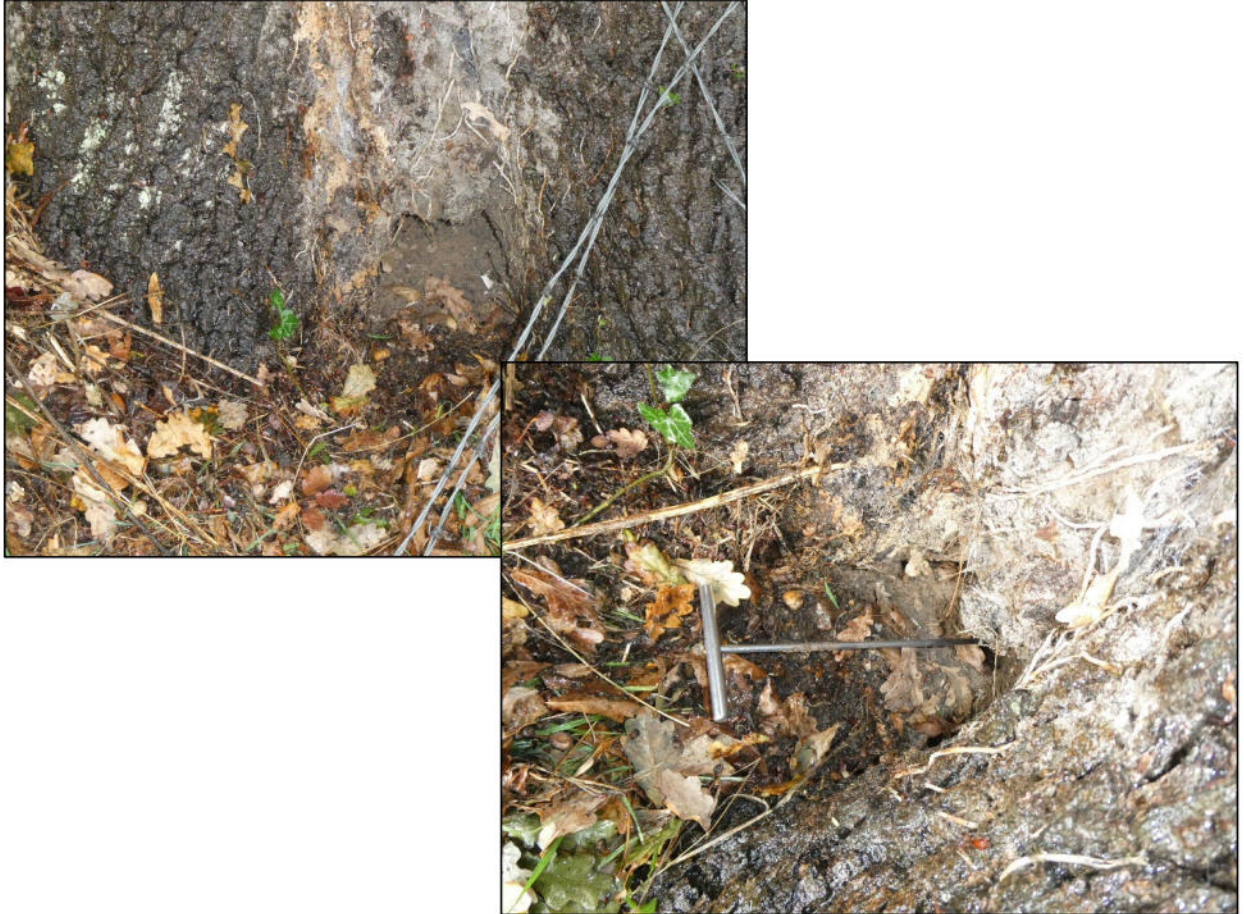
**Tree 1** is 9.6 metres from the adjacent property, see the location plan above. There is evidence of decay and dead bark at the base of the main stem and between the buttressing on the east, south and west sides of the stem. A cavity was observed on the southeast side. We tested the cavity with a stainless-steel probe recording a depth of 40cm. Further probing was conducted between the buttressing, and we detected the early signs of decay on the west and east sides below the root collar, see examples at Figure 2 on page 3.

Figure 2. Small cavity southeast side, Oak 1, with example of stainless probe, 20.10.25

We conducted decay detection as a result of the visual inspection using the IML PD400 Resi drill. The testing was conducted close to ground level on the cardinal points with one control test at 1.5 metres above ground level (AGL) on the south side, copies of the tests result are included with this letter.

A total of 5 tests were undertaken, and a cavity was detected between 12 and 26cm before the needle auto retracted, as a result of the cavity. No further cavities or advanced decay was detected at the test locations; copies of the results are included with this letter.

Tree 1: Remove all deadwood over 50 millimetres diameter. Conduct a visual re-inspection in July 2026 and monitor the physiological and structural condition annually for further decline and conduct a further decay detection test in 3 years.

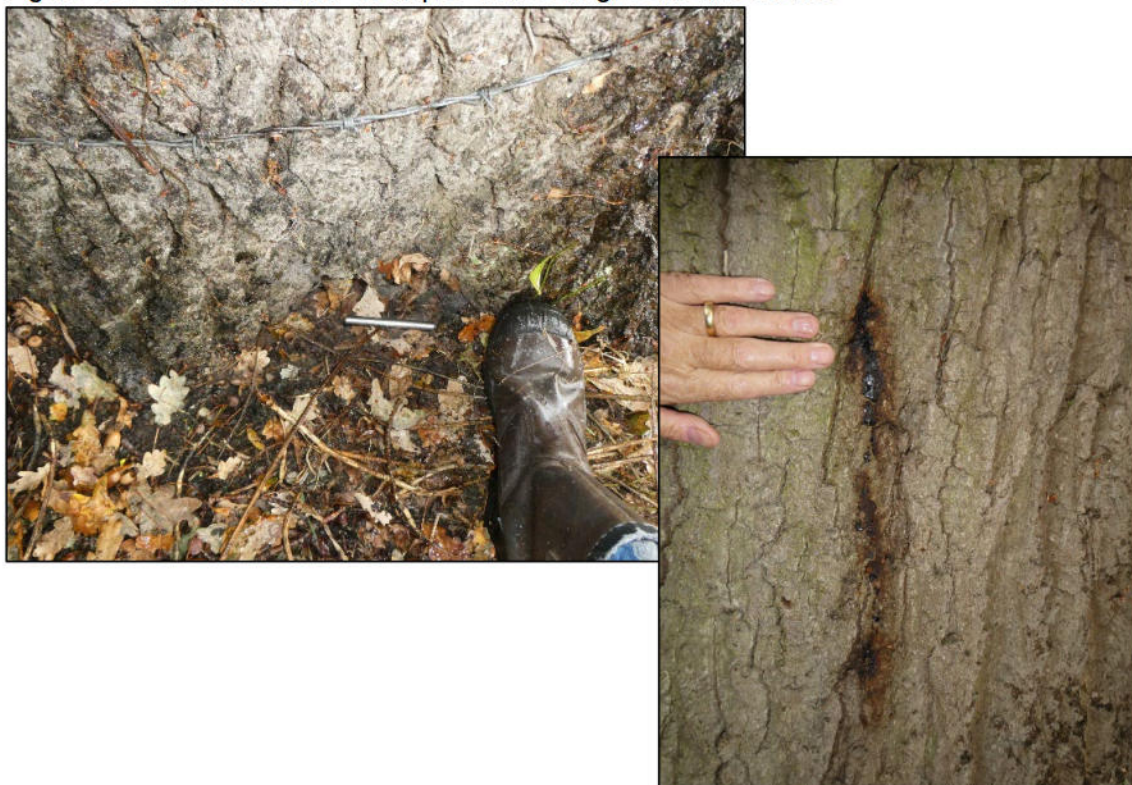
The main stem has barbed wire ingrown into the bark and an area of bleeding bark was observed on the southwest side, see Figure 3 on page 4.

Figure 3. Barbed wire and example of bleeding, Oak 1, 20.10.25

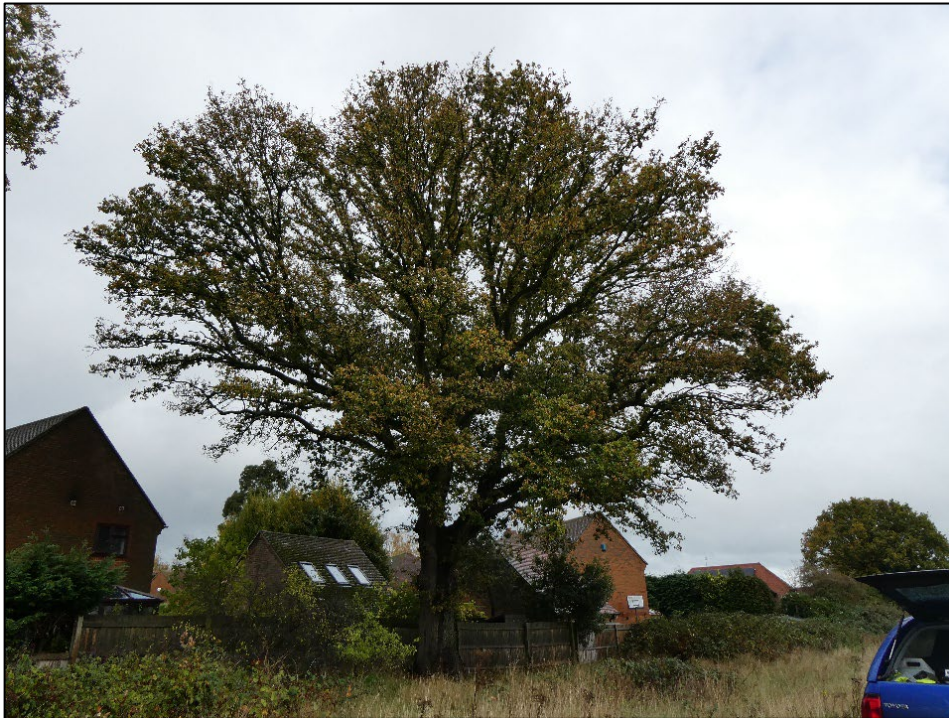
The canopy is broadly symmetrical with minor deadwood visible in the upper canopy. We assessed the physiological indicators of tree health, including leaf size, leaf density, chlorophyll content, incremental growth and fruit/seed production. The tree exhibits poor leaf density and the autumn colouration skewed the visual indication of chlorophyll content, with leaf density low and overall poor physiological appearance, see Figure 4 on page 4.

Figure 4. Oak 1, canopy appearance, 20.10.25

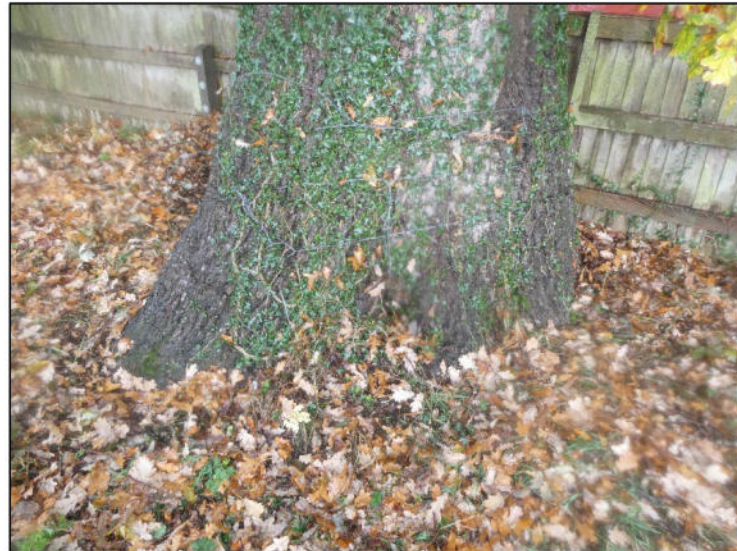
The tree is approximately 16 metres from the rear of 11 The Hawthorns, Charvil, see the location plan on page 2. The base of the stem has barbed wire entwined around it and broad buttressing on the south side (see Figure 5 on page 5) and two small cavities between the buttressing, that were examined with a stainless-steel probe, see Figure 6 on page 5.

Figure 5. Oak 2, buttressing, 20.10.2025

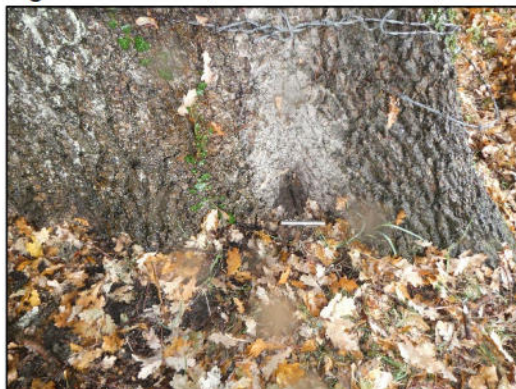
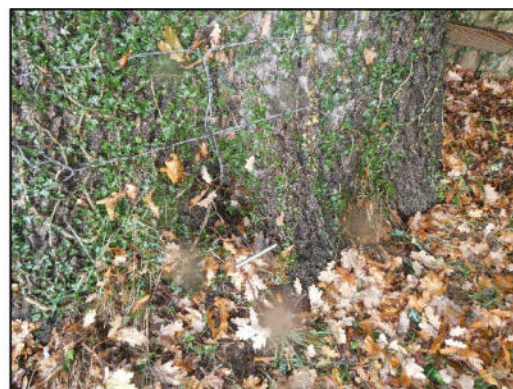
Figure 6. Oak 2, buttress cavities, 20.10.25

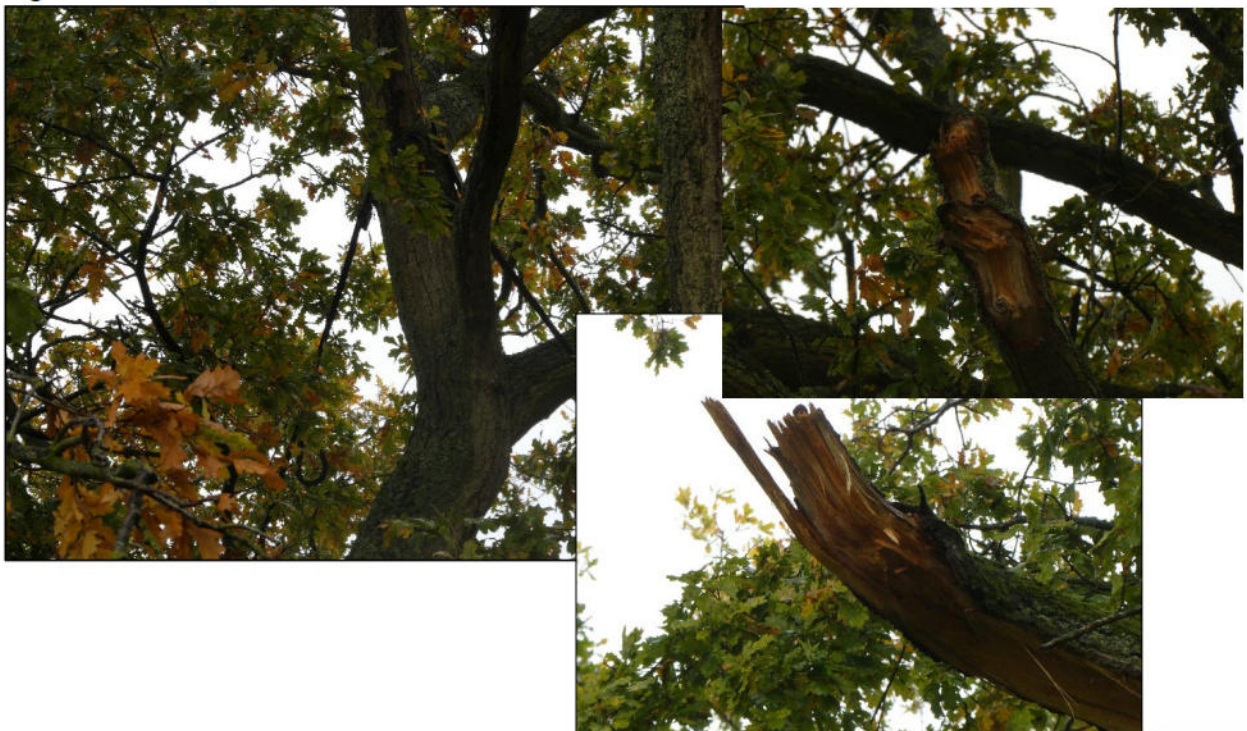
The canopy is broadly symmetrical, with significant regrowth from the reduction pruning locations. Two non-invasive braces have been installed in the north side of the upper canopy and following the failure of a lateral limb on the east side several branch stubs are visible see examples at Figure 7 on page 5.

Figure 7. Oak 2, non-invasive brace and branch stubs 20.10.25

We examined the failure locations with binoculars and a sample of the failed branch on the ground. There was no evidence of decay and no obvious structural defects such as included branch unions.

The failure of lateral branches is not uncommon in some tree species. With no obvious structural defect or decay the most probable cause is branch drop sometimes referred to as summer branch drop (SBD), a sudden and unexpected dropping of branches often without warning. Typically occurring during warm, humid weather, particularly in late spring or summer often exacerbated by drought or heavy rainfall.

Regular tree inspections and maintenance can help identify weak branches. The numerous tight unions associated with the regrowth following the crown reduction provide structural weakness that may result in premature limb failure. The risk associated with the potential limb failure requires remedial pruning that would be in accordance with arboricultural best practice.

Tree 2: Carry out a selective crown reduction of the lateral limbs previously reduced. The reduction should where possible follow similar locations as undertaken in 2017 and be undertaken within 12 months of the date of this report.

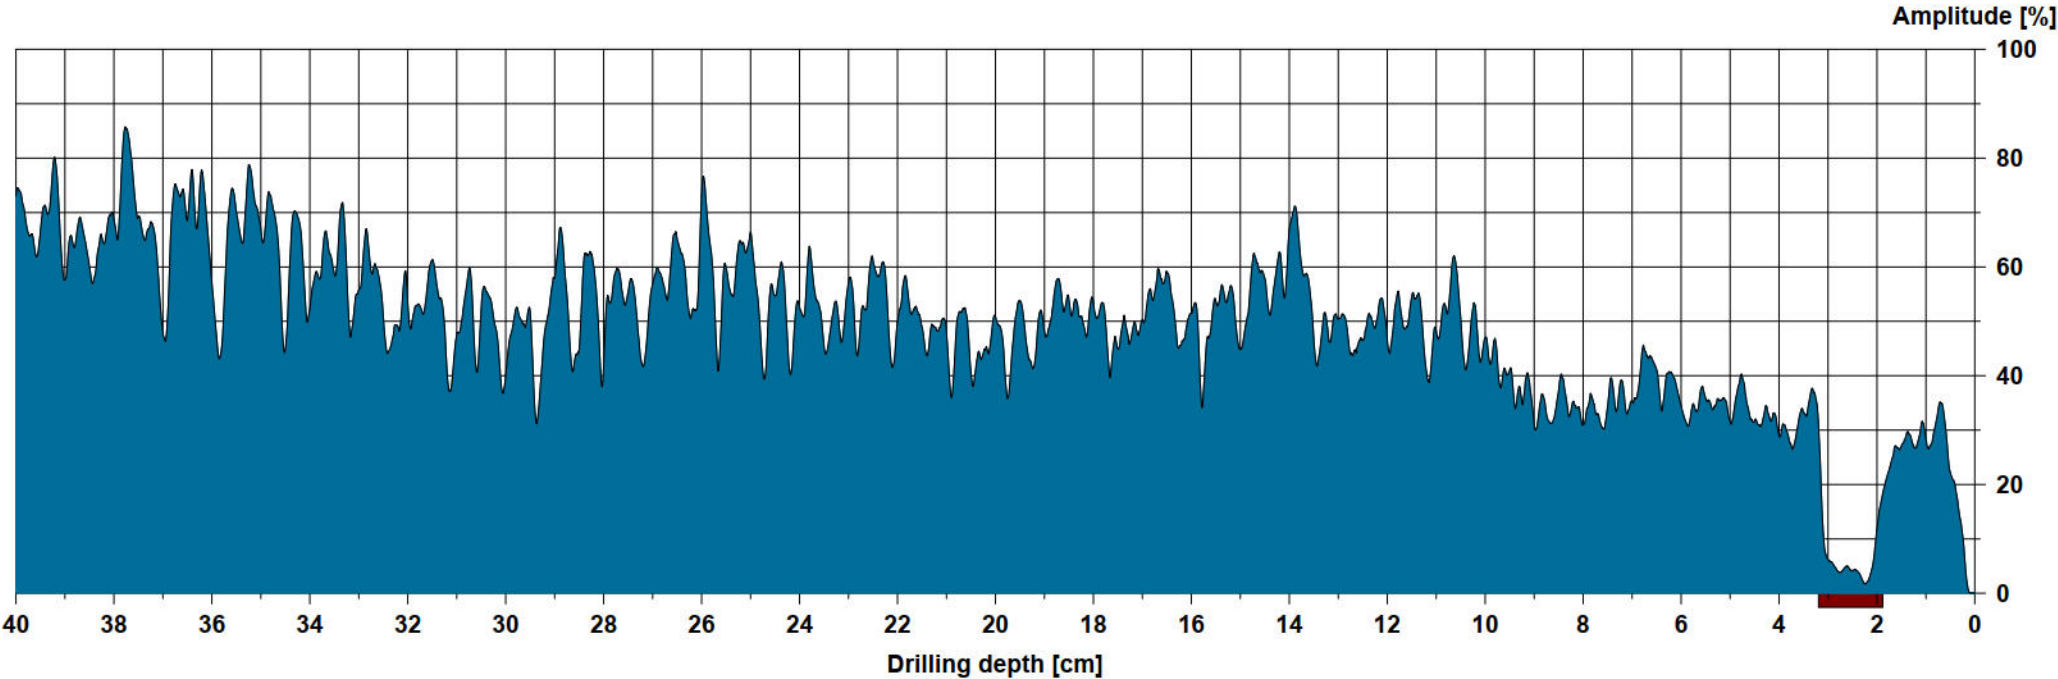
From 1,88 cm to 3,19 cm : Decay

Test at circa 1.5m above ground level south side. Isolated area of decay at 2cm. No significant decay detected at the test location.

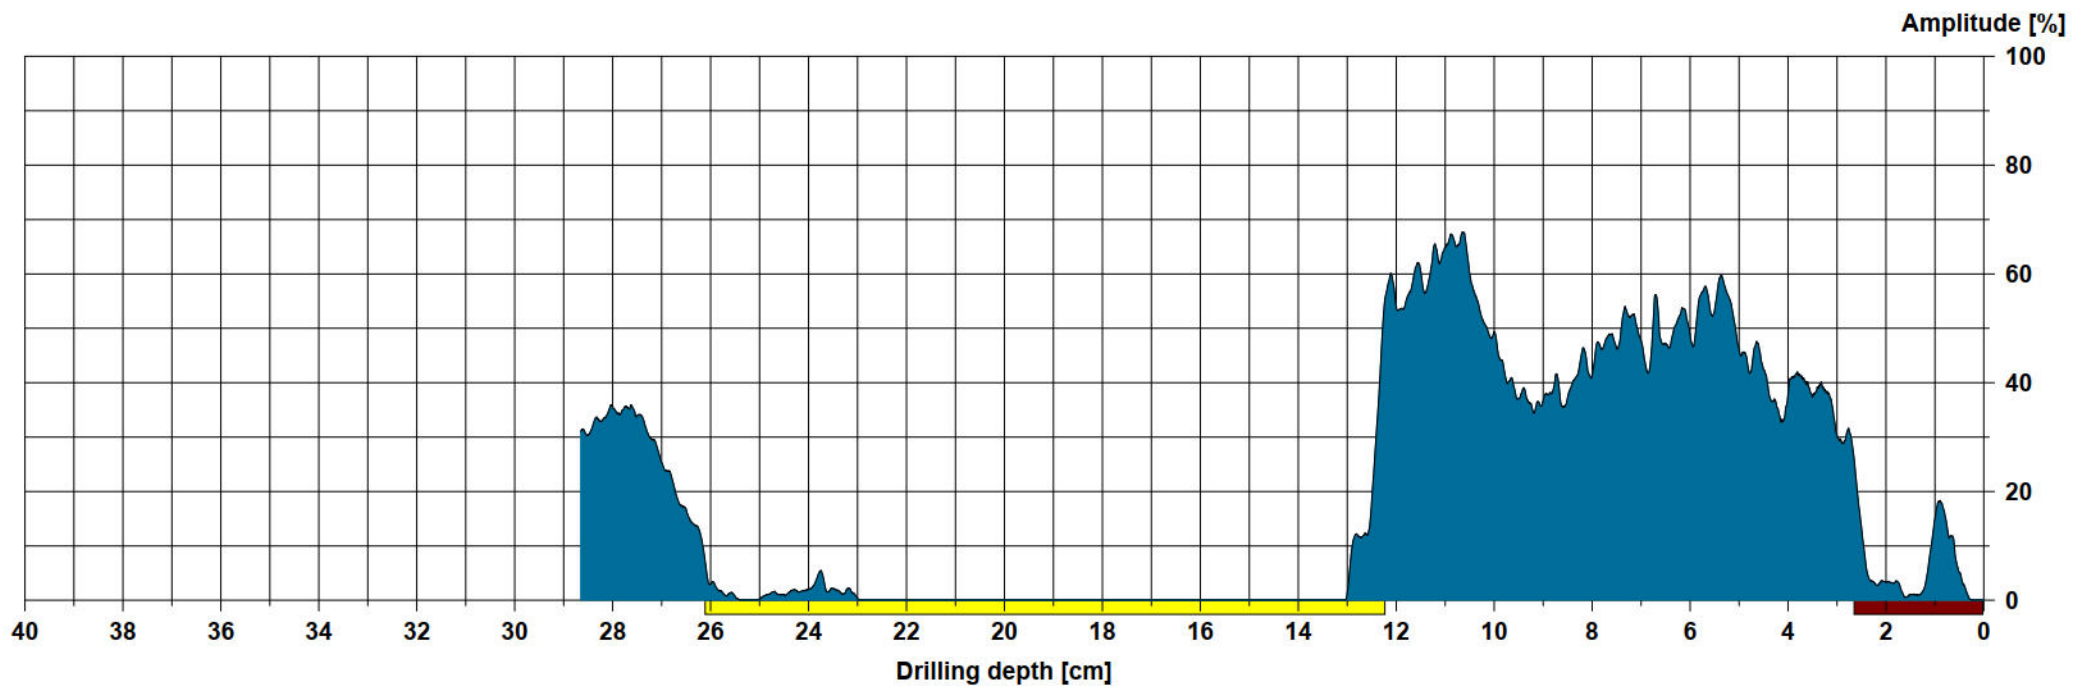
From 0,02 cm to 2,65 cm : Decay  
From 12,23 cm to 26,11 cm : Cavity

Test at circa 10cm above ground level east side. Decay detected behind the bark to 2.5cm and a cavity was detected at 13cm. The needle auto retracted at 29cm due to the cavity.

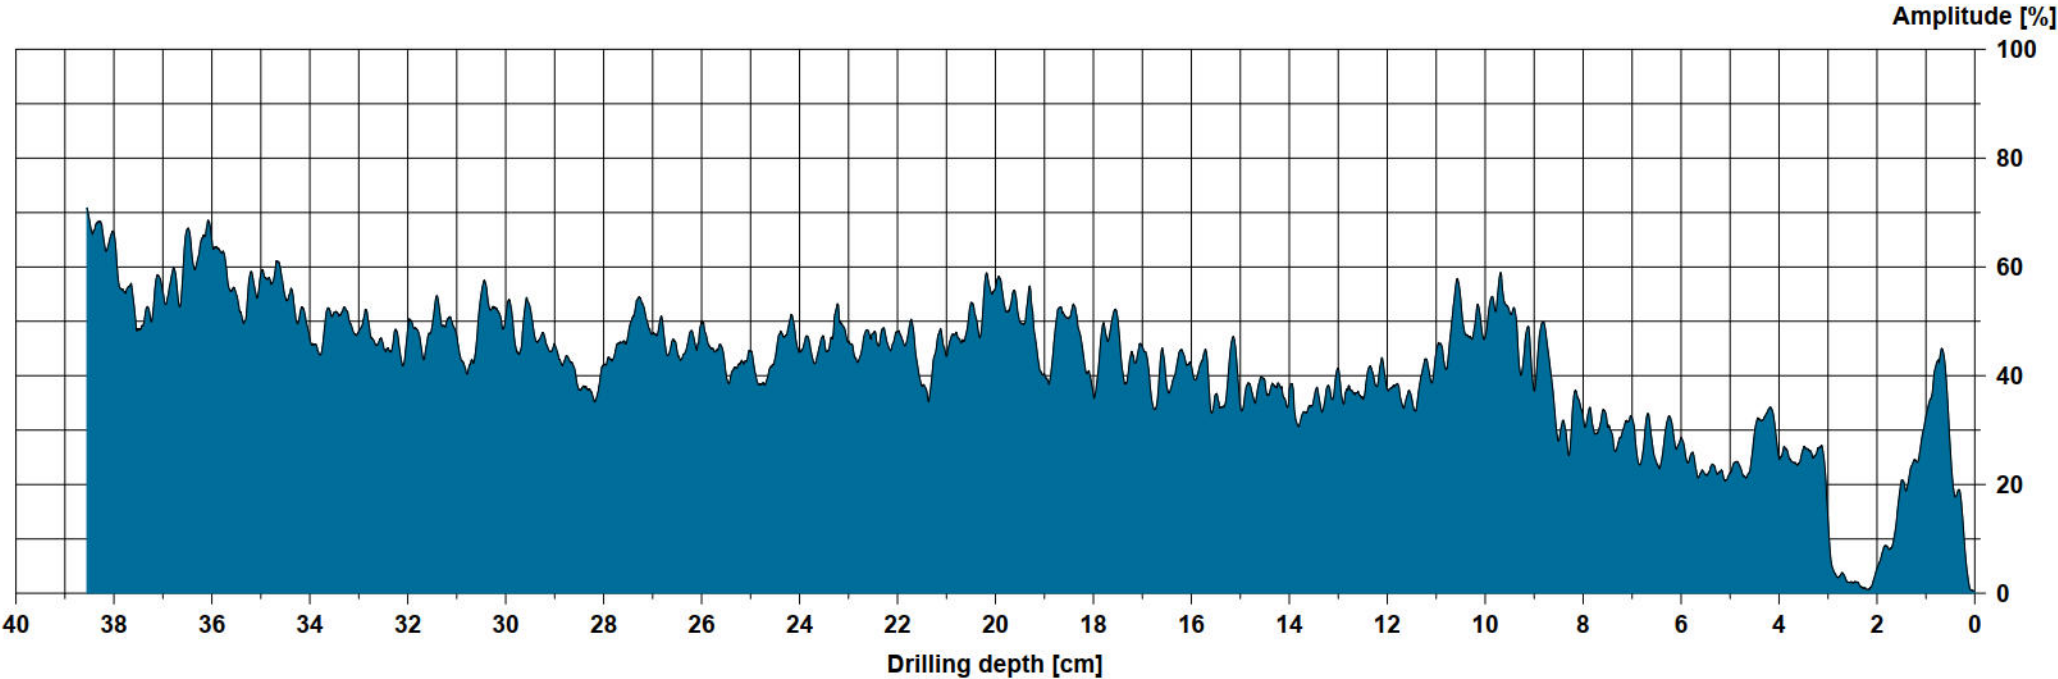
Test at circa 40cm above ground level north side due to proximity of fence and debris. No significant decay detected at the test location. Needle auto retracted at 39cm due to feed speed.

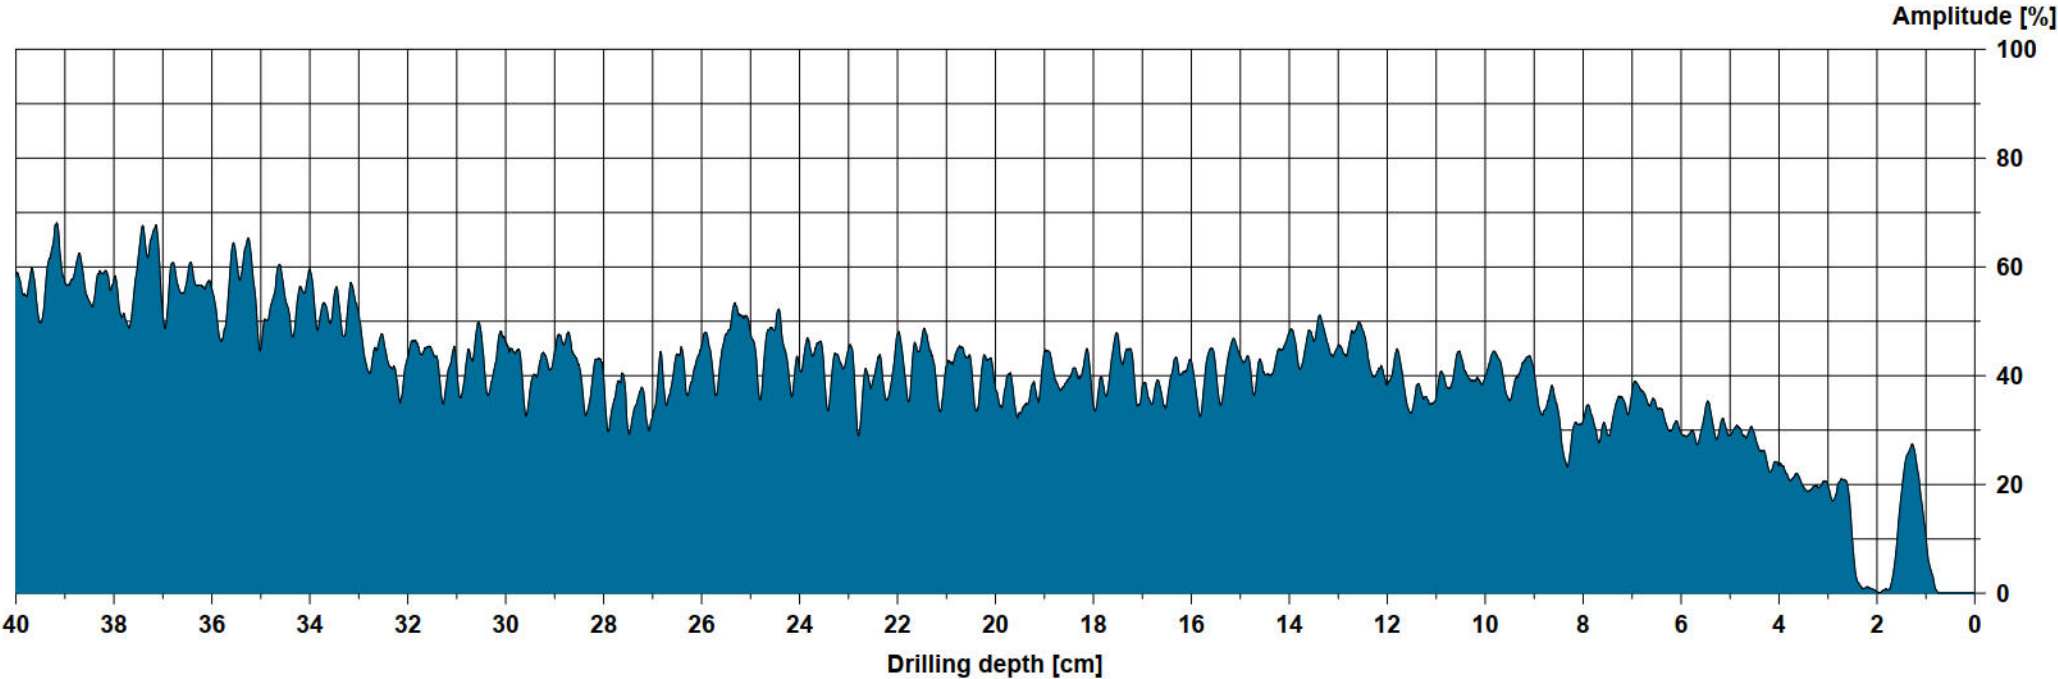
Test at circa 10cm above ground level south side. Isolated area of decay behind the bark at 2cm. No significant decay detected in the remaining sample location.

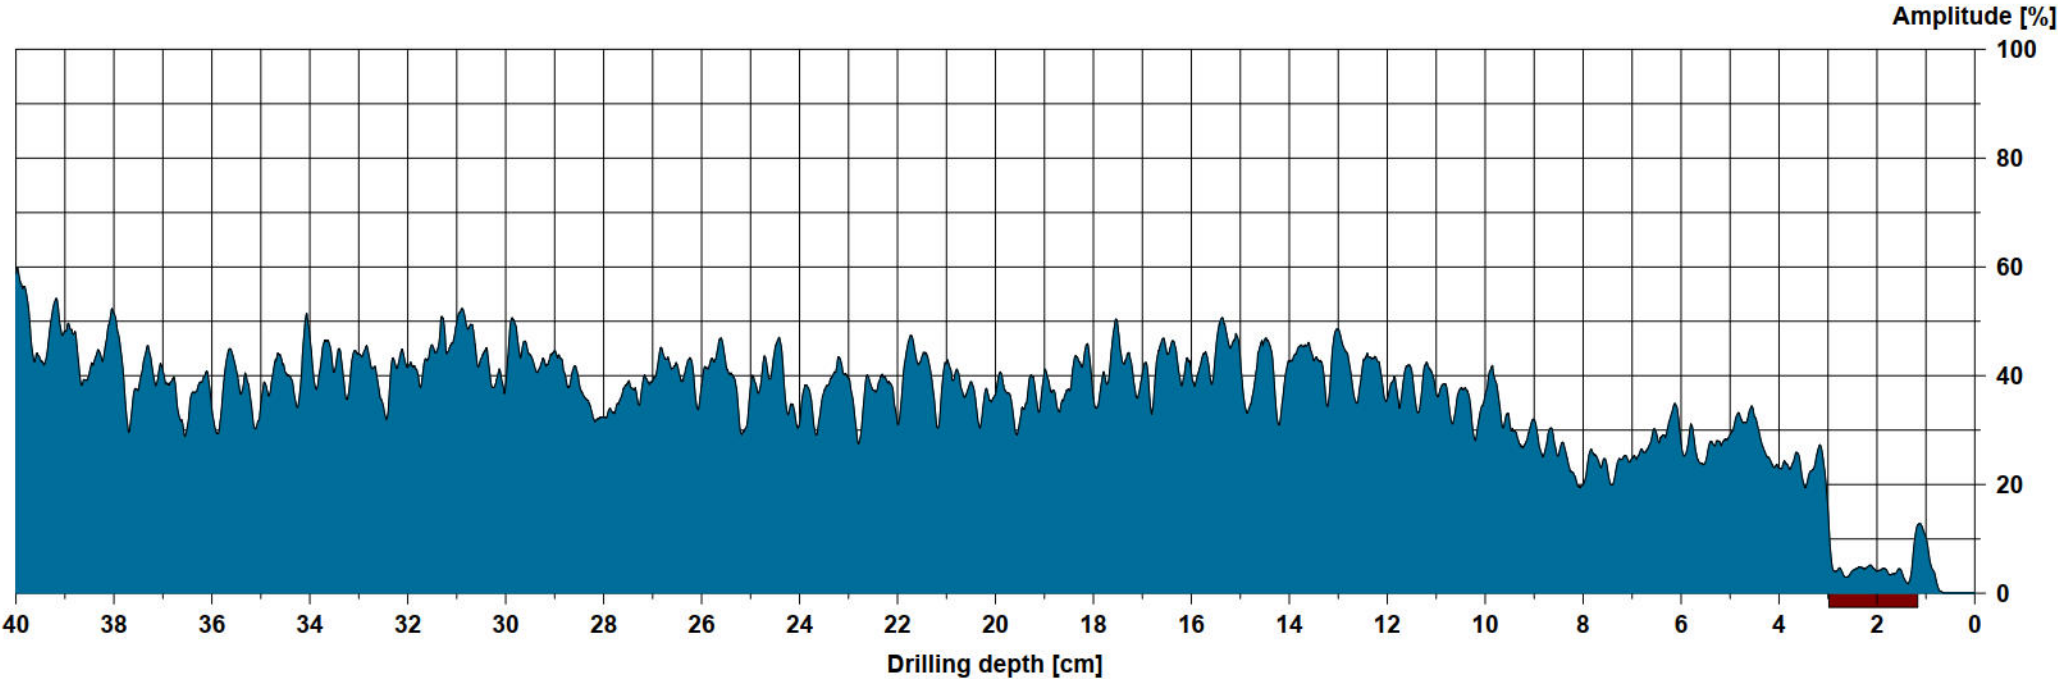
From 1,17 cm to 2,98 cm : Decay

Test at circa 10cm above ground level west side. Area of incipient decay behind the bark that is isolated. No significant decay detected at the test location.

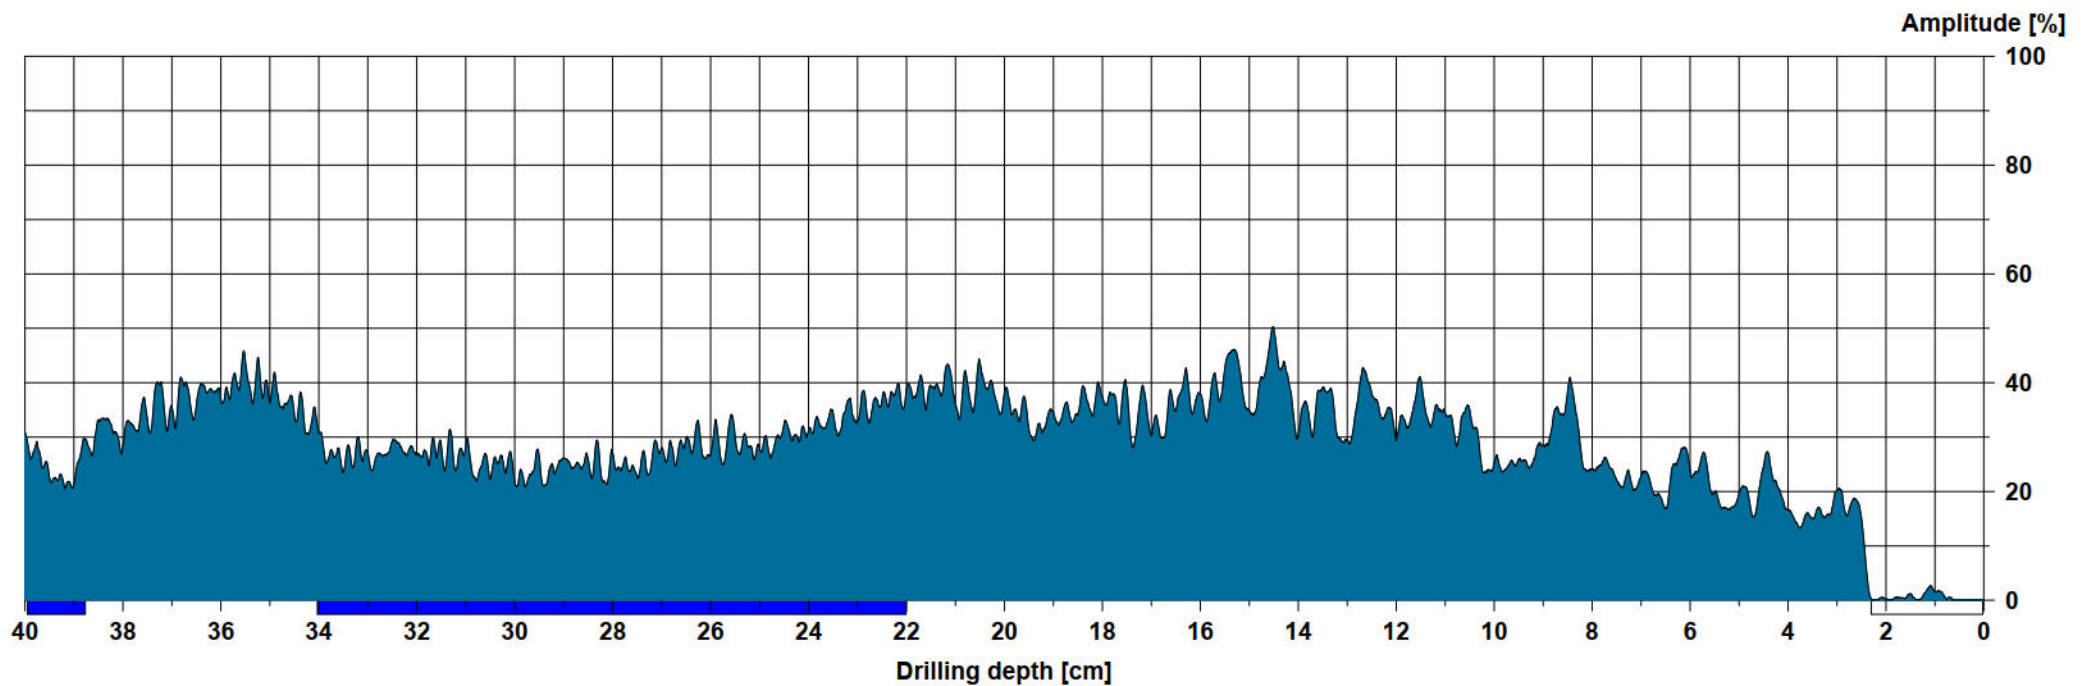
| From | 0,02 cm | to | 2,30 cm | : | Bark |
| From | 22,01 cm | to | 34,03 cm | : | Incipient decay |
| From | 38,77 cm | to | 39,95 cm | : | Incipient decay |

Test at circa 10cm above ground level east side.  
No amplitude until 2cm due to the bark.  
Amplitude then falls from 22cm where it should be rising before recovering at 34cm and dropping off at 39cm.

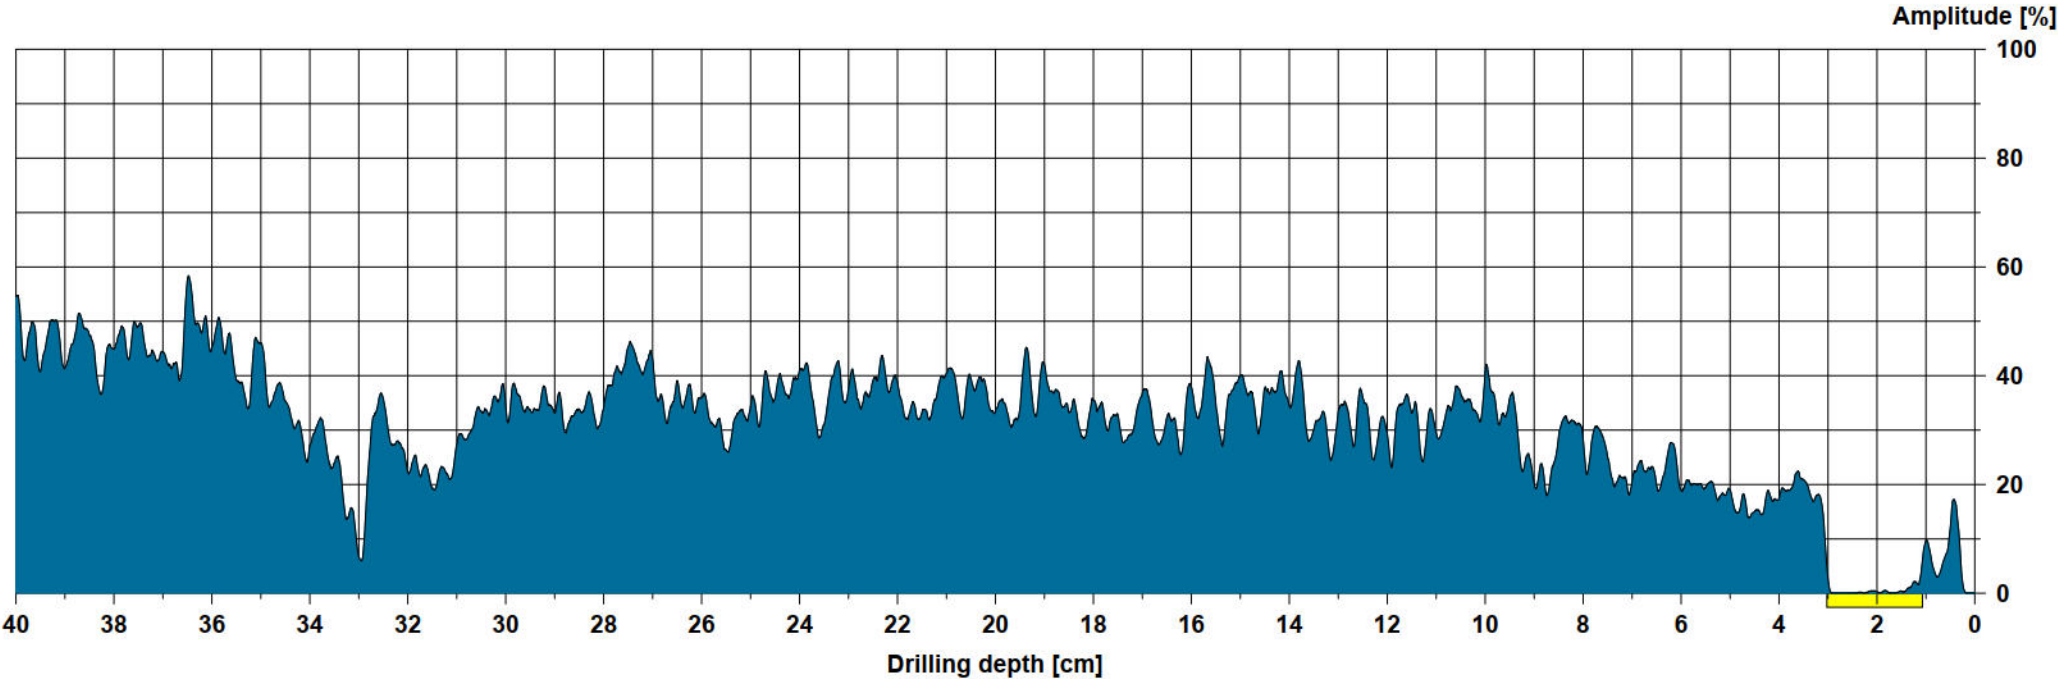
From 1,07 cm to 3,02 cm : Cavity

Test at circa 10cm above ground level north side. Small isolated cavity detected behind the bark. Somewhat irregular amplitude with sudden drop at 33cm indicating early stages of decay.

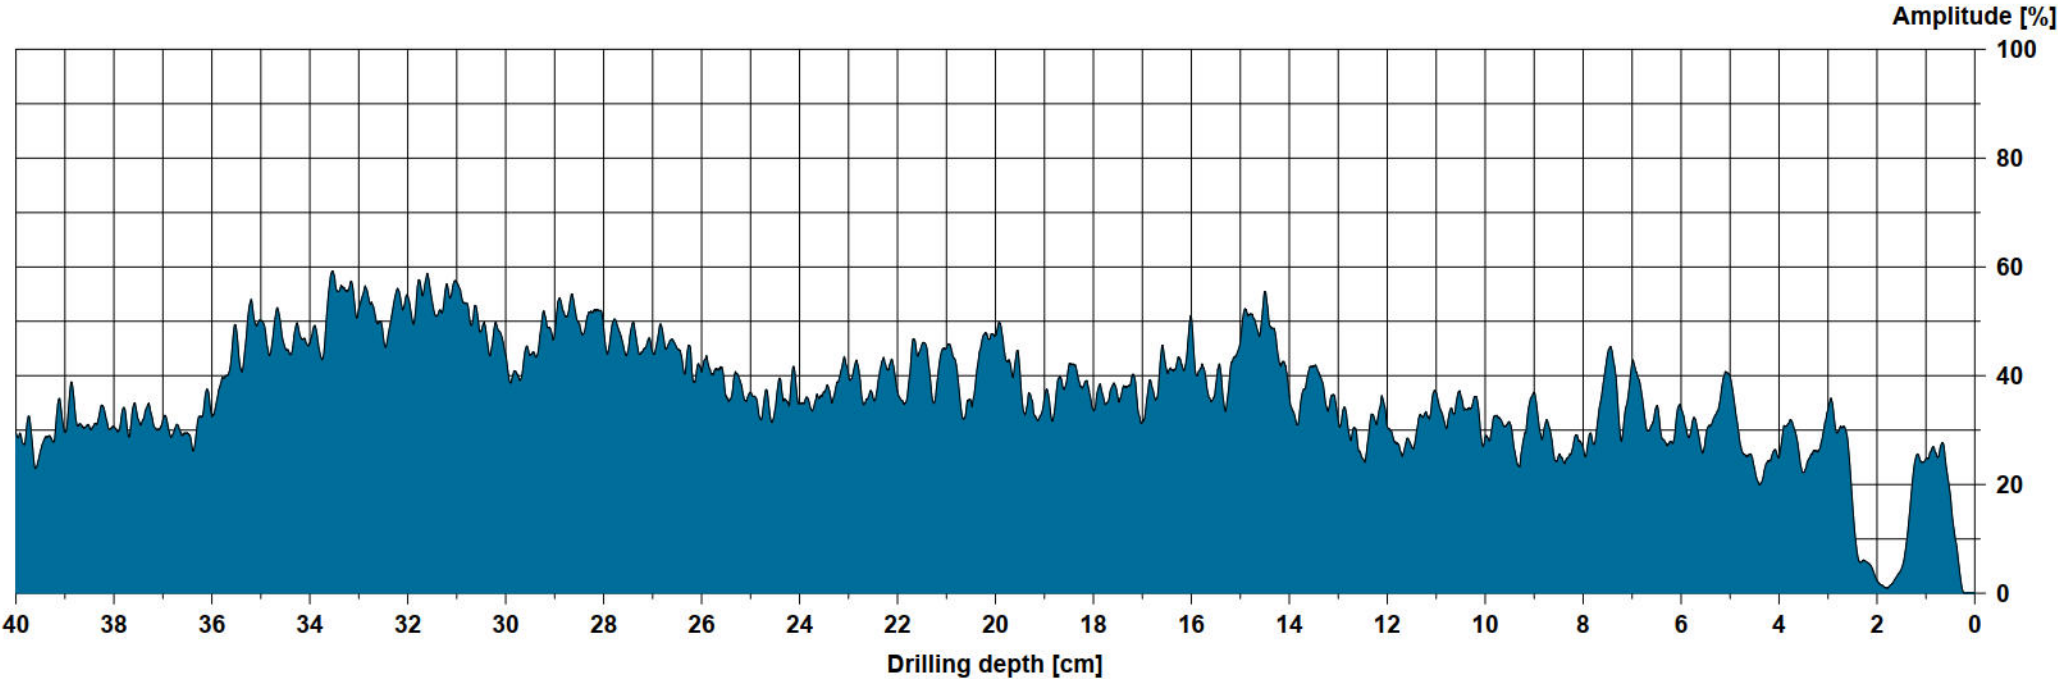
Test at circa 10cm above ground level south side. Low amplitude until 2cm due to the bark. Amplitude then appears typical for the species before falling at 36cm most probably due to incipient decay.

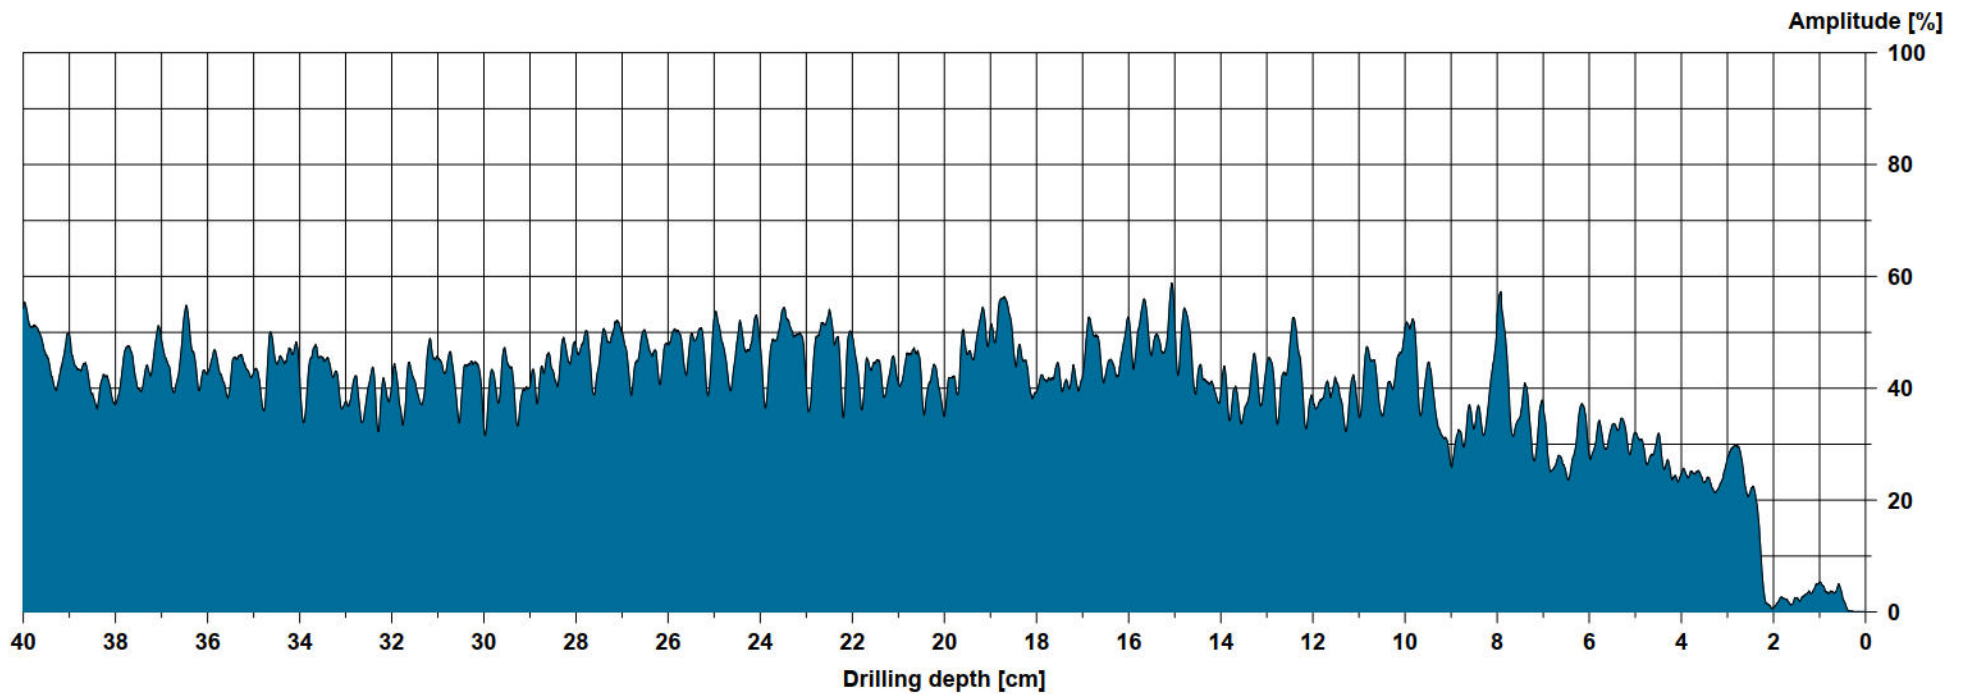
Test at circa 10cm above ground level west side. Low amplitude until 2cm due to the bark. Amplitude typical for the species with no significant decay at the test location.
