Loddon Garden Village - North

DESIGN RESPONSE

Road Safety Audit – Loddon Garden Village North

Stage: 2

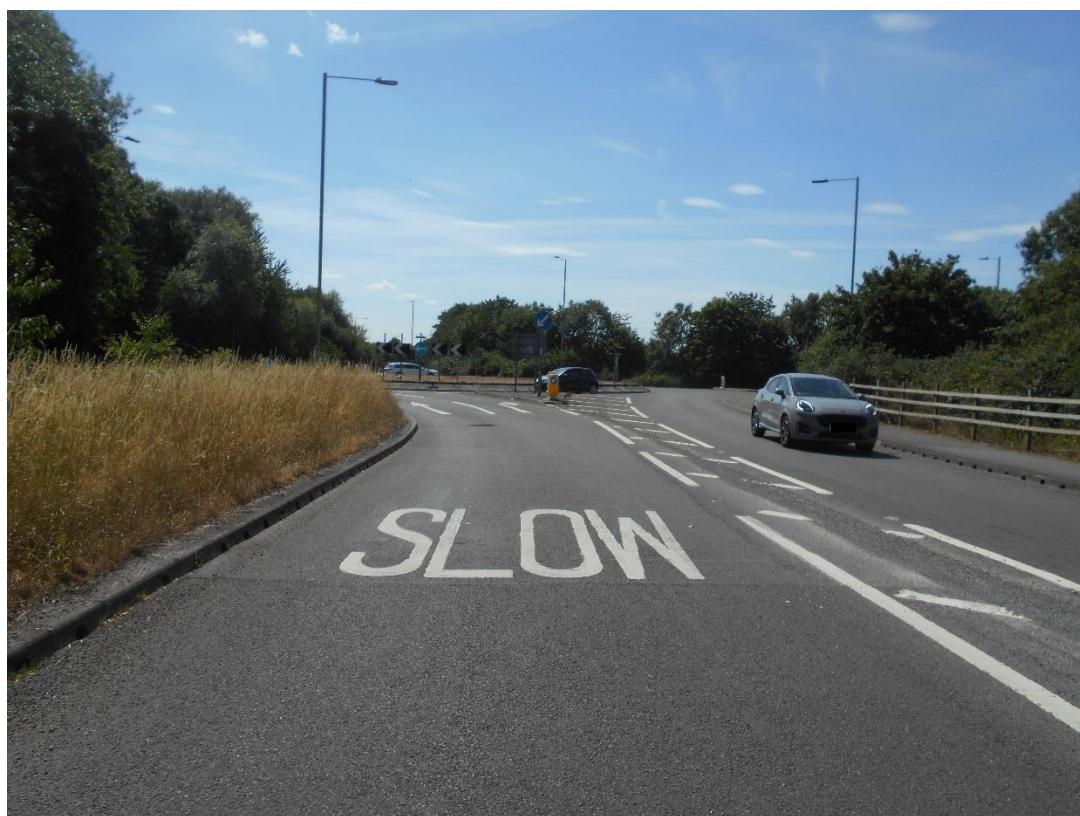
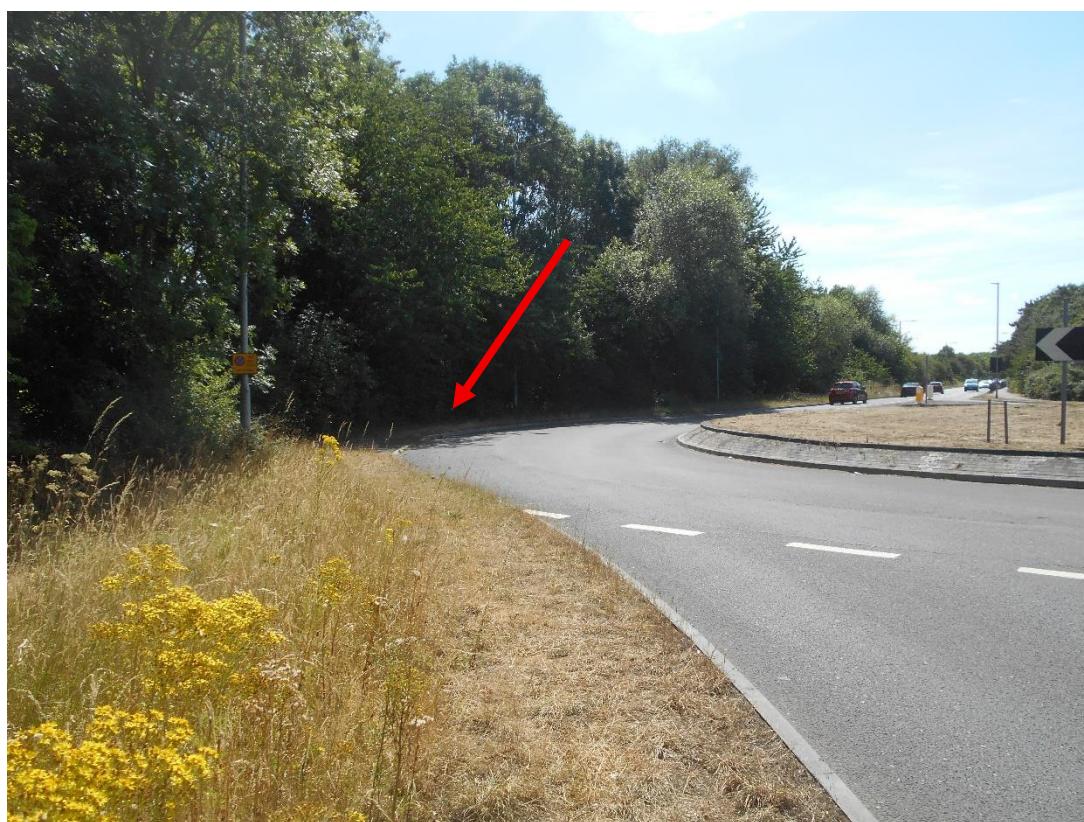
Looking west on the B3270 towards the existing roundabout. The new road will join the roundabout to the left of the central island (site arrowed)

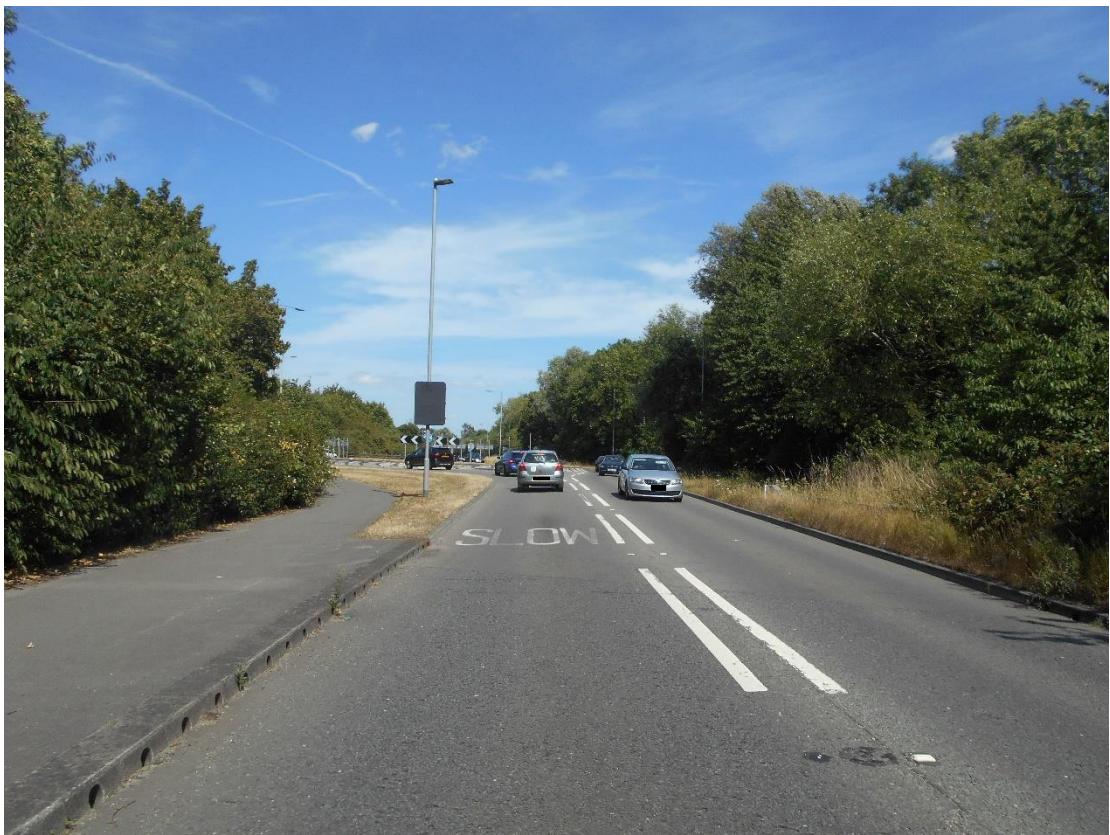
Looking east on the B3270 towards the existing roundabout. The proposed Toucan will be on this approach, just past the SLOW marking. Note the vehicle-activated speed visor sign mounted on the left, which suggests high speeds are experienced on this approach

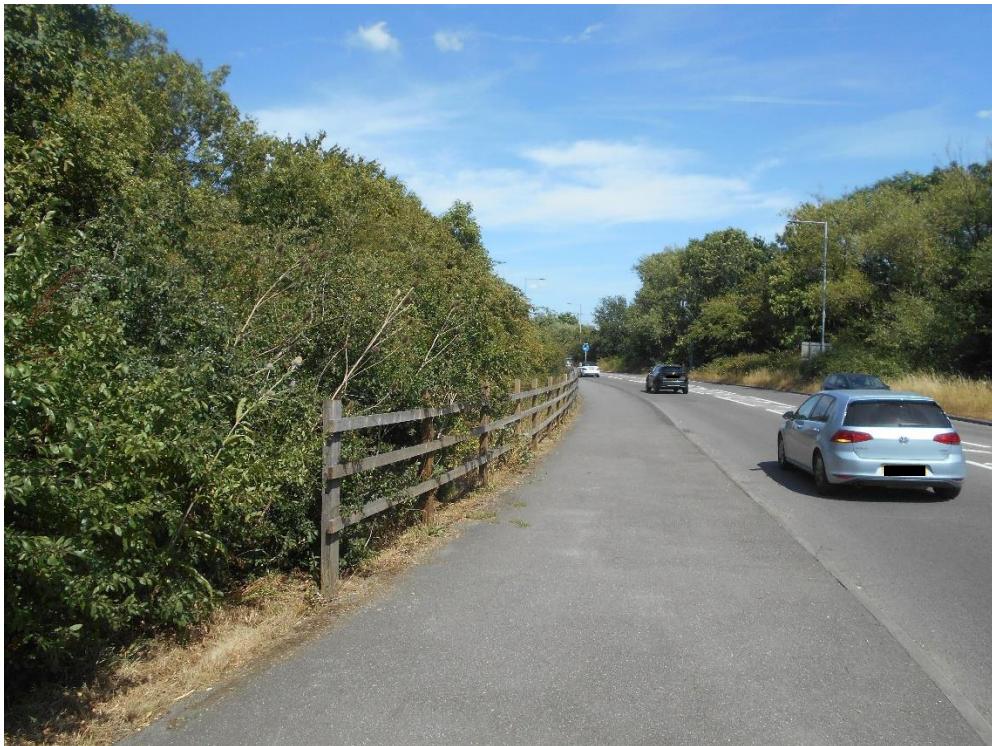
There are significant ditches running behind these existing paths, which will be exposed once the vegetation is removed to construct the path, such that path users may risk falling into it

Shared use path immediately to the east of the roundabout, with an existing fence to protect the ditch which is hidden in the vegetation

2.1.4 Noted, fencing to be included.

Recommendation – Provide fencing to protect against falls

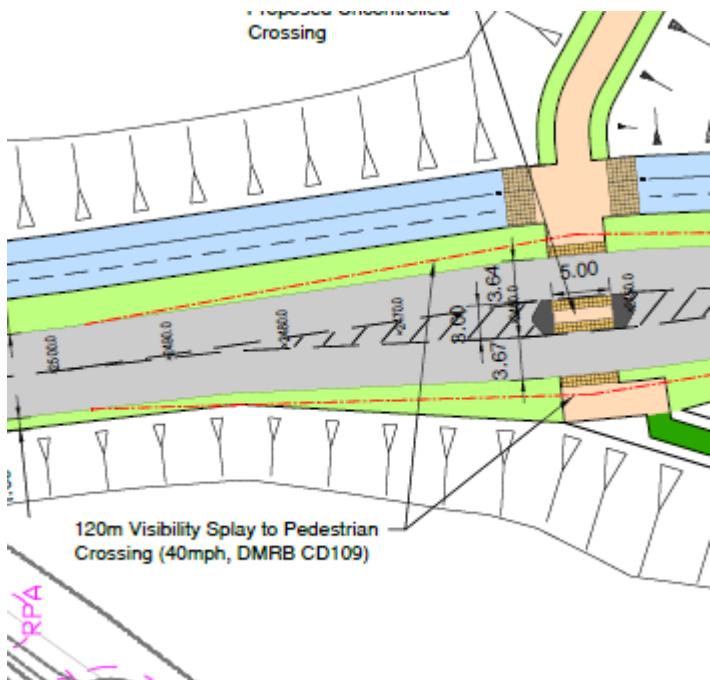
The visibility distances quoted on drawing 0108A are 120 metres, however from the chainage figures shown on the drawing the splays appear to be no more than 45 metres

2.16.4 Noted, drawing error, speeds are to be 30mph therefore 43m sightlines are required (MfS). Drawing to be amended.

Recommendation – Ensure the full 120 metres sightlines can be achieved
