Loddon Garden Village - South

DESIGN RESPONSE

Prepared by:	Chris Shaw
Authorised by:	Leigh Abley
Date:	08 July 2025
Document Reference:	A392 – R067 LGV Observer Way RSA 2 Designers Response

Road Safety Audit – Loddon Garden Village - Observer Way Roundabout

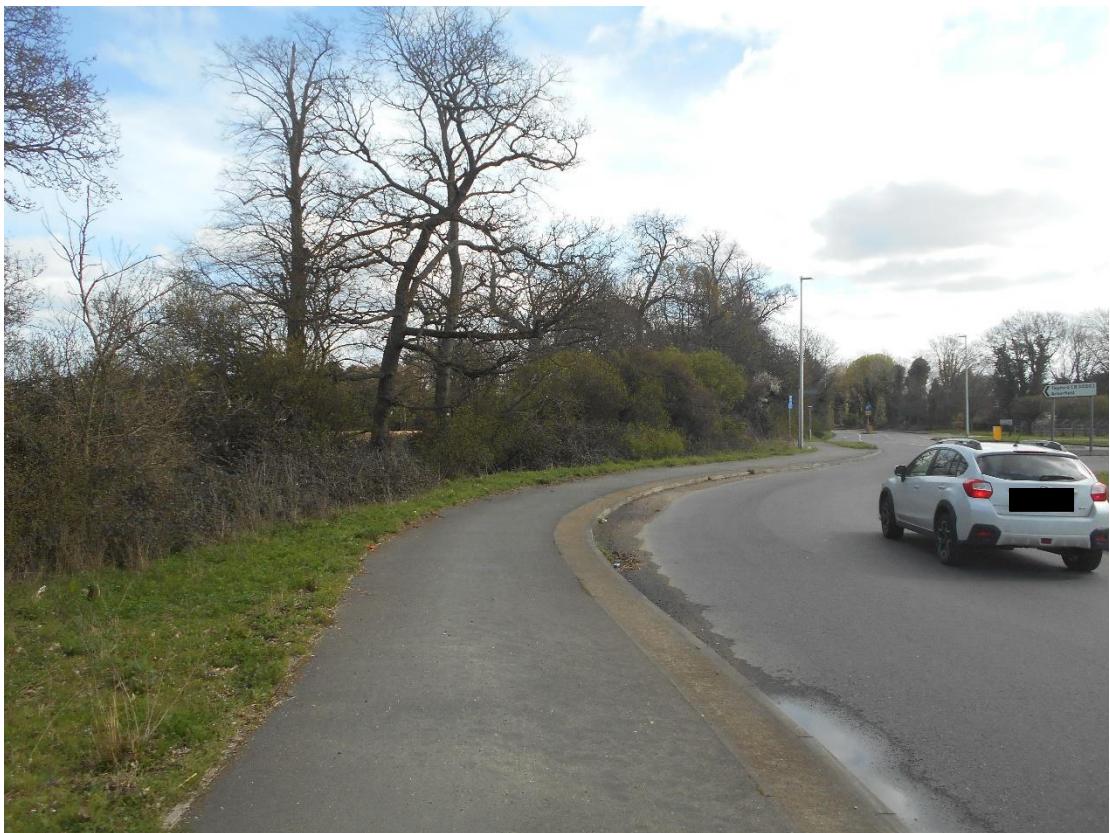
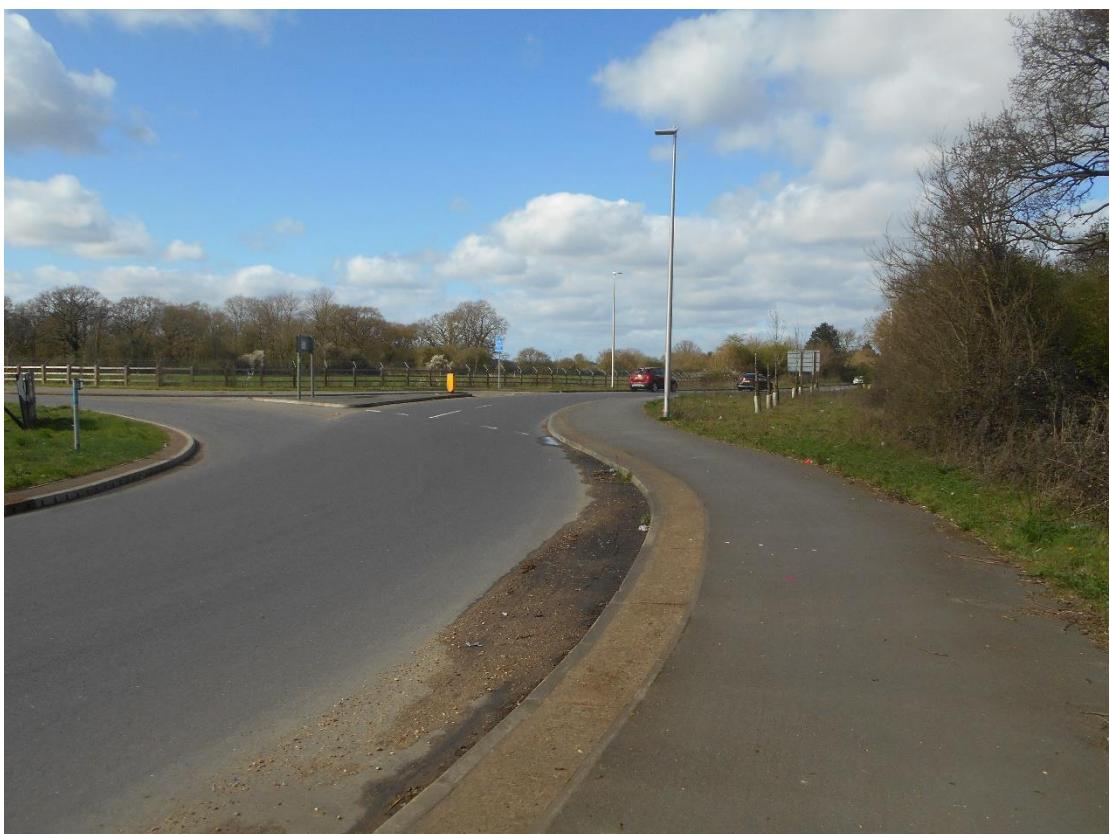
Views to left and right for a driver emerging from the new roundabout arm

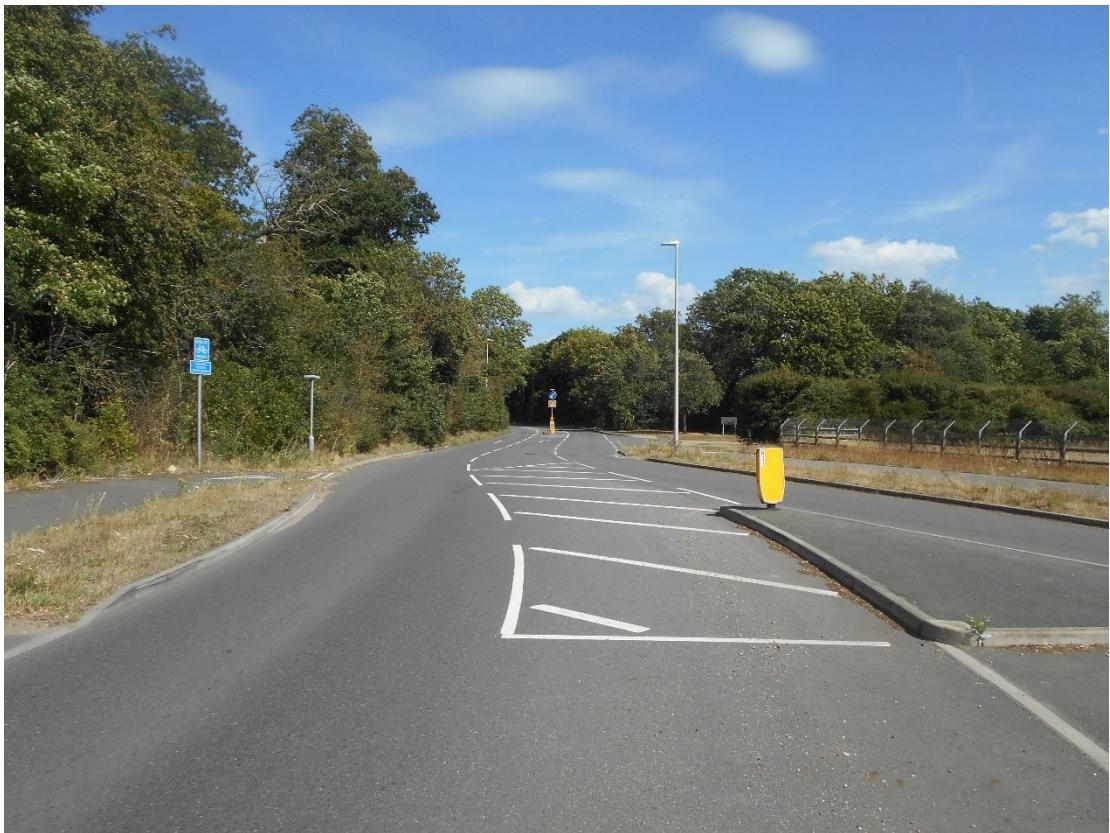
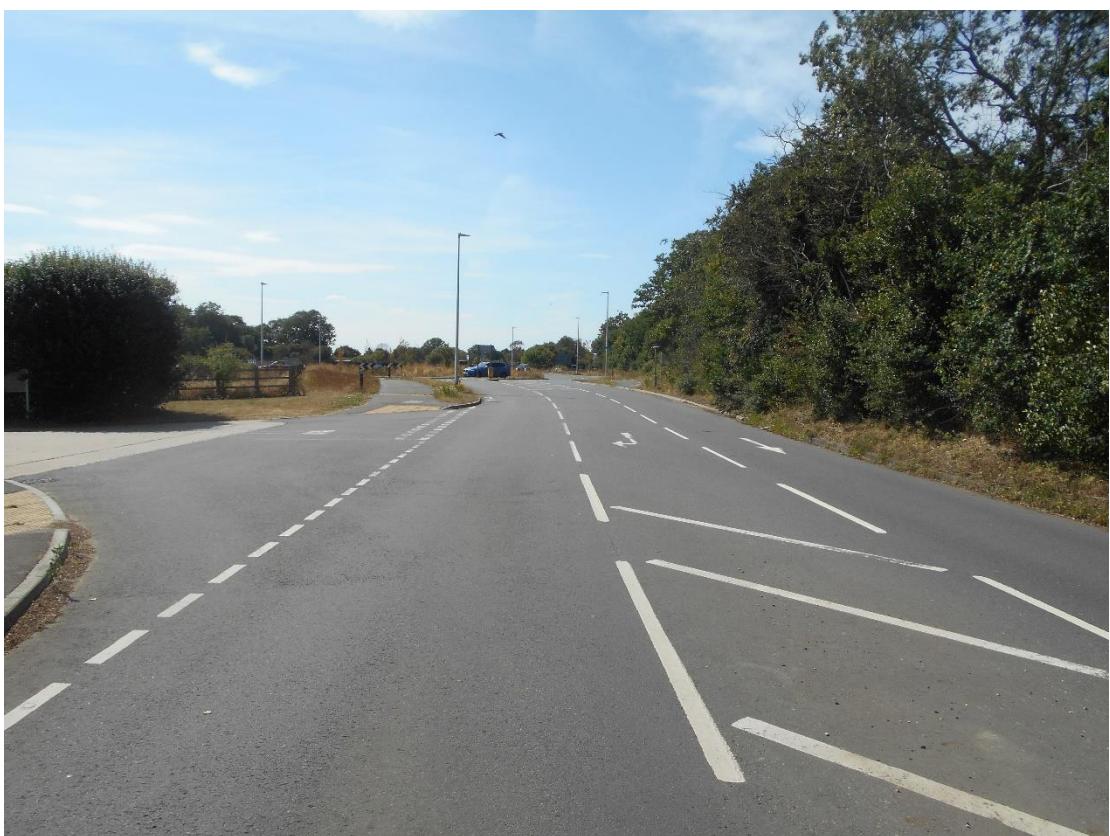
Views from west (top) and east of the proposed Toucan site on the unclassified section of Reading Road

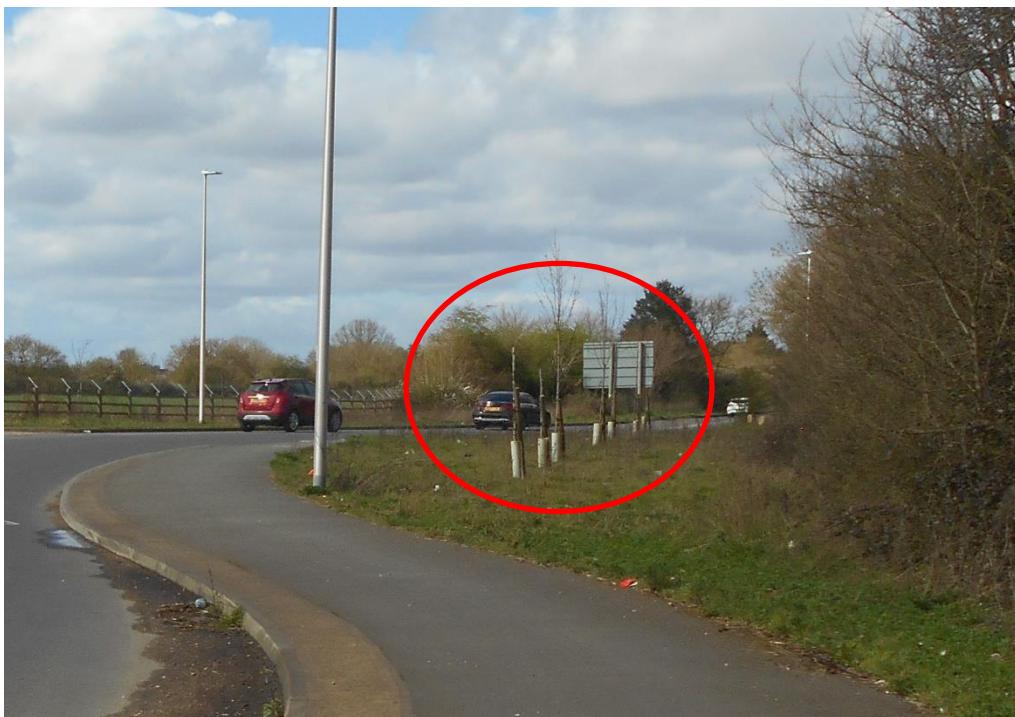
2.4.2 Risk of junction collisions, Some saplings have been planted in this area. As they grow and mature they will restrict visibility to the right for drivers emerging from the new road, increasing the risk of an emerging vehicle being struck by a vehicle entering the roundabout from the north-west.

Some saplings have been planted in this area. As they grow and mature they will restrict visibility to the right for drivers emerging from the new road, increasing the risk of an emerging vehicle being struck by a vehicle entering the roundabout from the north-west

Mature trees here will restrict visibility to the right

2.4.4 Saplings to be removed / relocated.

Recommendation – Remove the saplings

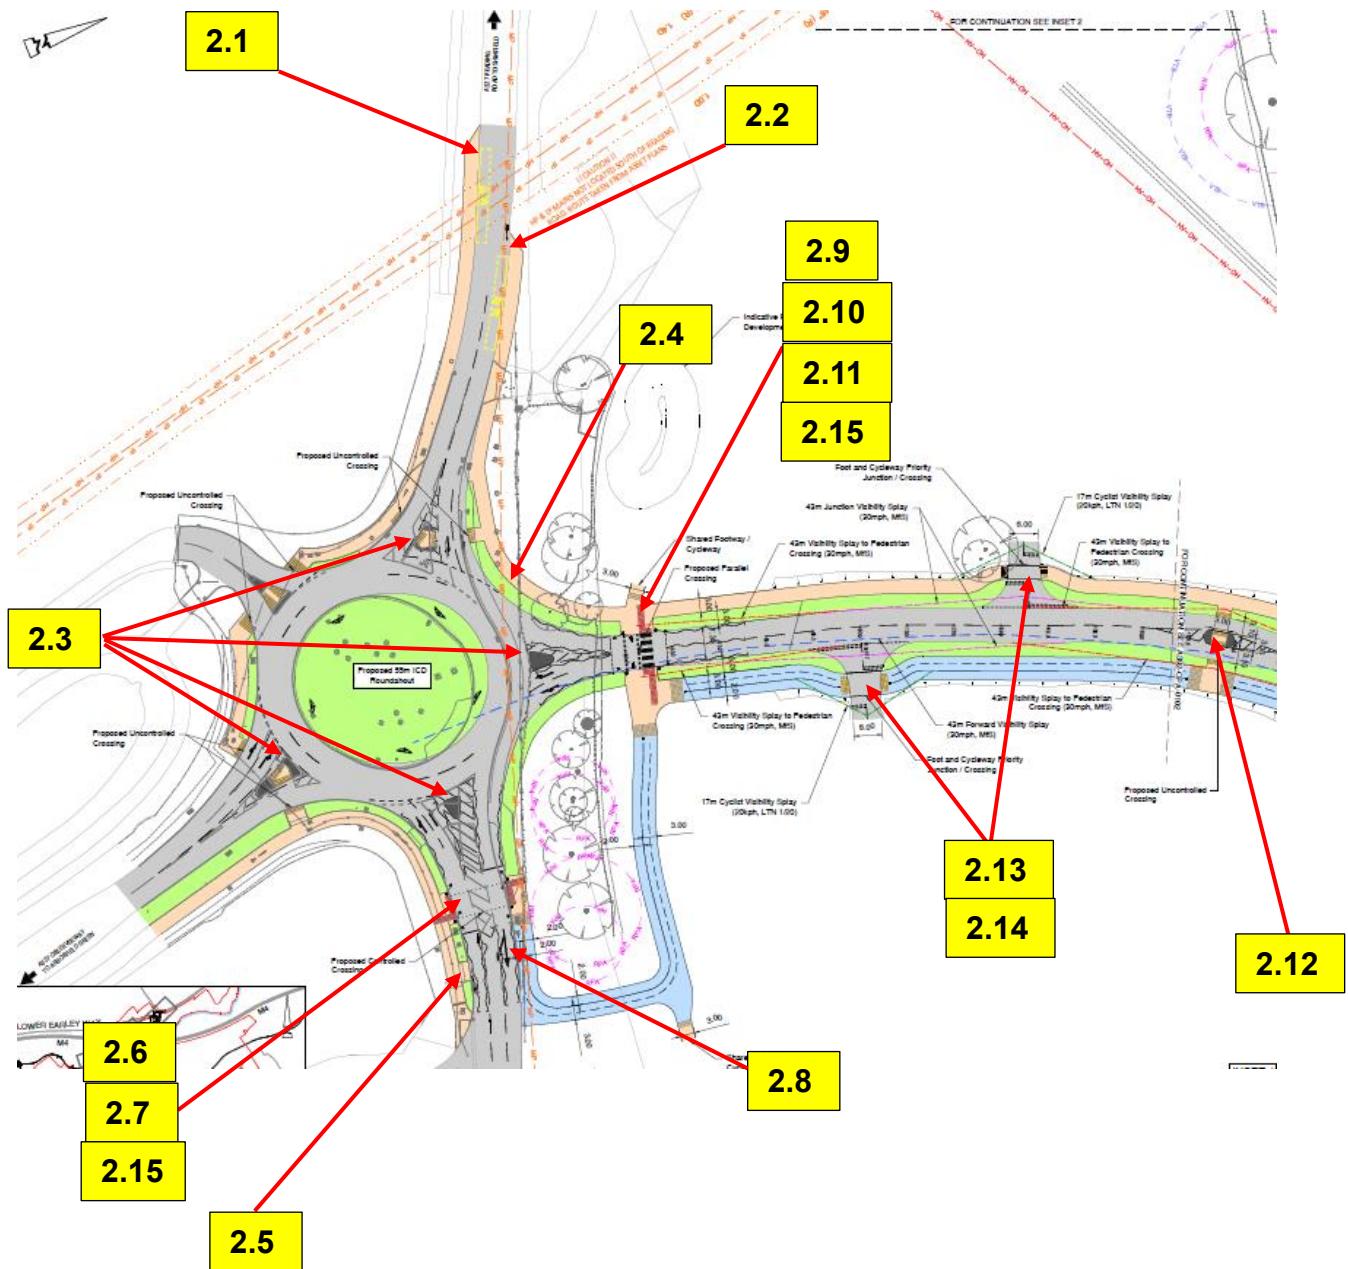
Appendix B: Key Plan showing Audit Problems

2. Safety Issues Raised in this Stage 2 Road Safety Audit. (see Appendix B for locations)
