10 September 2024

**Re: Preliminary Bat Roost Assessment – 11 Dukes Wood, Crowthorne, RG45 6NF**

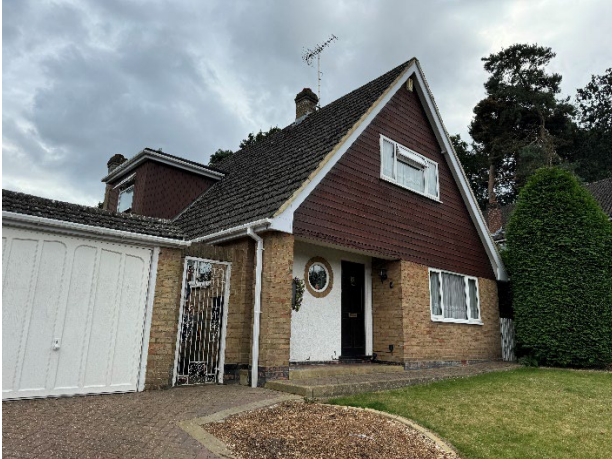
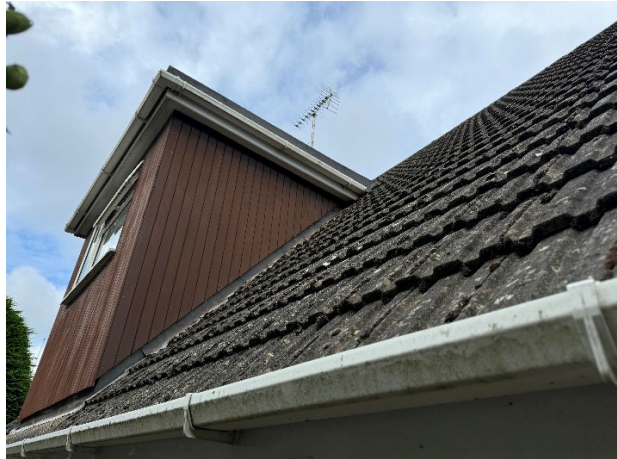
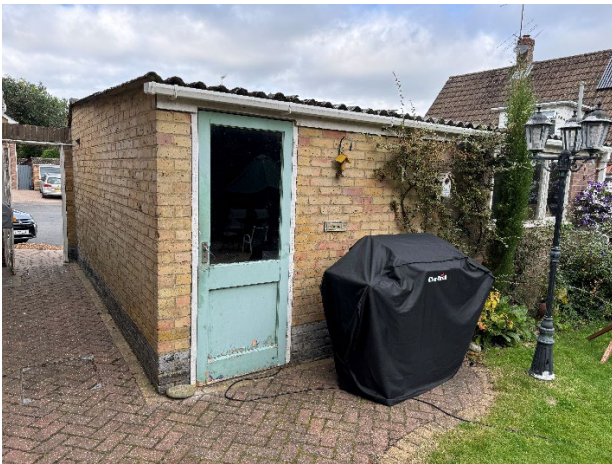
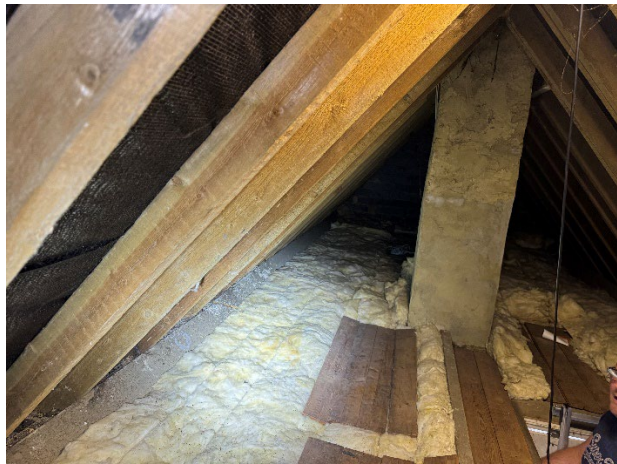
The house was of brick construction dating from the 1970s and had a pitched concrete pantile covered gable ended roof with dormers on opposite pitches and was completely devoid of evidence of bat presence. The exterior of the dormers and gable ends of the house were covered in shiplap timber cladding. The loft space was clean and dry with a traditional 1F roofing felt evident below the tiles. The loft was devoid of any evidence of bats, which included a complete absence of bat dropping and other debris on the fibreglass insulation across the loft floor that appeared, from a notice or work pinned to a rafter, to have been installed 16 years ago. The garage was a simple brick built building with an unlined cement sheet mono-pitch roof covering with unsealed eaves and was also devoid of bat evidence.

The house was in good structural condition with no missing, lifted or slipped roof tiles, and the shiplap cladding on the gable ends and dormers was all tightly fitted with no obvious gaps suitable for bats to access behind the cladding. The roof soffits were also all intact and tightly fitted and offered no obvious access points for roosting bats. There were two small lead flashing lifts around the base of the two roof mounted chimneys but no associated evidence bats.

In summary given the complete absence of bat evidence and lack of potential bat roost features, I would suggest that the house and garage do not support roosting bats, and I would assess both buildings as having **negligible bat roost suitability**, requiring no further survey or assessment in relation to your redevelopment proposal.

A selection of Site photos taken on the day of survey are provided below.
