29 April 2024  
Our ref.: 24/500

**Re: Chimney Inspection – Flat 3, Old Dairy Court, Wargrave**

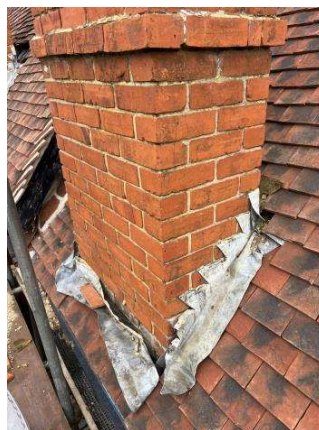
At the time of inspection refurbishment works were being undertaken to the roof containing the chimney. The roof tiles had been recently replaced although the lead flashing was lifted and had not yet been reinstated; likely delayed whilst a decision is made on how to deal with the chimney in question.

*Photograph 01 – Existing lead flashing around base of the chimney*

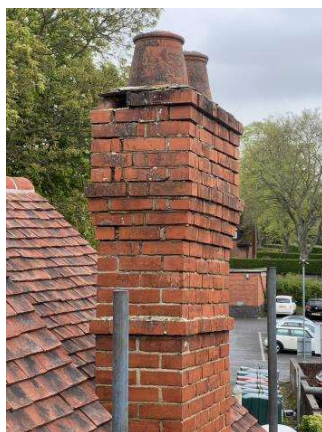
Externally the chimney is in poor condition. The pointing is worn and missing in sections and there are areas of loose and spawled brickwork, notably around the head. The chimney also has a pronounced lean from front to back which is likely due to uneven weathering and the deterioration of the mortar joints. This leaning in itself is not uncommon in chimneys, however eventually it leans to such a degree where it is considered unsafe. The lean on this chimney is pronounced enough that it now needs safeguarding works.

Photograph 02 – Poor / missing pointing and loose brickwork to the head of the chimney

The chimney needs to be repaired and safeguarded or removed as in its current state it is unstable. This is of particular concern considering its location immediately adjacent to the grounds of 79 High Street which are in constant use.

Given that the chimney is no longer in use and cannot be put back into use (as the chimney breast has been removed) I would recommend that it is taken down entirely and the tiled roof surface reinstated over. This would be a more cost effective approach given that to retain the chimney it would need to be taken down, rebuilt and restrained with a tie bar. Removing the chimney would also remove one of the penetrations through the roof which could be a weak point for damp ingress in the future.

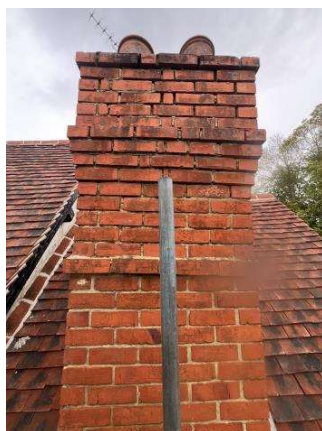
Photograph 03 – Pronounced lean from front to back

Notwithstanding the above, more concerning is the lack of restraint to the chimney which is allowing considerable lateral movement. The chimney can be rocked / moved by hand with little pressure.

In summary I could not see any evidence internally that the chimney is supported inadequately following the removal of the chimney breast below, however the remaining section of chimney above the roof line has lacked maintenance and thus the brickwork and pointing has deteriorated. This has no doubt exacerbated the front to back lean which will have been caused by differential weathering. The lean in itself coupled with the worn pointing raises concerns regarding stability of the chimney, however it is the lack of any lateral restraint and ease of movement which is of greater concern. This is likely due to the chimney being largely above the roof line with only the lower courses being restrained by the adjacent rafters, effectively making it top heavy.

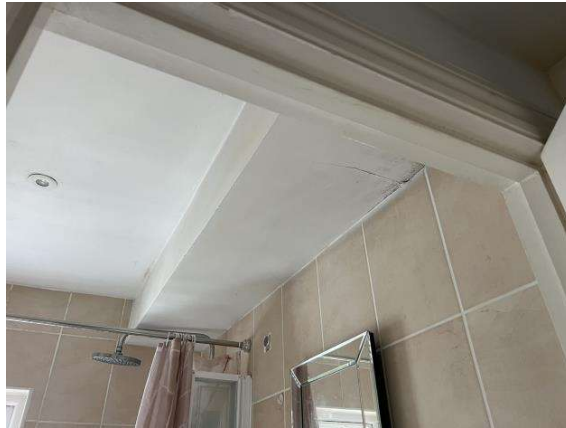
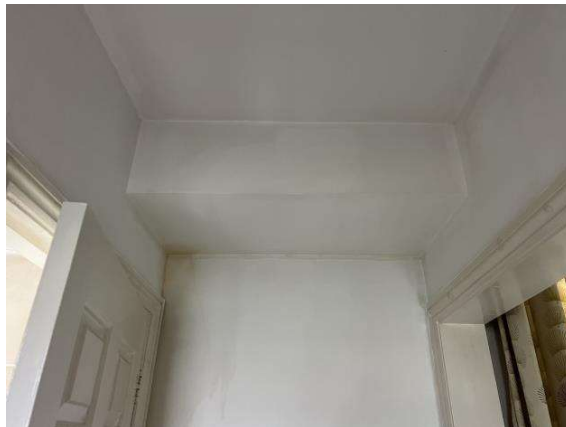
Running across the bathroom and landing ceilings on the first floor is a finished boxing which sits directly below the chimney location. Whilst I could not see what is contained within the boxing it is almost certainly some form of structural member which is supporting the chimney above (inserted when the chimney breast below was removed). This is evidenced by the boxing spanning between the rear external wall and the internal spine wall adjoining the stairs, which are both load bearing walls. Within the roof void I was able to view the chimney

extending down through the first floor ceiling into the boxing location, however again due to the lath and plaster ceiling finish I was unable to see the nature of the structural support concealed within. There was no evidence to suggest that the structural support within the boxing has moved or is inadequate for its purpose.

Photographs 04 & 05 – Structural support for chimney likely concealed with ceiling boxing in both the first floor bathroom and landing

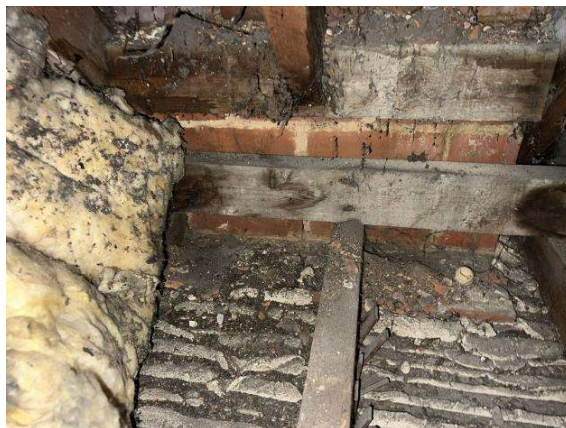
Photograph 06 – Chimney extended down into boxing location from roof void
