STANLAKE PARK MANOR HOUSE  
NORTH WEST ELEVATION WORKS

FRONT ELEVATION

2401-EX-3c

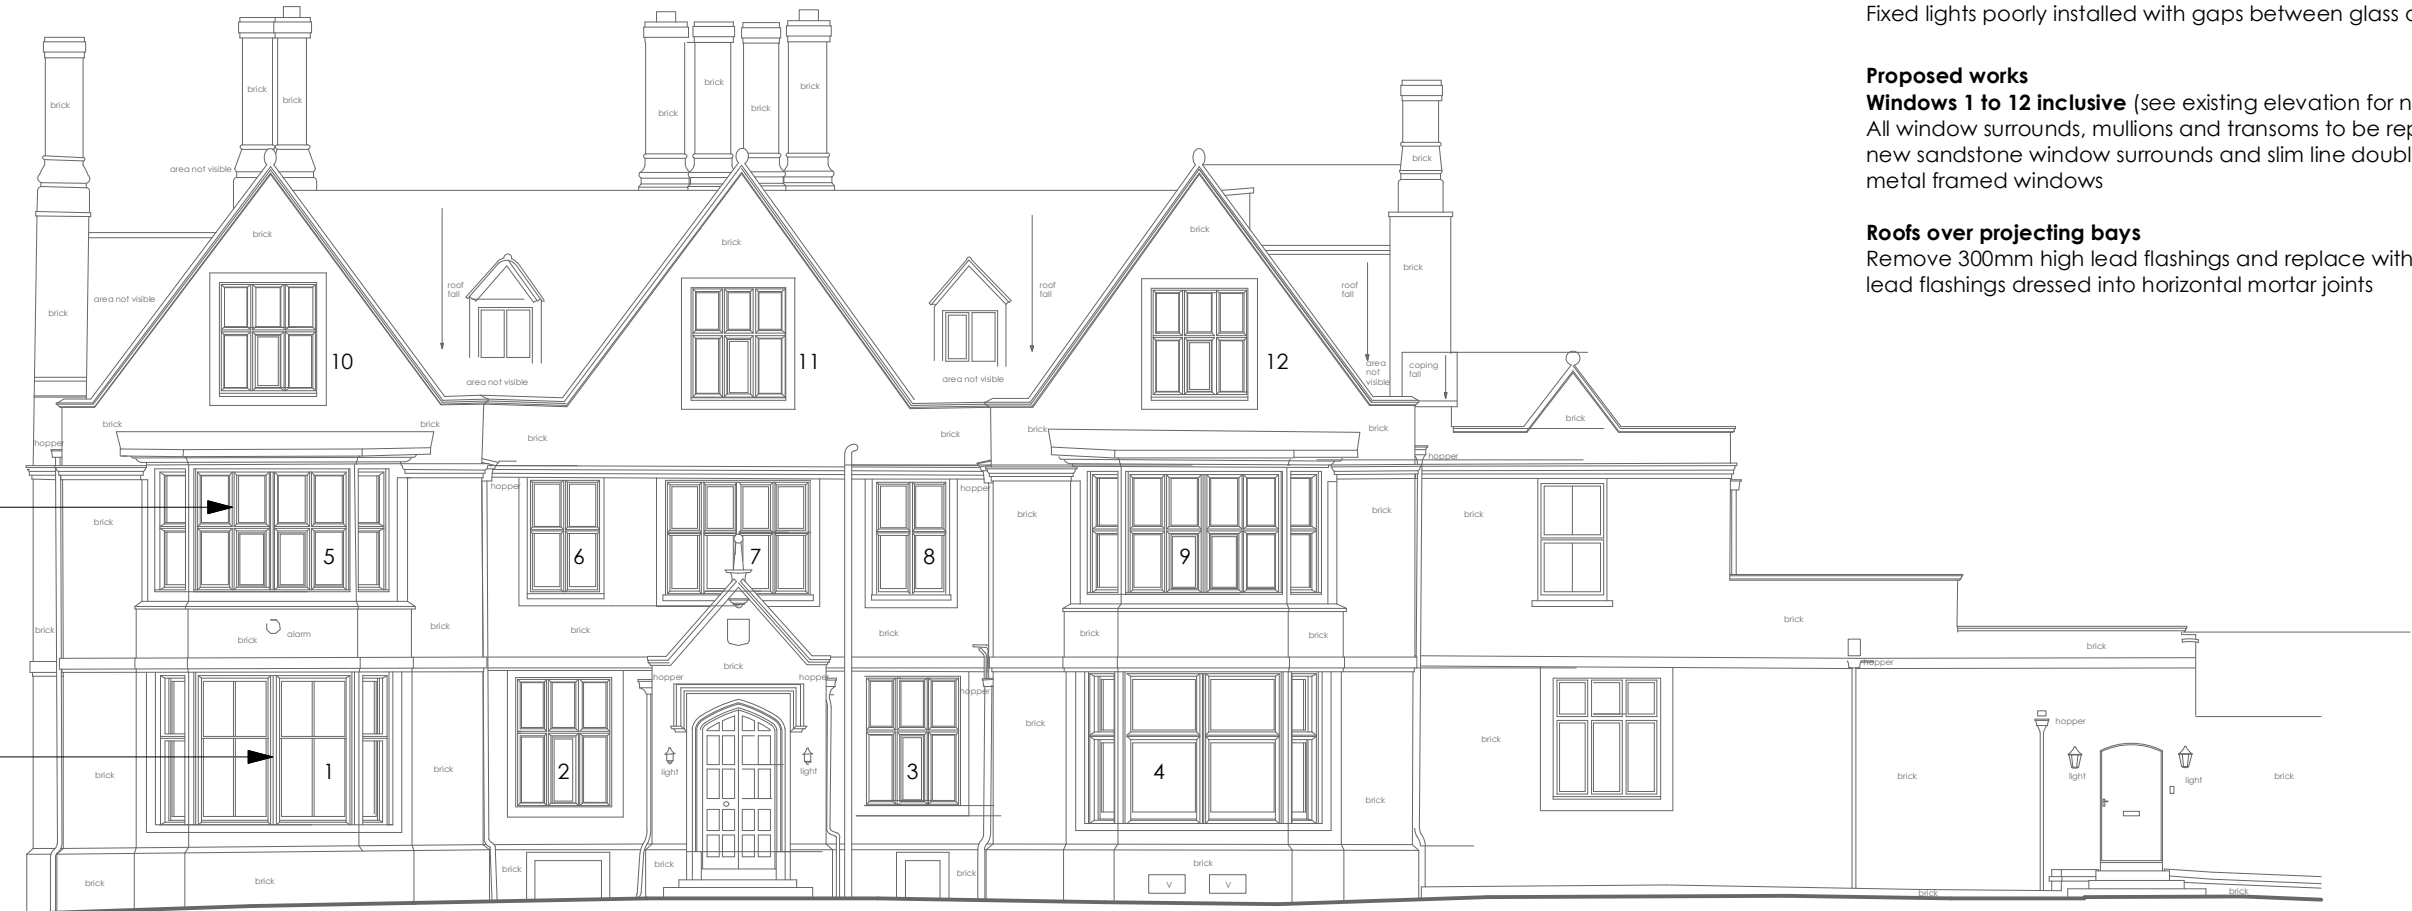
Existing

Window glass is flat indicating that all glass was replaced within the last 100 years

inappropriate  
cement mortar  
repair

stone/render string course  
in poor condition

stone/render plat band  
in poor condition

**Notes**  
Many casements now poorly aligned and unable to close due to structural movement and/or deterioration and/or previous inappropriate or inadequate repairs

Fixed lights poorly installed with gaps between glass and mullions

brick panel  
to be  
dismantled  
and rebuilt

bricks to be n  
numbered for  
rebuilding
