**STANLAKE PARK MANOR HOUSE**

**PHOTOSHEETS**

**2401-EX-7**

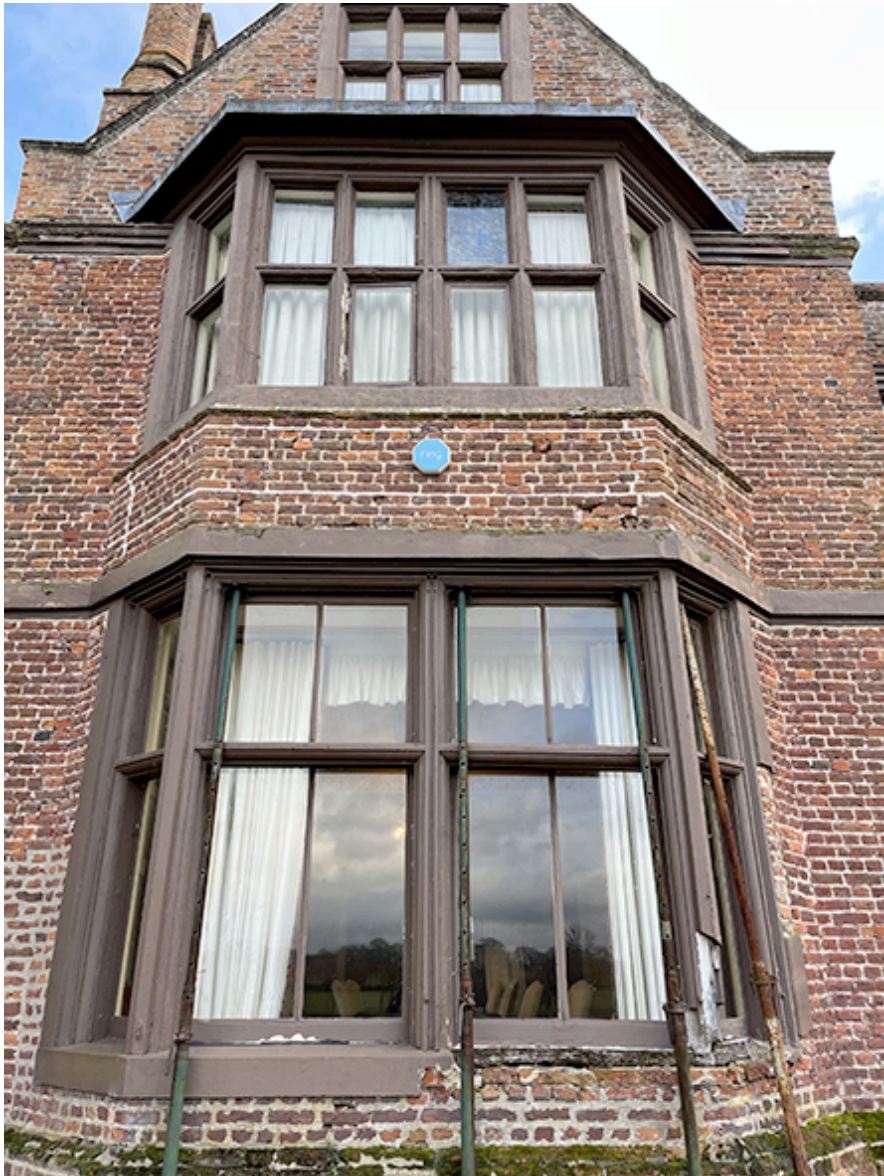
cement render over original moulded brick cornice, now in poor condition.  
**Proposed works:** Assess render and remove any defective or loose material. Assess brickwork substrate, repair if required and form moulded render in lime render

cement render over original brick plat band, now in poor condition.  
**Proposed works:** Assess render and remove any defective or loose material. Assess brickwork substrate, repair if required and form moulded render repair in lime render

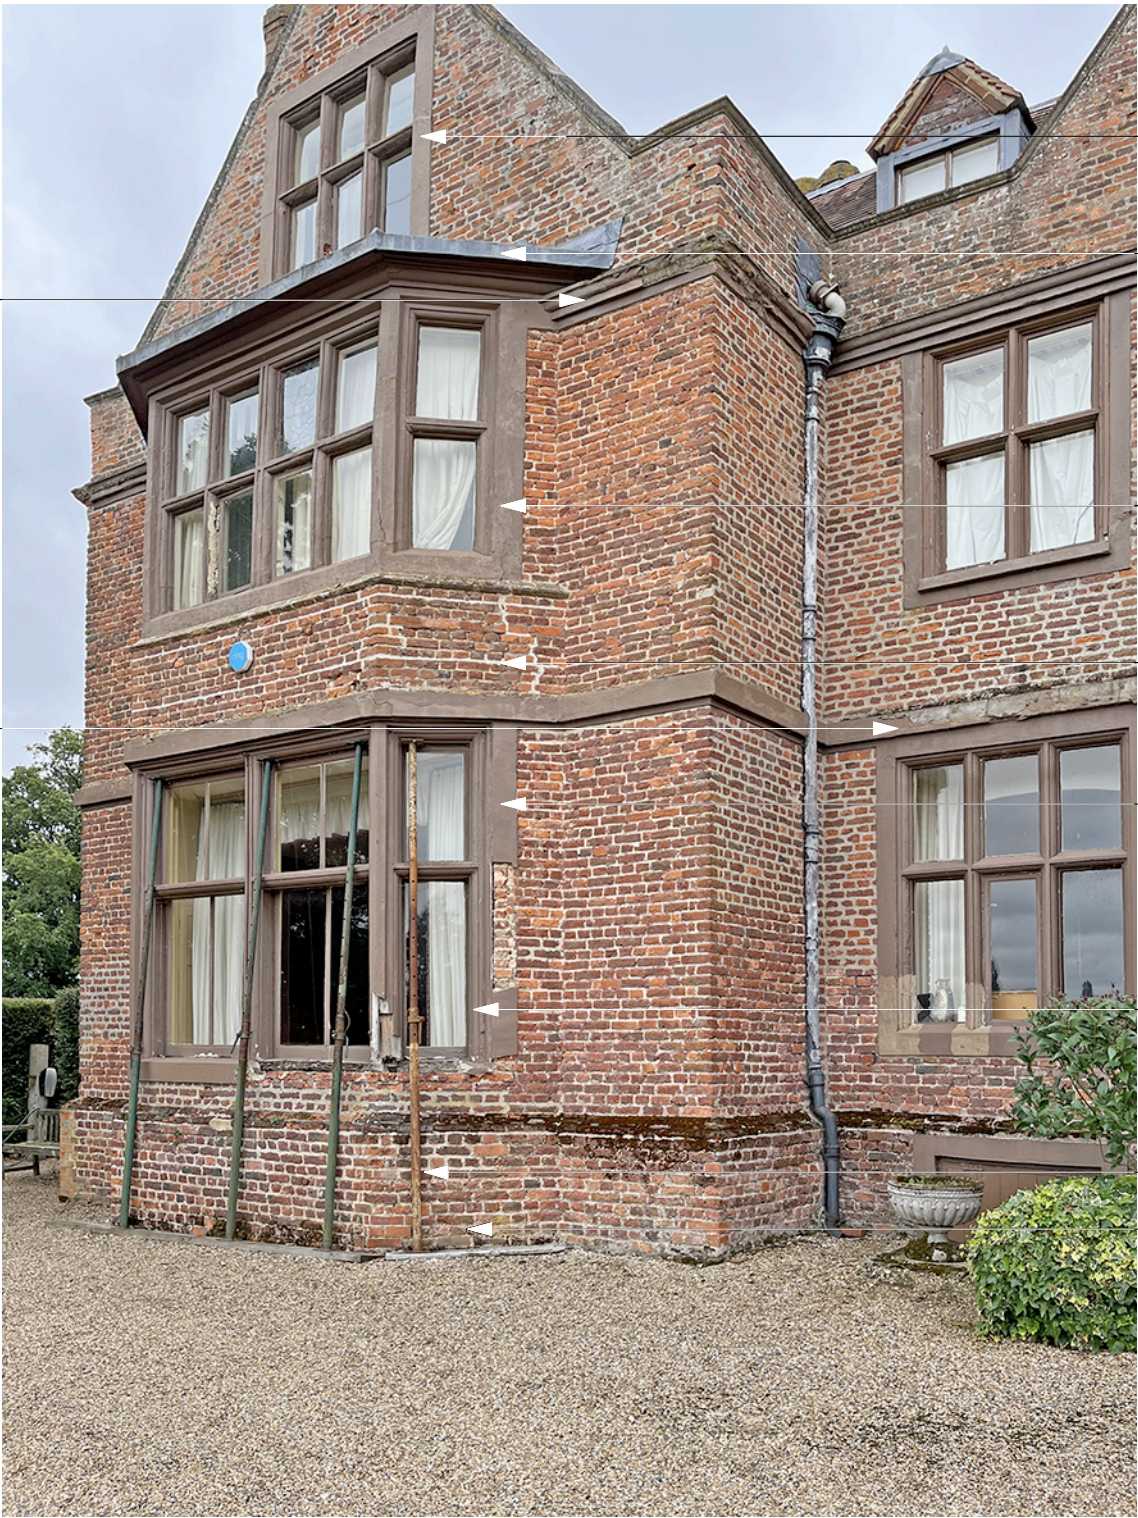
Moulded brick mullions and window surround with cement render and non breathable textured paint finish. Glazing less than 100 years old  
**Condition:** cement render spalling and in poor condition, central window binding due to poor detailing  
**Proposed works:** replace window surround in sandstone with slim line double glazing in metal frame

sandstone window surround and mullions with cement render repairs and inappropriate non breathable paint finish  
**Condition:** Cement render repairs in poor condition. Stonework has moved and cracked. Windows no longer open, or if open, close propoerly. Movement has resulted in gaps between glazing and stonework  
**Proposed works:** replace sandstone window surround and mullions, with new glazing and casements (see detail provided)

helibar repair and reinforcement by Cliveden Conservation approx 2015, to reinforce brickwork due to collapse of timber window below

cement render to simulate original stone window frame has failed, exposing gap between brickwork and timber window surround

late 19th/early 20th century timber replacement bay window with 2x2 sash windows to front of bay  
**Condition:** Timber rotten  
**Proposed works:** replace timber window surround and mullions with sandstone, including new fixed lights and casements in lieu of sashes

acrow props supporting window head

extensive areas of tuck pointing have failed and been replaced with poorly applied cement based mortar
