## STANLAKE PARK MANOR HOUSE

### PHOTOSHEETS

**2401-EX-8**

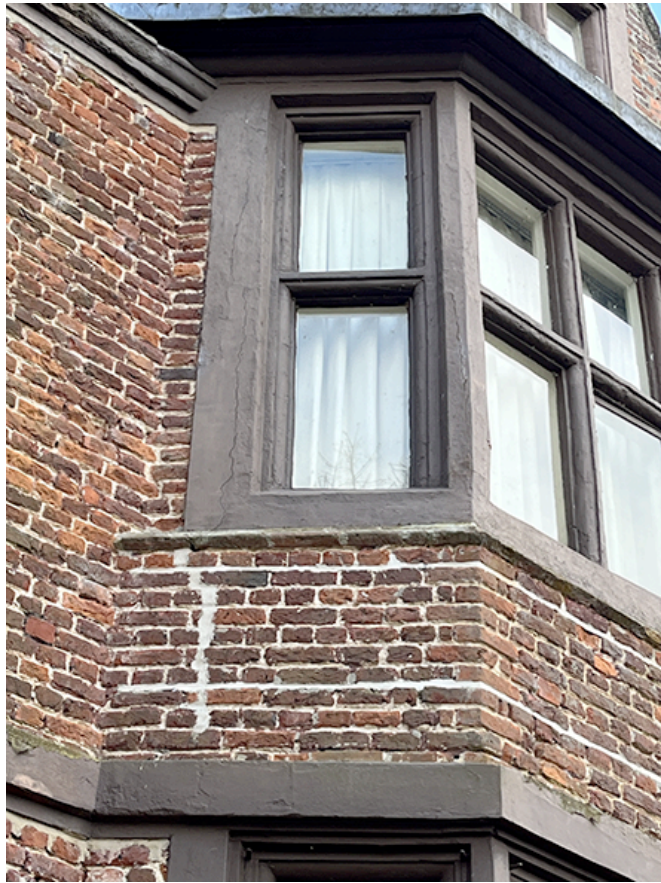
1st floor north bay

Bay detaching from front wall

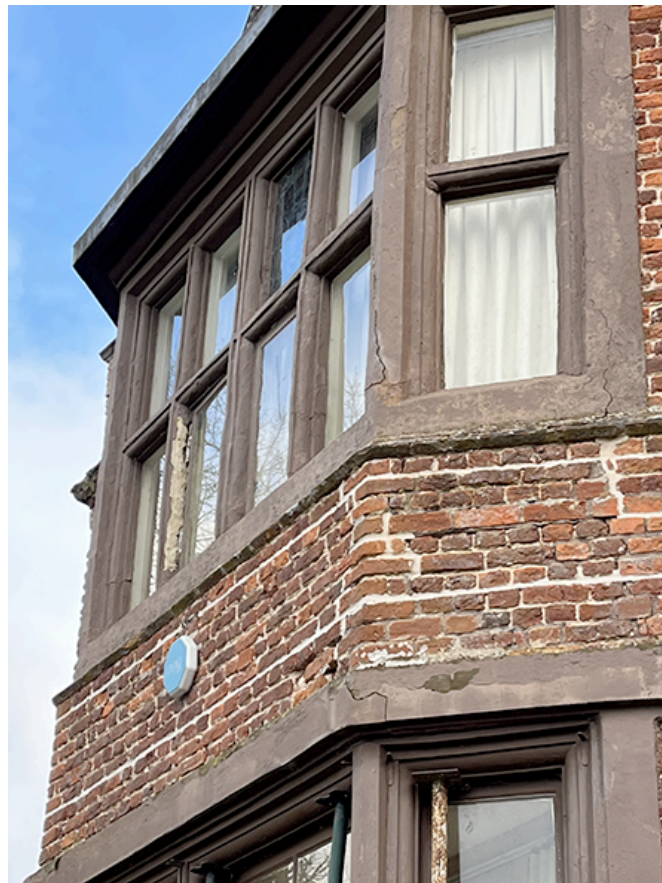
1st floor north bay

Bay detaching from front wall

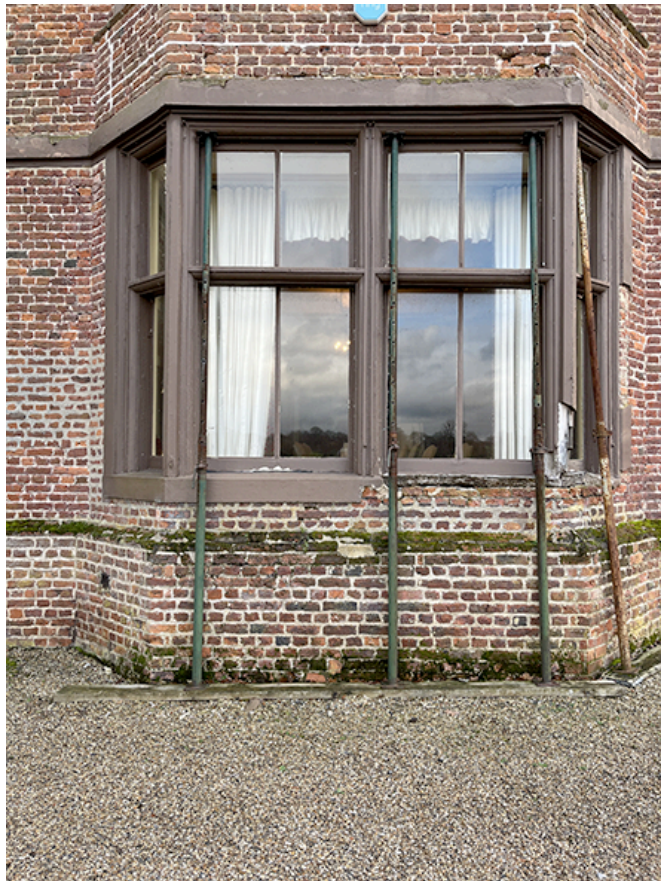
Ground floor north bay

Window head supported on acroprops

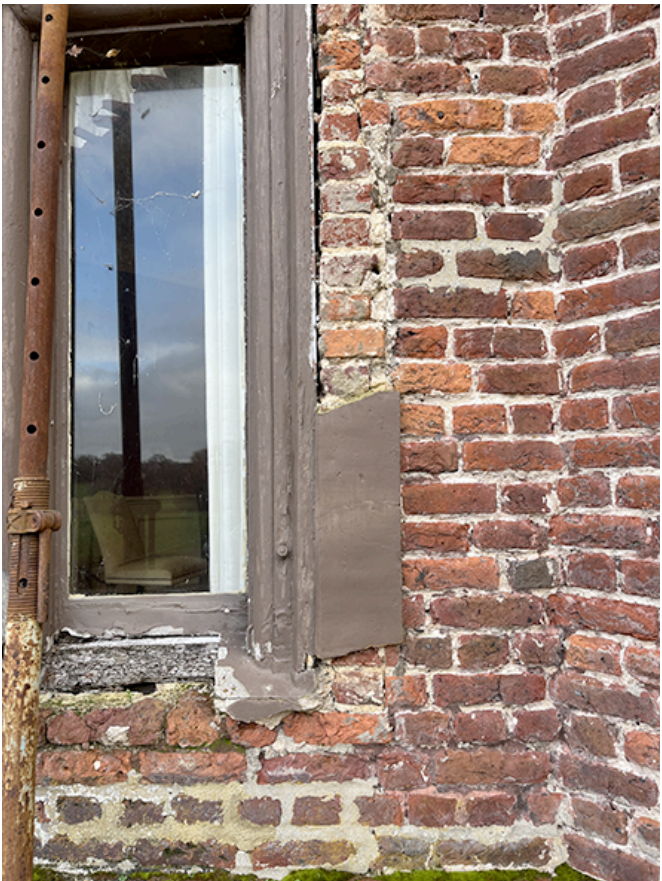
Ground floor north bay

Failed timber and render window surround

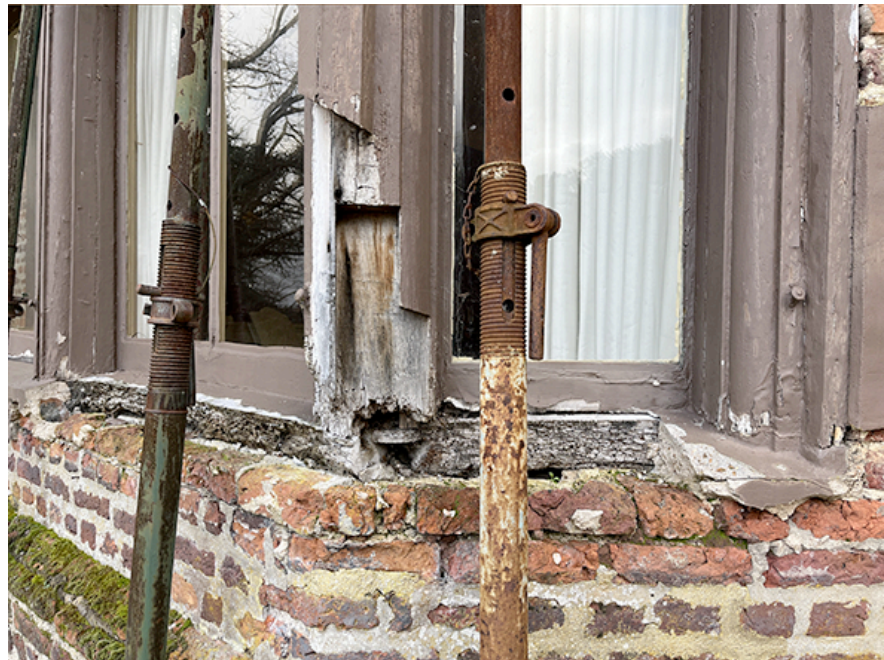
Ground floor snorth bay

Failed timber corner detail and cill
