**STANLAKE PARK MANOR HOUSE**  
**PHOTOSHEETS**

NTS  
Janaury 2025

**2401-EX-11**

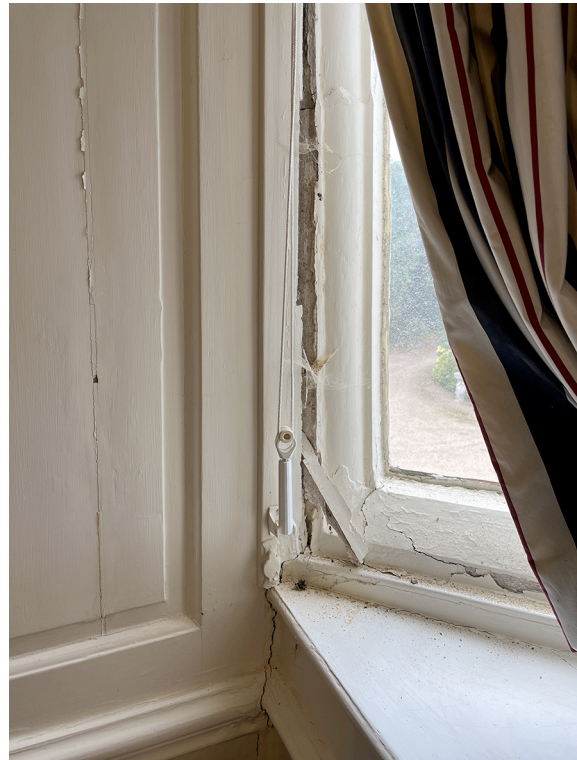
1st floor north bay  
Bay detaching from front wall

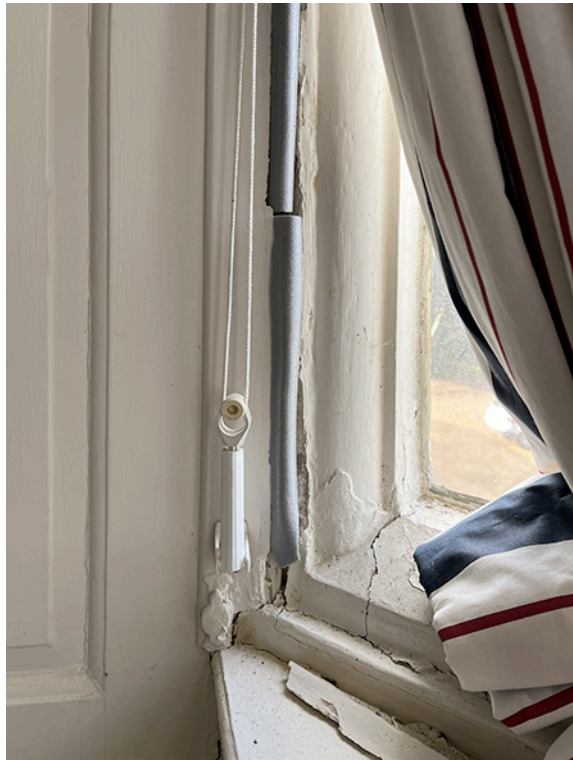
1st floor north bay  
Close up showing foam pipe insulation stuffed into gap between window and wall

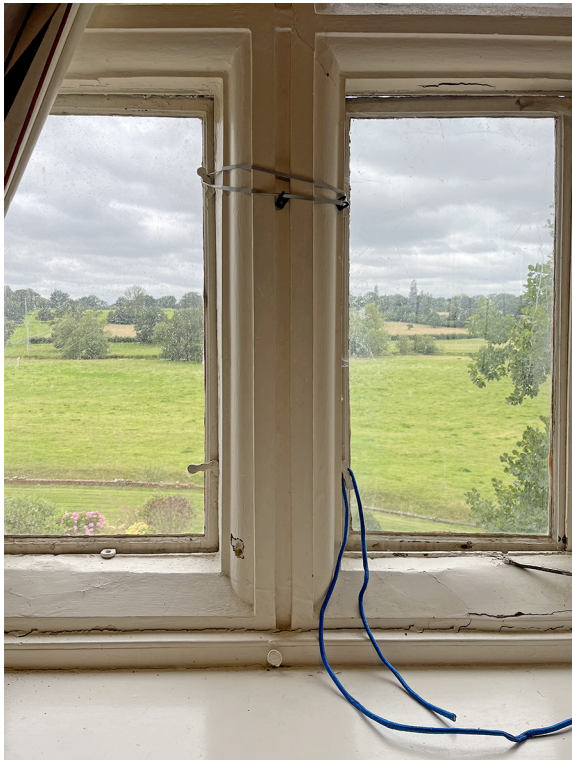
1st floor north bay  
Central mullion and casement windows  
Casements do not close and frame is no longer weatherproof

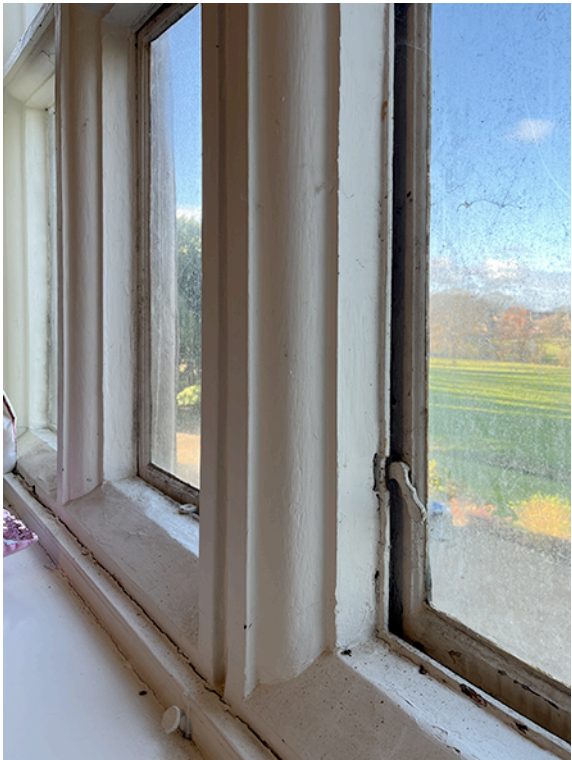
1st floor north bay  
Central mullion and casement windows  
Casements do not close and frame is no longer weatherproof

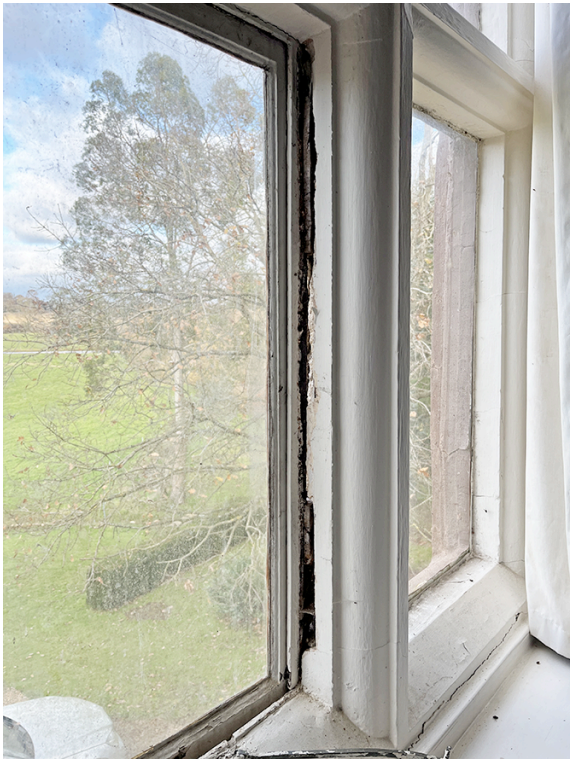
1st floor north bay  
Mullion and casement windows  
Casements do not close and frame is no longer weatherproof

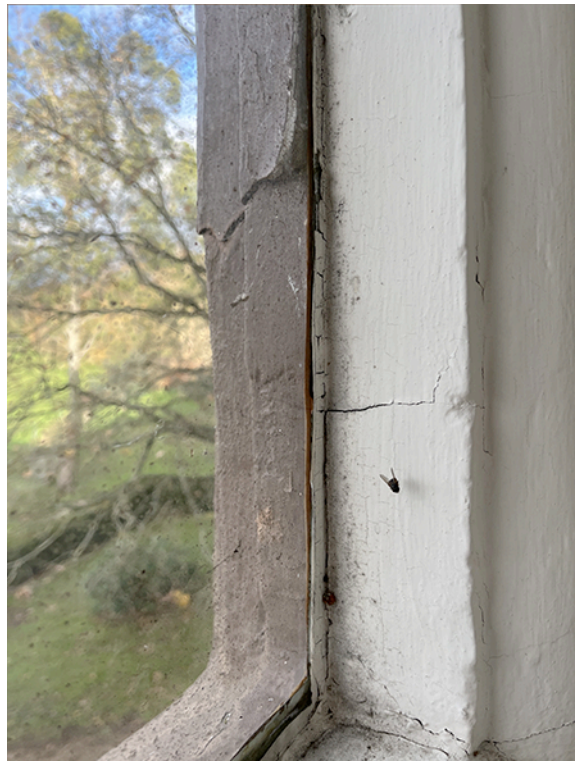
1st floor north bay  
Close up showing fixed light fixing and poor cement based repair to external stonework which intself has now failed

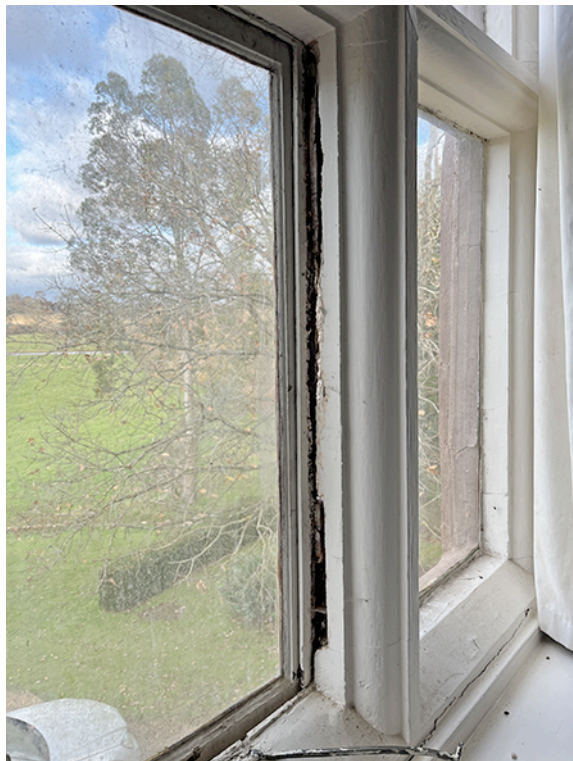
1st floor north bay  
South east mullion showing poor quality cement based stonework repair

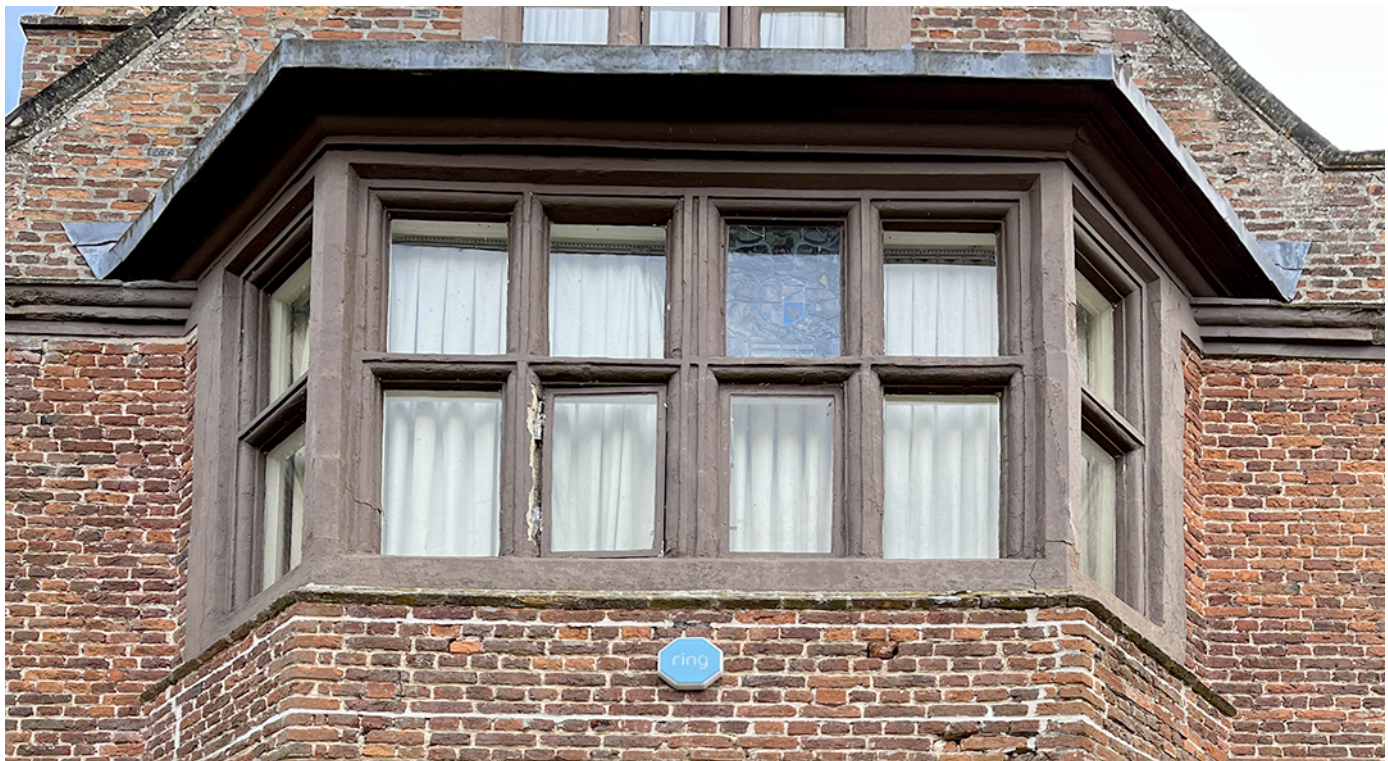
1st floor north bay  
stonework in very poor conditon, with extensive cement based repairs (now in very poor condition) and inappropriate paint finish
