**STANLAKE PARK MANOR HOUSE**

**PHOTOSHEETS**

**2401-EX-12**

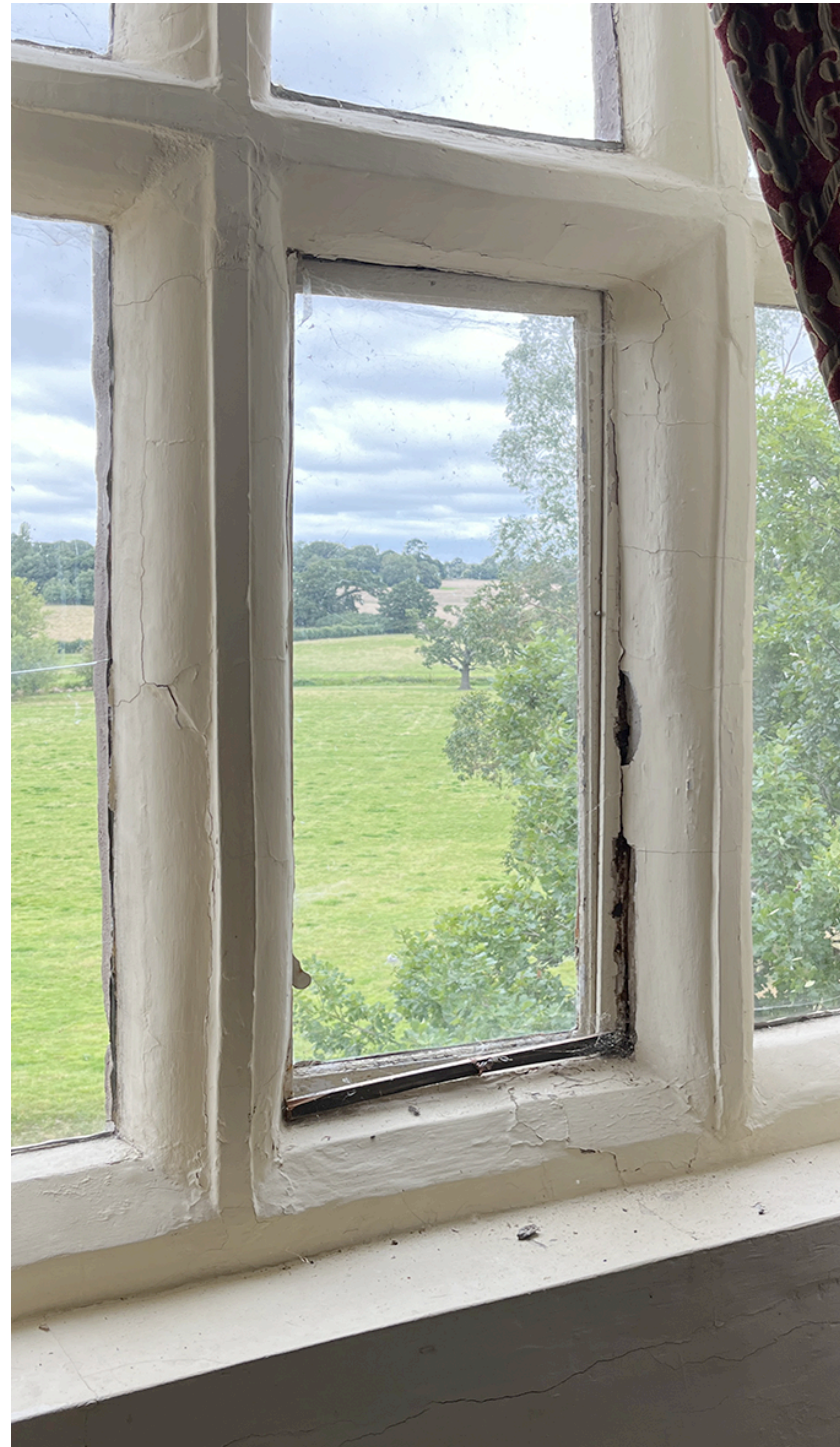
2nd floor

Render in poor condition internally and externally. External render spalling

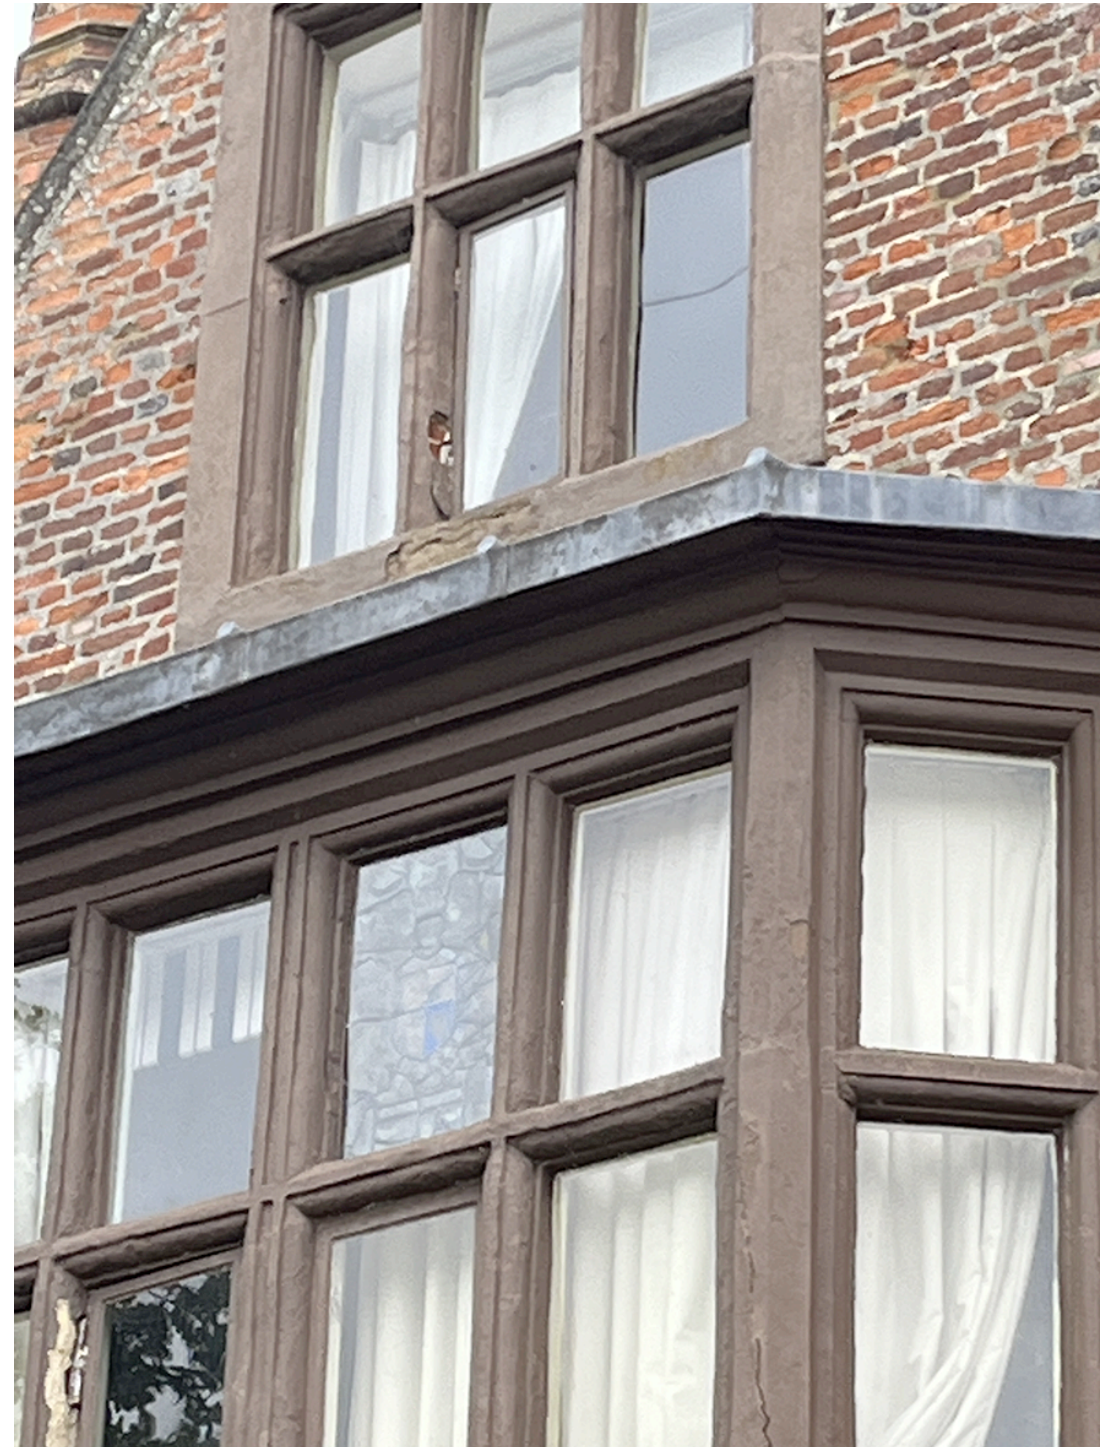
Window cannot be closed due to structural movement and construction detail of window binding on internal render
