| Job | <b>STANLAKE PARK MANOR HOUSE</b> |
| Subject | <b>HERITAGE ASSESSMENT AND IMPACT STATEMENT</b> |
| Date | June 2025 |
| Ref | 2401-17846 |

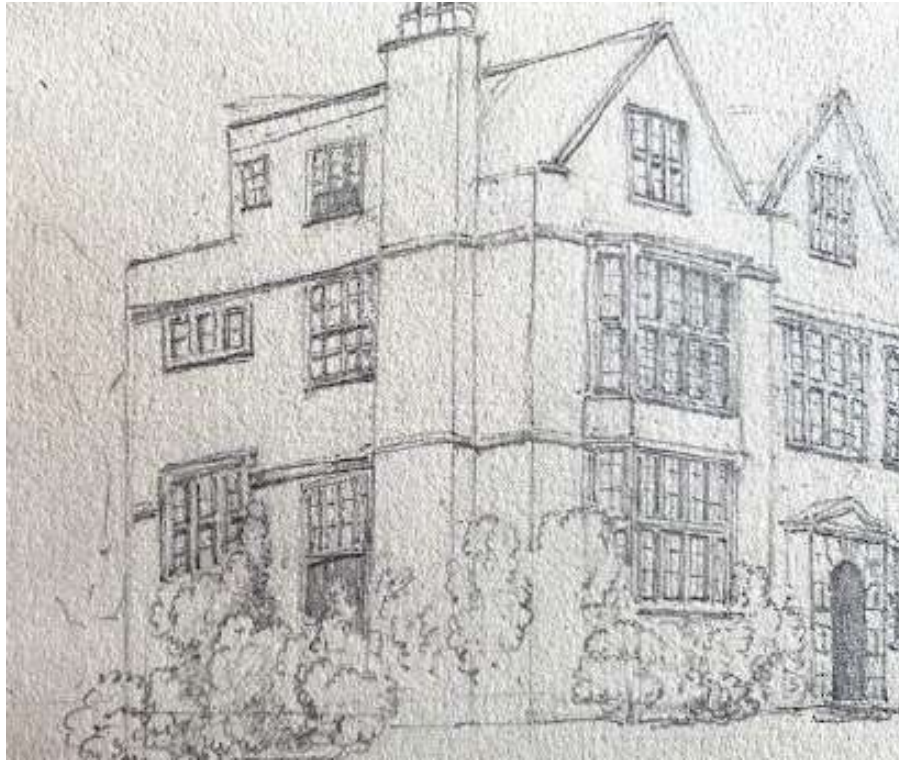
*Anonymous sketch, 1828*

The sketch from 1828 shows a larger scale view of the north corner, which confirms the window mullion layout with leaded window panes.

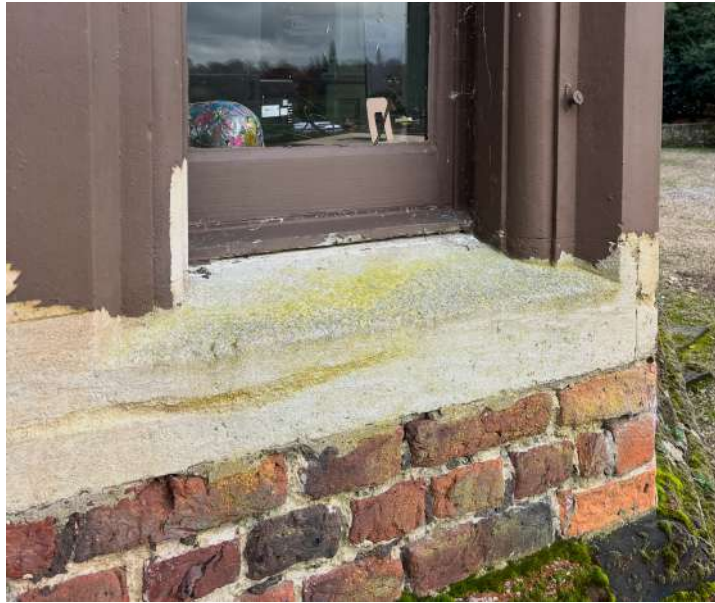
Right hand bay, ground floor, showing unpainted sandstone, painted sandstone mullions, and painted Victorian/Edwardian sash window

Replace the ground floor window frames and surrounds to the left and right canted window bays in sandstone mullions, reflecting the pre 19<sup>th</sup> century mullion arrangement of 4 panels over 4 panels, with fixed glass panes and casements as shown.

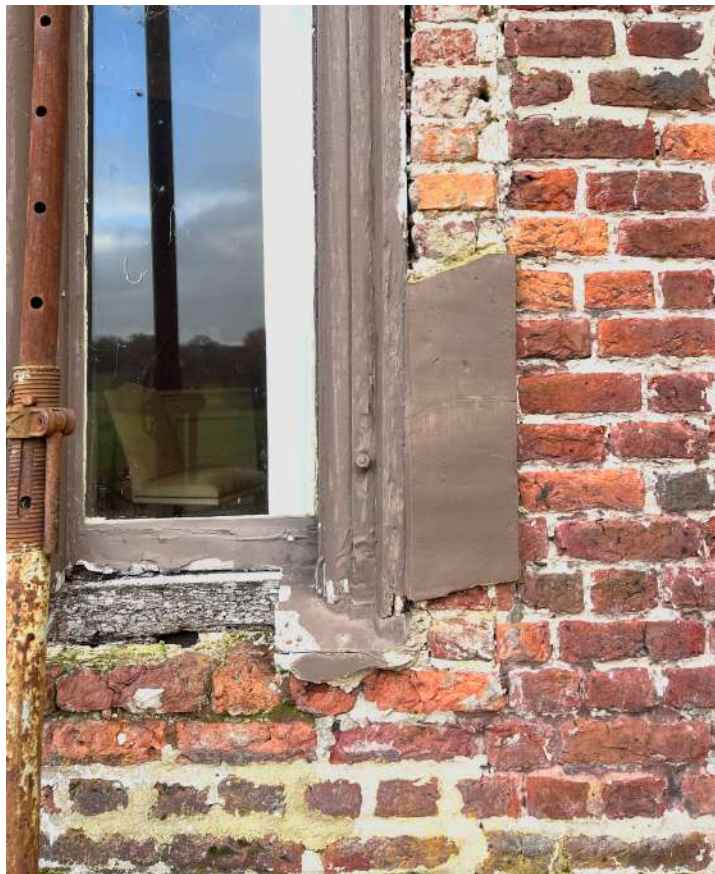
Left hand bay ground floor detail showing timber window and surround, timber cill, and render side panel, all in very poor condition. Also note tuck pointing now disappeared, with cement mortar repairs

**Condition**      As noted above, the ground floor left hand bay is in very poor condition. The window mullions are formed in timber, which has rotted badly, causing the brickwork spandrel panel above to drop. The brickwork has been repaired with helibar reinforcement and lime mortar pointing, but the window bay has continued to collapse, which have necessitated acrow prop support (see photos).

**Assessment**   Robin Crane (RIBA SCA) and specialist conservation structural engineer Clive Dawson of Hockley Dawson have inspected the front elevation, the related interiors, and the collapsing projecting bay. Clive Dawson's assessment is that the brickwork and foundations below the ground floor window are structurally sound, but that the brickwork above ground should be rebuilt and the ground floor window replaced.

Carefully remove the facing brickwork and number each brick, for reassembly in the correct order. Carefully remove the ground timber window. Carefully remove the 1<sup>st</sup> floor stone window, and store the stained-glass window insert for reuse in the same location.

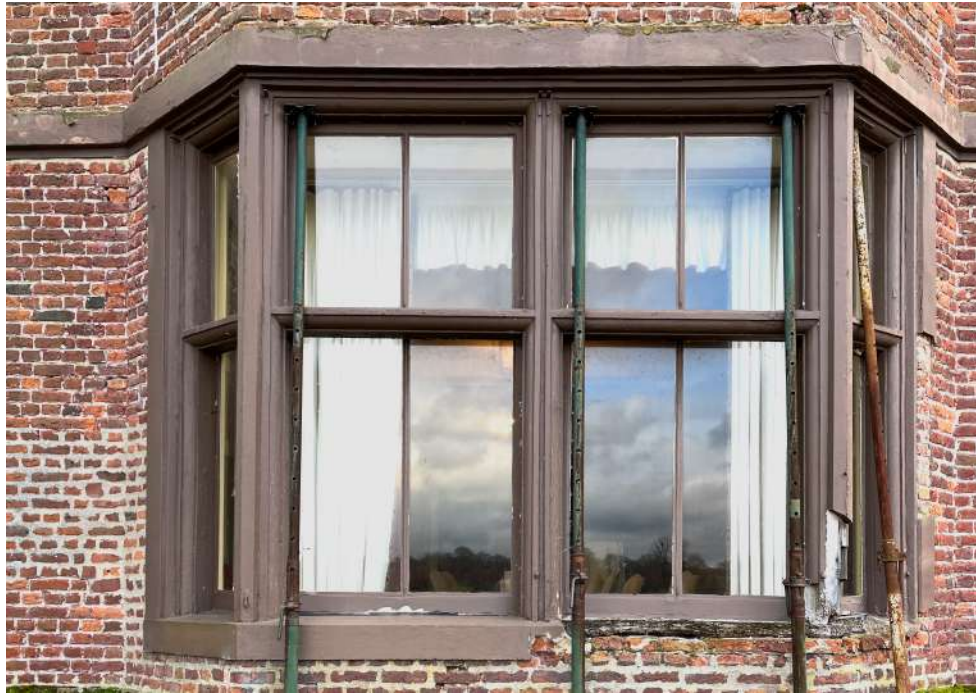
*Left hand bay ground floor showing timber window surround, timber cill, and render side panel, all in very poor condition. Also note tuck pointing now disappeared, with lime mortar repairs and inappropriate cement-based repairs (left hand side wall, lower section)*
