**Tree condition and hazard survey of trees  
at**

**Hill House, Basingstoke Road, Spencers Wood, RG7 1AL**

30<sup>th</sup> October 2025

J1643

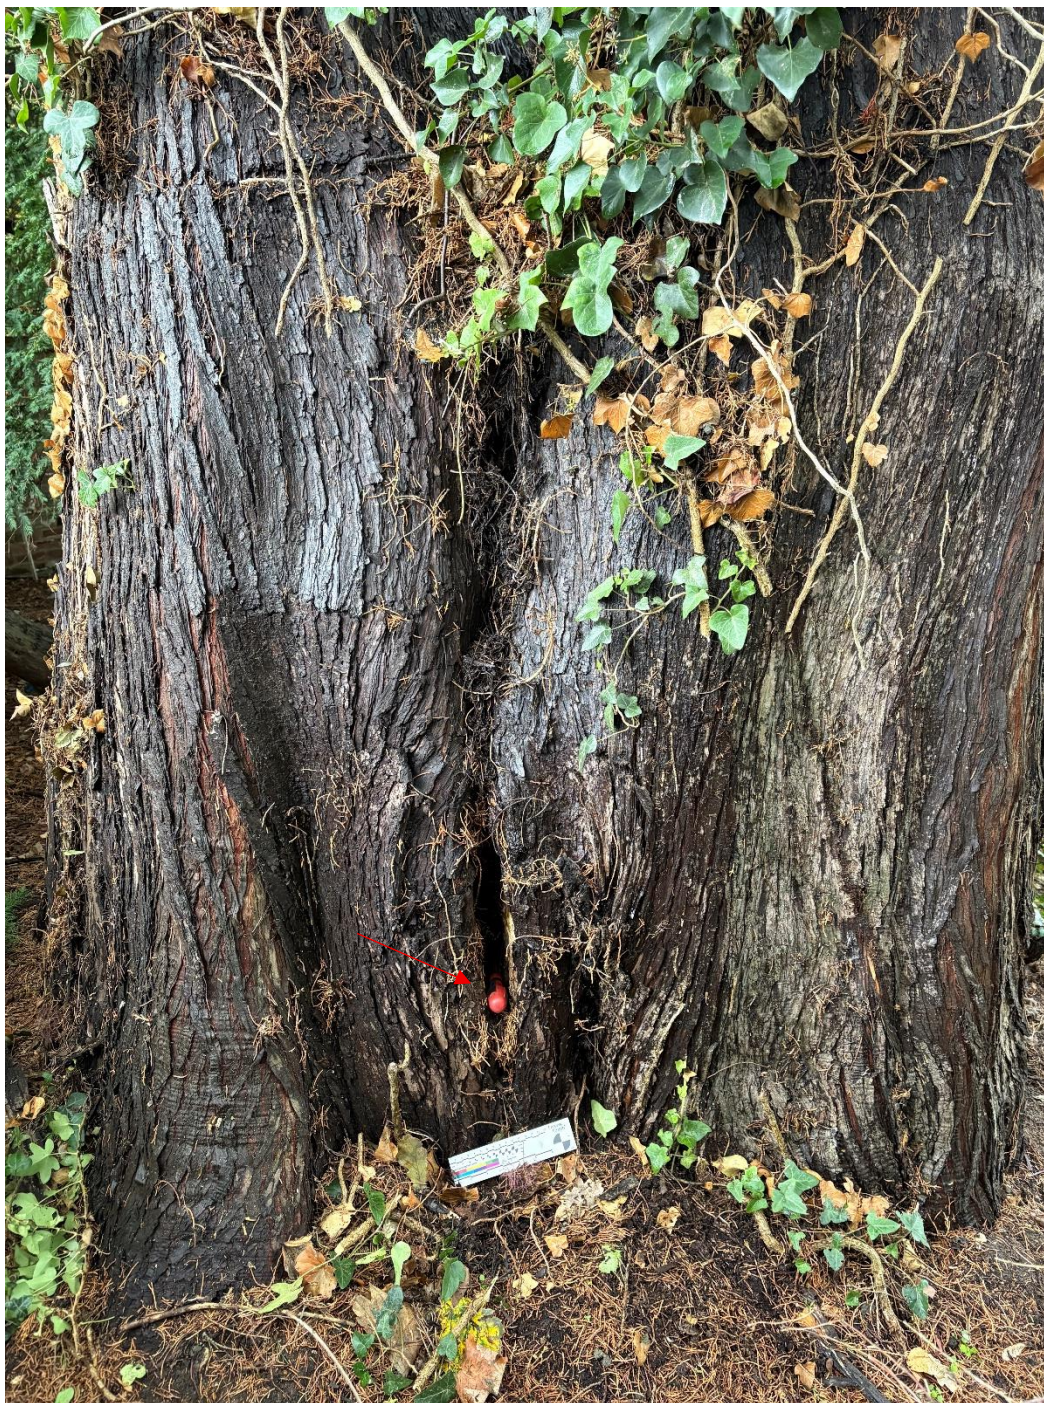
| Designation | Reference number | Species | Height (m) | Age class | Physiological condition | Structural condition | Condition notes | Condition related tree works | Priority |
|---|---|---|---|---|---|---|---|---|---|
| T | 2190 | Monterey cypress <i>Cupressus macrocarpa</i> | 25 | Mature | Good | Poor | Typical series of branch failures throughout. Two stems from base with significant decay at the union. | Crown reduction from 25m to a final height of 18m with a horizontal radial canopy spread of 8m. Reason: to reduce the potential for structural failure. Install flexible cable bracing. Reason to reduce the potential for structural failure. | High |

SAL2 2190 with split on north side and decay between the two stems; red handle of 40cm long series screwdriver identified by red arrow. Full extent of depth not identified.

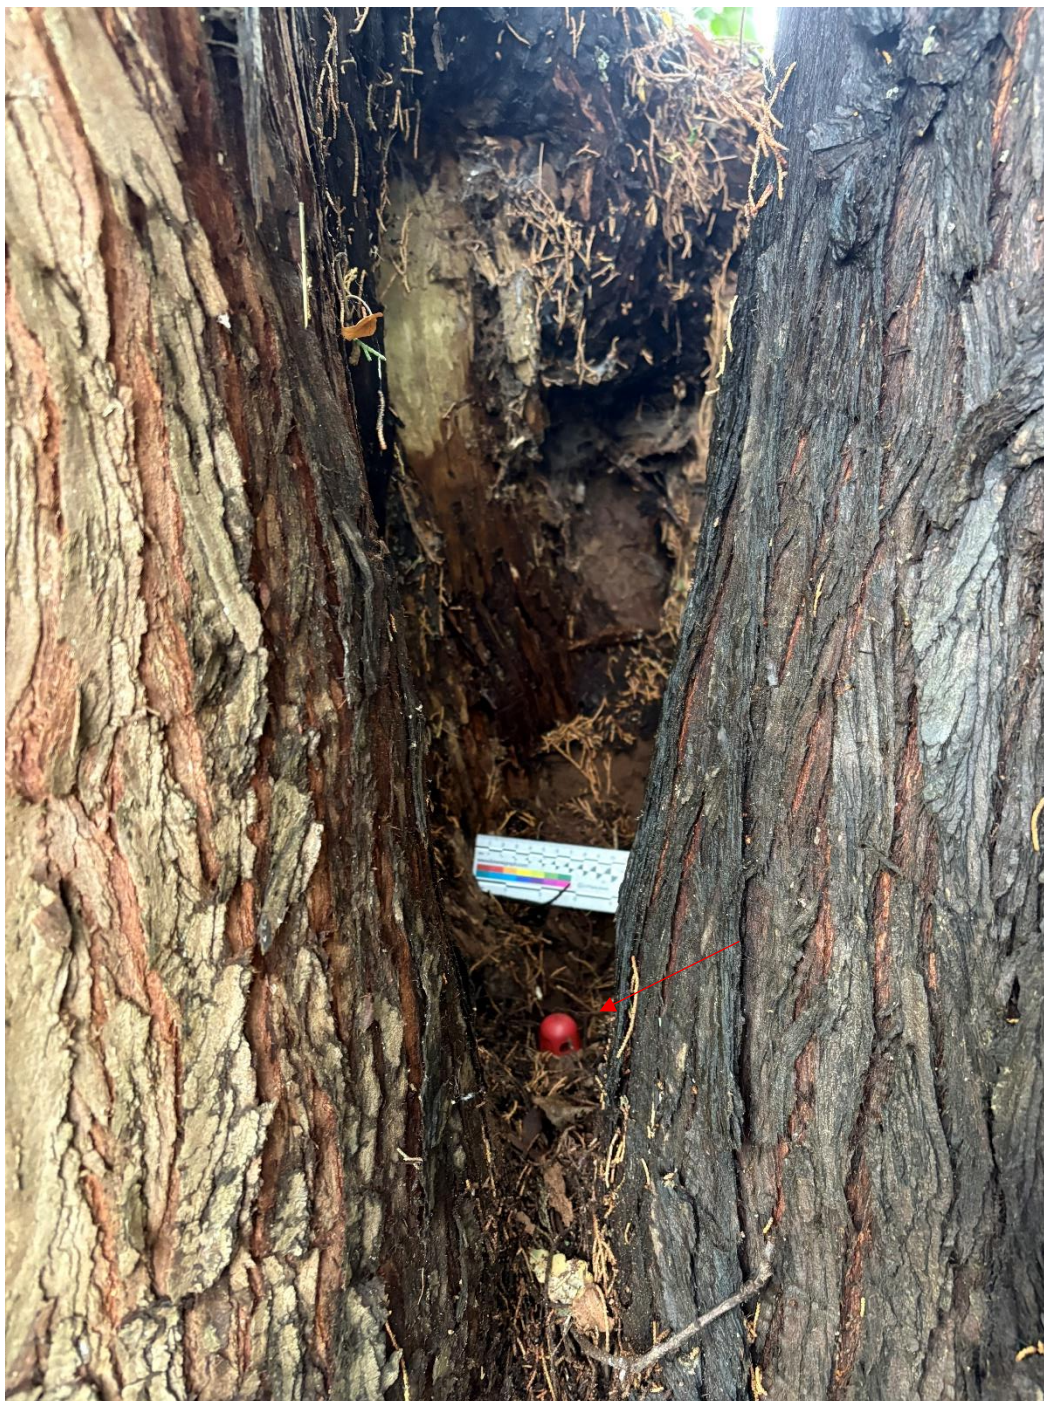
SAL3 2190 with split on south side and decay between the two stems; red handle of 40cm long series screwdriver identified by red arrow. Full extent of depth not identified.

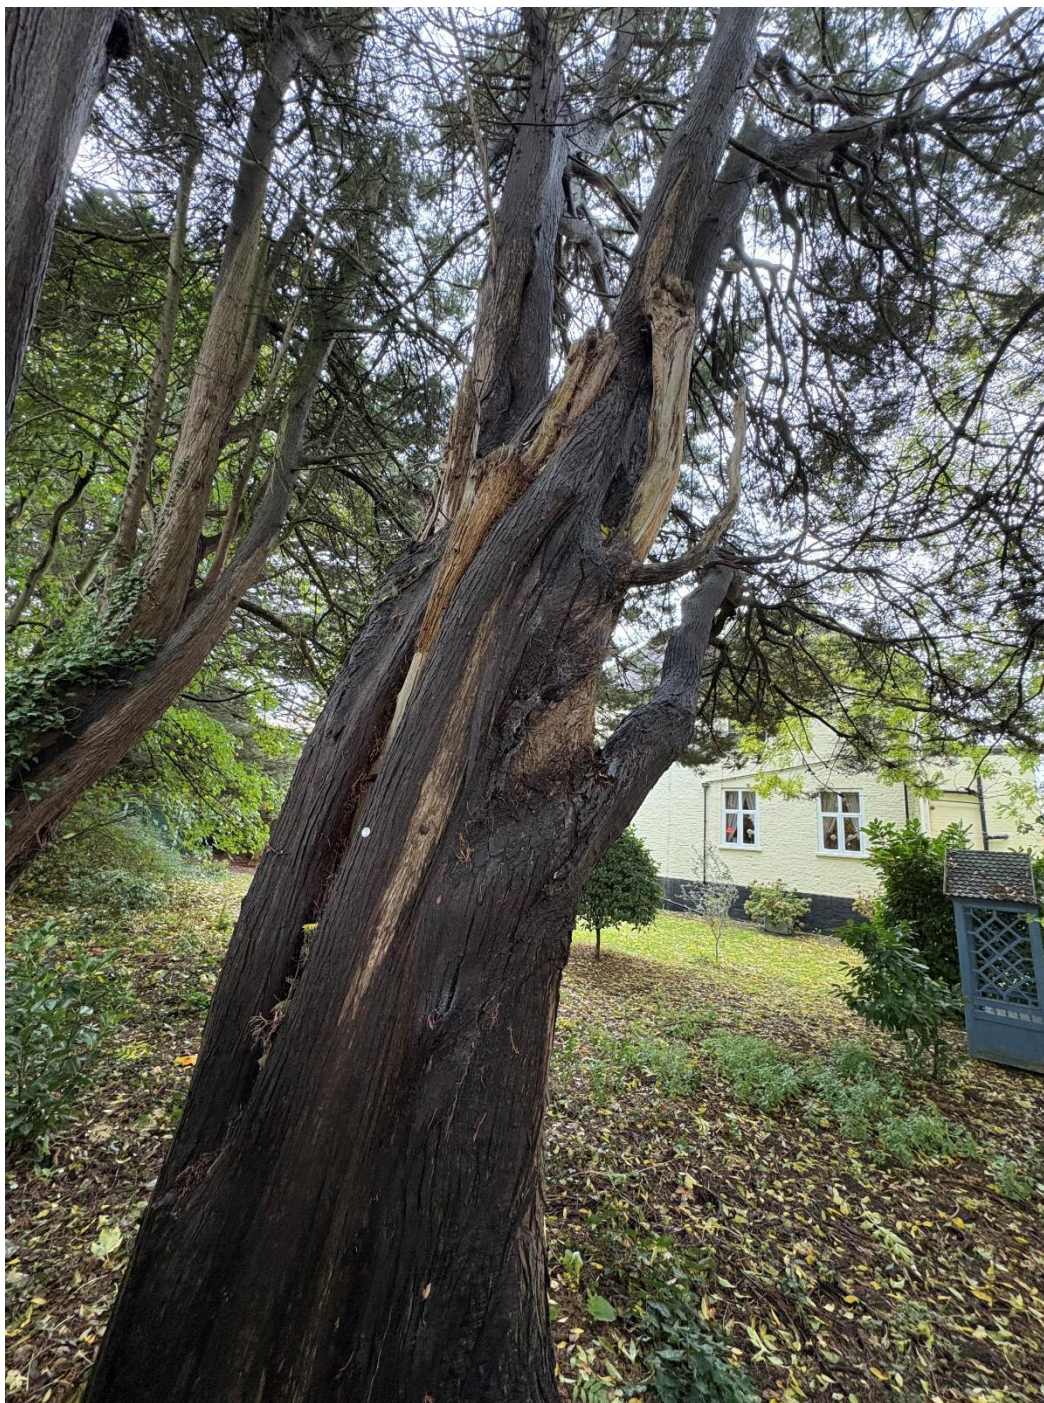
| Designation | Reference number | Species | Height (m) | Age class | Physiological condition | Structural condition | Condition notes | Condition related tree works | Priority |
|---|---|---|---|---|---|---|---|---|---|
| T | 2192 | Monterey cypress<br><i>Cupressus macrocarpa</i> | 23 | Mature | Good | Poor | Asymmetrical canopy towards the west and dwelling. Top previously lost pruned with mature regrowth. Series of branch failures throughout with subsequent decay on the tension side. | Crown reduction from 23m to a final height of 18m with a horizontal radial canopy spread of 6m.<br>Reason: to reduce the potential for structural failure. | Moderate |

SAL4 2192 with decay on the upper / tension side of the stem.

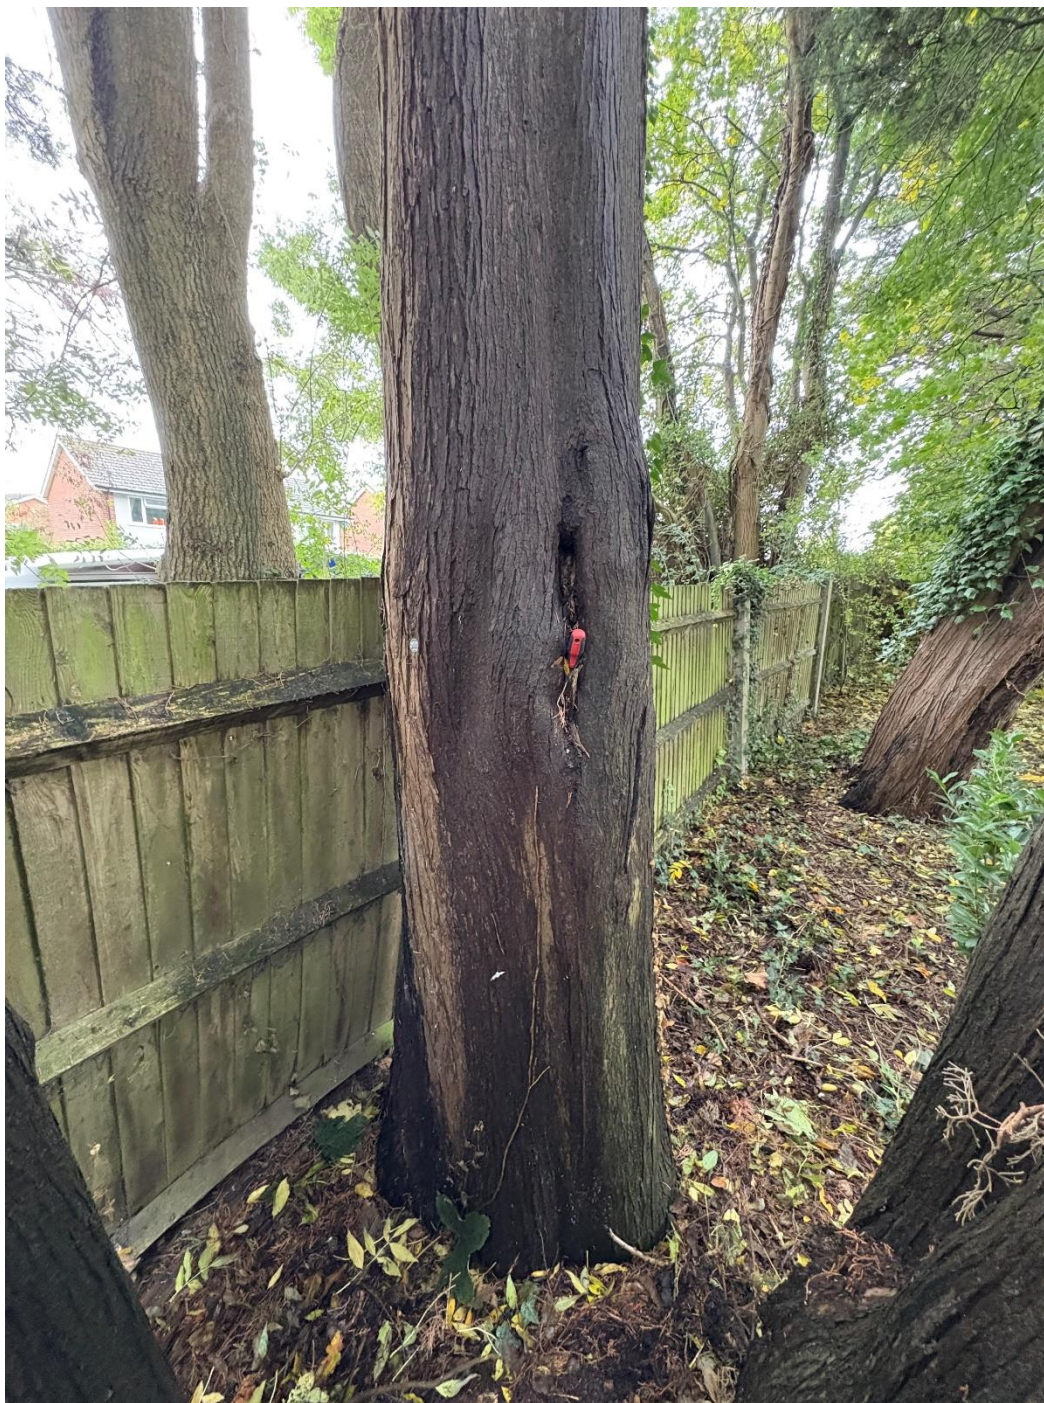
| Designation | Reference number | Species | Height (m) | Age class | Physiological condition | Structural condition | Condition notes | Condition related tree works | Priority |
|---|---|---|---|---|---|---|---|---|---|
| T | 2193 | Monterey cypress<br><i>Cupressus macrocarpa</i> | 23 | Mature | Good | Poor | Asymmetrical canopy towards the east and highway. Top previously lost or pruned with mature regrowth. Series of branch failures throughout with subsequent decay. Cavity at 1.5m with decay extending down towards the roots. | Crown reduction from 23m to a final height of 18m with a horizontal radial canopy spread of 5m.<br>Reason: to reduce the potential for structural failure. | Moderate |

SAL5 2193 with decay extending downwards. Full extent of depth not identified.

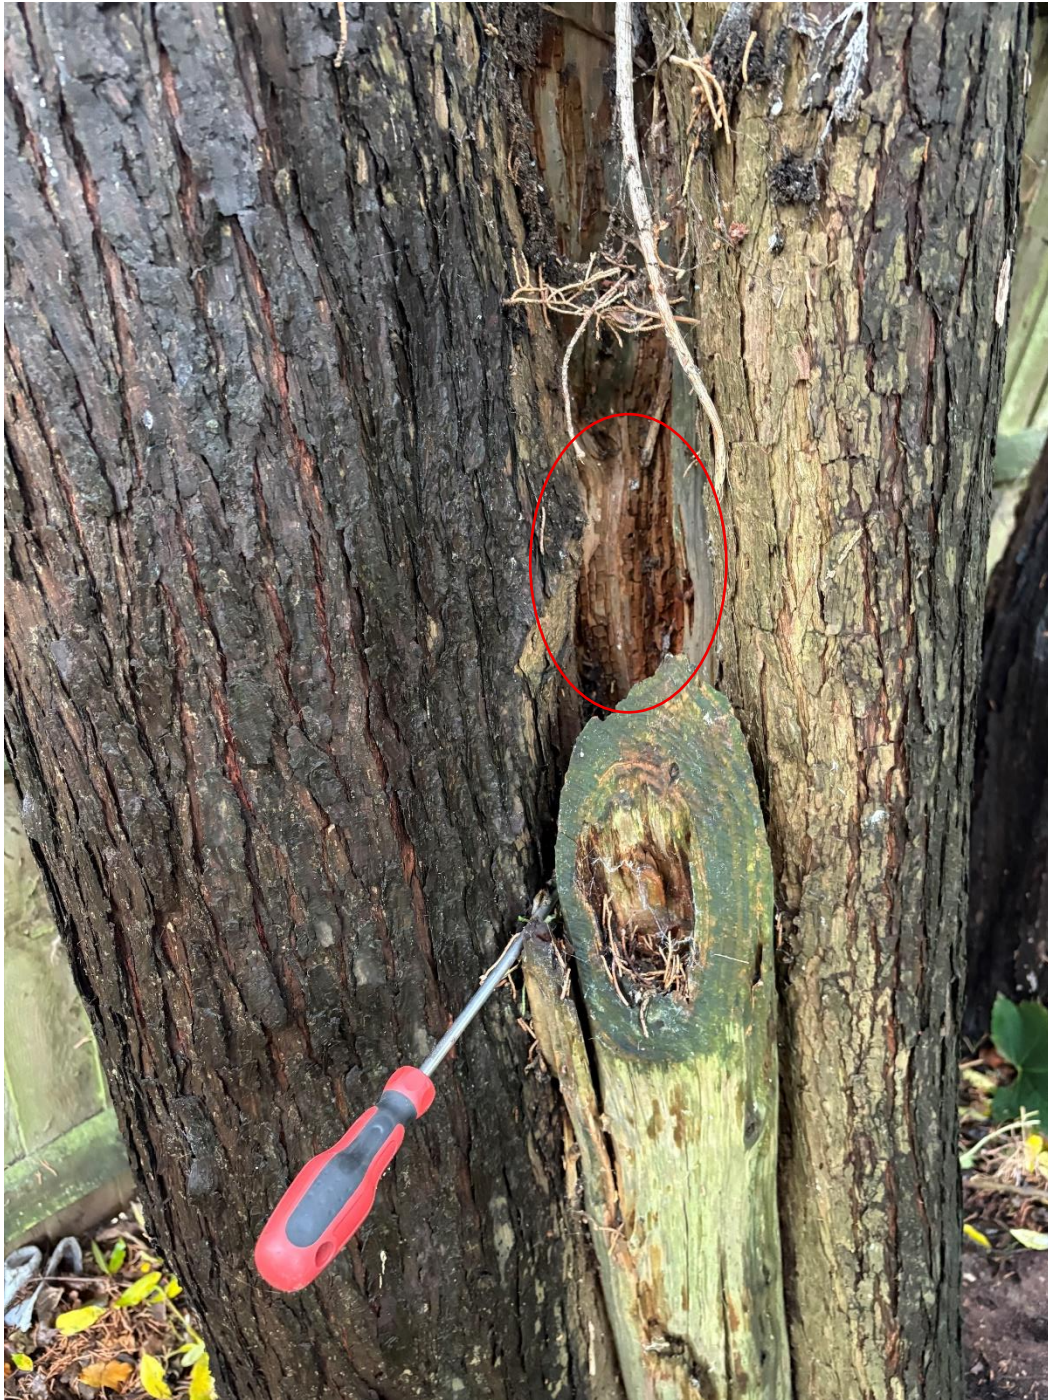
SAL6 2160 with brown rot evident as shown by red oval.
