### **Resistograph Report**

**Oakfield Court, Wokingham**  
**RG41 2SW**

Date: 4<sup>th</sup> July 2025

Ref: TH 5320

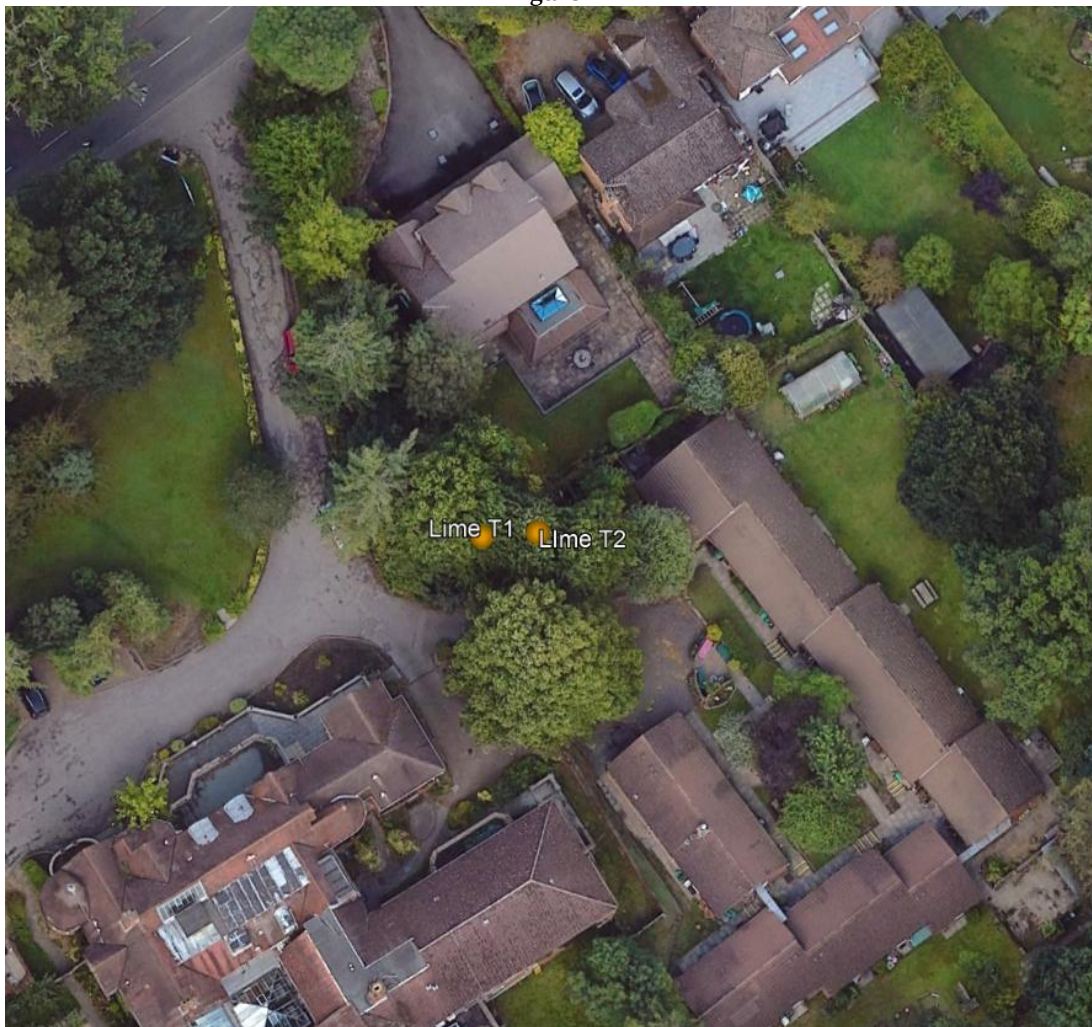
Figure 1

Further to a recent visual tree assessment (VTA) of two mature Lime trees (see Figure 1), historic fire damage was noted and so a resistograph test was carried out to determine the extent and significance of any decay within the trees' lower stems.

To summarise, apart from continuing with its current pruning regime, no work is required for Lime T1, but Lime T2 should be heavily reduced and managed as a smaller tree.

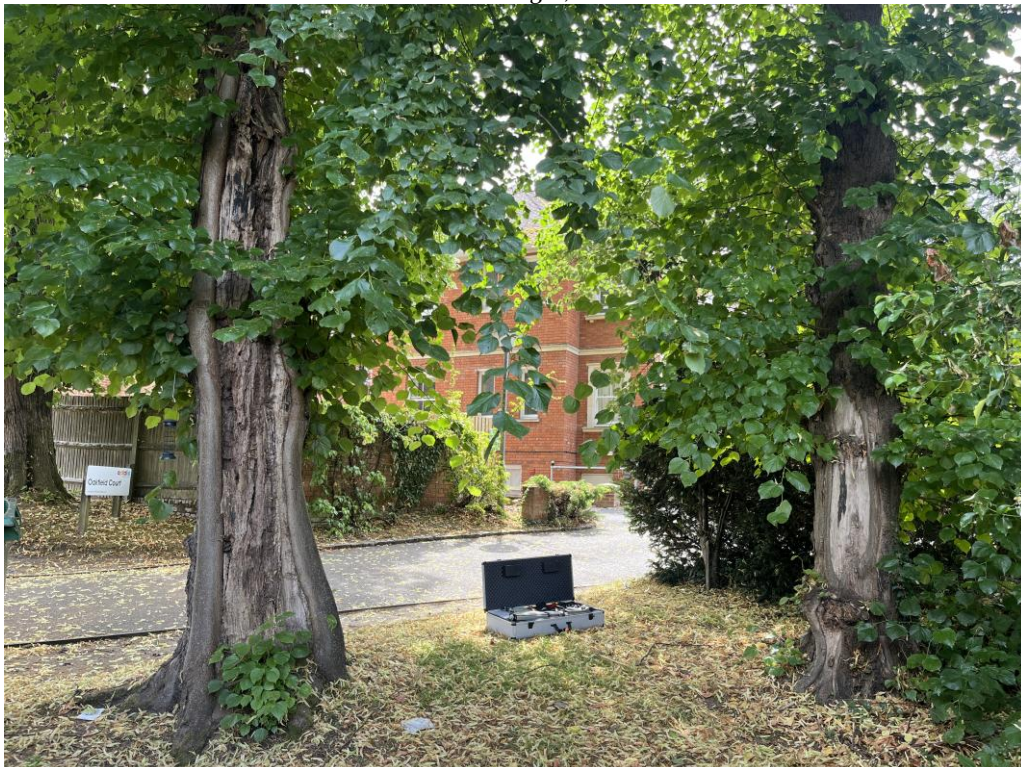
6.3 Both trees have historical fire damage on their lower stems. T1 isn't too badly affected but there is slight decay showing in the top part of the lower stem of T2.

6.4 Both trees are quite quickly laying down reaction wood along the edges of the wounds.

**Photo 1.** T1 is on the right, T2 is on the left

9.1 Both trees are already managed by light crown reductions. Lime T1 should continue this management (re-pruning about every 5 years), but the Lime T2 should be reduced slightly further than this to reduce the sail effect of the crown acting on the lower stem.

9.2 I would suggest that a crown reduction of around 6-8m in total height and about 3-4m in total width would suffice; the tree should then be managed at this smaller size with regular crown reductions.

9.3 Lime T2 should be re-tested with a Resistograph about every 5 years to track the progress of the decay. It might be the case that a further reduction in height becomes necessary.

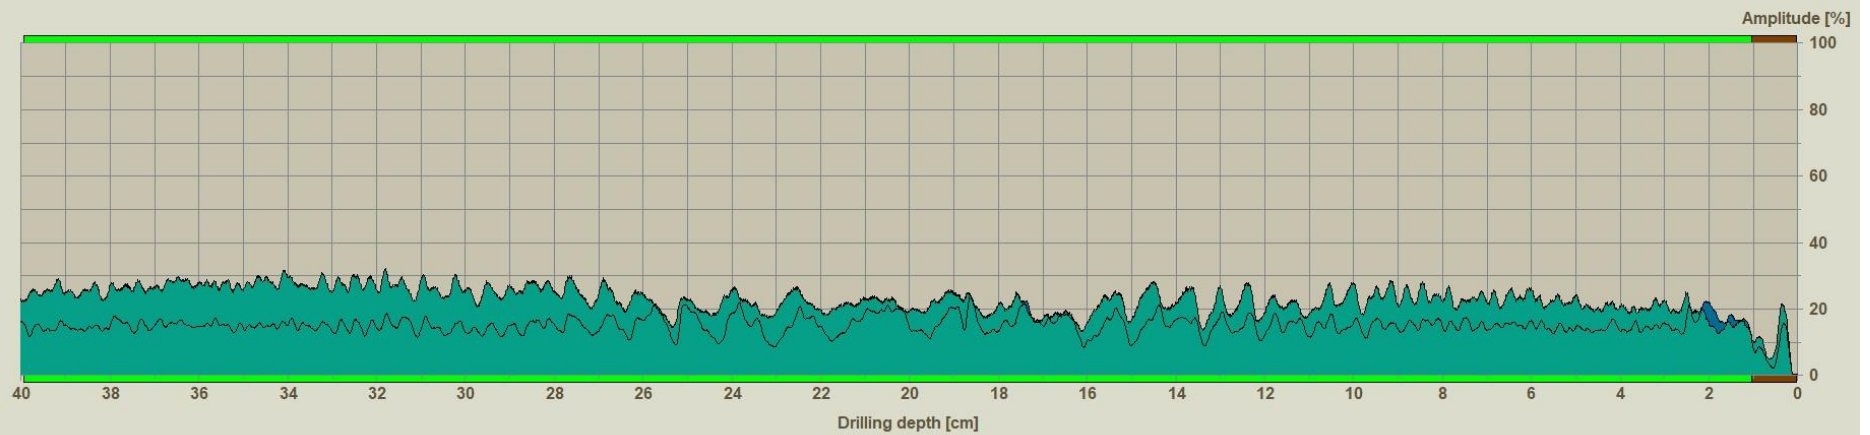
| ID number | : LimeT1 1.5m E | Needle state: | --- | Level | : |

8.1 The resistograph test for Lime T1 showed that, although there is a large wound in the stem, the decay is superficial and there is barely any decay present.

| From 0.02 cm to 1.03 cm | : Bark |
| From 1.05 cm to 39.95 cm | : Sound wood |

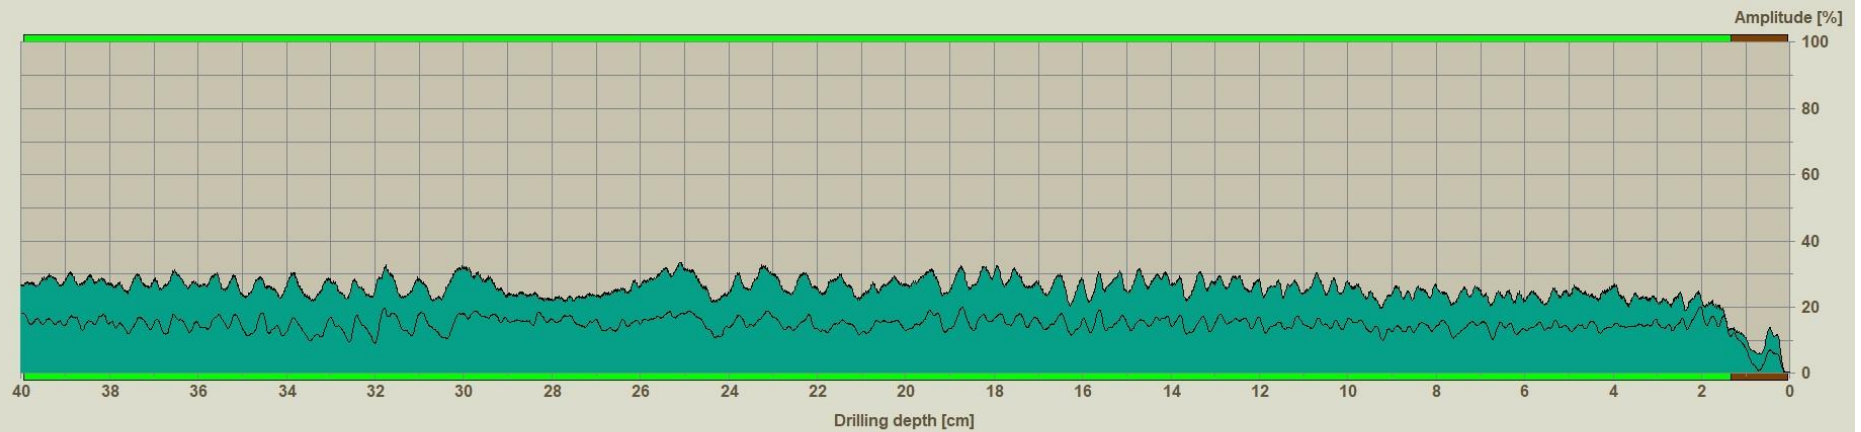
| ID number | : LimeT1 1.5m S | Needle state: | --- | Level | : |

| From 0,05 cm to 1,35 cm | : Bark |
| From 1,35 cm to 39,95 cm | : Sound wood |

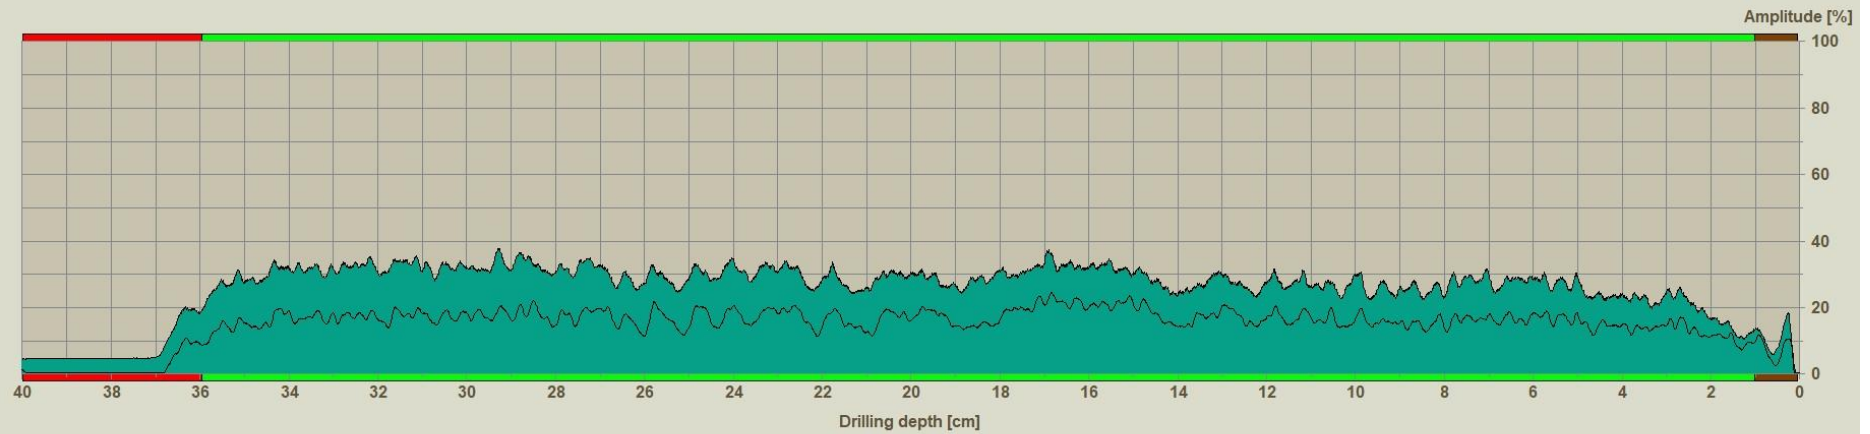
| ID number | : LimeT1 1.5m W | Needle state: | --- | Level | : |

| From | 0,05 cm to | 1,01 cm | : Bark |
| From | 1,01 cm to | 36,00 cm | : Sound wood |
| From | 36,97 cm to | 39,98 cm | : Cavity |

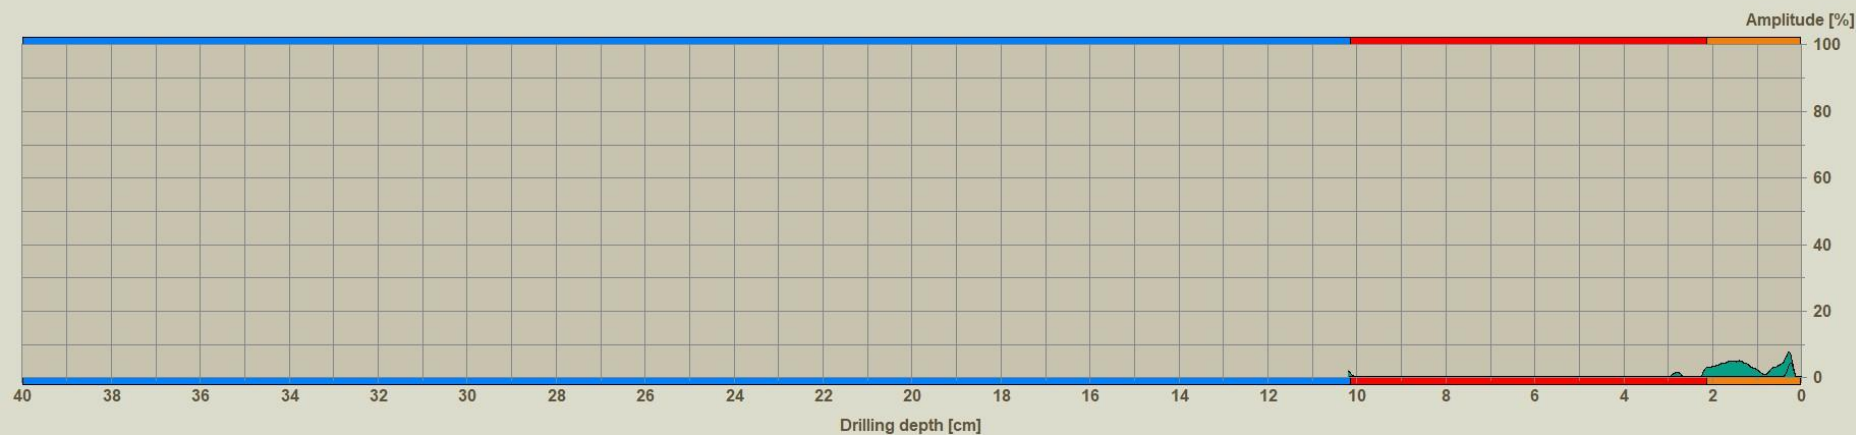
| ID number | : LimeT2 1.5m N | Needle state: | --- | Level | : |

\* Note. The drill automatically extracted at 20mm, but when tested with a screwdriver, there was solid wood after about 40-50mm (the drill extracted because of the thin layer of decayed wood).

| From | 0,02 cm to | 2,17 cm | : Degraded wood |
| From | 2,15 cm to | 10,16 cm | : Cavity |
| From | 10,14 cm to | 39,98 cm | : Needle exit |

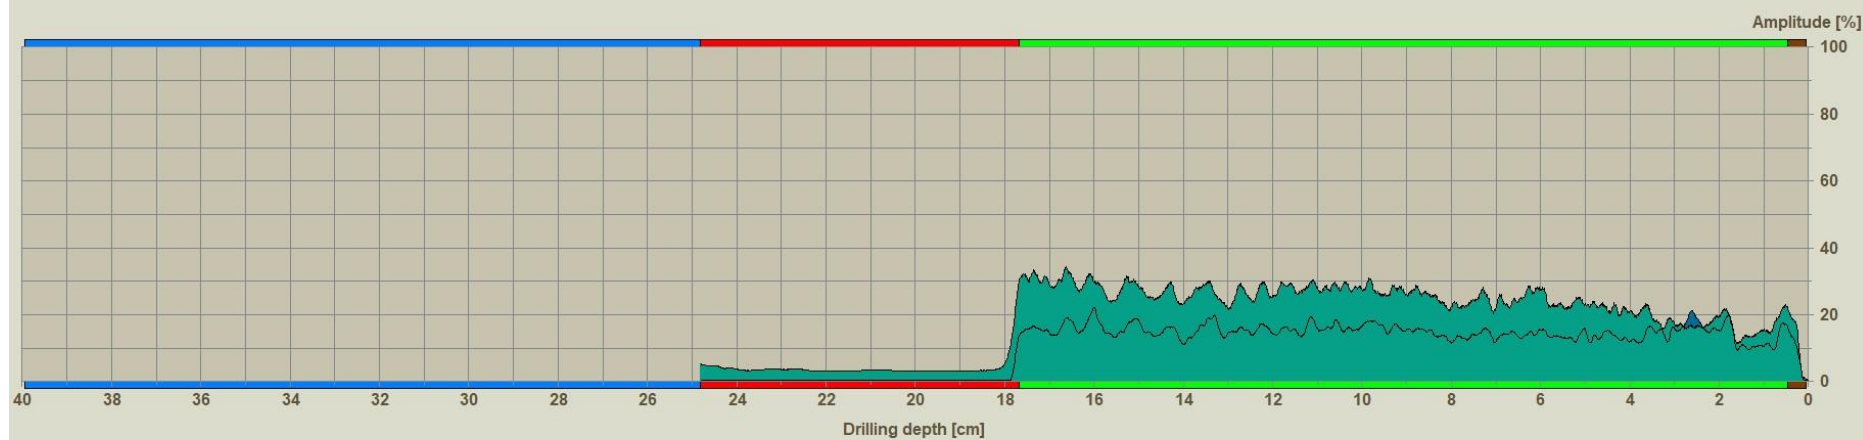
| ID number | : LimeT2 1.5m E | Needle state: | --- | Level | : |

| From | 0.05 cm | to | 0.48 cm | : | Bark |
| From | 0.48 cm | to | 17.67 cm | : | Sound wood |
| From | 17.67 cm | to | 24.81 cm | : | Cavity |
| From | 24.81 cm | to | 39.95 cm | : | Needle exit |

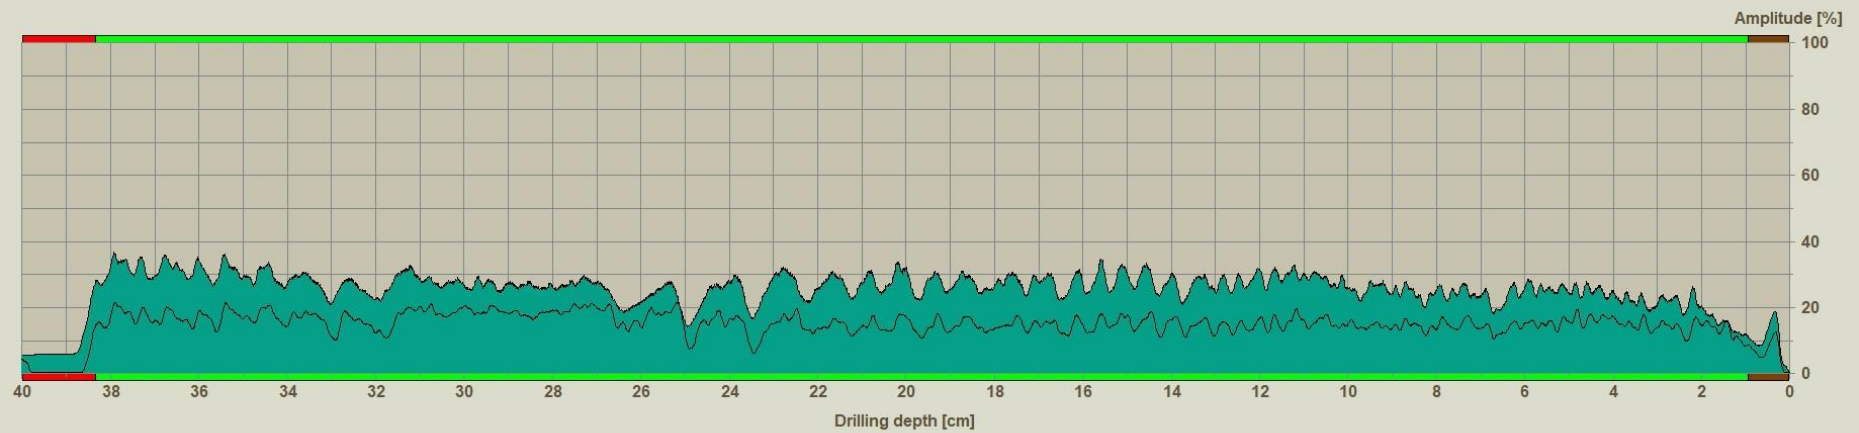
| ID number | : LimeT2 1.5m S | Needle state: | --- | Level | : |

| From | 0,02 cm | to | 0,96 cm | : | Bark |
| From | 0,94 cm | to | 38,33 cm | : | Sound wood |
| From | 38,33 cm | to | 39,98 cm | : | Cavity |

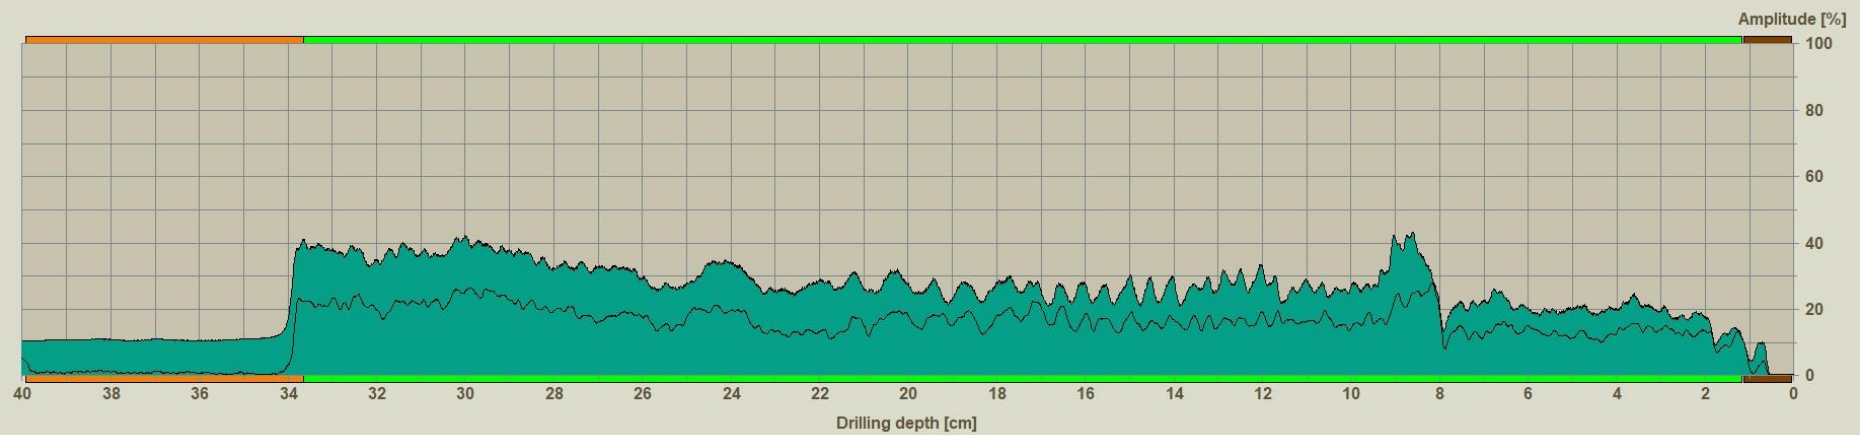
| ID number | : LimeT2 1.5m W | Needle state: | --- | Level | : |

| From | 0,05 cm to | 1,14 cm | : Bark |
| From | 1,17 cm to | 33,66 cm | : Sound wood |
| From | 33,66 cm to | 39,93 cm | : Degraded wood |

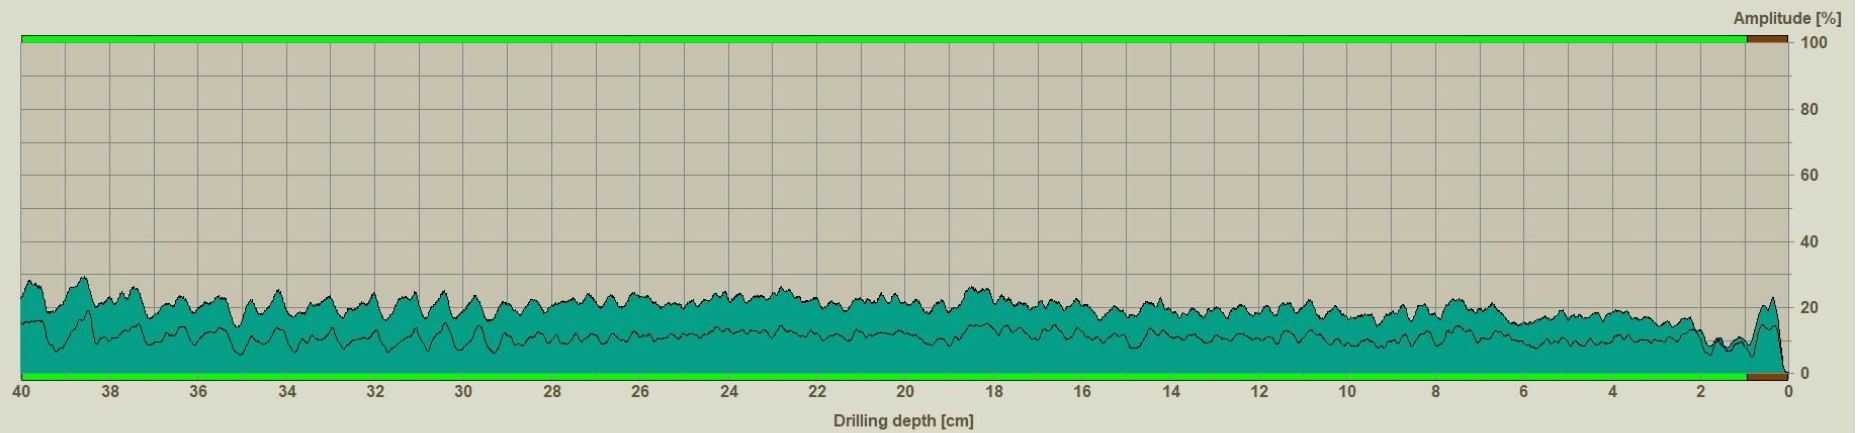
| ID number | : LimeT3C | Needle state: | --- | Level | : |

| From 0,02 cm to 0,94 cm | : Bark |
| From 0,96 cm to 39,98 cm | : Sound wood |
