**RE: Red oak tree at 16 Pound Lane, Sonning, RG4 6XE**

Thank you for your instruction to undertake an assessment of the red oak tree at the above site. You asked me to undertake a visual assessment of the tree and make comment on the damage caused to a nearby retaining wall. I duly visited on the 27<sup>th</sup> November 2024 and can now advise as follows.

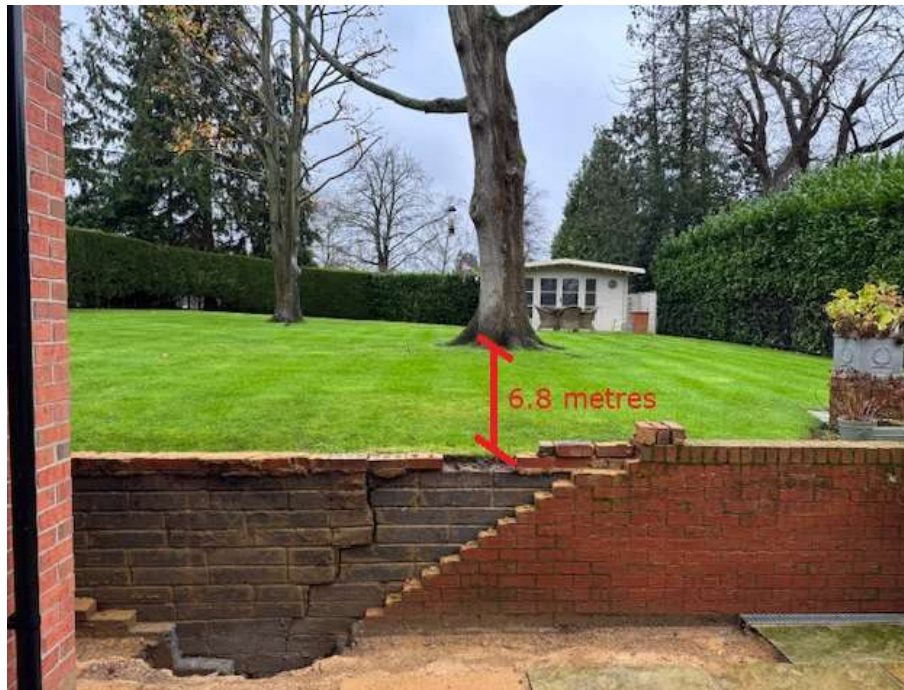
The tree is located 8.5m from the nearest part of the house and 6.8m from the nearest part of the subject retaining wall as shown in the photo below. The wall is circa 1m tall.

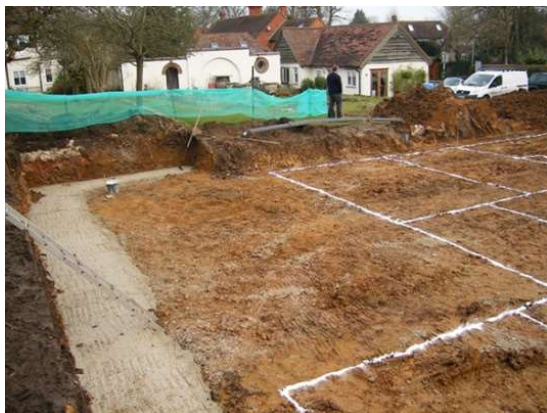
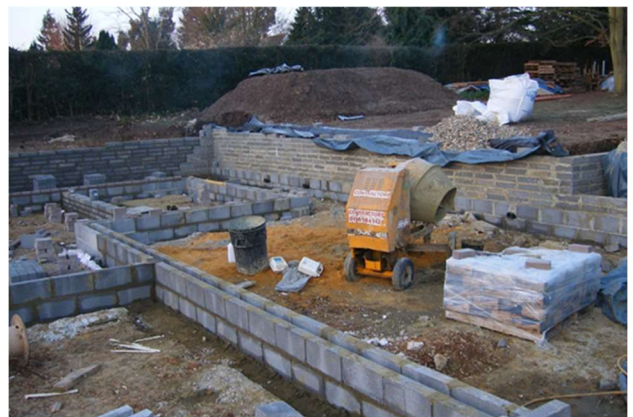
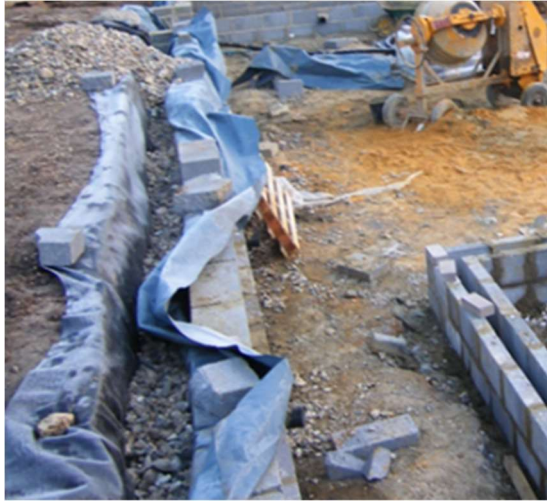
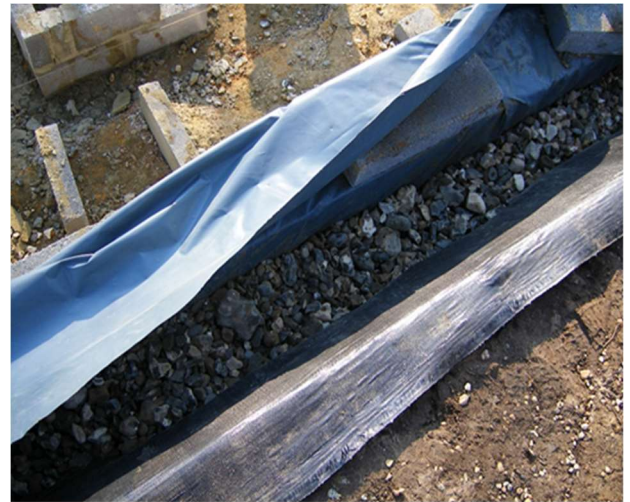
Between the back of the blockwork and the lawned portion of the garden is a void encapsulated with a polythene membrane filled with reject stone, at the base of the wall 100mm drainage outlets were installed at approximately 1M intervals as evidenced by the images below taken during construction.

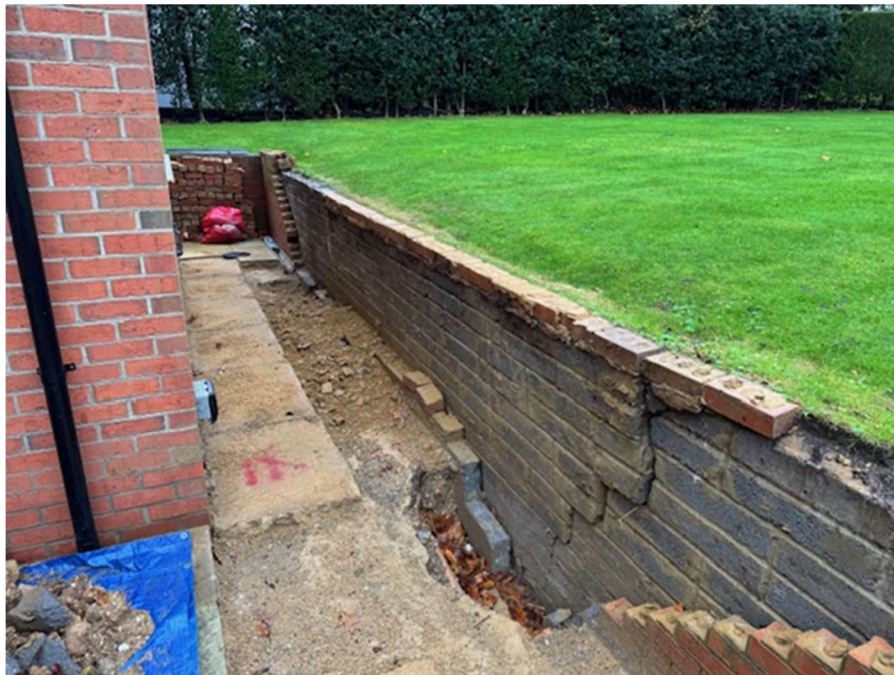
The wall is suffering from cracking consistent with clay shrinkage subsidence, this theory has been confirmed by an engineer who has stated:

*The crack profile indicates that differential foundation movement has occurred within the footing lower towards the steps. The movement is caused by the Oak tree root action on the bearing strata. The soil conditions are noted in the original ground investigation report undertaken for the house construction in 2012 The report states the strata is highly plastic clay with an index of 65 which shows the clay is highest volume change potential. The water demand of the Oak tree roots result in significant shrinkage of the clay up to 20m from the tree.*

Even to the 'naked-eye' the wall is bulging / leaning away from the tree. The cracks in the blockwork run from the top of the wall down the top of the first block off the foundation.

There are two visible cracks to the blockwork, the first as can be seen in the image above which has caused this section of the blockwork to move by 40mm, resulting in distortion and "bellying" of the blockwork between this point and the vertical crack through the blockwork at the other end, where the brickwork has been taken down and raked back.

*As the wall is 6.9M from the tree, foundation movement will be progressive unless action is taken to remove the tree, following which the blockwork can be repaired and brickwork reinstated.*

It is my considered opinion that any attempt to repair and reinstate the wall will be futile, a view shared with the Structural Engineer. Given the size of the tree, the soil type and proximity of the tree to the wall I concur with the Engineer and agree damage to the wall will continue as long as the tree is present. Given that the wall now presents a risk of failure (which is of particular concern for children and pets) a permanent solution is required and tree removal is the only sensible solution.

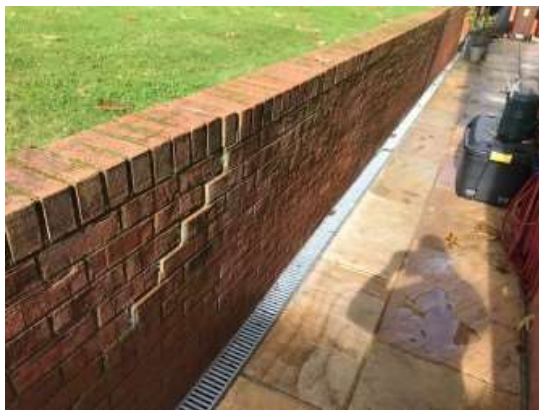
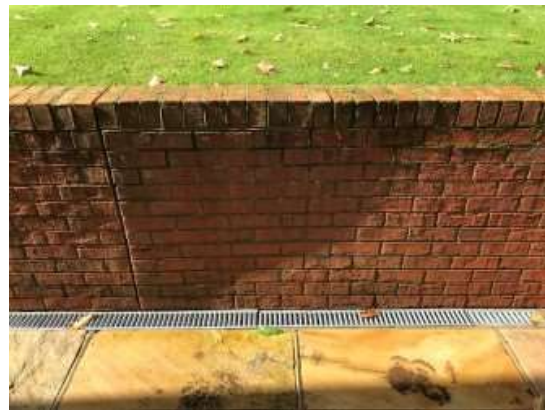
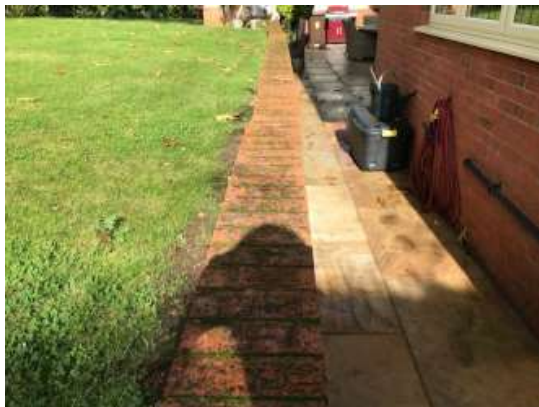
These cracks are 5m apart, this section of the blockwork retaining wall is falling towards the house. Images contained within Sarah Venners report in 2020 depict affected areas of brickwork then and images below reflect the progressive movement to the brickwork, prior to it being taken down to reveal blockwork movement behind.
