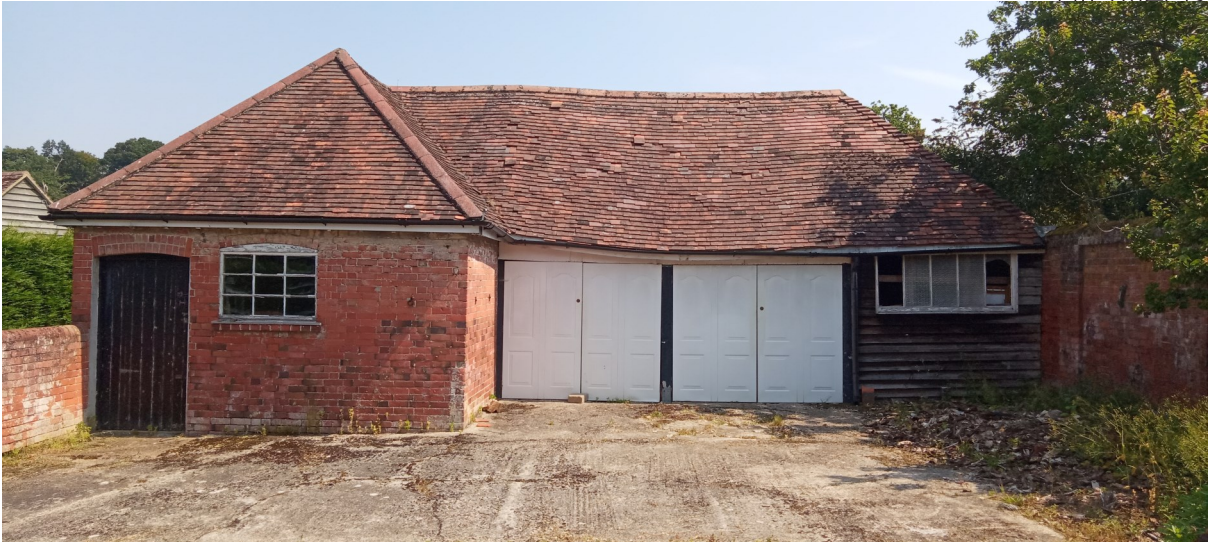
A) Front elevation of store building showing roof deflection over garage doors and affect on main roof ridge and structure

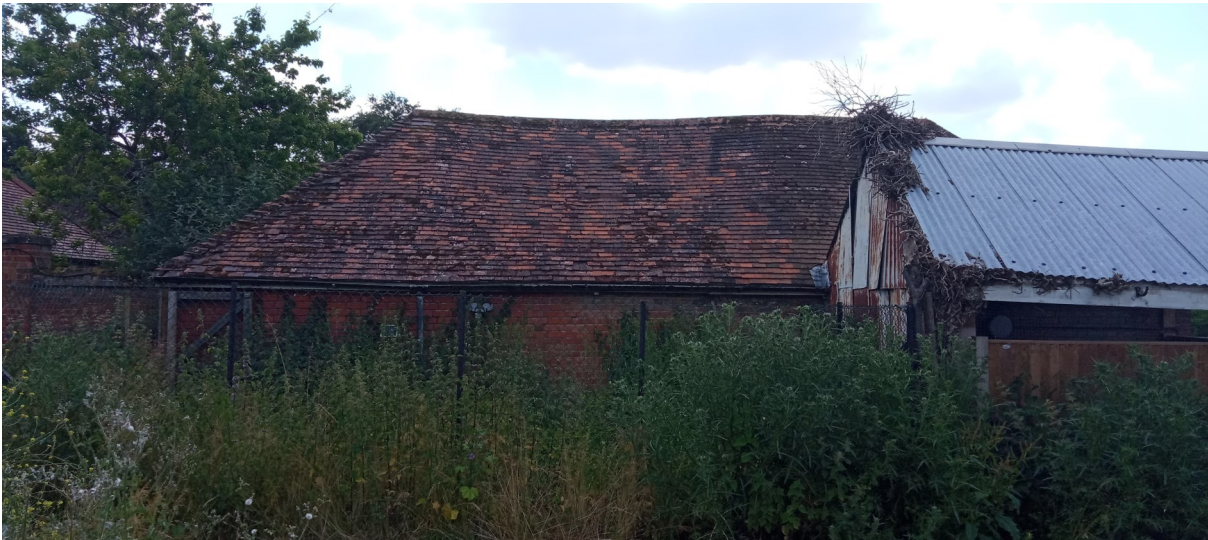
B) Rear elevation of store building showing distortion of main roof ridge

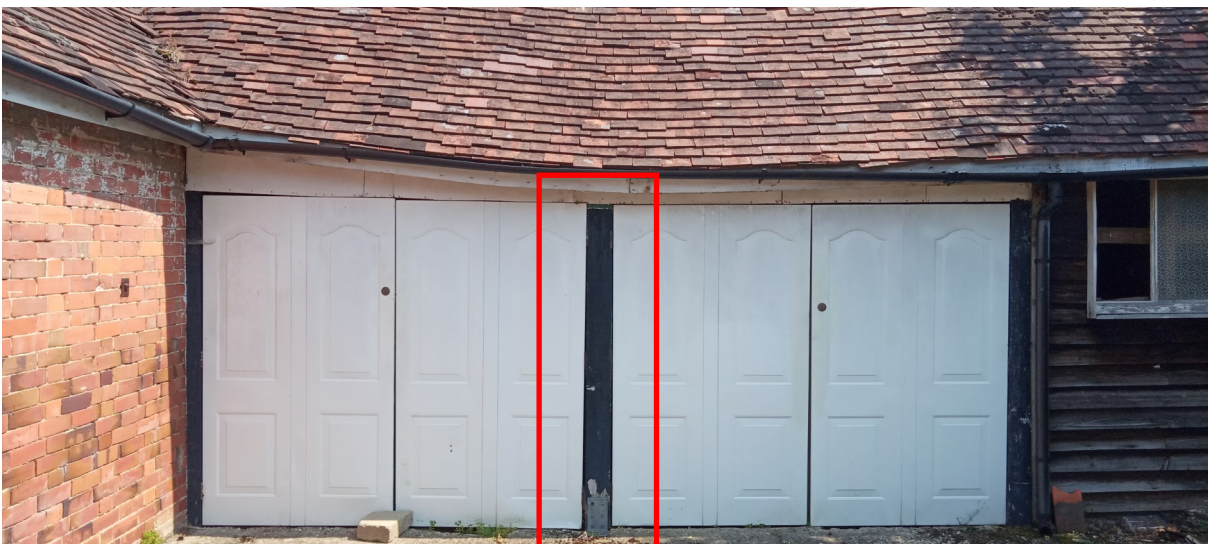
C) Close up view of showing deformation of roof eaves over garage doors with timber post outlined in red

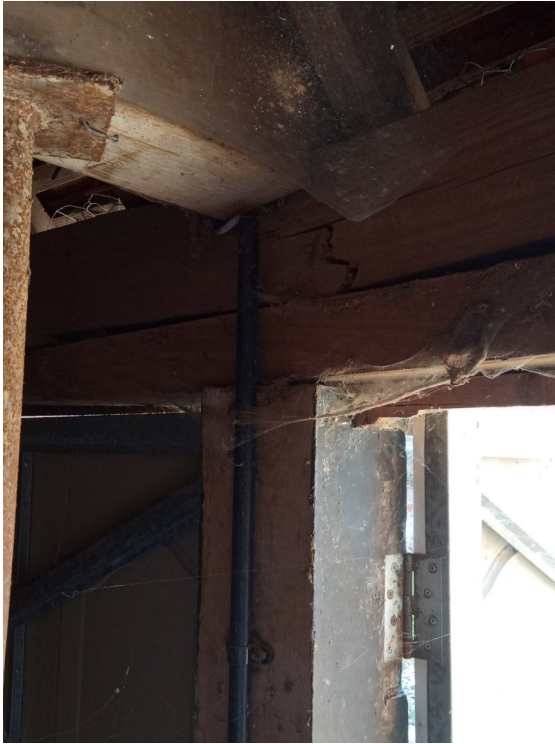
D) Junction of top of post and beam showing deflection and splitting

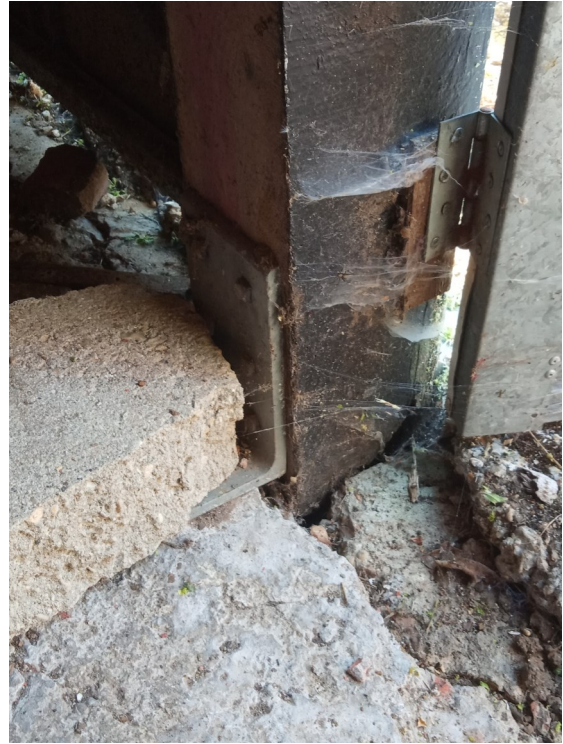
E) Rotten base of existing timber post

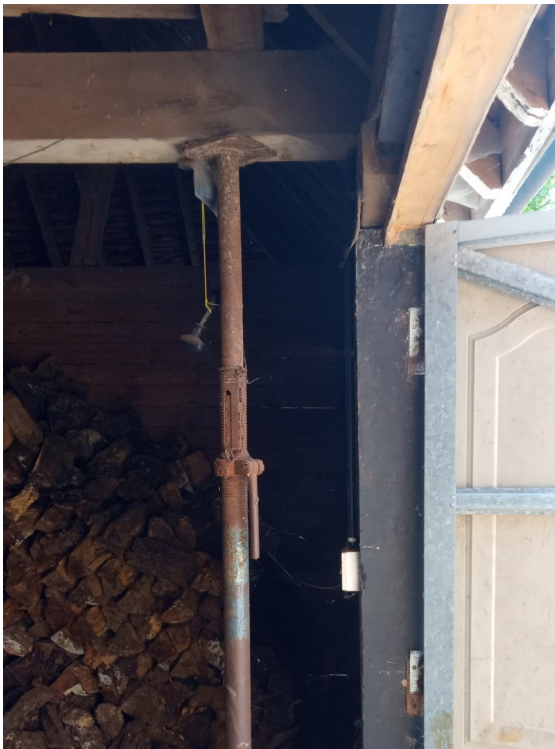
F) Acro prop to support existing lateral beam

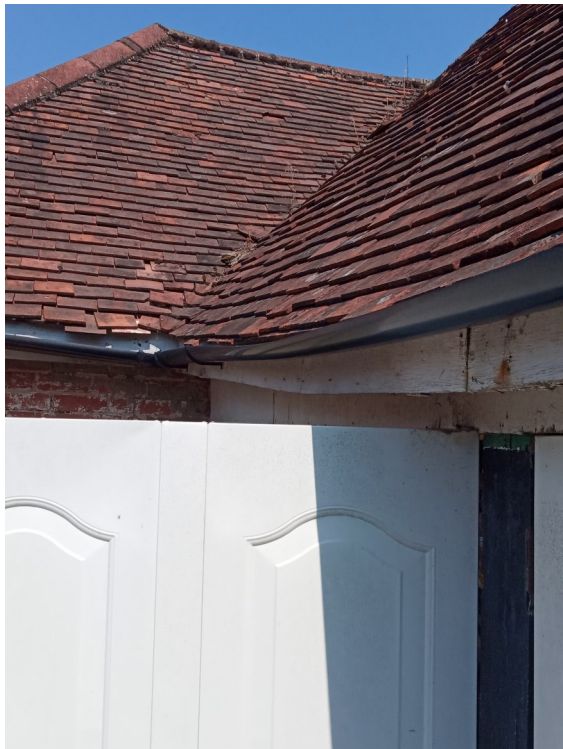
G) Roof deformation at eaves over garage doors
