## **VISUAL TREE ASSESSMENT AND DECAY DETECTION UPON AN OAK TREE LOCATED OPPOSITE 301A NINE MILE RIDE**

**Prepared for:  
Wokingham Borough Council  
Civic Offices  
Shute End  
Wokingham  
RG40 1BN**

**4 November 2025**

**Ref: SPH/VTa-25/20.10**

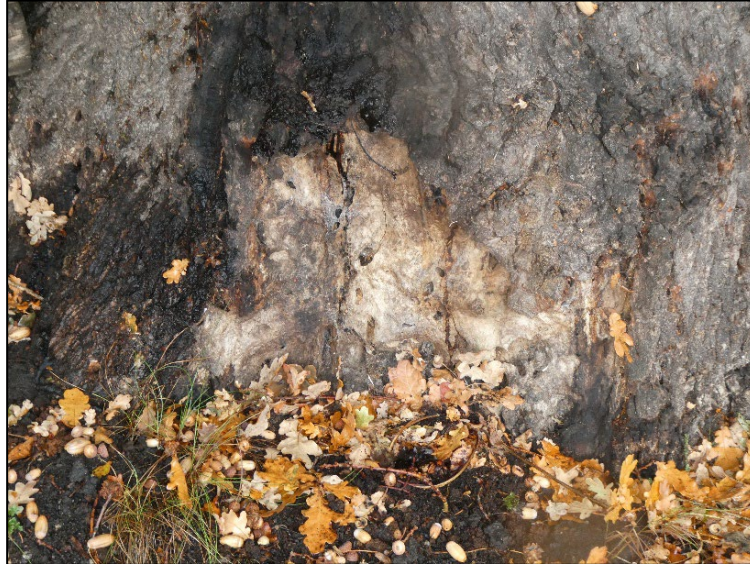
Figure 1. Oak, 301A Nine Mile Ride 20/10/2025

- 6.1 The tree is a mature specimen and is situated within falling distance of the adjacent footway, highway and access to 301A Nine Mile Ride.
- 6.2 There is no evidence of rootplate movement, no mounding or soil heave was observed, and there was no evidence to suggest the root zone is unstable at the time of inspection. The main stem has a cavity and missing bark on the south side of the stem at ground level (see Figure 1 on page 5) and the bark is dead either side of the cavity.

- 7.4 The wounding and cavity on the south side at ground level may have resulted from mechanical damage and this could be a primary location for the entry of decay pathogens.

- 8.1 In preparing these recommendations we have considered the amenity value, landscape character and target area.
- 8.2 There is little value in undertaking a crown reduction as the tree exhibits signs of decline and is decaying at ground level. The tree should be felled to ground level in sections, and the work should be undertaken within 6 months of the date of this report.
- 8.3 The tree work must be undertaken to British Standard (BS3998:2010) and align with industry best practice.

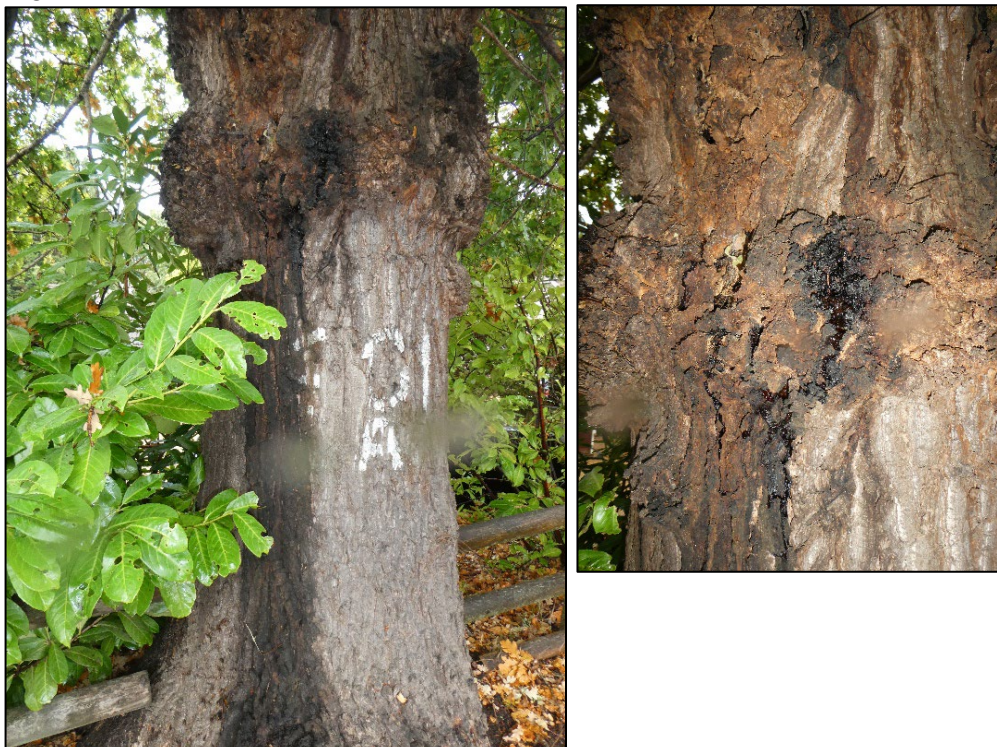
Figure 2. Oak, 301A Nine Mile Ride 20/10/2025

- 6.3 The main stem has a natural taper with burring that commences at approximately 2 meters AGL and continues into the canopy. Stem soundings were undertaken with a nylon mallet from ground level to 1.8 metres AGL and areas of loose and dead bark were noted on the west and east sides either side of the cavity. Bleeding exudates were observed on the main stem emanating from approximately 2 metres AGL on the south side and staining can be seen extending to ground level, see example at Figure 2 below.

- 7.3 Bleeding exudates on oak trees are usually caused by bacterial or fungal infections that develop under the bark affecting the cambium, leading to tissue death and sap leakage. The main causes are bacterial infections such as *Brenneria goodwinii* (previously *Brenneria quercina*), associated with Acute Oak Decline (AOD) in the UK and parts of Europe. The bacteria invade through wounds or natural fissures, colonizing the inner bark, this leads to necrosis of the phloem, gas formation, and production of dark, sticky exudates oozing from the bark.

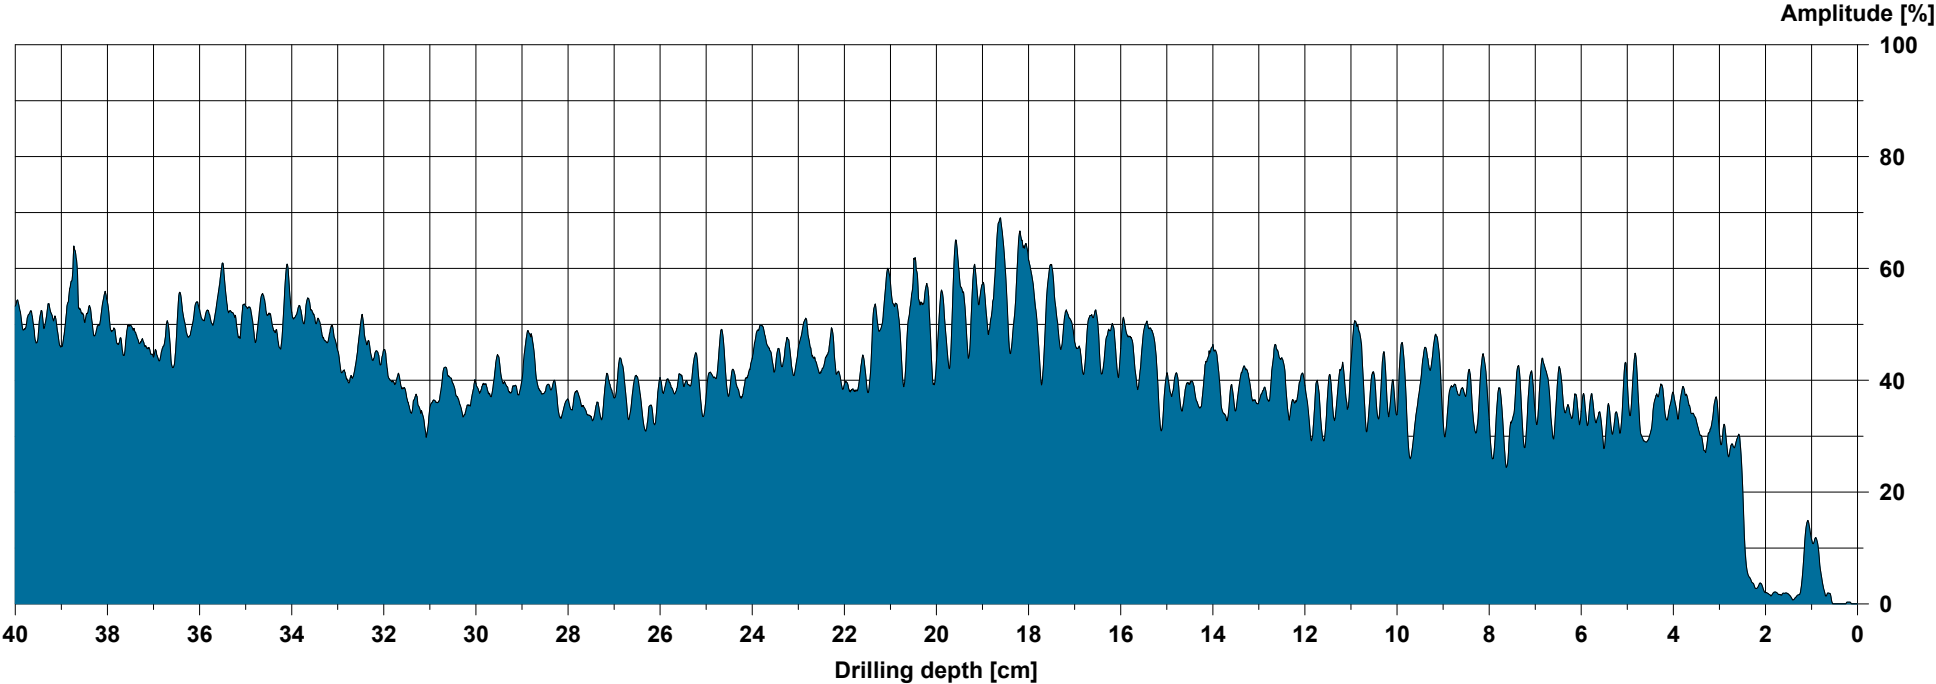
Control test at 1.5 metres above ground level. No significant decay at the test location.

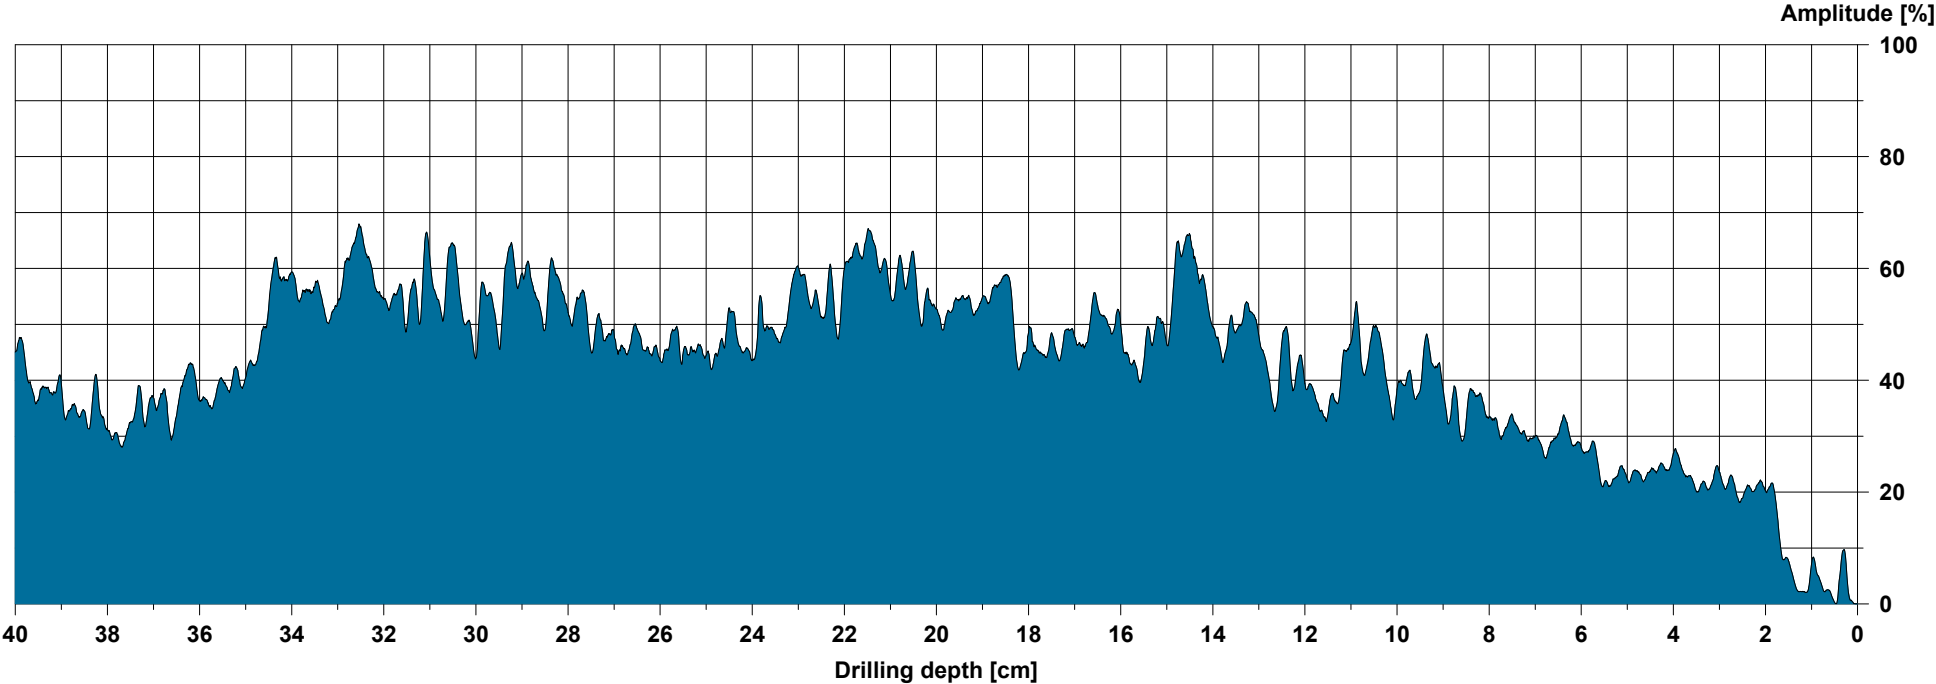
Test close to ground level east side. Decay evident as erratic amplitude from 0 to 8.5cm. Growth rings unclear and fall in amplitude at 34.5cm all indicate incipient decay at test location.

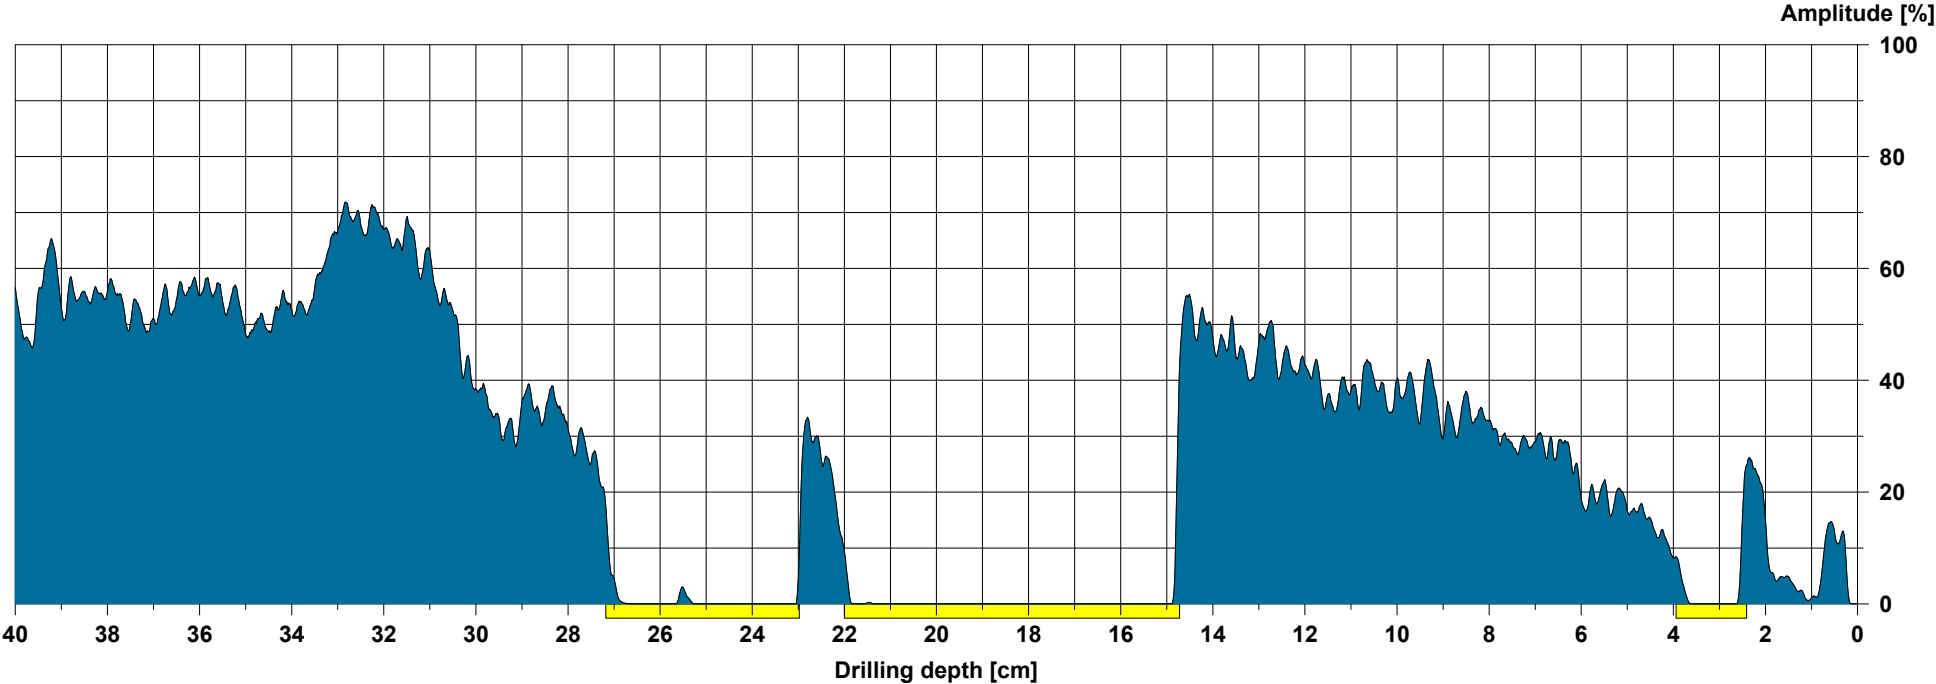
- From 2,41 cm to 3,94 cm : Cavity
- From 14,72 cm to 22,00 cm : Cavity
- From 22,98 cm to 27,18 cm : Cavity

Test close to ground level north side. Decay evident in low amplitude from 1 to 2cm. Small cavity at 2.5cm and further cavities at 15 and 23cm.

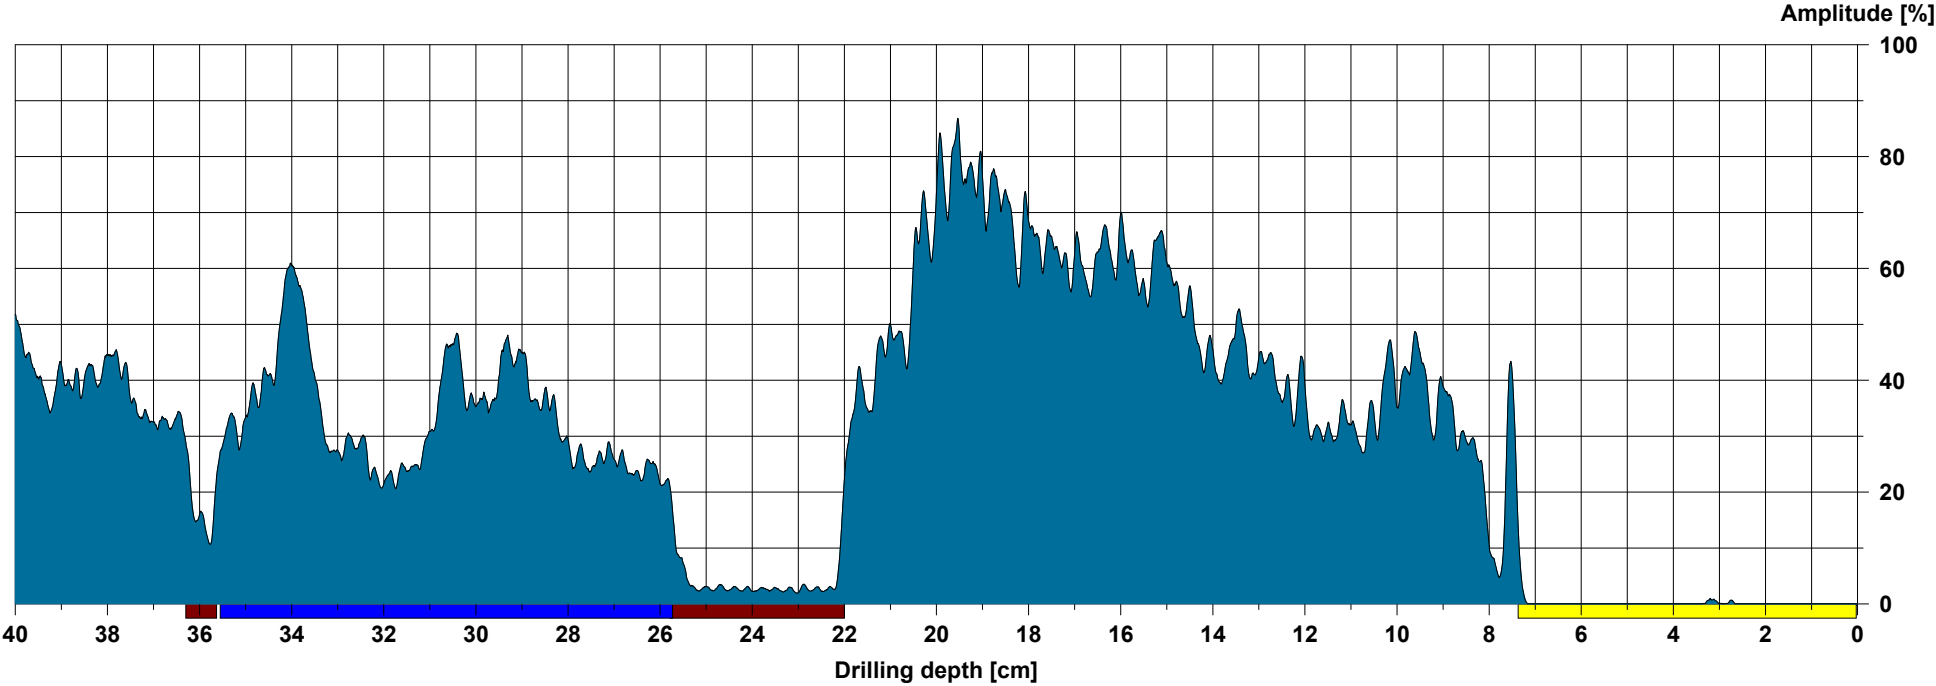
- 7.2 The cavity at ground level on the south side appears to be shallow (circa 7cm) however, the stem beyond the cavity is also decaying from 22cm. The cavity detected on the opposite side of the stem (north) appears to be isolated and the decay detected on the west side also appears to be isolated around 26cm.

| From 0,03 cm to 7,37 cm | : Cavity |
| From 22,00 cm to 25,78 cm | : Decay |
| From 25,73 cm to 35,55 cm | : Incipient decay |
| From 35,63 cm to 36,30 cm | : Decay |

Test close to ground level south side. Cavity evident from 0 to 7cm. Further decay between 22 and 25.5cm with irregular amplitude indicating incipient decay and significant drops in amplitude for example at 36cm indicates advanced decay.

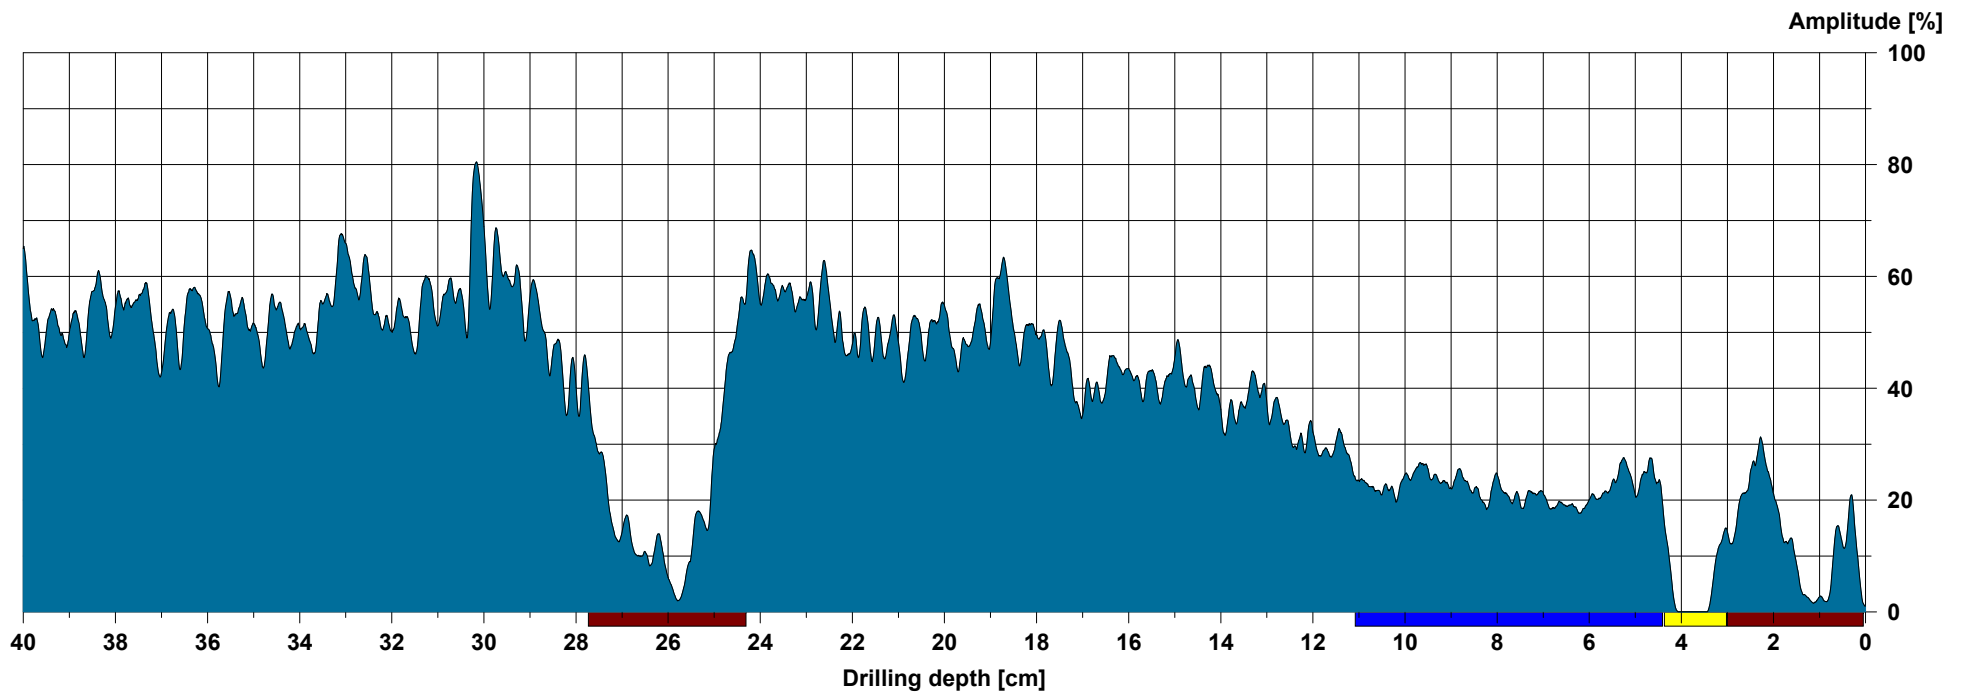
| From | 0,05 cm to | 3,00 cm | : Decay |
| From | 3,02 cm to | 4,37 cm | : Cavity |
| From | 4,41 cm to | 11,08 cm | : Incipient decay |
| From | 24,31 cm to | 27,73 cm | : Decay |

Test close to ground level west side. Decay evident just behind the bark with irregular low amplitude and a sudden fall in amplitude at 24cm indicating a localised area of decay.
