# ARBORICULTURAL REPORT

## TREE CONDITION SURVEY

79 PINWOOD AVENUE  
CROWTHORNE  
BERKSHIRE  
RG45 6RR

DECEMBER 2025  
Ref: 06909 / 2025

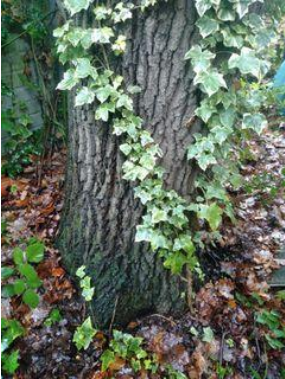
| Ref: | Species | Measurements | Survey Notes | Condition | Other Data | Recommendations | Photo |
|---|---|---|---|---|---|---|---|
| T001 | Pedunculate oak<br>( <i>Quercus robur</i> ) | Height (m): 15<br>Crown Radius (m): 6N, 6E, 8S, 2W<br>DBH (cm): 62<br>Life Stage: Mature<br>Life Exp.: 40+ Years | <p>Mature oak. Prefabricated garage at base. Shed close to base in neighbouring property.</p> <p>Dense leaf litter built up around base and some garden paraphernalia restricts access around base.</p> <p>Variegated ivy stems on trunk. Where accessible, base clear, bark intact. Sound intonation even and satisfactory. No fungal fruiting bodies evident.</p> <p>Single stem. Branching from 4m. Canopy previously topped around 6m and now formed from mature regrowth 300mm diameter.</p> <p>Asymmetrical crown low over garage and shed. Minor deadwood in crown.</p> <p>Longer slim dead branch on North side over neighbouring garage.</p> <p>Buds dense and even. Good vitality.</p> | Good | Wildlife Value:<br>Good<br>Inspection<br>Limitations: Root collar buried | <ul style="list-style-type: none"> <li>Remove deadwood.</li> <li>Crown lift to create up to 4.5m canopy clearance above ground level.</li> <li>Reduce canopy by 3m height and 2m northern, east and south lateral spread to create a more compact canopy shape following essential reduction of adjacent trees in linear group.</li> </ul> <p><b>Timescale:</b><br/>04-Jun-2026<br/>(6 Months)</p> | |

| Ref: | Species | what3words<br>(Location Identifier) | Recommendations | Work<br>Timescale |
|---|---|---|---|---|
| T001 | Pedunculate oak<br>(Quercus robur) | ///mutual.fills.animal | <ul style="list-style-type: none"> <li>Remove deadwood.</li> <li>Crown lift to create up to 4.5m canopy clearance above ground level.</li> <li>Reduce canopy by 3m height and 2m northern, east and south lateral spread to create a more compact canopy shape following essential reduction of adjacent trees in linear group.</li> </ul> | 04-Jun-2026<br>(6 Months) |

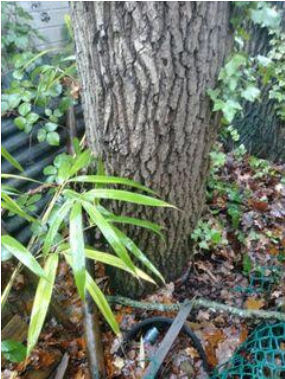
| Ref: | Species | Measurements | Survey Notes | Condition | Other Data | Recommendations | Photo |
|---|---|---|---|---|---|---|---|
| T002 | Pedunculate oak<br>( <i>Quercus robur</i> ) | Height (m): 16<br>Crown Radius (m): 6N, 1E, 5S, 2W<br>DBH (cm): 58<br>Life Stage: Mature<br>Life Exp.: 40+ Years | <p>Mature oak. Prefabricated garage at base. Shed close to base in neighbouring property.</p> <p>Dense leaf litter built up around base and some garden paraphernalia restricts access around base. Ivy on trunk.</p> <p>Where accessible, base clear, bark intact. Historic stem wound on Northwest side of lower trunk fully occluded.</p> <p>Sound intonation even and satisfactory. No fungal fruiting bodies evident.</p> <p>Single stem. Tree has previously been topped around 6m above ground level with 7 mature branches from topping point.</p> <p>Suppressed, oval crown low over garden of 81. Minor deadwood in crown. Longer slim dead branch on North side over neighbouring garage.</p> <p>Buds dense and even. Good vitality.</p> | Good | Wildlife Value:<br>Good<br>Inspection<br>Limitations: Root collar buried | <ul style="list-style-type: none"> <li>Remove deadwood.</li> <li>Crown lift to create up to 4.5m canopy clearance above garden of 81.</li> <li>Reduce canopy by 3m height and 2m south lateral spread to create a more compact canopy shape following essential reduction of adjacent trees.</li> </ul> <p><b>Timescale:</b><br/>04-Jun-2026<br/>(6 Months)</p> | |

| Ref: | Species | what3words<br>(Location Identifier) | Recommendations | Work<br>Timescale |
|---|---|---|---|---|
| T002 | Pedunculate oak<br>(Quercus robur) | ///ever.raves.museum | <ul style="list-style-type: none"> <li>Remove deadwood.</li> <li>Crown lift to create up to 4.5m canopy clearance above garden of 81.</li> <li>Reduce canopy by 3m height and 2m south lateral spread to create a more compact canopy shape following essential reduction of adjacent trees.</li> </ul> | 04-Jun-2026<br>(6 Months) |

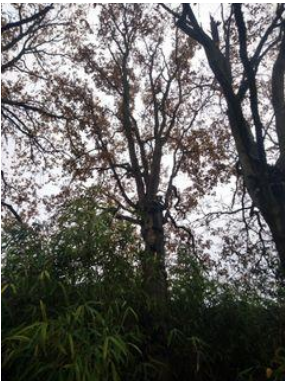
| Ref: | Species | Measurements | Survey Notes | Condition | Other Data | Recommendations | Photo |
|---|---|---|---|---|---|---|---|
| T003 | Pedunculate oak<br>( <i>Quercus robur</i> ) | Height (m): 16<br>Crown Radius (m): 1N, 3E, 5.5S, 3.5W<br>DBH (cm): 47<br>Life Stage: Mature<br>Life Exp.: 40+ Years | <p>Mature oak. Within dense bamboo area. 5m from side of 81 Pinewood Avenue.</p> <p>Dense leaf litter built up around base. Bamboo restricts access.</p> <p>Where accessible, base clear, bark intact. Two vertical scars on Northeast side of lower trunk to around 2.5m suggests crack or historic wound on lower trunk.</p> <p>Sound intonation even and satisfactory. No fungal fruiting bodies evident.</p> <p>Single stem. Tree has previously been topped around 6m above ground level with 7 slender branches from topping point.</p> <p>One large branch on North side of crown 250mm diameter, broke causing damage to garage. Broken branch decayed and suggests more decay likely around topping point.</p> <p>Suppressed, oval crown low over 81. Touching roof<br/>Some deadwood in central crown.</p> <p>Bud density normal. Reasonable vitality.</p> | Good | Wildlife Value:<br>Good<br>Inspection<br>Limitations:<br>Bamboo | <ul style="list-style-type: none"> <li>Remove deadwood.</li> <li>Crown lift to create up to 4.5m canopy clearance above garden of 81.</li> <li>Reduce canopy by 3-4m following recent branch failure to create a more compact canopy shape and reduce the exposure of all remaining branches.</li> </ul> <p><b>Timescale:</b><br/>04-Jun-2026<br/>(6 Months)</p> | |

| Ref: | Species | what3words<br>(Location Identifier) | Recommendations | Work<br>Timescale |
|---|---|---|---|---|
| T003 | Pedunculate oak<br>(Quercus robur) | ///truth.pitch.minute | <ul style="list-style-type: none"> <li>Remove deadwood.</li> <li>Crown lift to create up to 4.5m canopy clearance above garden of 81.</li> <li>Reduce canopy by 3-4m following recent branch failure to create a more compact canopy shape and reduce the exposure of all remaining branches.</li> </ul> | 04-Jun-2026<br>(6 Months) |

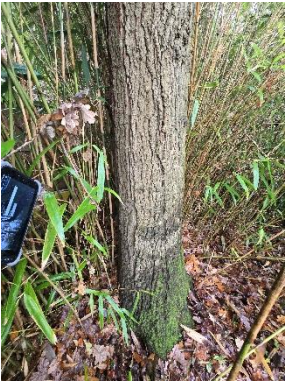
| Ref: | Species | Measurements | Survey Notes | Condition | Other Data | Recommendations | Photo |
|---|---|---|---|---|---|---|---|
| T004 | Pedunculate oak<br>( <i>Quercus robur</i> ) | Height (m): 17<br>Crown Radius (m): 7.5N, 5E, 5S, 3W<br>DBH (cm): 49<br>Life Stage: Mature<br>Life Exp.: 40+ Years | <p>Mature oak. Within dense bamboo area. Dense leaf litter built up around base.</p> <p>Broad, even buttress roots. Base clear, bark intact. Sound intonation even and satisfactory. No fungal fruiting bodies evident.</p> <p>Single stem. Tree has previously been topped around 6m above ground level with 6 branches of various diameters from topping point. Nest or drey in fork.</p> <p>Tip of large stem in central canopy broke causing damage to garage. Remaining canopy irregular and asymmetrical with elongated branches newly exposed and vulnerable to breakage.</p> <p>Low branches and less than 0.5m canopy clearance over garage roof. Branches on south side touching roof.</p> <p>Deadwood in central crown over lower occupancy area. Buds density normal. Reasonable vitality.</p> | Good | Wildlife Value:<br>Good<br>Inspection<br>Limitations:<br>Bamboo | <ul style="list-style-type: none"> <li>Remove deadwood.</li> <li>Crown lift to create up to 4.5m canopy clearance above garden of 79.</li> <li>Reduce canopy by 3-4m following recent branch failure to create a more compact canopy shape and reduce the exposure of all remaining branches.</li> </ul> <p><b>Timescale:</b><br/>04-Jun-2026<br/>(6 Months)</p> | |

| Ref: | Species | what3words<br>(Location Identifier) | Recommendations | Work<br>Timescale |
|---|---|---|---|---|
| T004 | Pedunculate oak<br>(Quercus robur) | ///using.love.hood | <ul style="list-style-type: none"> <li>Remove deadwood.</li> <li>Crown lift to create up to 4.5m canopy clearance above garden of 79.</li> <li>Reduce canopy by 3-4m following recent branch failure to create a more compact canopy shape and reduce the exposure of all remaining branches.</li> </ul> | 04-Jun-2026<br>(6 Months) |

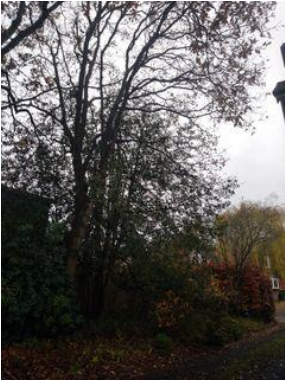
| Ref: | Species | Measurements | Survey Notes | Condition | Other Data | Recommendations | Photo |
|---|---|---|---|---|---|---|---|
| T005 | Pedunculate oak<br>( <i>Quercus robur</i> ) | Height (m): 16<br>Crown Radius (m): 6.5N, 1E, 6S, 6W<br>DBH (cm): 51<br>Life Stage: Mature<br>Life Exp.: 40+ Years | <p>Mature oak. End tree in linear group.</p> <p>Broad, even buttress roots. Base clear, bark intact. Sound intonation even and satisfactory. No fungal fruiting bodies evident.</p> <p>Single stem to 4.5m where trunk forks.</p> <p>Tree has previously been topped 0.5m above ground level with 5 branches around 200mm above topping point.</p> <p>Low branches and less than 20cm canopy clearance to roof of 79.</p> <p>Deadwood in central crown over lower occupancy area. Bud density normal. Reasonable vitality.</p> | Good | Wildlife Value:<br>Good<br>Inspection Limitations:<br>Bamboo | <ul style="list-style-type: none"> <li>Remove deadwood.</li> <li>Reduce height by 3-4m and 2-3m lateral spread to create reasonable clearance to property and reduce overbearing nature of tree.</li> </ul> <p><b>Timescale:</b><br/>04-Jun-2026<br/>(6 Months)</p> | |

| Ref: | Species | what3words<br>(Location Identifier) | Recommendations | Work<br>Timescale |
|---|---|---|---|---|
| T005 | Pedunculate oak<br>(Quercus robur) | ///apron.such.left | <ul style="list-style-type: none"> <li>Remove deadwood.</li> <li>Reduce height by 3-4m and 2-3m lateral spread to create adequate clearance to property and reduce overbearing nature of tree in relation to 81 Pinewood Avenue.</li> </ul> | 04-Jun-2026<br>(6 Months) |

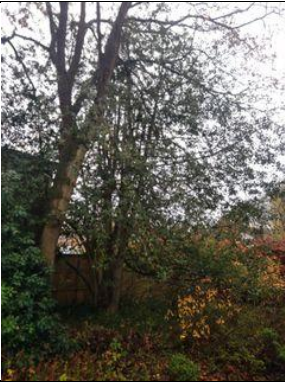
| Ref: | Species | Measurements | Survey Notes | Condition | Other Data | Recommendations | Photo |
|---|---|---|---|---|---|---|---|
| T006 | Common holly<br>( <i>Ilex aquifolium</i> ) | Height (m): 9<br>Crown Radius (m): 5N, 4.5E, 3S, 3.5W<br>DBH (cm): 50<br>Life Stage: Mature<br>Life Exp.: 40+ Years | <p>Multi-stem small tree.</p> <p>All stems previously topped at 4m and again at 5m.</p> <p>Dense regrowth 3m+ long from previous topping points. Foliage slightly sparse</p> | Fair | Wildlife Value:<br>Good | <ul style="list-style-type: none"> <li>Reduce height and lateral spread by 2.5m (1m) on south side to create a smaller, more compact canopy shape and reasonable clearance to 81.</li> </ul> <p><b>Timescale:</b><br/>04-Dec-2026<br/>(1 Year)</p> | |

| Ref: | Species | what3words<br>(Location Identifier) | Recommendations | Work<br>Timescale |
|---|---|---|---|---|
| T006 | Common holly<br>(Ilex aquifolium) | ///remit.press.lived | <ul style="list-style-type: none"> <li>Reduce height and lateral spread by 2.5m (1m) on south side to create a smaller, more compact canopy shape and reasonable clearance to 81.</li> </ul> | 04-Dec-2026<br>(1 Year) |
