## **VISUAL TREE ASSESSMENT AND DECAY DETECTION UPON AN OAK TREE LOCATED BETWEEN 9 & 10 BRADLEY DRIVE**

**Prepared for:  
Mike Pearce  
Team Leader Operational Tree Management  
Wokingham Borough Council  
Civic Offices  
Shute End  
Wokingham RG40 1BN**

**4 September 2025**

**Ref: SPH/VTa-25/26.08**

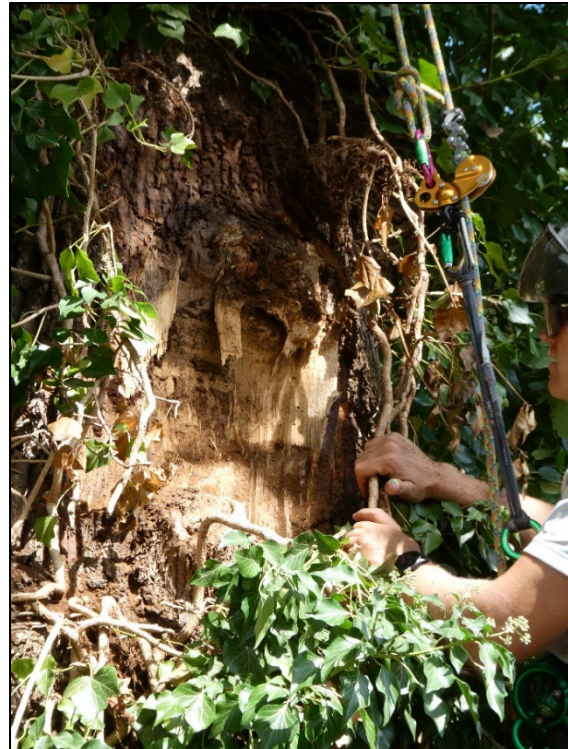
- 6.3 The large cavity observed during the 2014 and 2022 inspection appears to have changed very little, on this occasion, no fungal fruiting bodies were visible. It was probed and was 85cm wide from front of the cavity and decay was detected down to 55cm. There is a new tear out wound following the recent failure of a lateral branch below the cavity at 2.4 metres AGL, see Figure 1 below.

Figure 1. Tear out wound. Oak at 9 & 10 Bradely Drive 26.08.2025

- 7.3 The tear out wound at 2.4 metres AGL has left a superficial wound that resembles those following an included branch union failure and no significant decay was observed at this location.

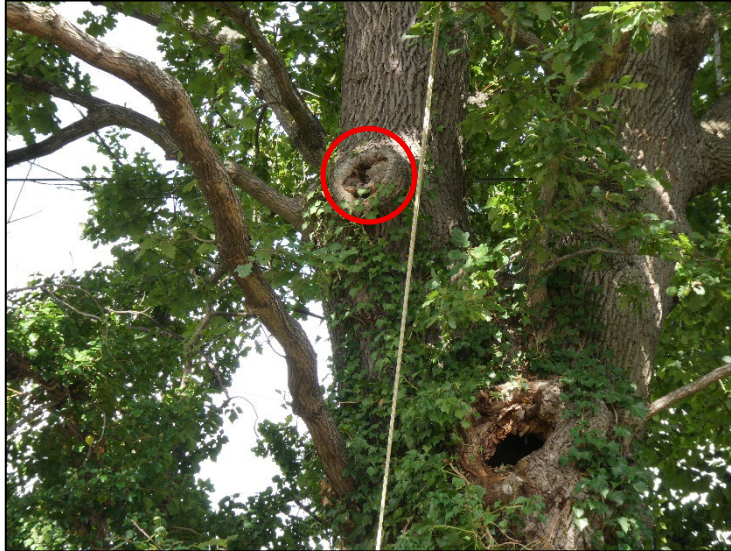
- 6.4 The main stem becomes co-dominant above a large cavity at 4.5 metres AGL. The co-dominant stems form from a tensile union and the northern stem has a cavity at 5.6 metres AGL (see Figure 2 on page 6) and the southern stem has a cavity adjacent to a lateral limb on the eastern side of the stem, this can be seen from the access to 197 Finchampstead Road, see Figure 3 on page 6. The cavity at 8 metres AGL observed during the 2014 and 2022 inspection now has *Laetiporous sulphureus*, (chicken of the woods) visible (see Figure 3 on page 6), highlighted in green.

- 6.7 The results from the northern stem perpendicular to the cavity detected advanced decay from 21cm.
- 6.8 The results from the southern stem with cavity at 8 metres AGL indicates advanced decay from 18cm.

Figure 2. Cavity on northern stem. Oak at 9 & 10 Bradely Drive 26.08.2025

- 7.4 The cavity on the northern stem at 5.6 metres has good callous growth an indicator of tree vitality and when probed as 15cm deep with the Resi drilling indicating advanced decay that is probably tracing the branch geometry, this is the normal route for decay pathogens as the tree attempts to compartmentalise any decay.

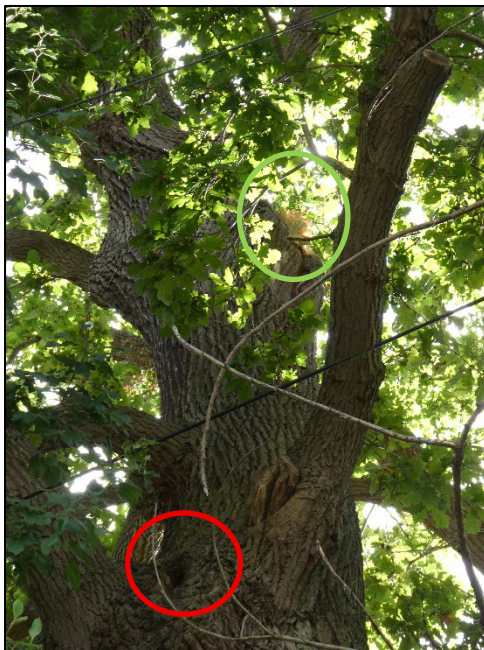
Figure 3. Cavity on southern stem and FFB. Oak at 9 & 10 Bradely Drive 26.08.2025

- 7.5 The wound at 8 metres AGL had previously been colonised by *Polyporus squamosus* (Dryad's saddle) and this appears to have been replaced by *Laetiporous sulphureus*, (chicken of the woods). The decay is probably tracing the branch geometry, as the stub adjacent to it decays and the tree attempts to compartmentalise any decay.

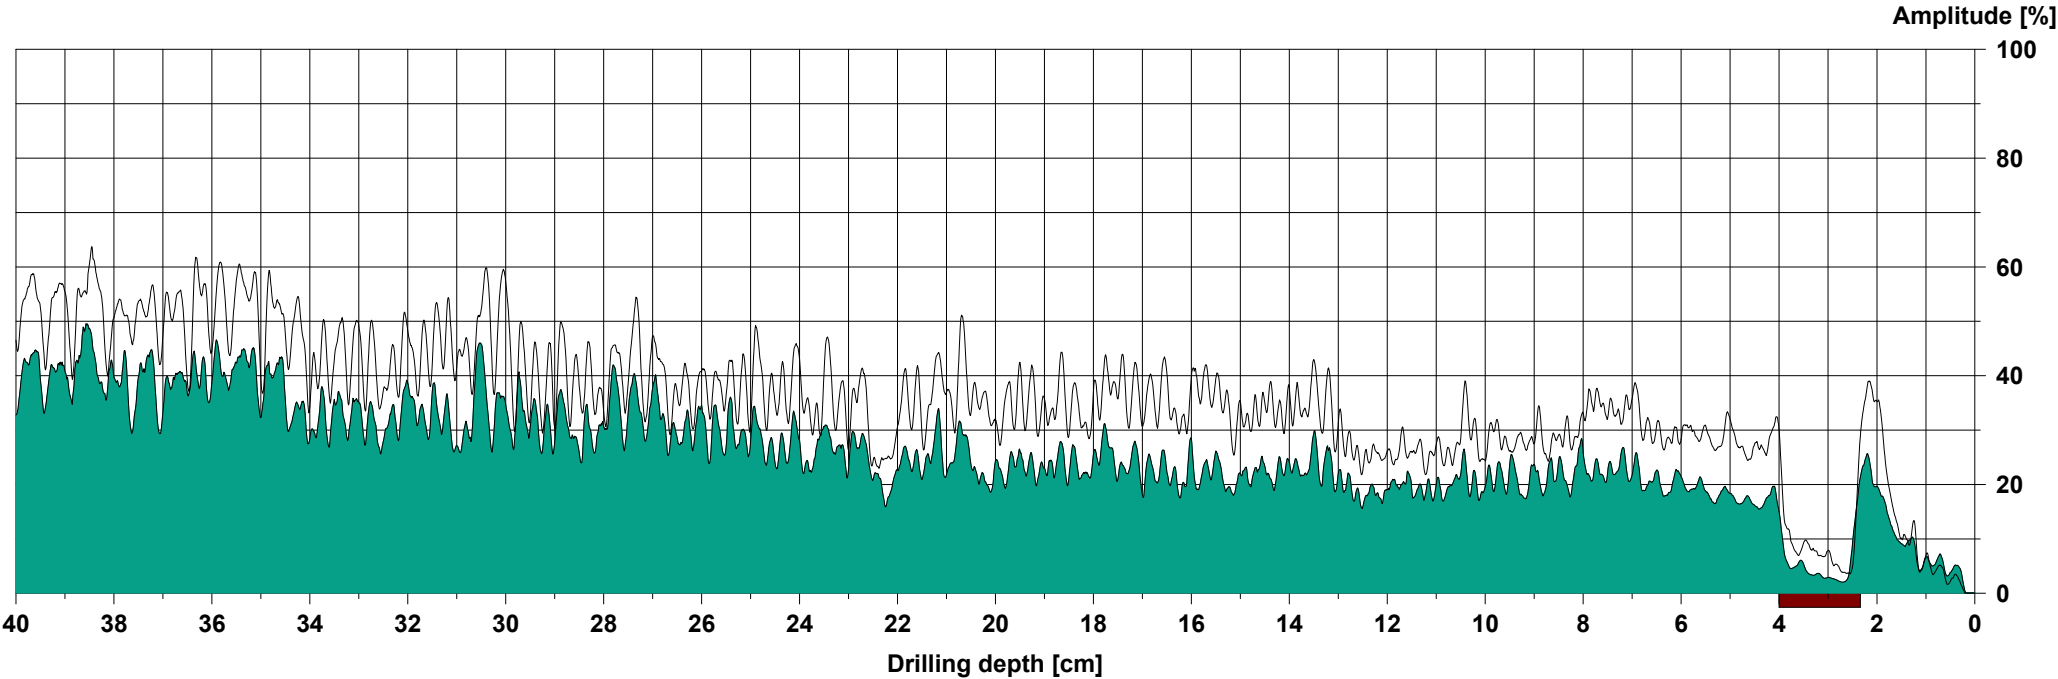
From 2,34 cm to 4,00 cm : Decay

Control test at 1.5m AGL north side. Small isolated area of decay behind bark.

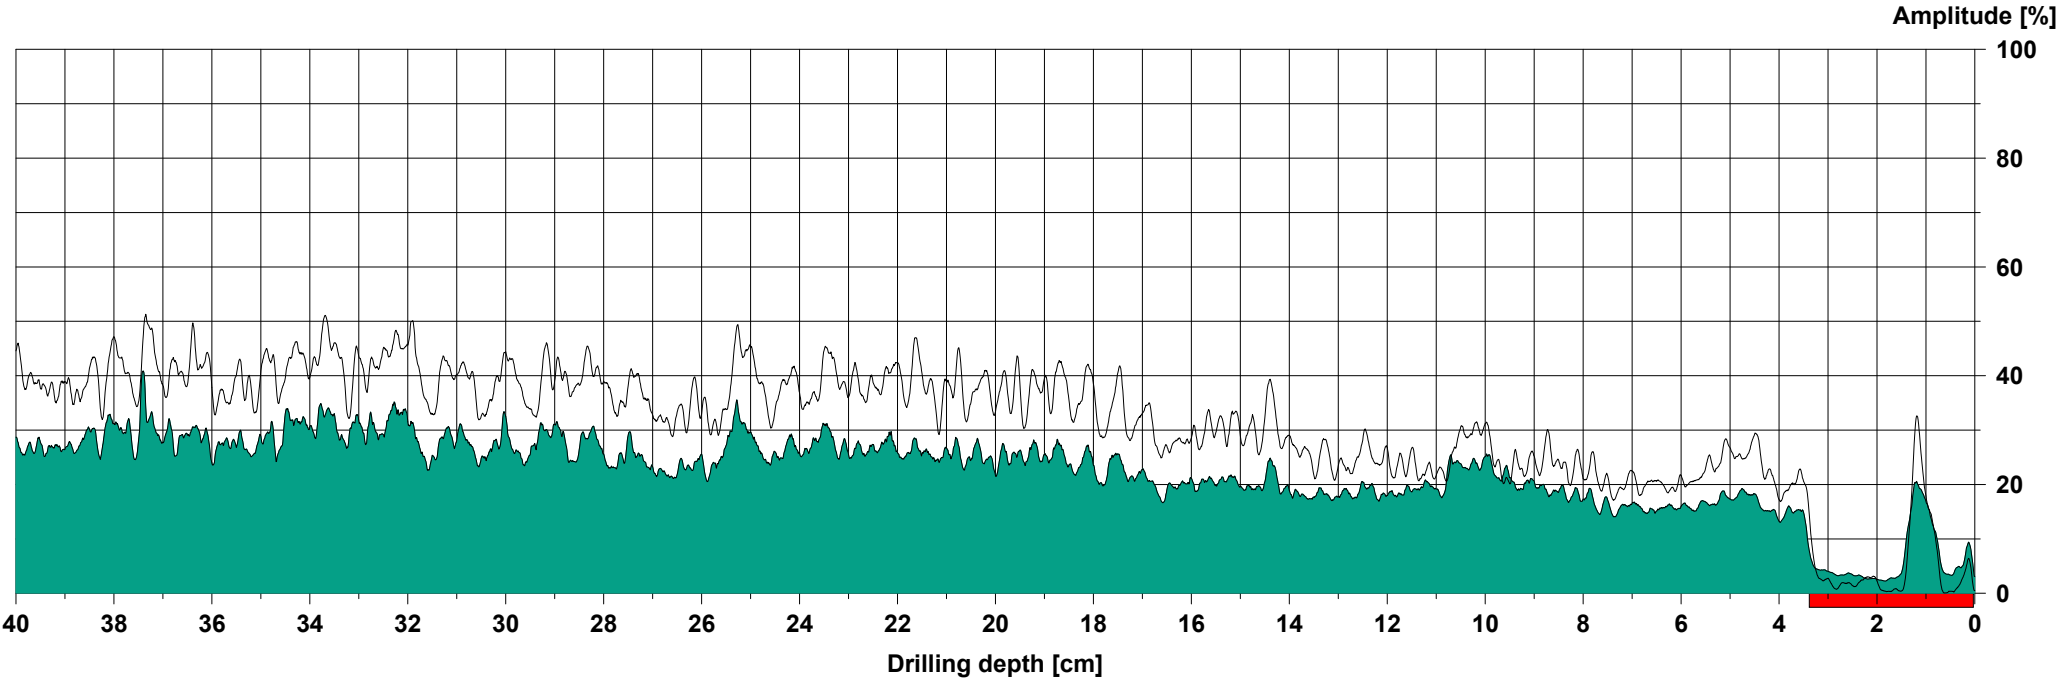
From 0,03 cm to 3,38 cm : Decay

Test east side. Low amplitude due to bark with isolated area of decay between 1 and 3 cm.

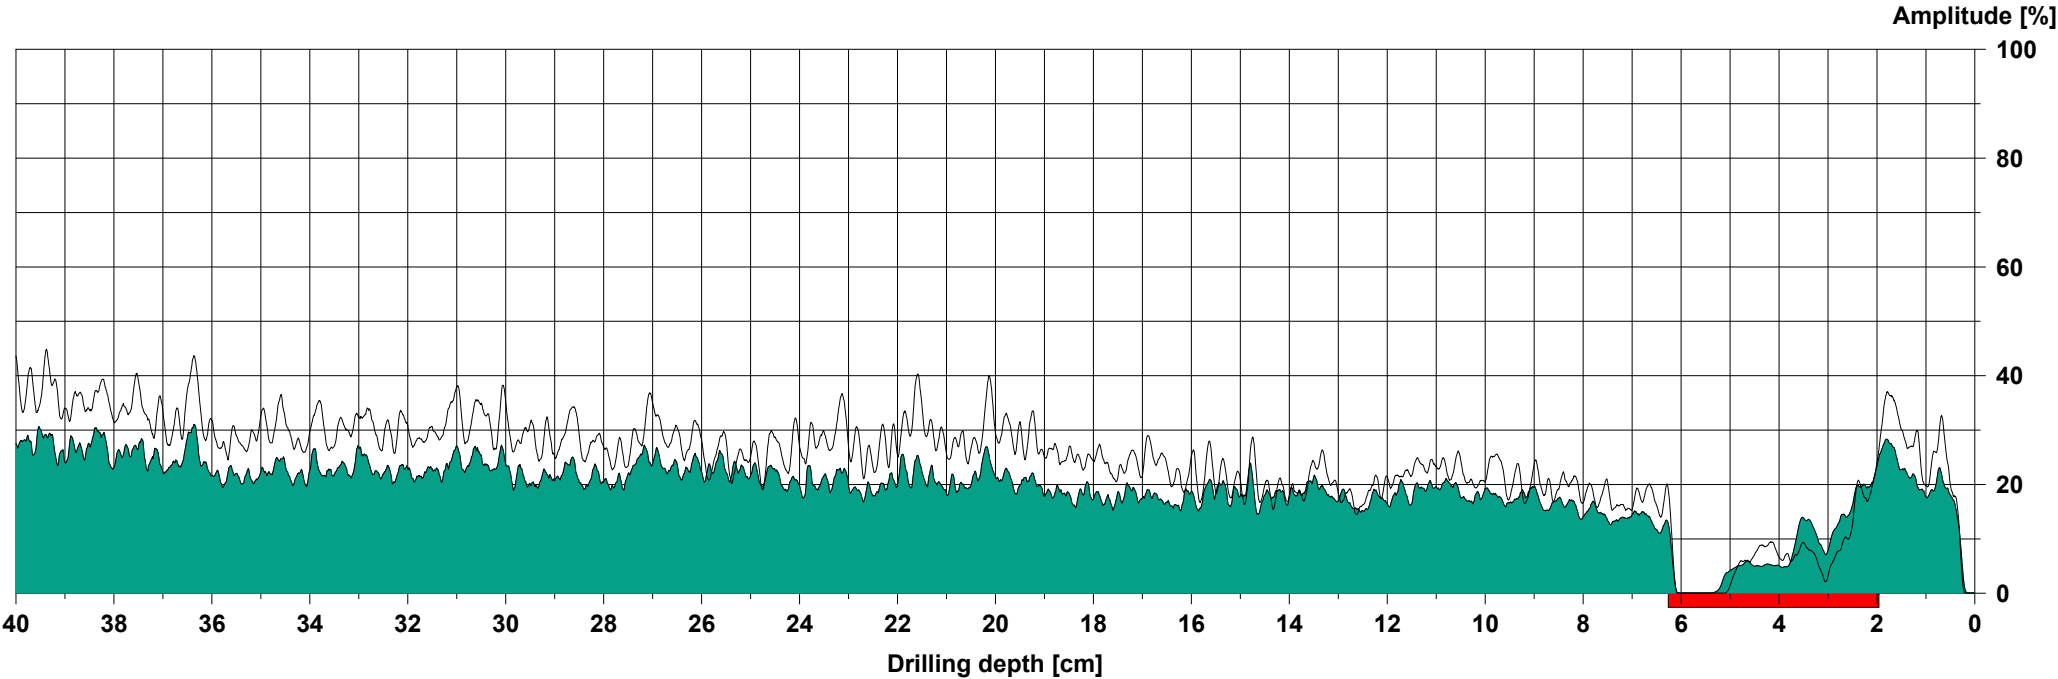
From 1,96 cm to 6,26 cm : Decay

Test north side. Isolated decay between 2 and 6cm.

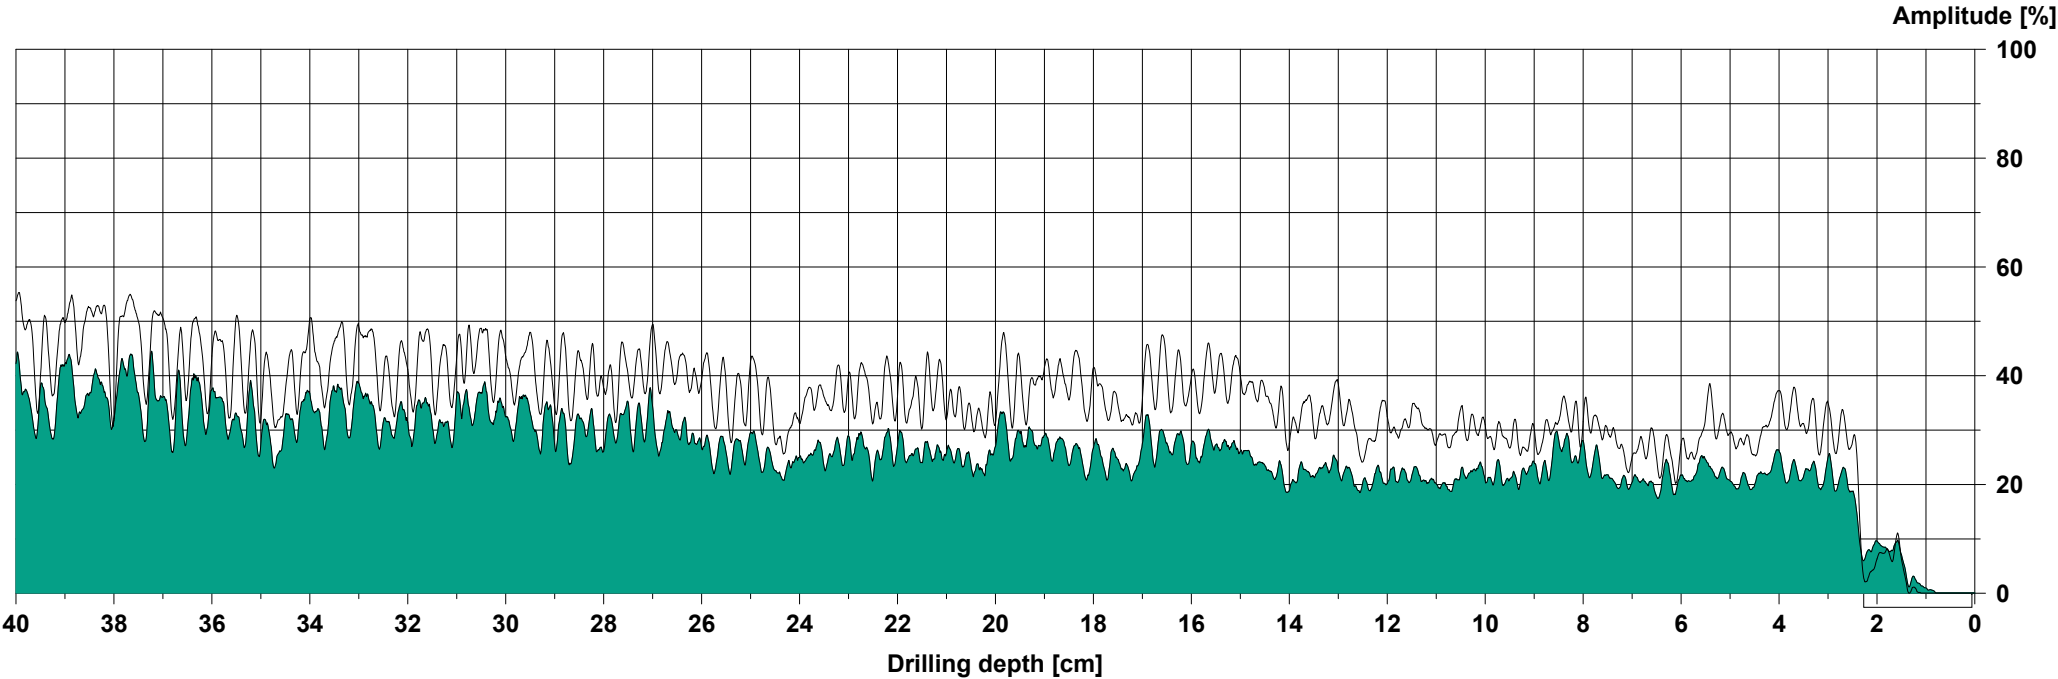
From 0,06 cm to 2,27 cm : Bark

Test south side. Low amplitude due to bark from 0 to 2cm.

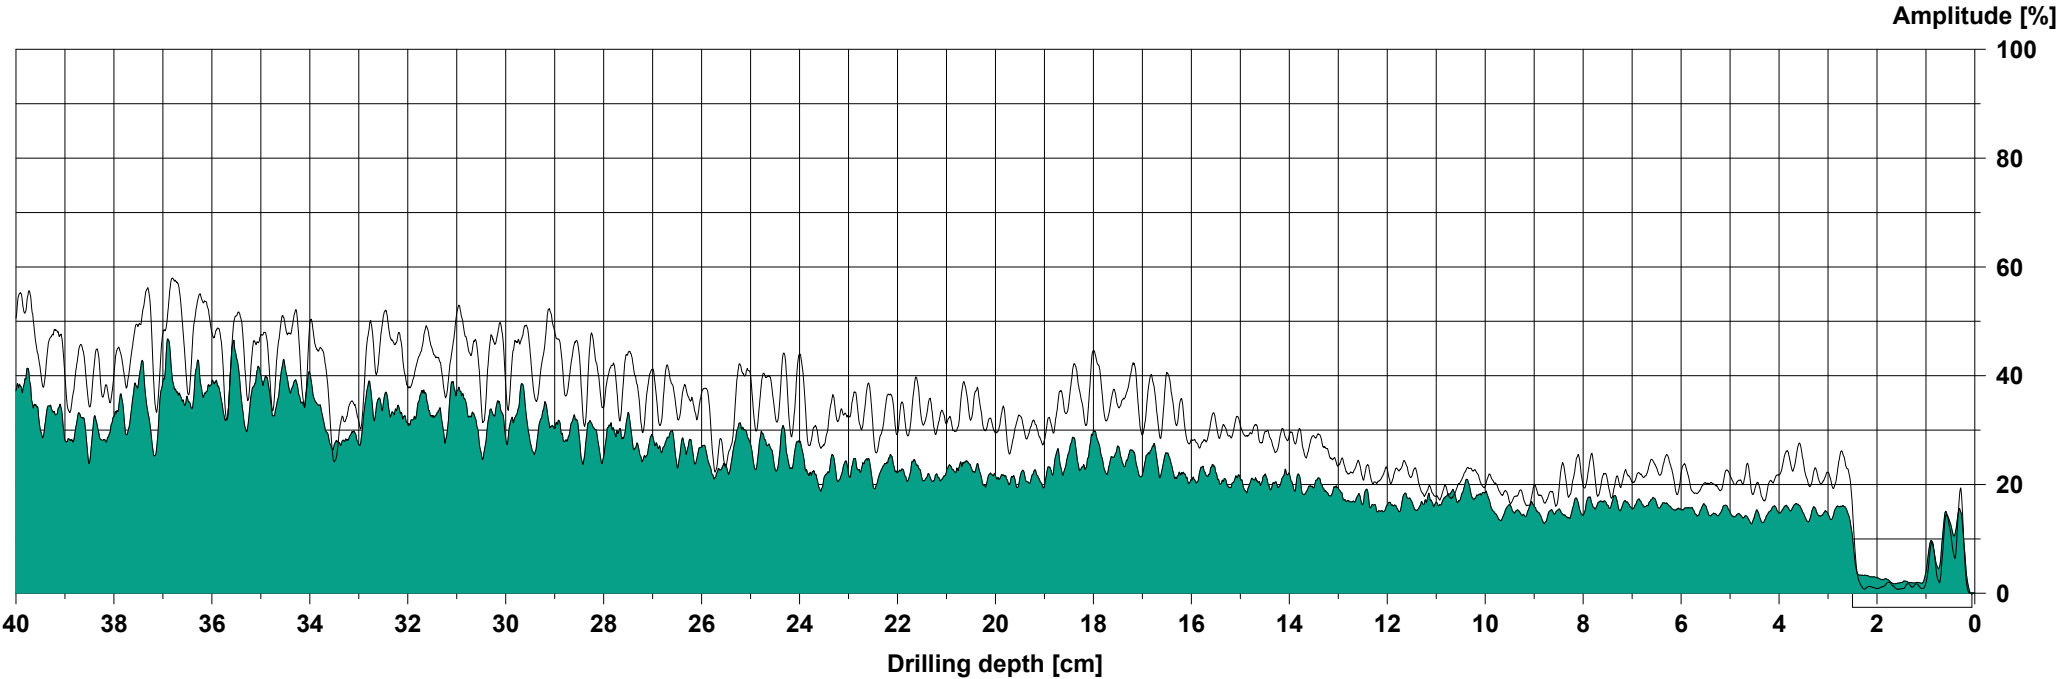
From 0,06 cm to 2,50 cm : Bark

Test west side. Low amplitude due to bark from 0 to 2.5cm.

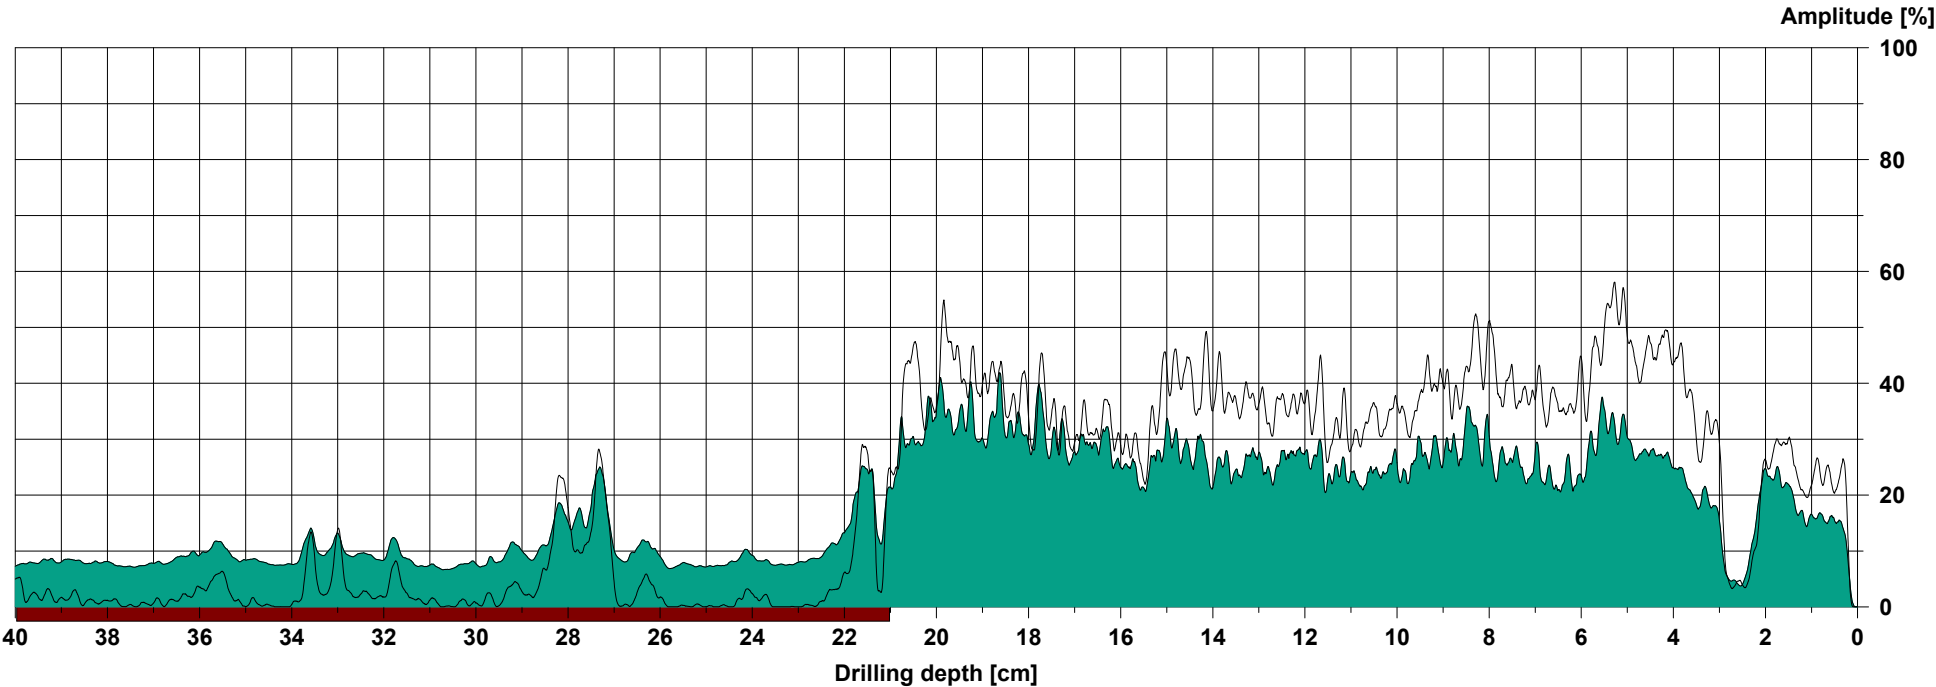
From 21,02 cm to 39,97 cm : Decay

North east side of northern stem opposite side to cavity. Advanced decay starts 21cm.

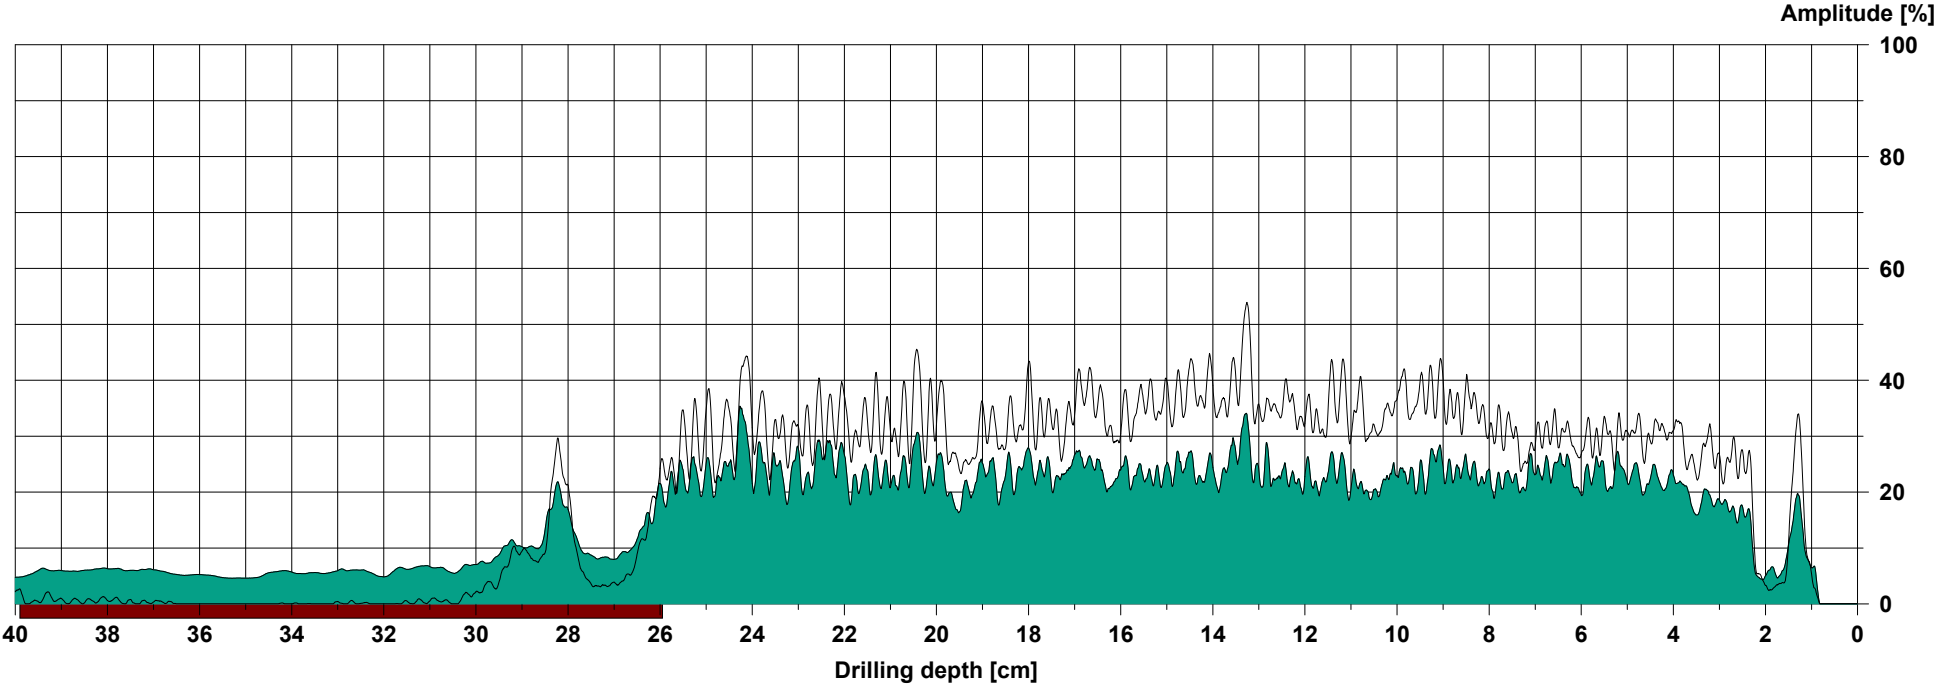
| From 25,95 cm to 39,90 cm : Decay |

Main stem with cavity at 4.5m AGL. Test undertaken opposite side to cavity opening. Advanced decay starts 26cm and is consistent with the visual and manual inspection.

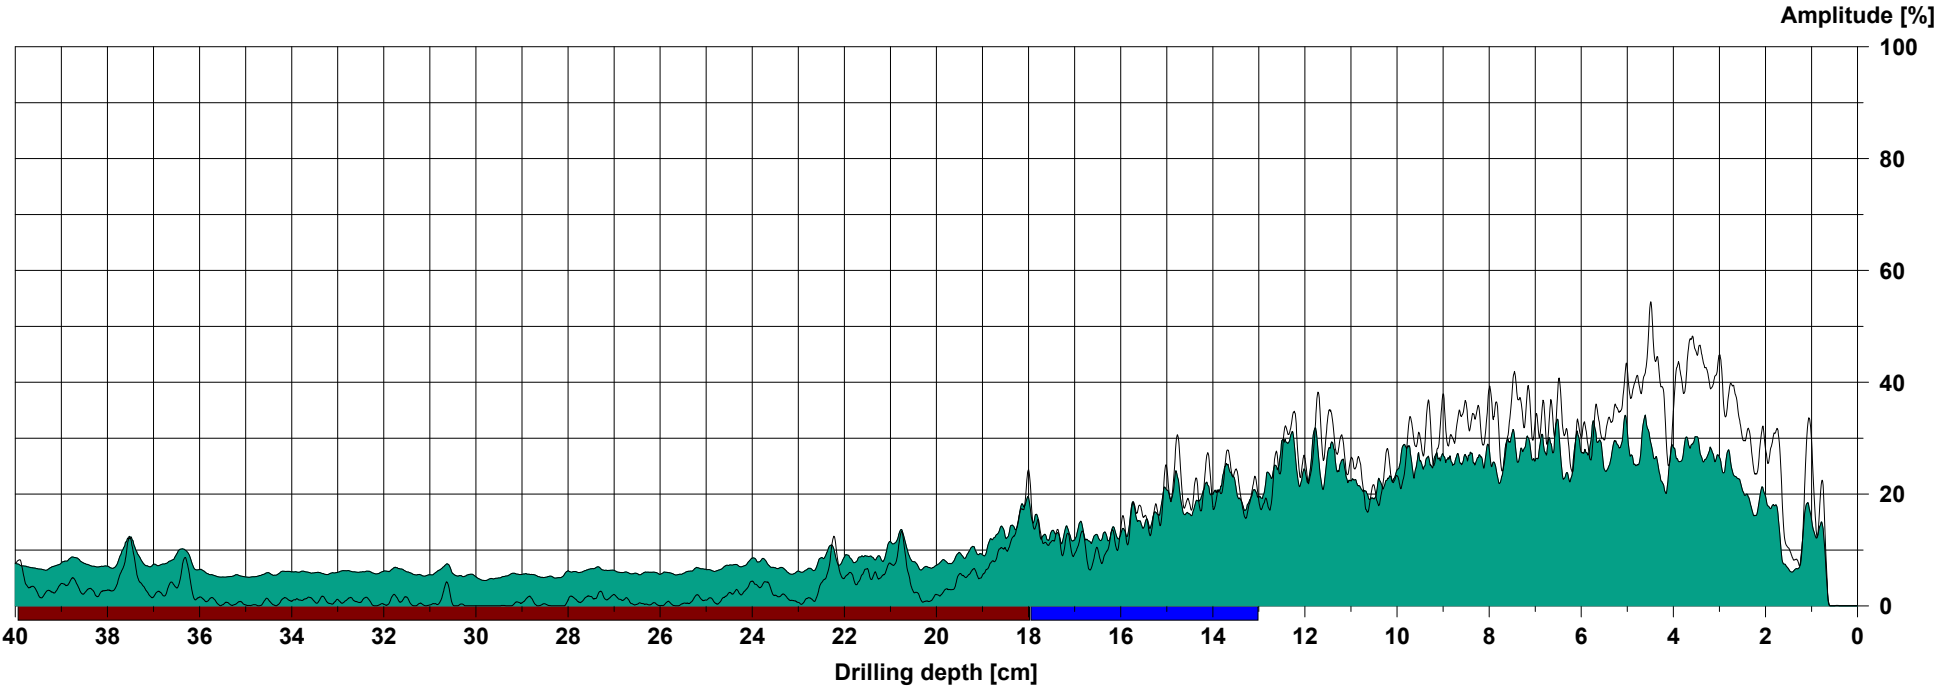
- From 13,02 cm to 17,95 cm : Incipient decay
- From 17,98 cm to 39,94 cm : Decay

Southern stem with cavity at 8m AGL. Test undertaken perpendicular to the cavity. Amplitude starts to drop around 12.5cm with advanced decay from 18cm.
