**Templemount, Blakes Rd, Wargrave**

**Preliminary Bat Roost Appraisal (PRA)**

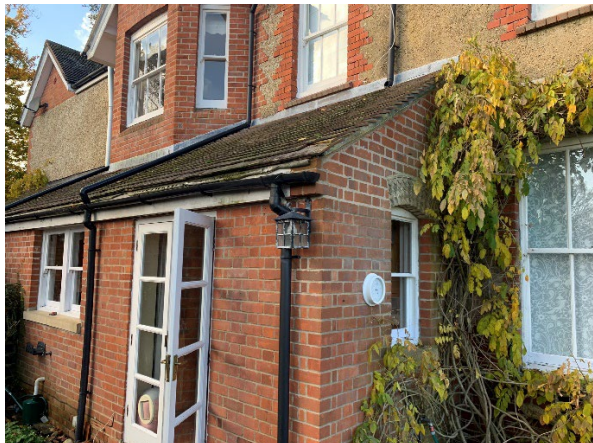
The property is of traditional construction, comprising exposed brickwork elevations, sections of pebble-dashing, a complex roof layout, timber eaves and clay roof tiles, with two protruding chimney stacks. The existing kitchen lies on the southeast elevation and protrudes from the main elevation with the benefit of a lean-to clay-tiled roof structure. The PRA focusses on this existing single-storey lean-to area.

*Pitched roof above existing kitchen.*

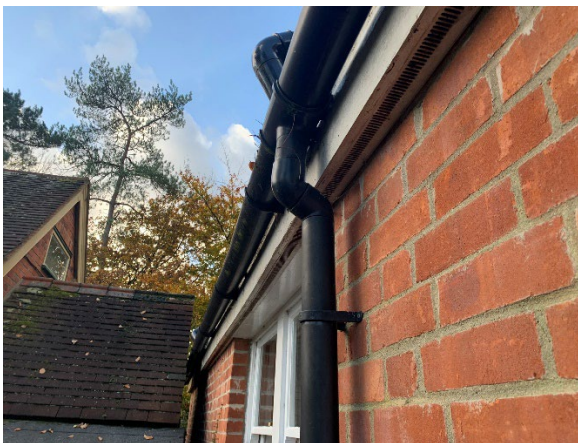
Externally, all brickwork was found to be in an excellent condition, with no damaged, failed or missing bricks of mortar. The windows were all timber framed but were well-fitted and sealed into the surrounding brickwork and lintels, offering no gaps, cracks or holes for bats to utilise. The tile verge on the eastern end of the roof had been sealed with mortar, which remained fully intact. The roof was comprised of clay tile which were generally in a good condition, with one or two partially lifted, but not offering any significant gaps for bats to utilise. The lower row of tiles sat immediately over a line of black uPVC guttering, with a breathable roofing membrane extending beyond the end of the tiles. The guttering was affixed to a uPVC soffit which was fitted with ventilation gaps (too small to allow

bat access – see photograph below) and was tightly sealed to the brickwork. The roof was sealed to the elevation of the main property with lead flashing which was well-seated and offered no suitable gaps for bats to use. An ornamental climber was present at the eastern gable, sprawling to 2m height but offering sparse cover and with stems <5m in width and offering no potential roosting value to bats. Overall, there are no potential access points for bats or birds to get into the roof structure above the kitchen, and no potential roosting features (PRFs) were found during the external assessment.

*Well-sealed soffits to external brickwork.*

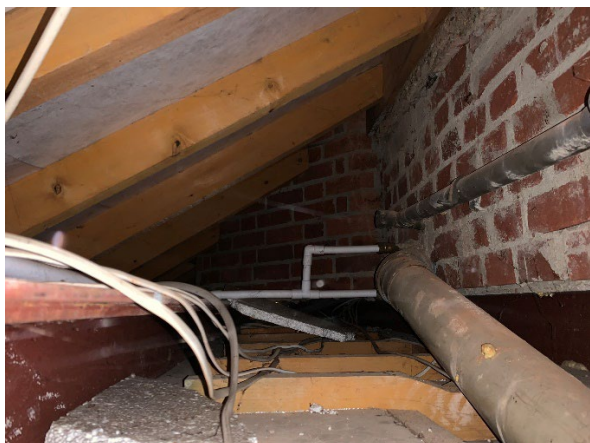
An inspection of the internal area found the kitchen to be in current use, with a small roof space above the usable area. The roof space was access via a hatch and was found to be approximately 1m wide and with a height of approximately 80cm. The roof comprised exposed timbers (smooth sawn) with the breathable membrane above and the tiles above. The timbers were un perfect condition, the membrane was intact and there were no PRFs noted. The brickwork elevation of the main building was visible and was found to be in a good condition, with no gaps/cracks and therefore no PRFs. Numerous services run through the roof space and spotlights into the kitchen below offered partial illumination. There was no insulation to the roof space.

In summary, no PRFs were identified and no bats or any evidence of bats, such as droppings, feeding remains or staining, were found anywhere within the roof space. Coupled with the external appraisal, **the kitchen area is concluded to be of Negligible Bat Roost Potential (BRP).**

*Roof space with exposed timbers and services.*

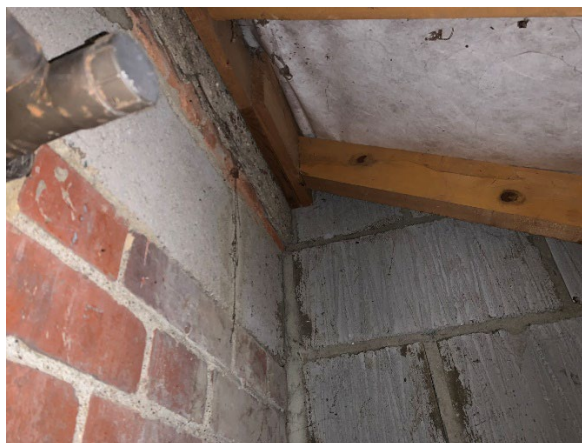
*Roof membrane and well-sealed brick/block work.*
